Denver Field Branch Bond Release Evaluation Report

Permittee:	Mountain Coal Company, LLC
Operator:	Mountain Coal Company, LLC
Site:	West Elk Mine
Permit No:	C-1980-007
Date of Inspection:	June 27 - 29, 2023
Inspection Type:	Partial Phase II and partial Phase III bond release
Weather:	Sunny and warm with dry ground conditions
Operator Representatives:	Garren Atchley, Mark Peirce, Nicki Poulos, Cody Rapke, and Jessica Wilczek
State Official:	Leigh Simmons
USDA - FS Official:	Dan Gray
OSMRE Official:	Tom Medlin #562

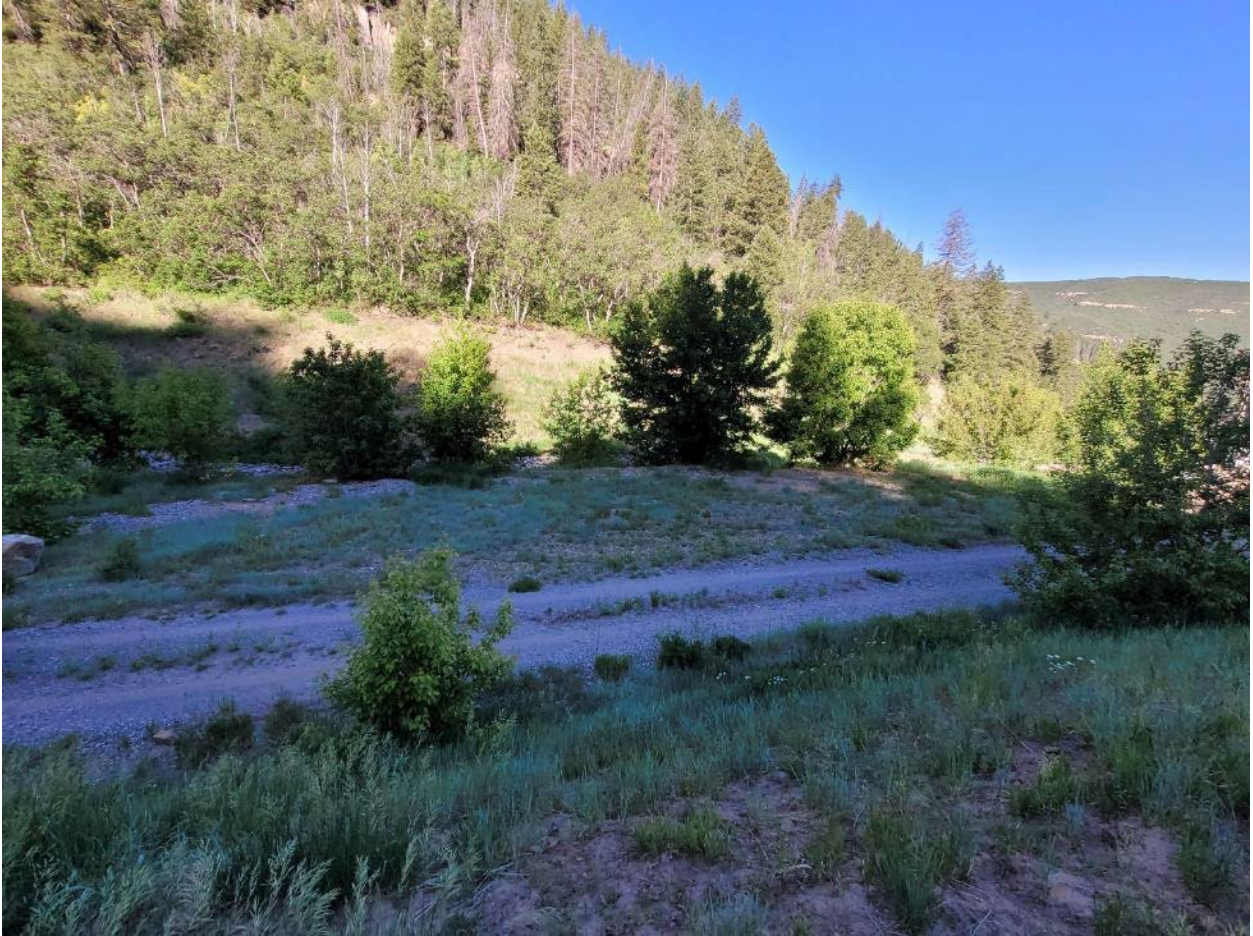
Figure 35. 24-09 and access road.

24-09: 0.10 ac. This pad was constructed around an access road that existed prior to mining. No issues.

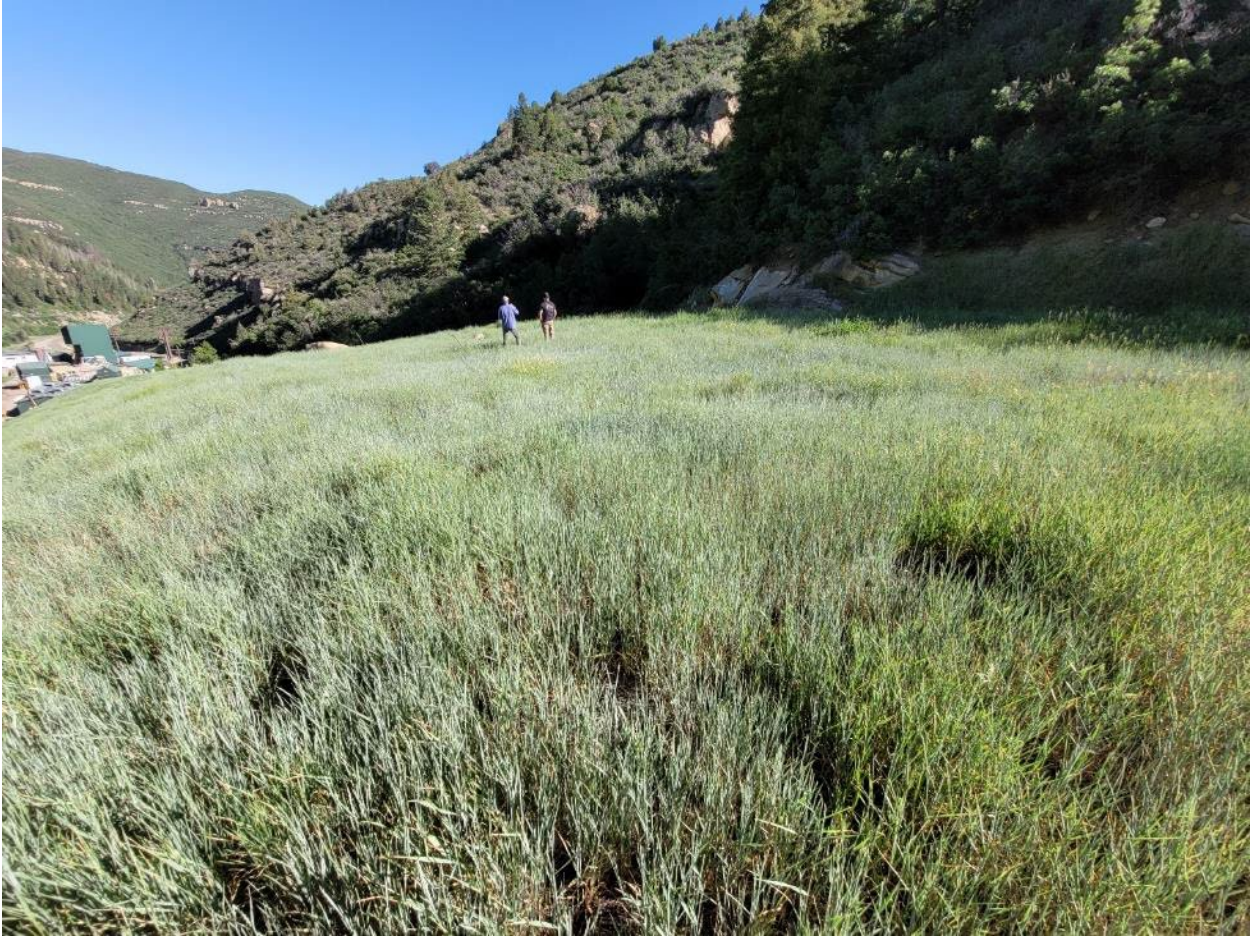
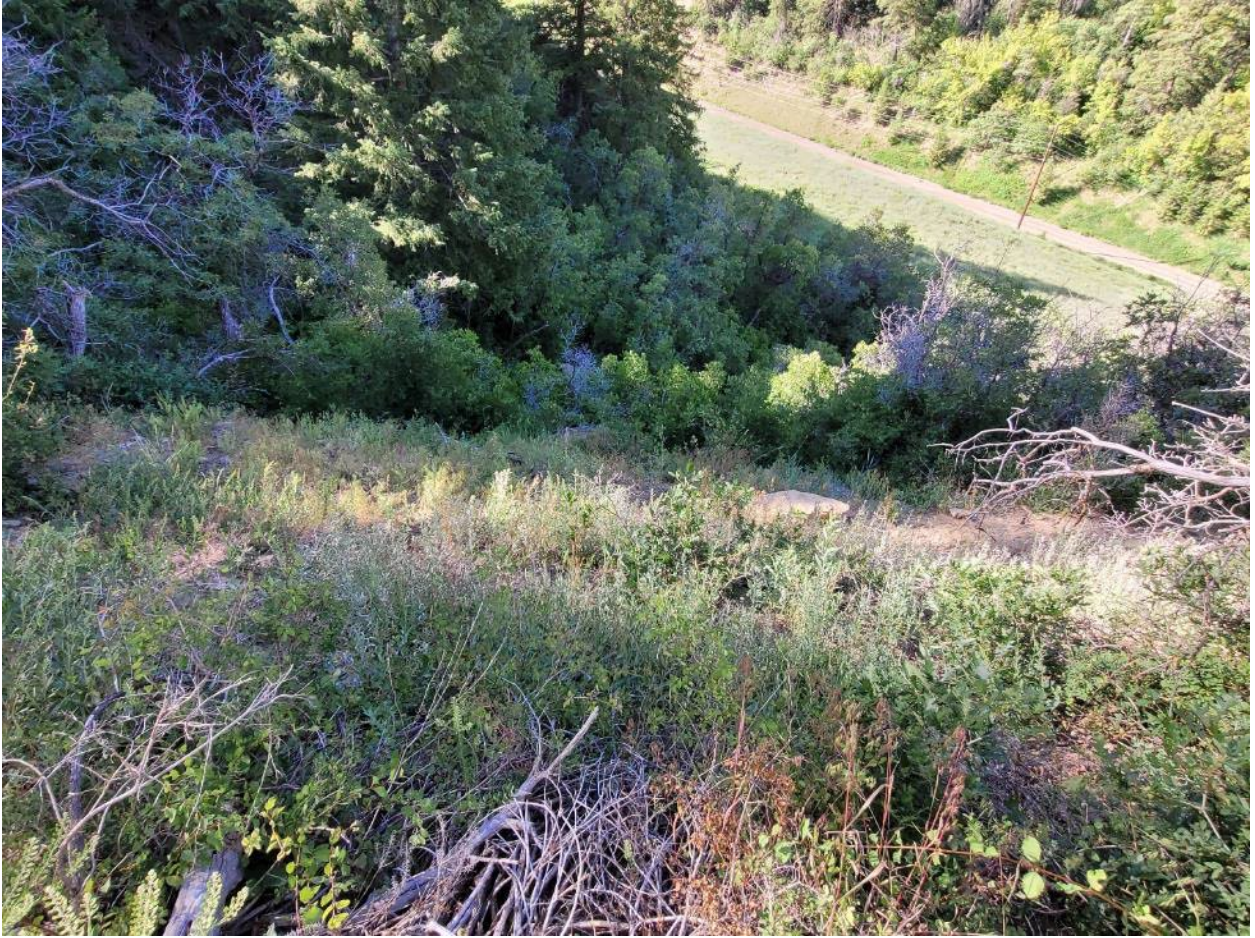
Figure 36. Topsoil stockpile atop 23HG3E3XC.

23HG3E3XC and 23HG1E3XC: 0.13 ac. In the time since plugging, abandonment, and reclamation of pad 23HG3EXC, a topsoil stockpile was bonded-for and constructed atop the pad. Therefore, reclamation bonding for the topsoil stockpile will remain after the Division's Proposed Decision under SL-17 becomes final. No issues.

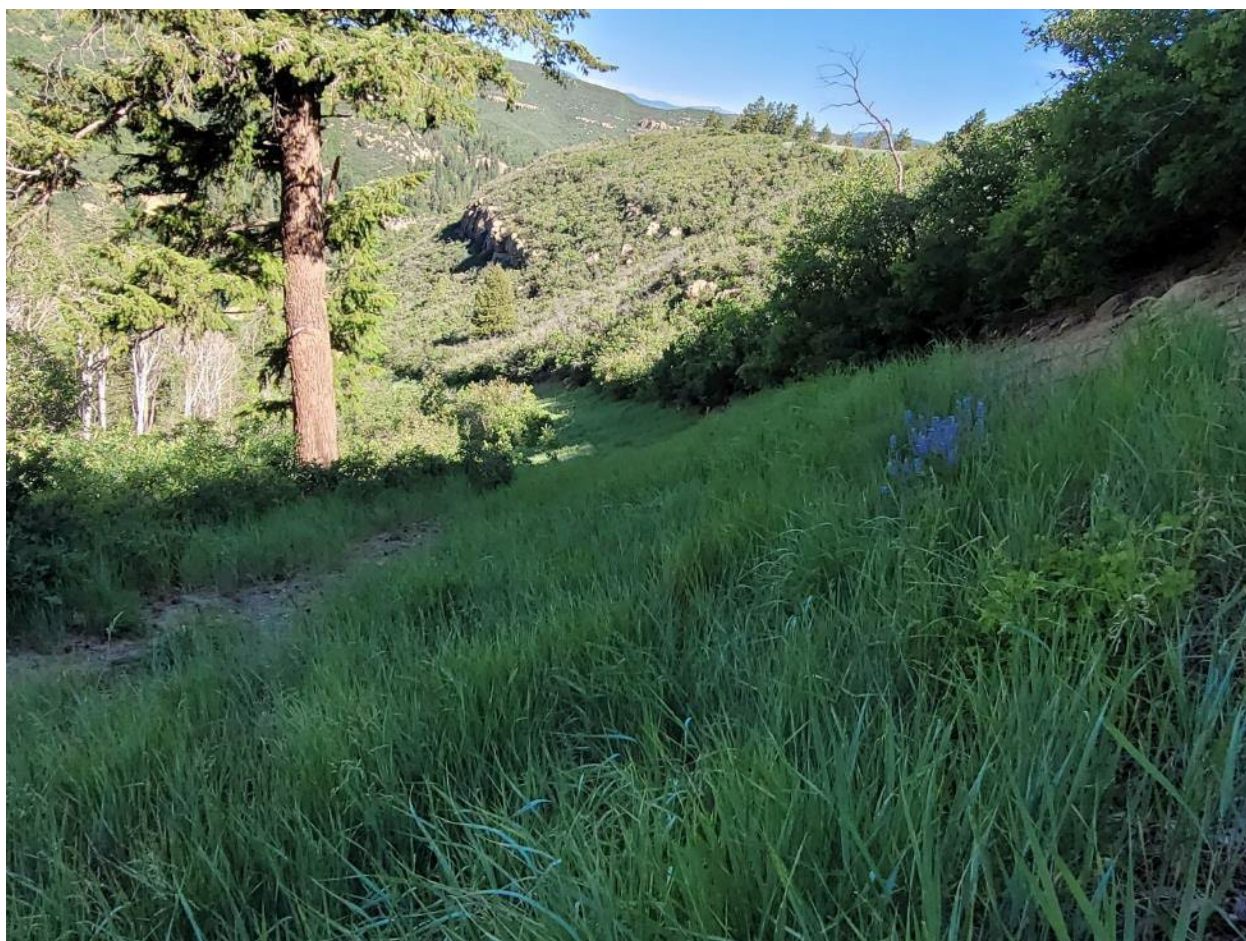
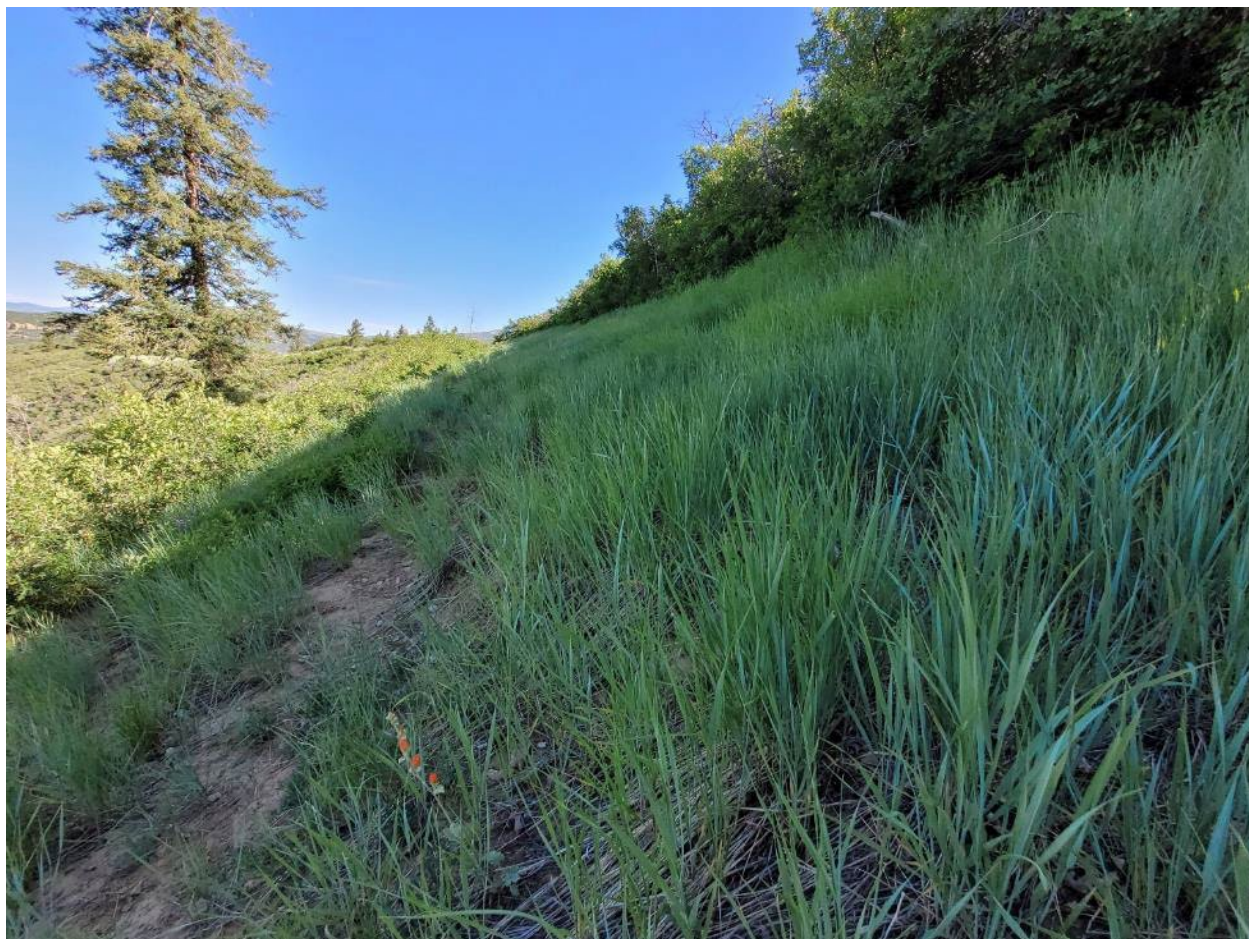
Figure 38. Road to 24HG1E3XC / 24HG1E4-5XC / 24HG2E5XC.

Road to 24HG2E5XC / 24HG1E4-5XC / 24HG1E3XC: 1.57 ac. Limited quantity of Canada thistle at the top of road; treat before release.

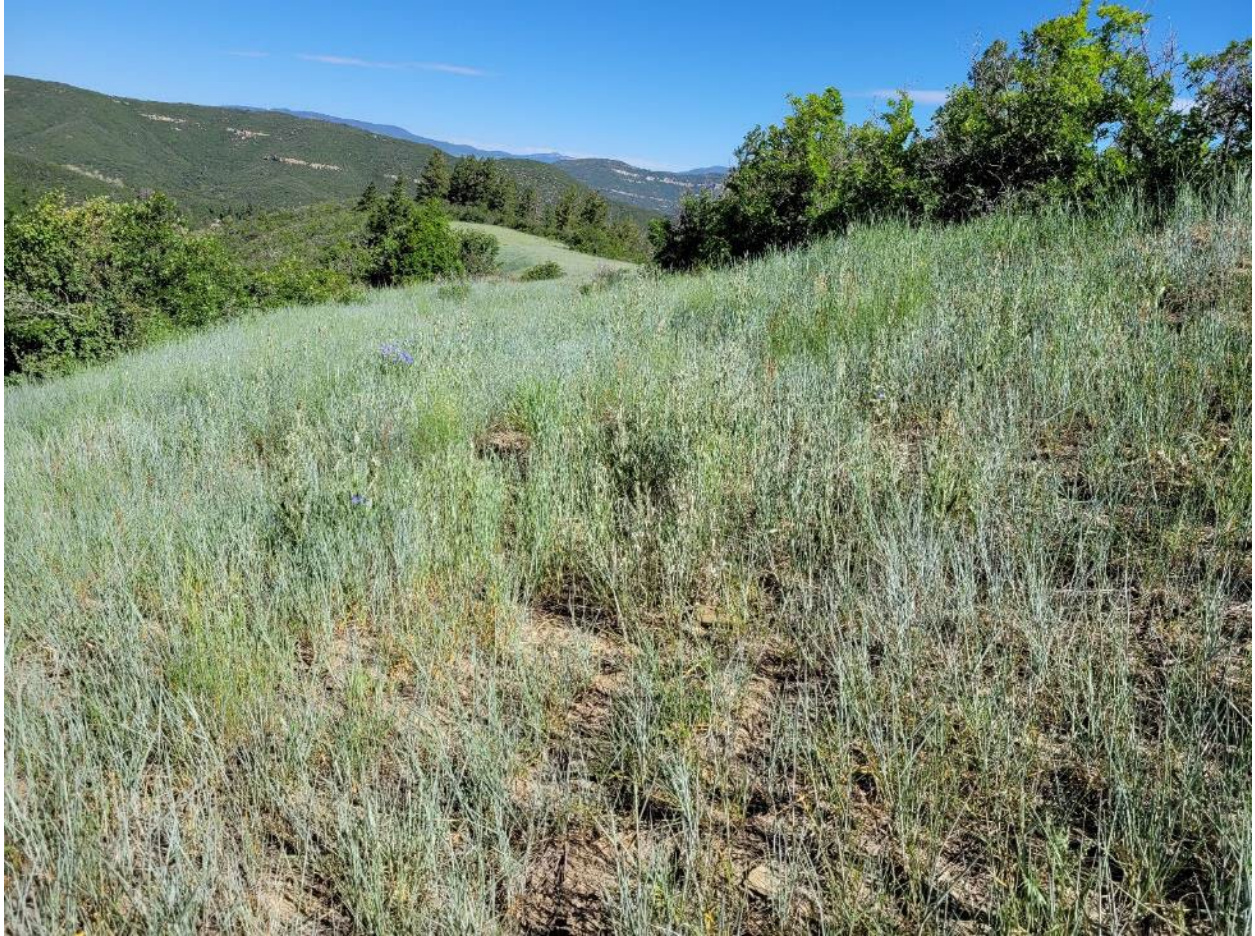
Figure 40. Road to 24HG1E3XC / 24HG1E4-5XC / 24HG2E5XC, final section. Limited Canada thistle interspersed, midground right.

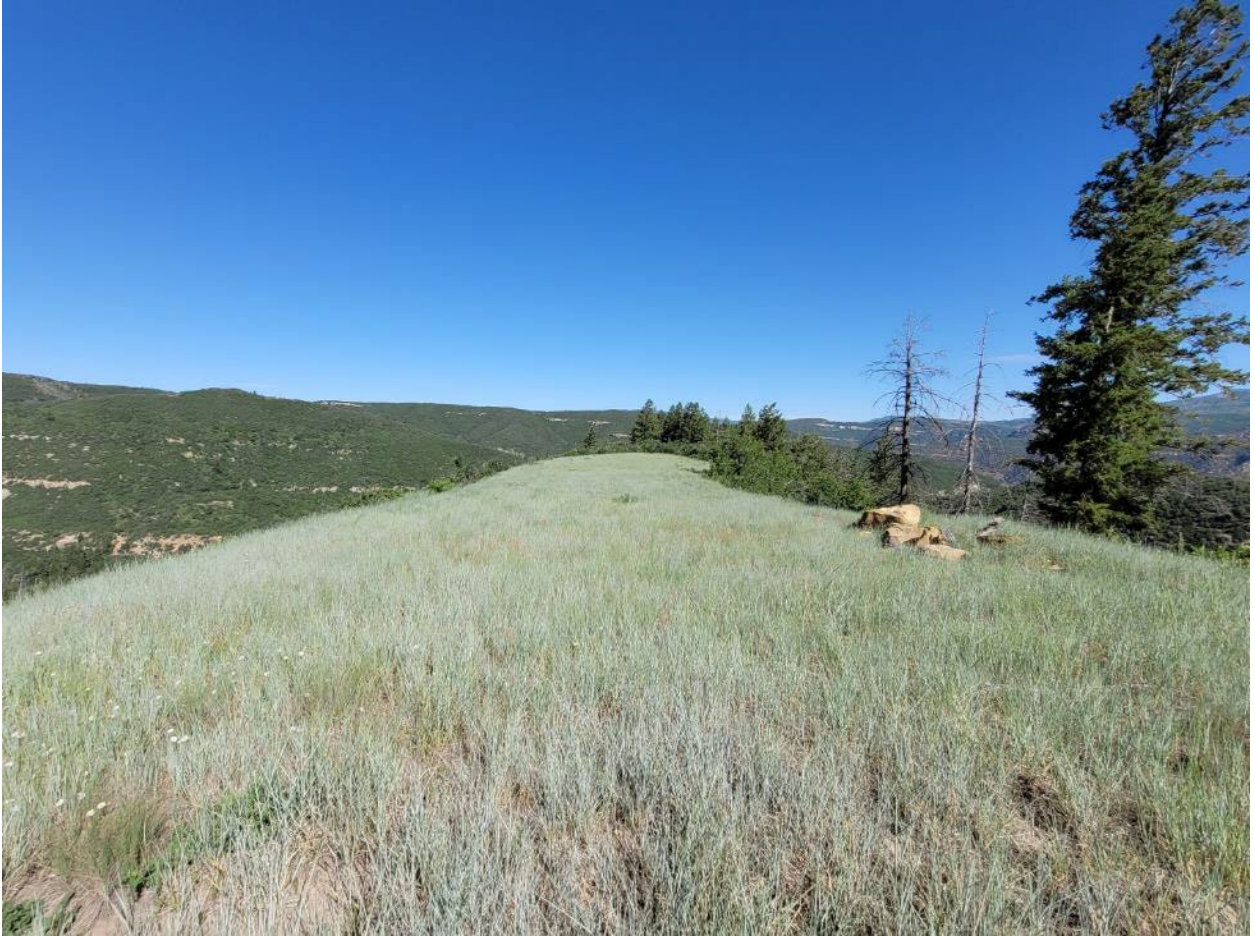
Figure 41. 24HG1E3XC / 24HG1E4-5XC / 24HG2E5XC.

24HG2E5XC / 24HG1E4-5XC / 24HG1E3XC: 0.90 ac. No issues.
