MINERALS PROGRAM INSPECTION REPORT
PHONE: (303) 866-3567

MINE NAME: LGPD2 Mine	MINE/PROSPECTING ID#: M-2019-026	MINERAL: Gemstones	COUNTY: Park
INSPECTION TYPE: Monitoring	WEATHER: Raining	INSP. DATE: July 24, 2023	INSP. TIME: 13:00
OPERATOR: Michael Royer	OPERATOR REPRESENTATIVE: None	TYPE OF OPERATION: 110(1) - Hard Rock Limited Impact	
REASON FOR INSPECTION: Normal I&E Program	BOND CALCULATION TYPE: Complete Bond	BOND AMOUNT: \$5,000.00	
DATE OF COMPLAINT: NA	POST INSP. CONTACTS: U.S. Forest Service	JOINT INSP. AGENCY: None	
INSPECTOR(S): Elliott Russell	INSPECTOR'S SIGNATURE:

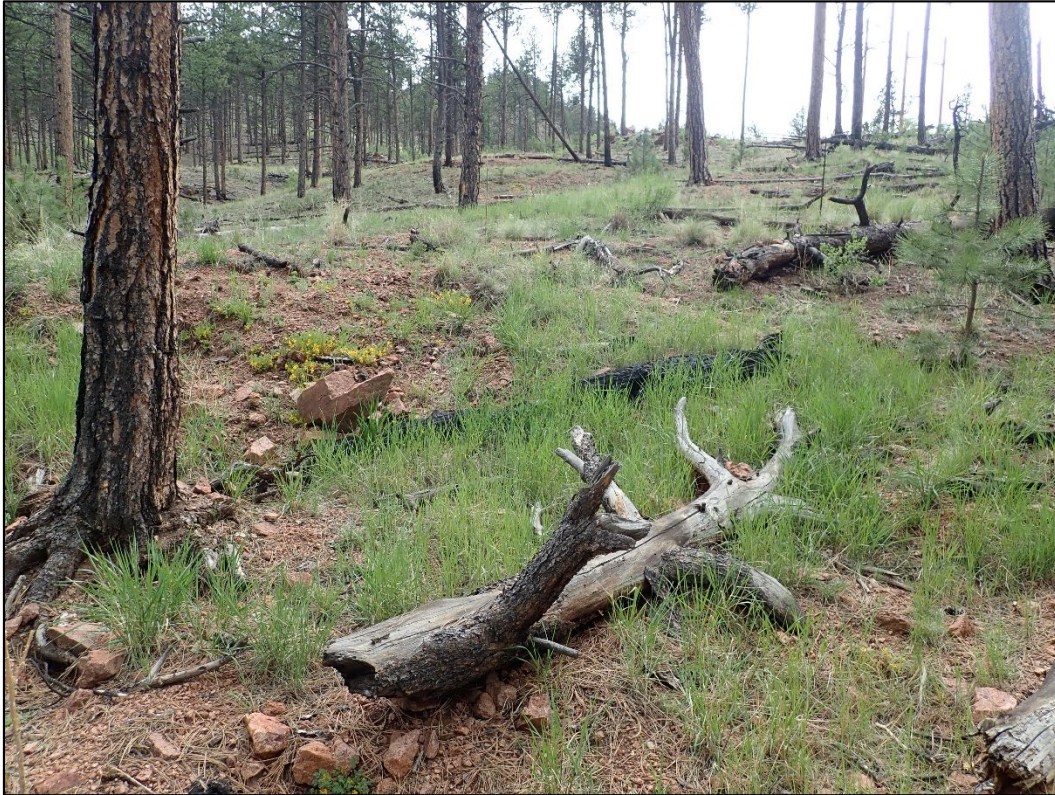
Photo 1. Reclaimed dig area in the northeast part of the permit; looking south.

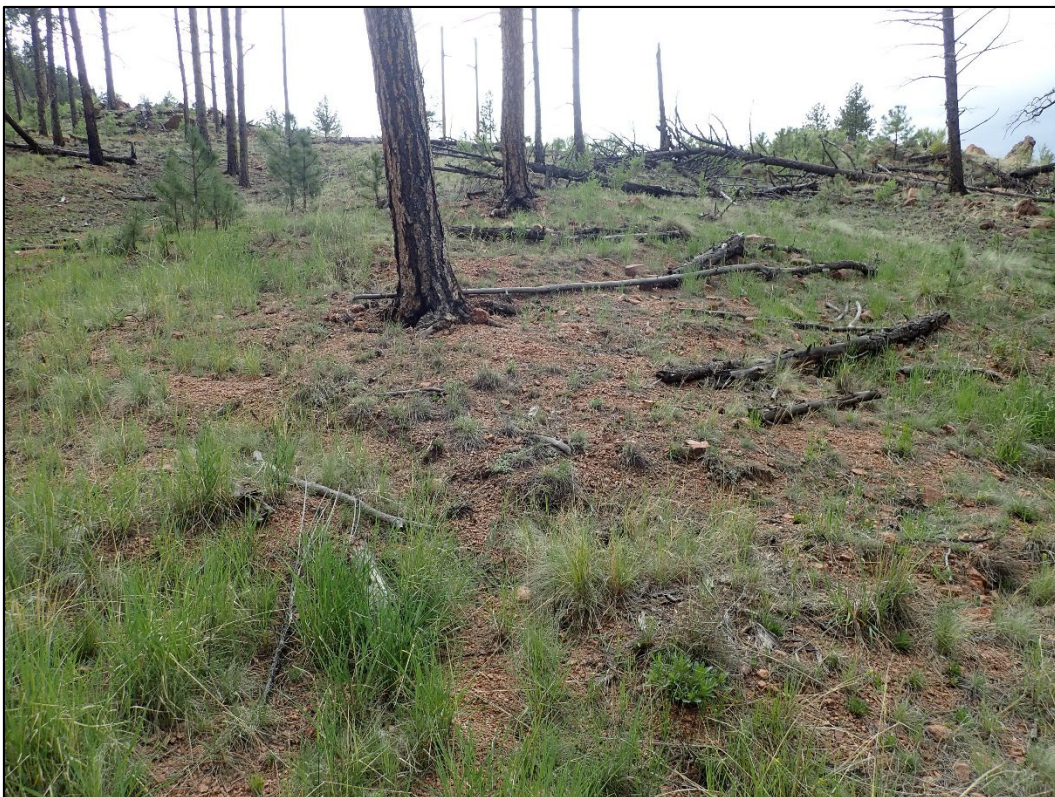
Photo 2. Reclaimed dig area in the northeast part of the permit; looking south.

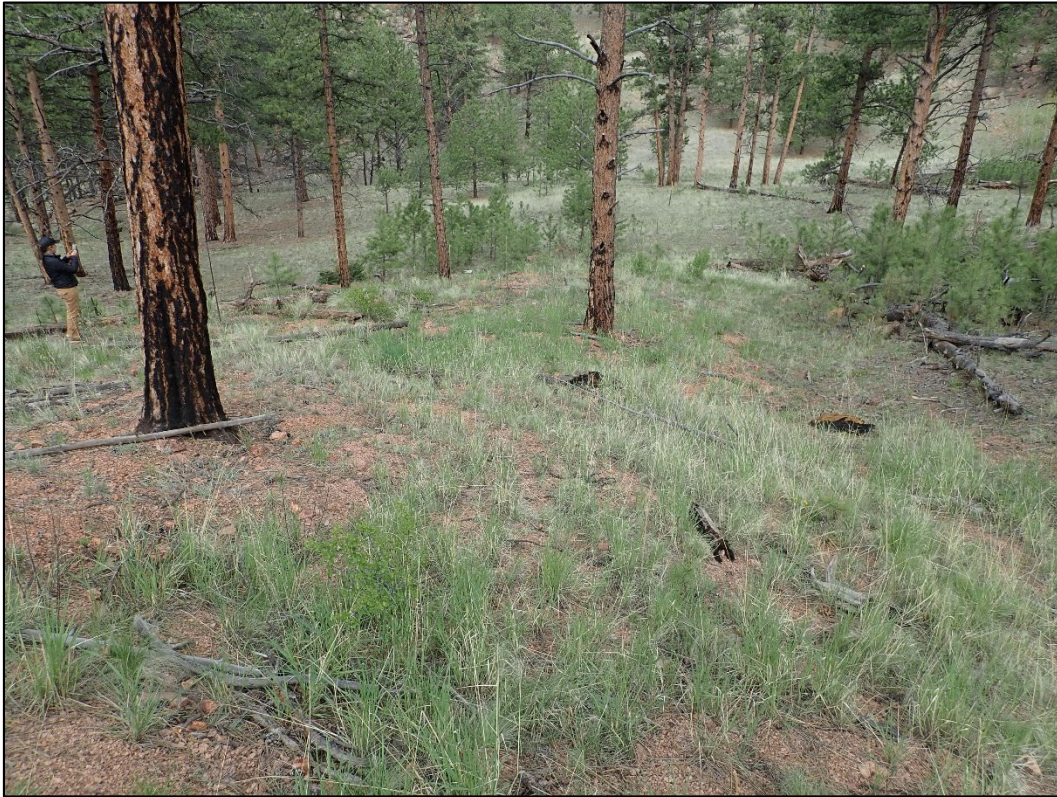
Photo 3. Reclaimed dig area in the northeast part of the permit; looking northeast.

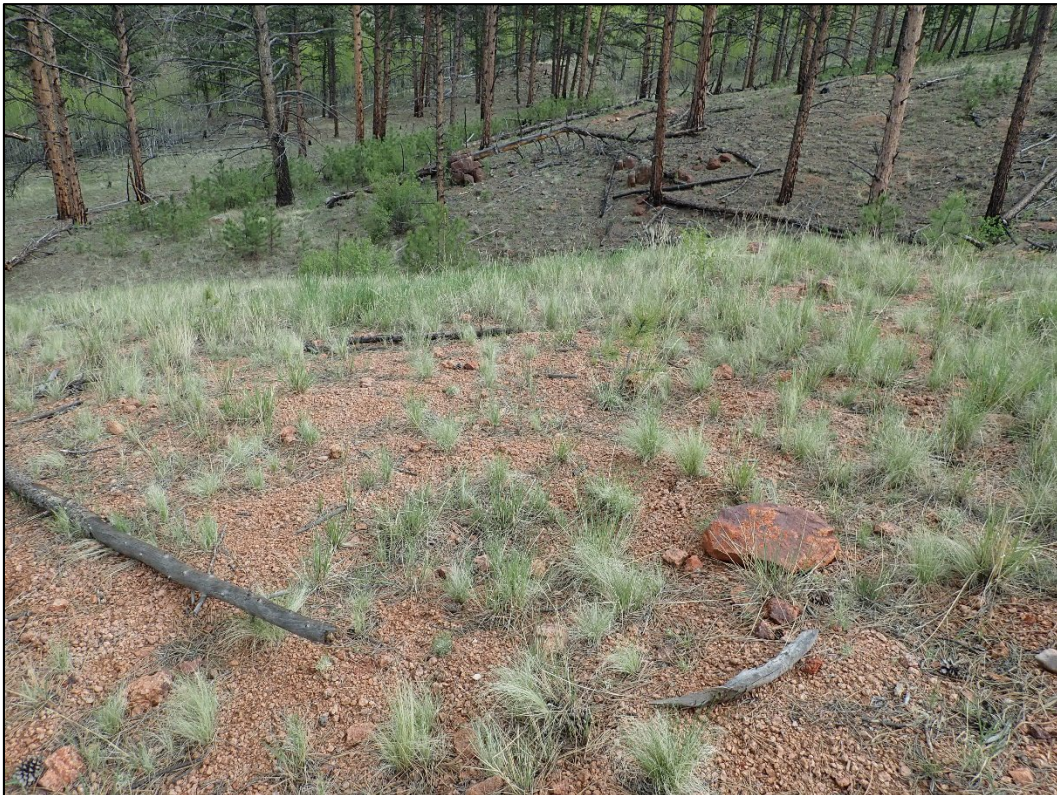
Photo 4. Reclaimed dig area in the northeast part of the permit; looking east.

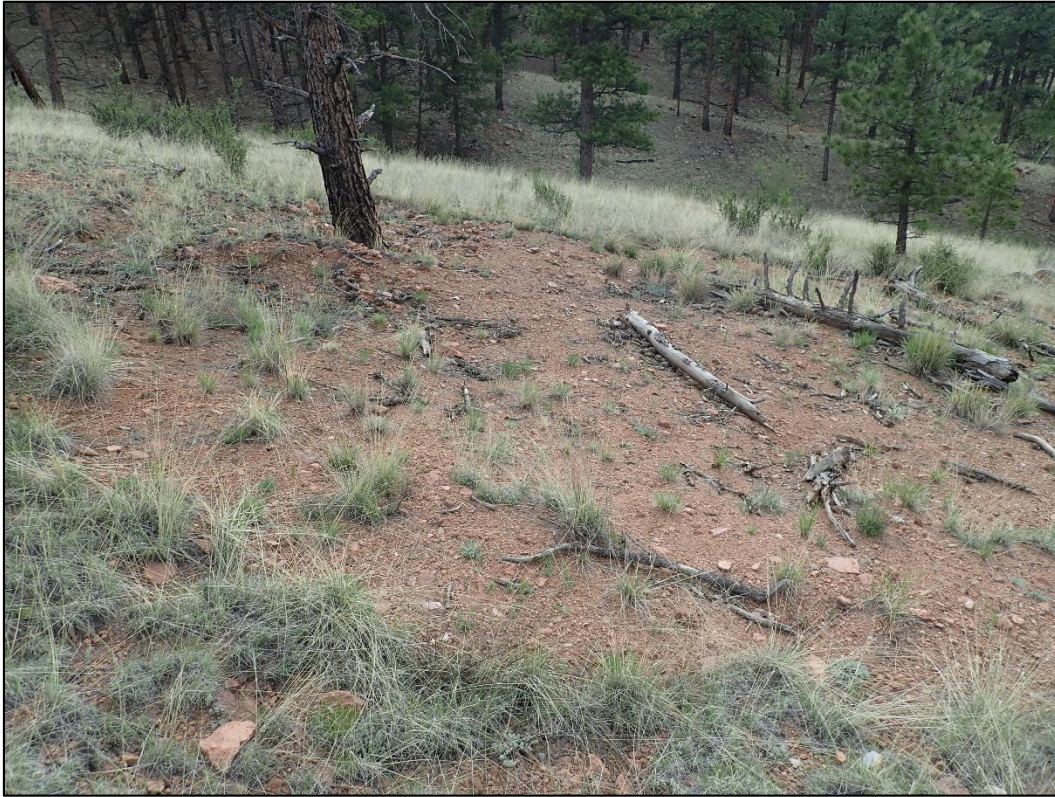
Revegetation: The affected lands were vegetated with a diverse community of grasses. Vegetative cover appeared to match or exceed adjacent off-site areas. No noxious weed infestations were observed. The southwest reclaimed dig sites were sparsely vegetated as compared to the northeast dig sites; this is likely due to being a south-southwest facing slope with little to no tree overstory to provide regulated soil temperatures and moisture retention, however these areas were appropriately reclaimed based on nearby undisturbed lands with similar conditions.

Photo 5. Reclaimed dig area in the southwest part of the permit; looking south.

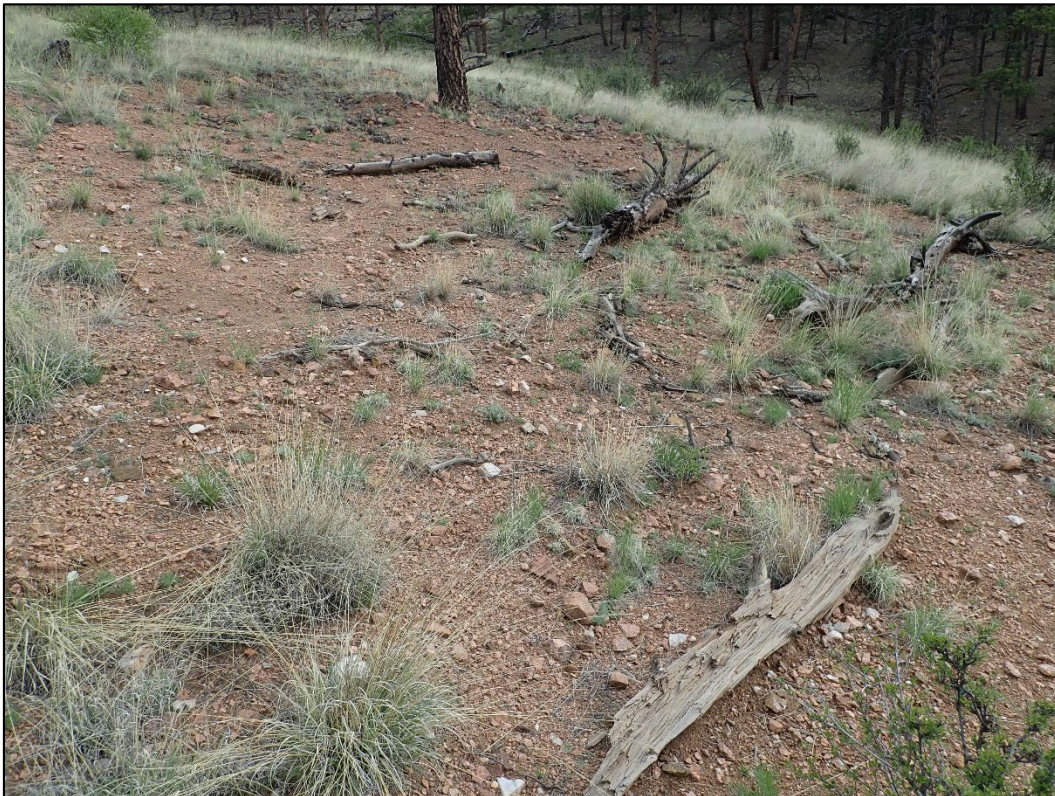
Photo 6. Reclaimed dig area in the southwest part of the permit; looking southeast.

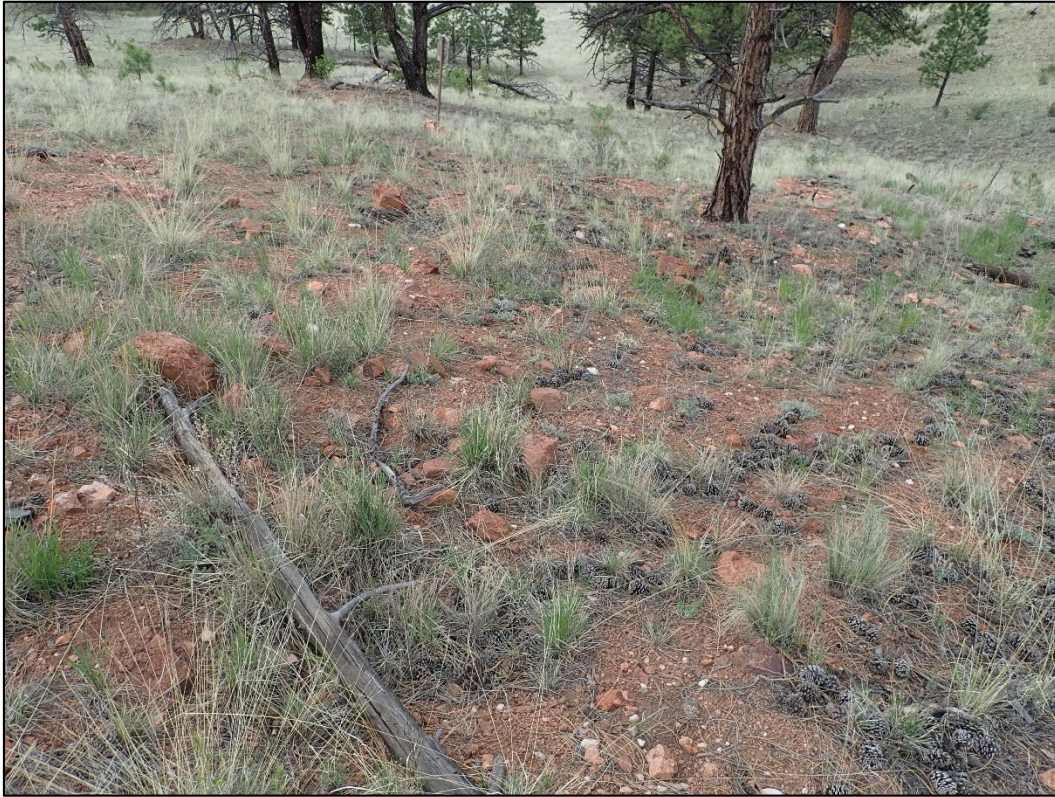
Photo 7. Reclaimed dig area in the southwest part of the permit; looking west.
