DRMS inspection report

MINERALS PROGRAM INSPECTION REPORT

MINE NAME: Anderson Pit	MINE/PROSPECTING ID#: M-2005-021	MINERAL: Sand and gravel	COUNTY: Delta
INSPECTION TYPE: Monitoring	WEATHER: Clear	INSP. DATE: July 18, 2023	INSP. TIME: 10:40
OPERATOR: Oldcastle SW Group, Inc. dba United Compas County	OPERATOR REPRESENTATIVE: Jesse Farmer	TYPE OF OPERATION: 112c - Construction Regular Operation

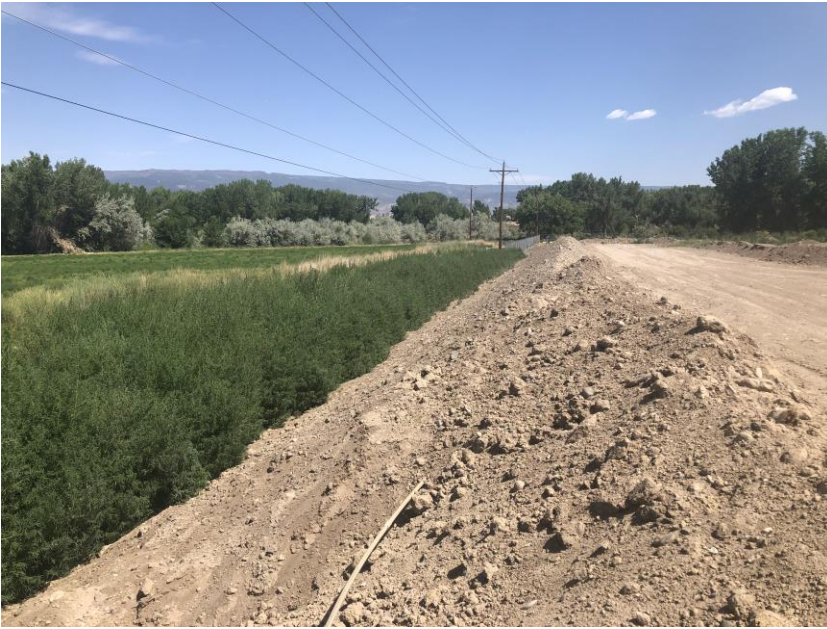
The berms around the pit area appear to be functioning well and preventing off-site impacts. The large trees in the buffer beside the Hutchins property (near northwest corner of site) appeared to be very healthy and include ponderosa pines and cottonwood.

Berm on west side of site, looking toward northwest corner

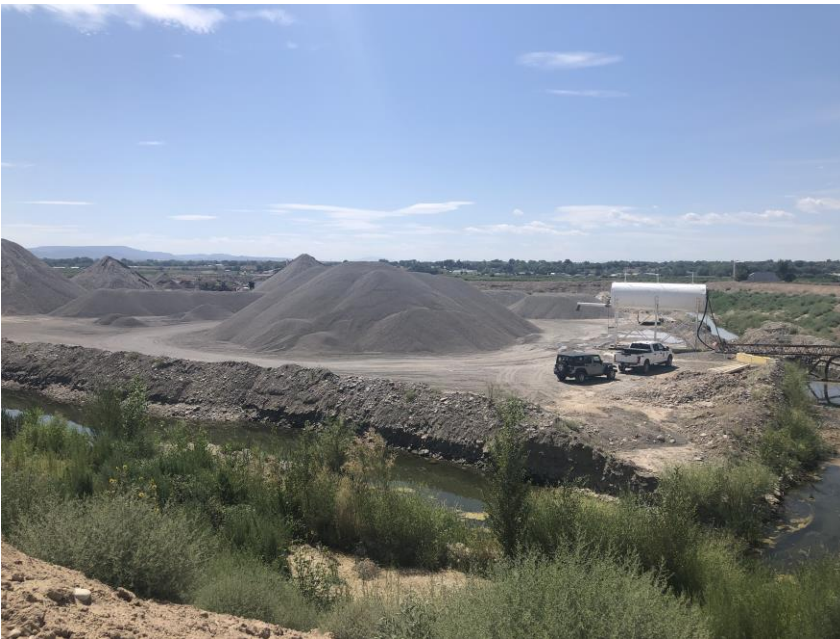
Pit excavation is completed in what is approximately the Phase 1 area. This area is approximately 12 feet below grade, as measured with a laser rangefinder (distance meter). Several piles of product were seen in this area, as well as piles of asphalt and concrete for recycling.

Phase 1 area from northwest corner of pit

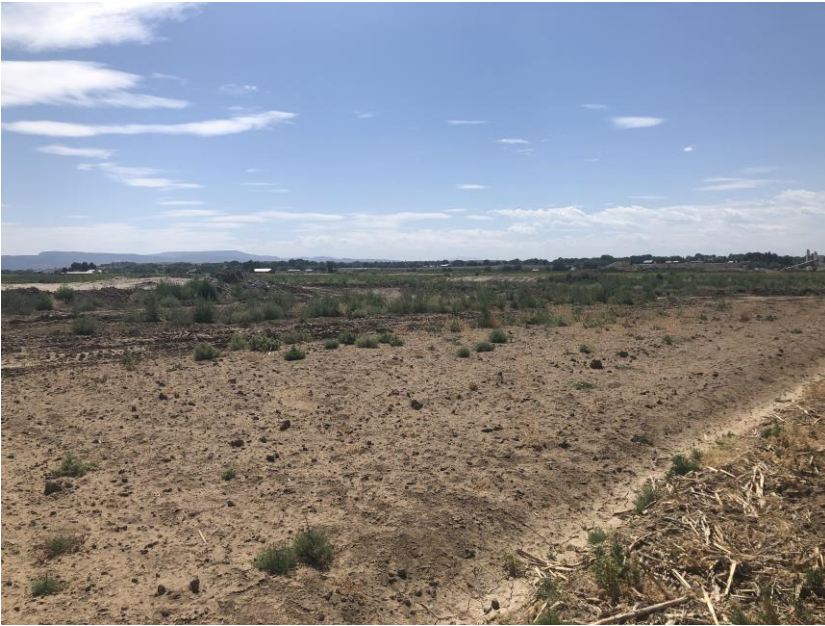
On the area that is approximately Phase 3 on Map C-2, the operator has begun to scrape topsoil off the top and dig a drainage ditch on the edge.

Newly disturbed area (approximately Phase 3)

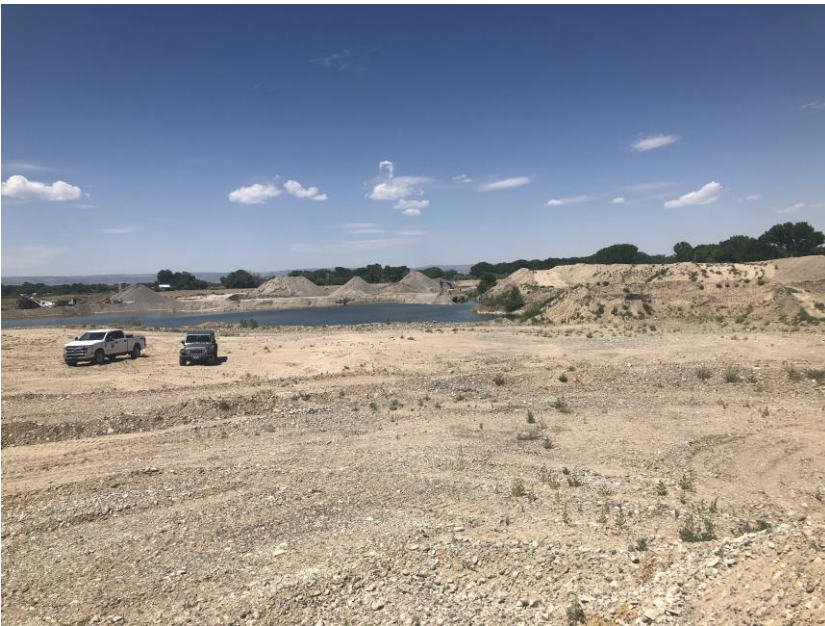
Looking southwest from northeast corner of pit

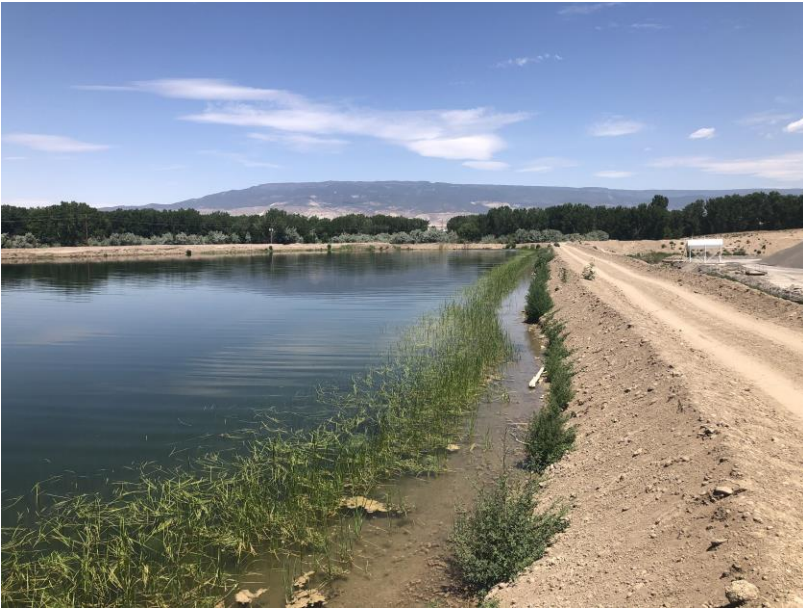
Dewatering trenches exist around the site, and a sump and two settling ponds have been constructed along the west side of the pit. The sump and ponds appear to be functioning to reduce loading of sediment offsite. Cattails and birds were seen at the northern pond. The discharge water was very clear entering the discharge pipe. Only one pond is shown on Map C-2 for the site, and a Technical Revision will be required to update the text (Exhibit D) and Map C-2 to better describe these structures.

Looking north from southeast corner of large settling pond

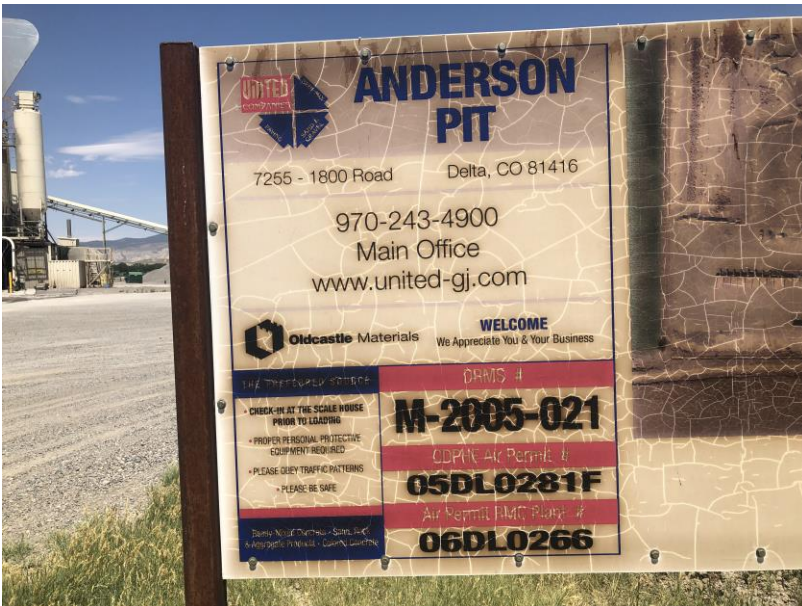
An adequate mine identification sign was clearly visible at the entrance to the site. The affected area was marked by fencing and landmarks that were clearly visible and adequate to delineate the affected area boundary.

Entrance sign
