MINERALS PROGRAM INSPECTION REPORT
PHONE: (303) 866-3567

MINE NAME: Branson Gravel Pit	MINE/PROSPECTING ID#: M-1997-100	MINERAL: Gravel	COUNTY: Las Animas
INSPECTION TYPE: Monitoring	WEATHER: Clear	INSP. DATE: July 19, 2023	INSP. TIME: 14:30
OPERATOR: Las Animas County	OPERATOR REPRESENTATIVE: Nick Lingus	TYPE OF OPERATION: 112c - Construction Regular Operation	
REASON FOR INSPECTION: Normal I&E Program	BOND CALCULATION TYPE: None	BOND AMOUNT: \$0.00	
DATE OF COMPLAINT: NA	POST INSP. CONTACTS: None	JOINT INSP. AGENCY: None	
INSPECTOR(S): Brock Bowles	INSPECTOR'S SIGNATURE:

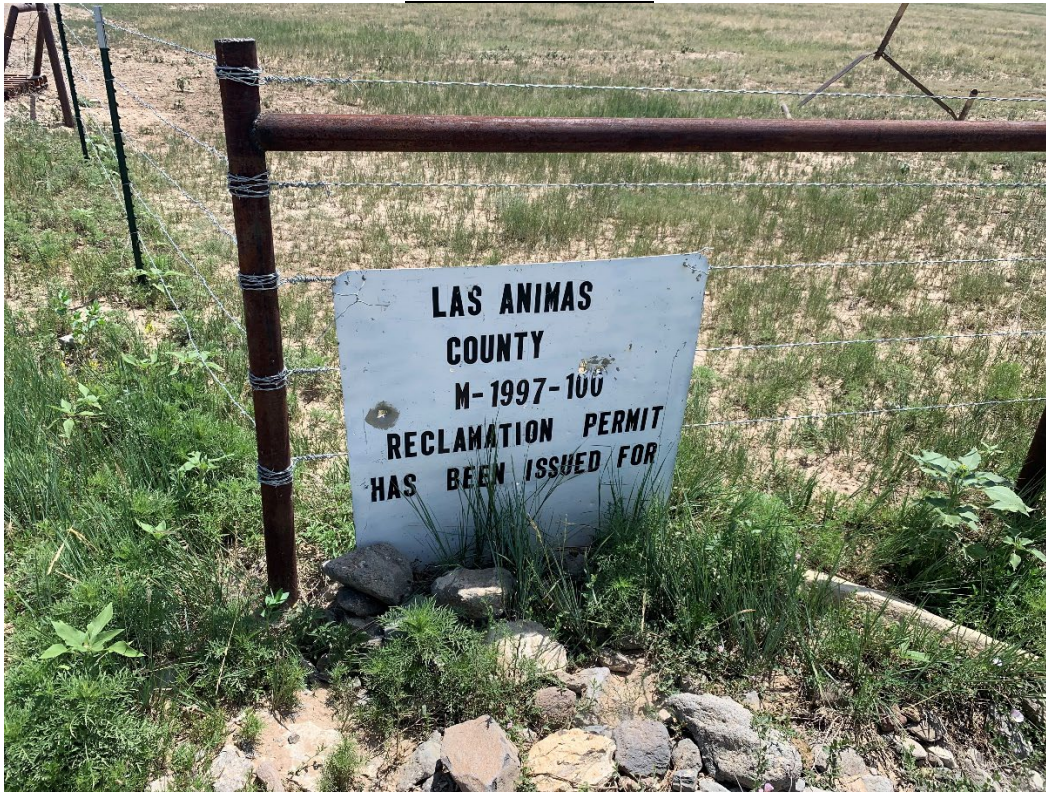
The mine entrance sign was in place at the entrance facing CR 4 (photo 1). T-posts were used to mark the permit boundary and were in place at the corners of the permit boundary.

Photo 1 – Mine entrance sign facing CR 4

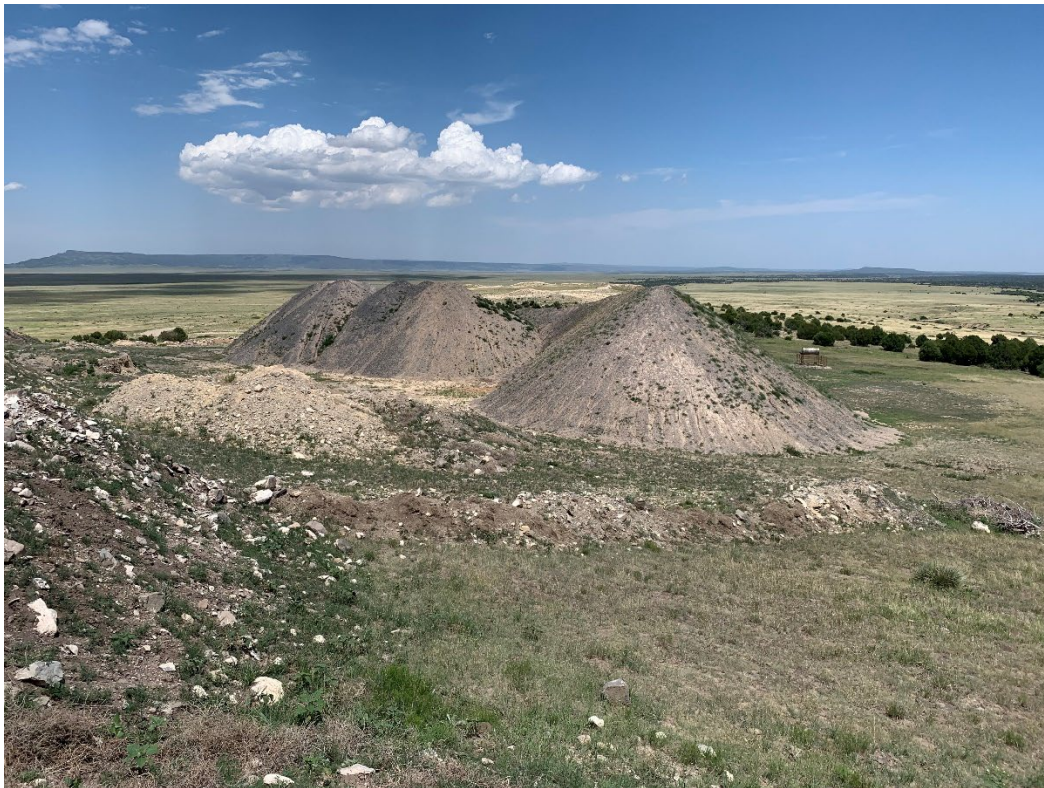
The site consists of an east and west mining areas. Both areas are on a hilltop with the product stockpiles located in the saddle area between the mining areas (photo 2).

Photo 2 – Product stockpiles in the saddle area between hilltops

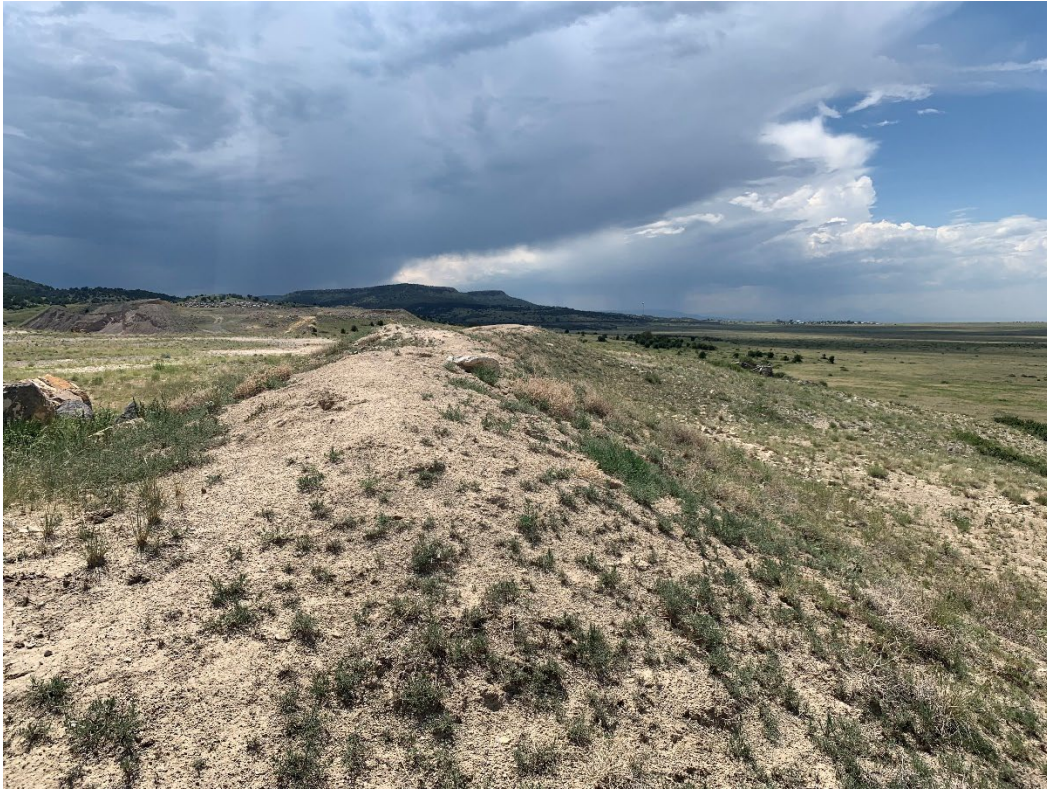
The east mining area is mostly mined out and has not been reclaimed. A berm was in place around the perimeter of the pit area (photo 3). No erosion features were seen and there was no sign of standing water.

Photo 3 – Eastern pit area, berm on north side facing west

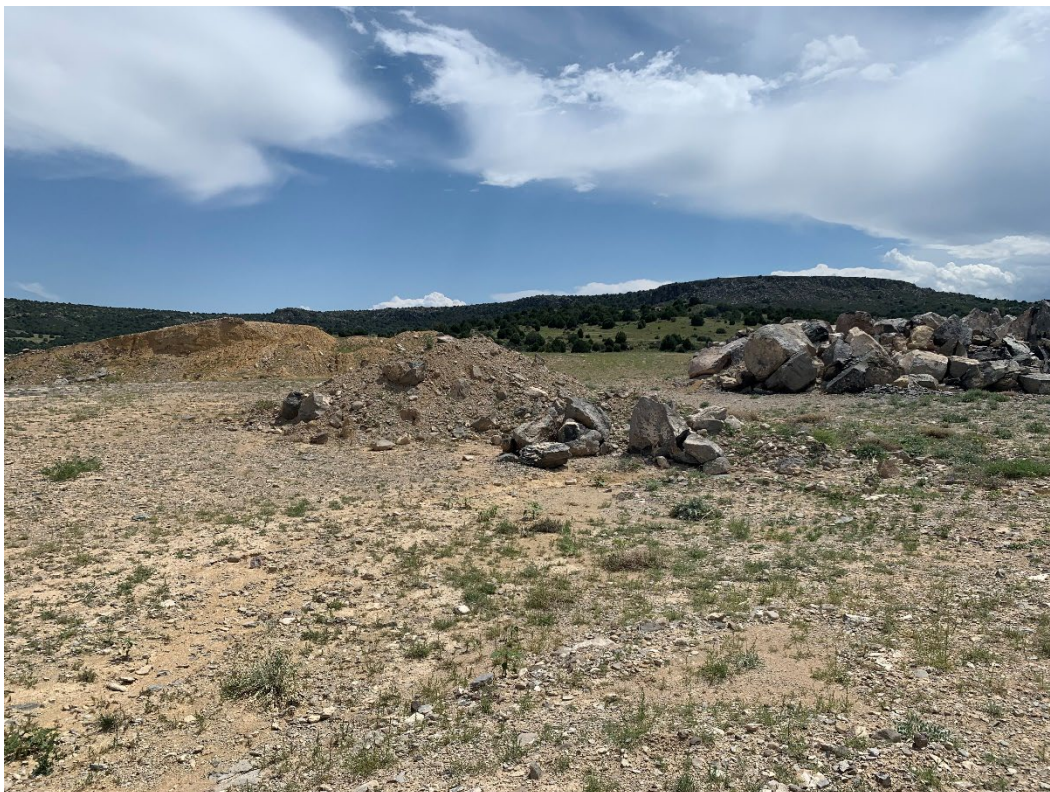
The west area contained some large rock piles and a gravel stockpile (photo 4). A contractor is hired as needed to crush and sort the gravel. The mined area was surrounded by a berm. The area was sloped to the east directing surface runoff to the saddle area. A few small rills/gullies were noted where the pit drains to the saddle area.

Photo 4 – West mining area
