## MINERALS PROGRAM INSPECTION REPORT

<b>MINE NAME:</b> Airport Gravel Pit	<b>MINE/PROSPECTING ID#:</b> M-1983-039	<b>MINERAL:</b> Sand and gravel	<b>COUNTY:</b> Las Animas
<b>INSPECTION TYPE:</b> Monitoring	<b>WEATHER:</b> Cloudy	<b>INSP. DATE:</b> July 19, 2023	<b>INSP. TIME:</b> 14:30
<b>OPERATOR:</b> Las Animas County	<b>OPERATOR REPRESENTATIVE:</b> Clint Chavez	<b>TYPE OF OPERATION:</b> 112c - Construction Regular Operation	
<b>REASON FOR INSPECTION:</b> Normal I&E Program	<b>BOND CALCULATION TYPE:</b> None	<b>BOND AMOUNT:</b> \$0.00	
<b>DATE OF COMPLAINT:</b> NA	<b>POST INSP. CONTACTS:</b> None	<b>JOINT INSP. AGENCY:</b> None	
<b>INSPECTOR(S):</b> Brock Bowles	<b>INSPECTOR'S SIGNATURE:</b>

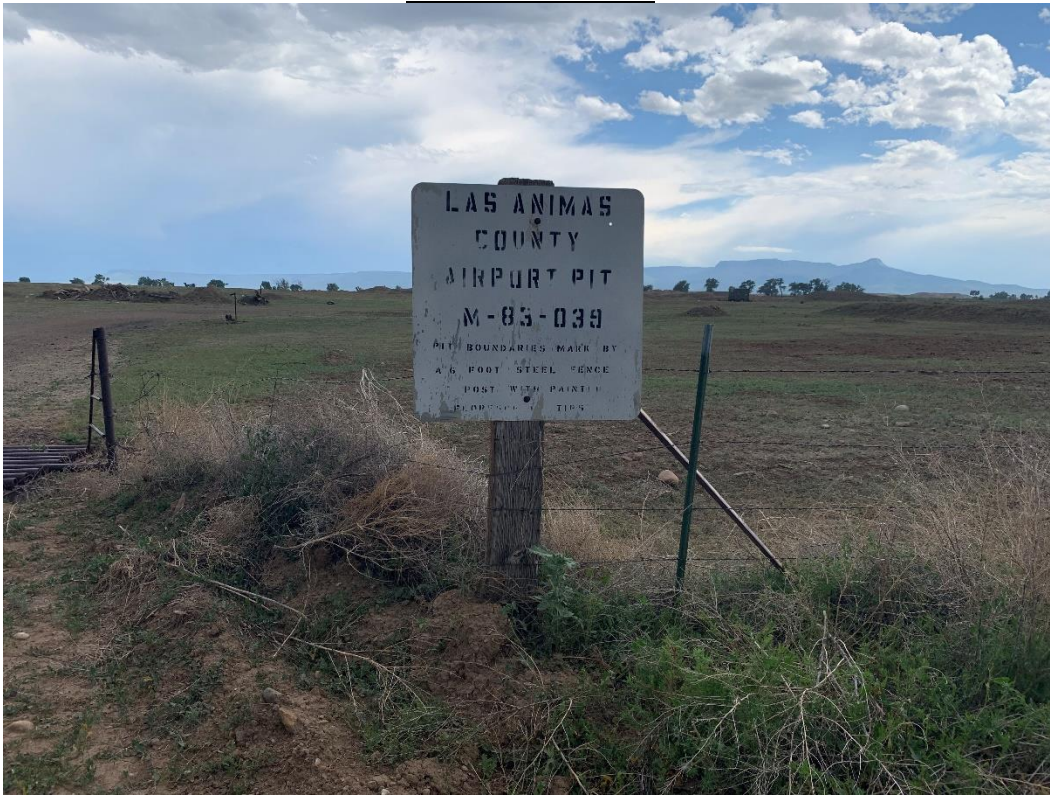
The mine entrance sign was in place at the entrance facing CR 36 (photo 1). A fenceline delineates the permit boundary on all sides.

Photo 1 – Mine entrance sign facing CR 36

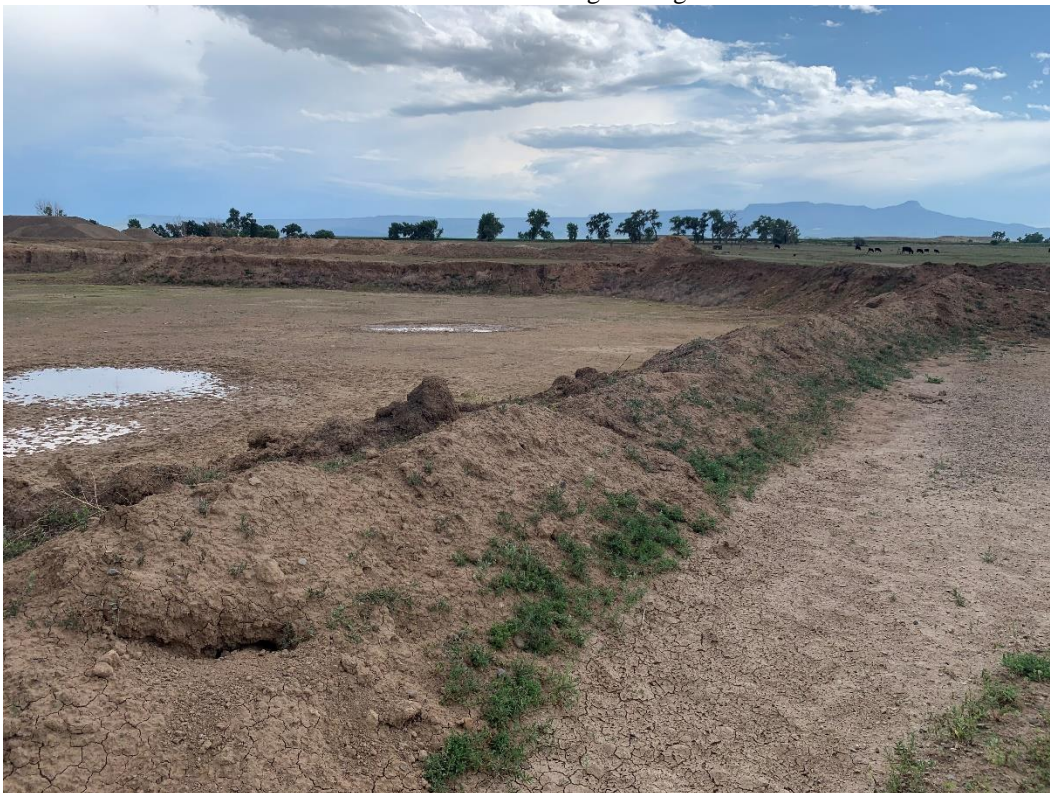
Mining is taking place in the eastern part of the pit. The main pit area is about 6 feet deep and a bout 10 acres in size (photo 2). The product stockpile is north of the mining area (photo 3). A contractor is hired to process the gravel on an as needed basis. Topsoil stockpiles were located around the pit with some vegetation on them.

Photo 2 – East end of mining area

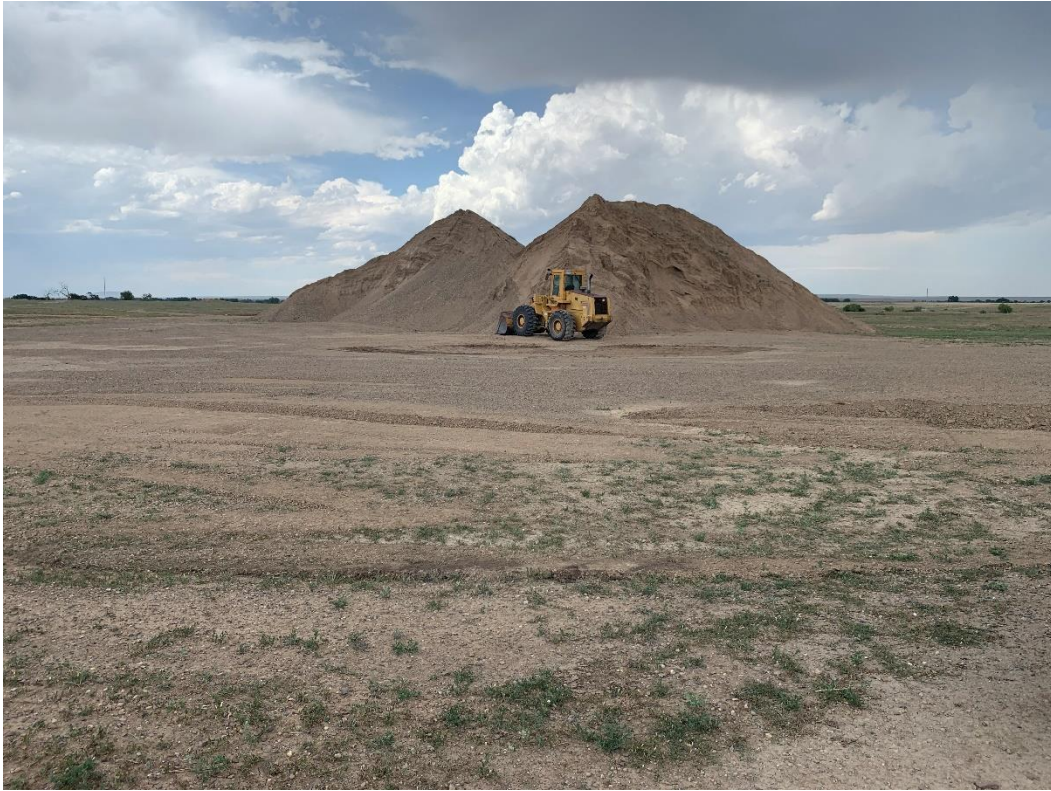
Photo 3 – Product stockpile northwest of pit area

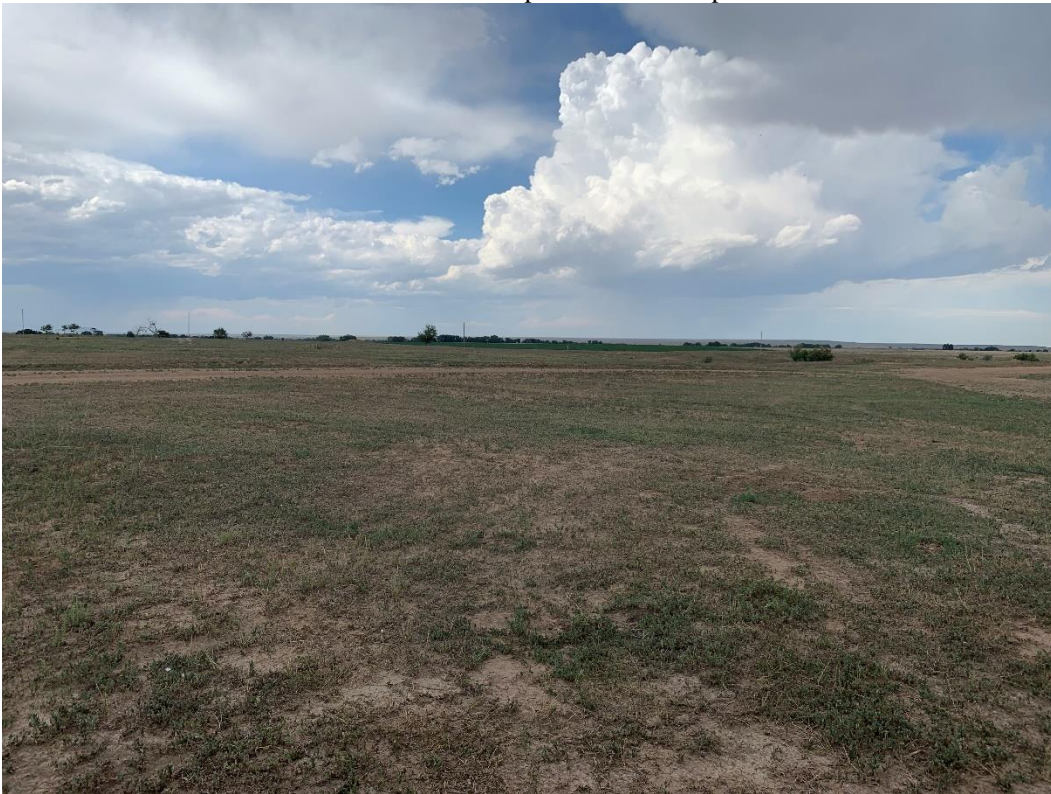
The western part of the permit area has mostly been reclaimed with the exception of the area around the old screening/crushing equipment (photo 4). The overall topography of the site is very flat and the only erosion features seen were located in the pit areas. The reclaimed areas appeared to be stable. No noxious weeds were noted on the site.

Photo 4 – Reclamation on western side of permit area
