Roadside Mine, C-1981-041, July Partial Inspection Report

PERMIT INFORMATION

Permit Number: C-1981-041 Mine Name: Roadside Portals Operator: Snowcap Coal Company, Inc Operator Address: Ms Tonya Hammond P.O. Box 1430 Palisade, CO 81526	County: Mesa Operation Type: Underground Permit Status: Active Ownership: Private
	Operator Representative Present: Tonya Hammond
Operator Representative Signature: (Field Issuance Only)

INSPECTION INFORMATION

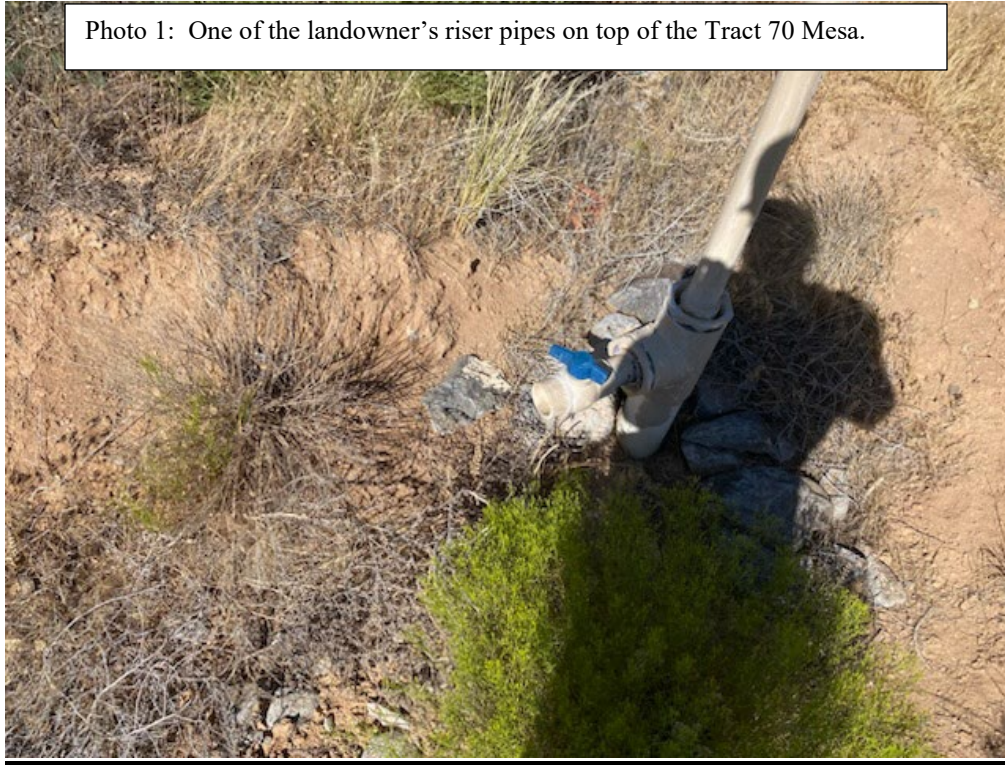
At the time of the inspection the landowners riser pipes on the Tract 70 Mesa were turned off. There was no evidence of recent water application to the trenches from the riser pipes (Photo 1). The land owner's middle field was also dry with no water application to the field being conducted. The landowner's pipe located at the southeastern section of Tract 71 was not connected. The trenches running along the east and north portions of Tract 71 were dry during the inspection (Photo 2). There was no evidence of recent water application to these trenches. The Carey pit, located at the southwest section of Tract 71 was also dry (Photo 3). A small section of the landowner's buried pipeline at the southern section of Tract 71 appeared to have had a recent leak. A small area of the pipe had been uncovered. This section of the landowner's buried pipeline was adjacent to SCC's new buried pipeline associated with the approved water augmentation plan. There did not appear to be any impact to SCC's buried pipeline (Photo 4).

Photo 1: One of the landowner's riser pipes on top of the Tract 70 Mesa.

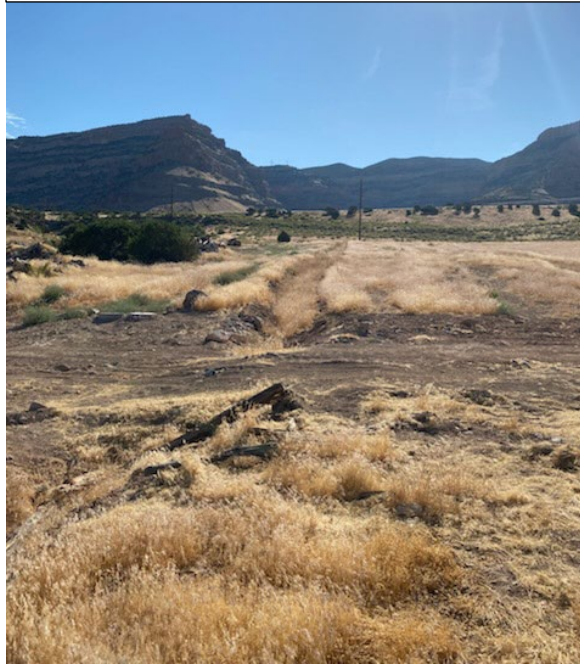
Photo 2: The landowner's trench on the northern part of Tract 71. The photo was taken looking to the east.

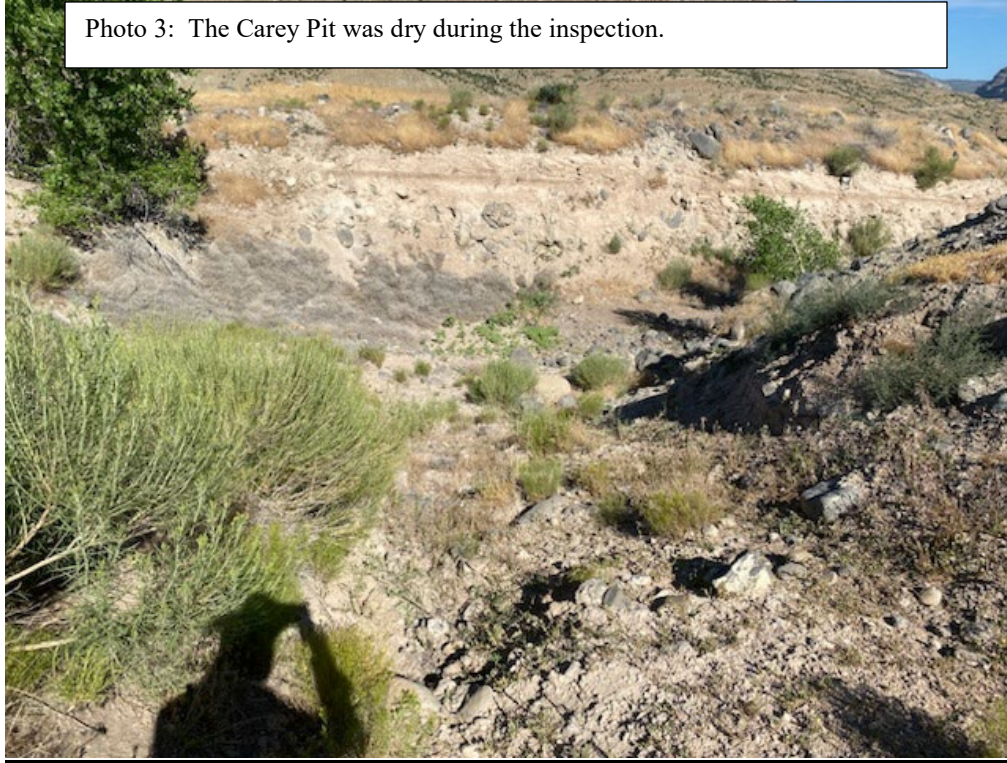
Photo 3: The Carey Pit was dry during the inspection.

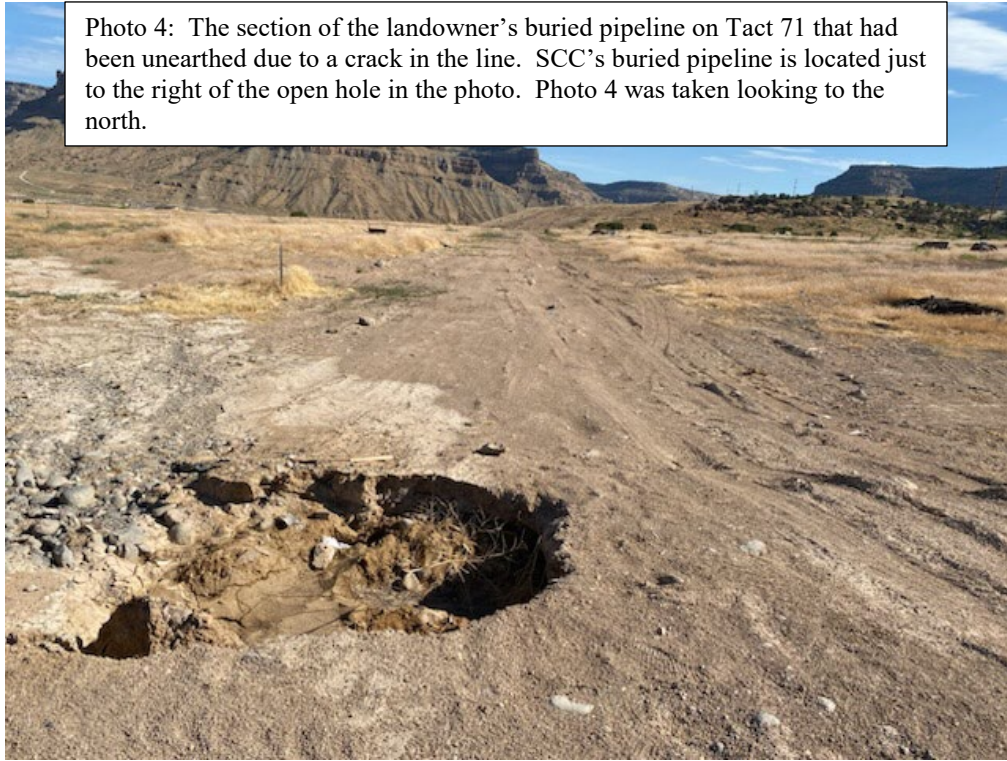
Photo 4: The section of the landowner's buried pipeline on Tact 71 that had been unearthed due to a crack in the line. SCC's buried pipeline is located just to the right of the open hole in the photo. Photo 4 was taken looking to the north.

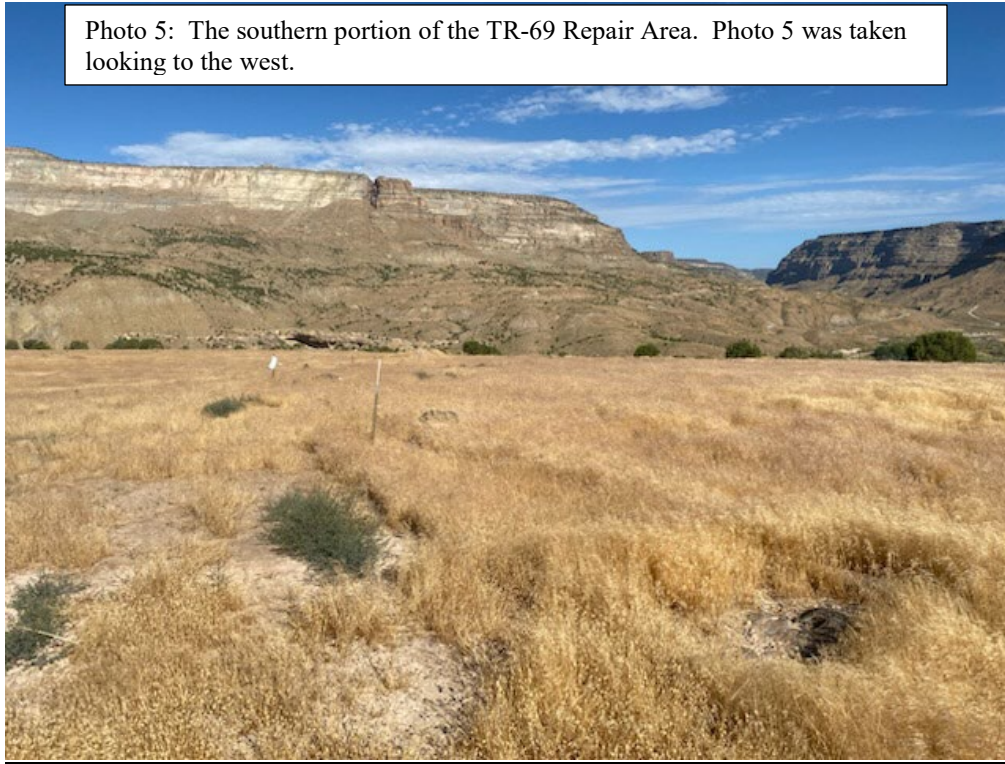
The TR-69 Repair Area consists of approximately 0.4 acres of reclamation located at the northern portion of Tract 71. The reclamation was associated with the disturbance created in the fall of 2019, approved under Technical Revision No. 69. The reclaimed area was stable with vegetative cover (Photos 5 and 6). Vegetation on the site has dried out as spring precipitation has ended. There were no indications of erosional features. The straw waddles located at the down-gradient portions were intact and in good condition. No off-site impacts were observed. The disturbed area was marked by several T-posts and a mine identification sign was posted on a T-post located along the southern boundary for the reclaimed area. The sign was in good condition and posted in a

Photo 5: The southern portion of the TR-69 Repair Area. Photo 5 was taken looking to the west.

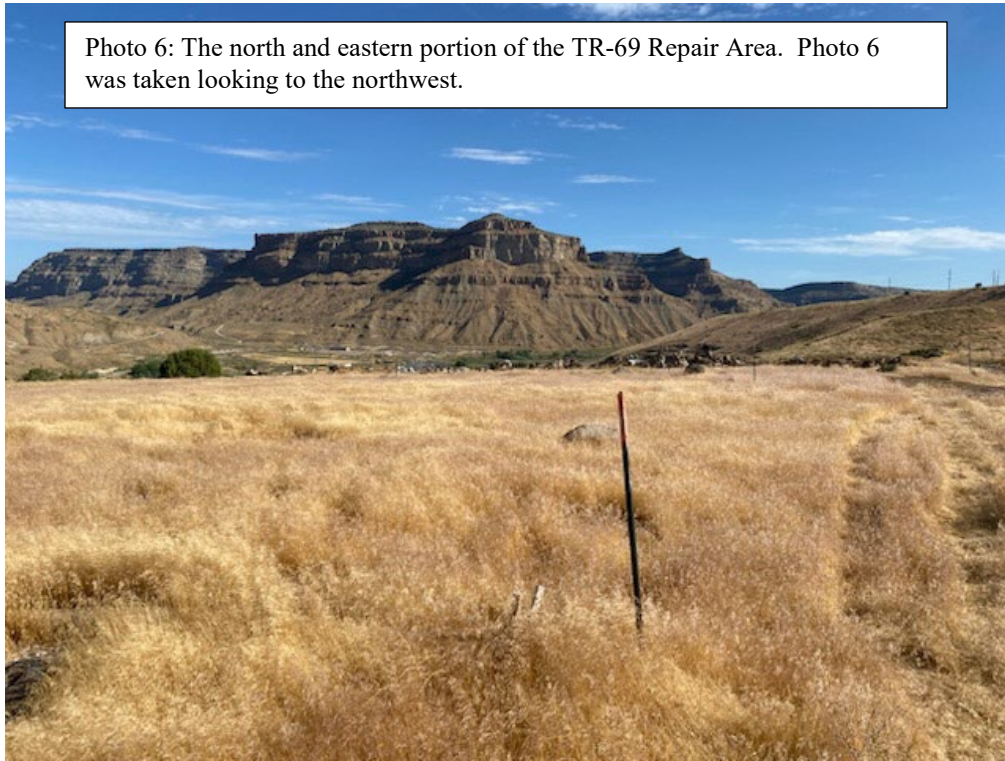
Photo 6: The north and eastern portion of the TR-69 Repair Area. Photo 6 was taken looking to the northwest.
