Huddleston-Berry
Engineering & Testing, LLC

Subject: Summary of Instrumentation Monitoring
2nd Quarter 2023
Bowie Coal Waste Disposal Area No. 2
Paonia, Colorado

SUBJECT: Summary Report, 2nd Quarter 2023, Inclinator and Active Vibrating Wire Piezometer Data April – June 2023, Bowie Mine #2 Coal Waste Disposal Area (CWDA) #2

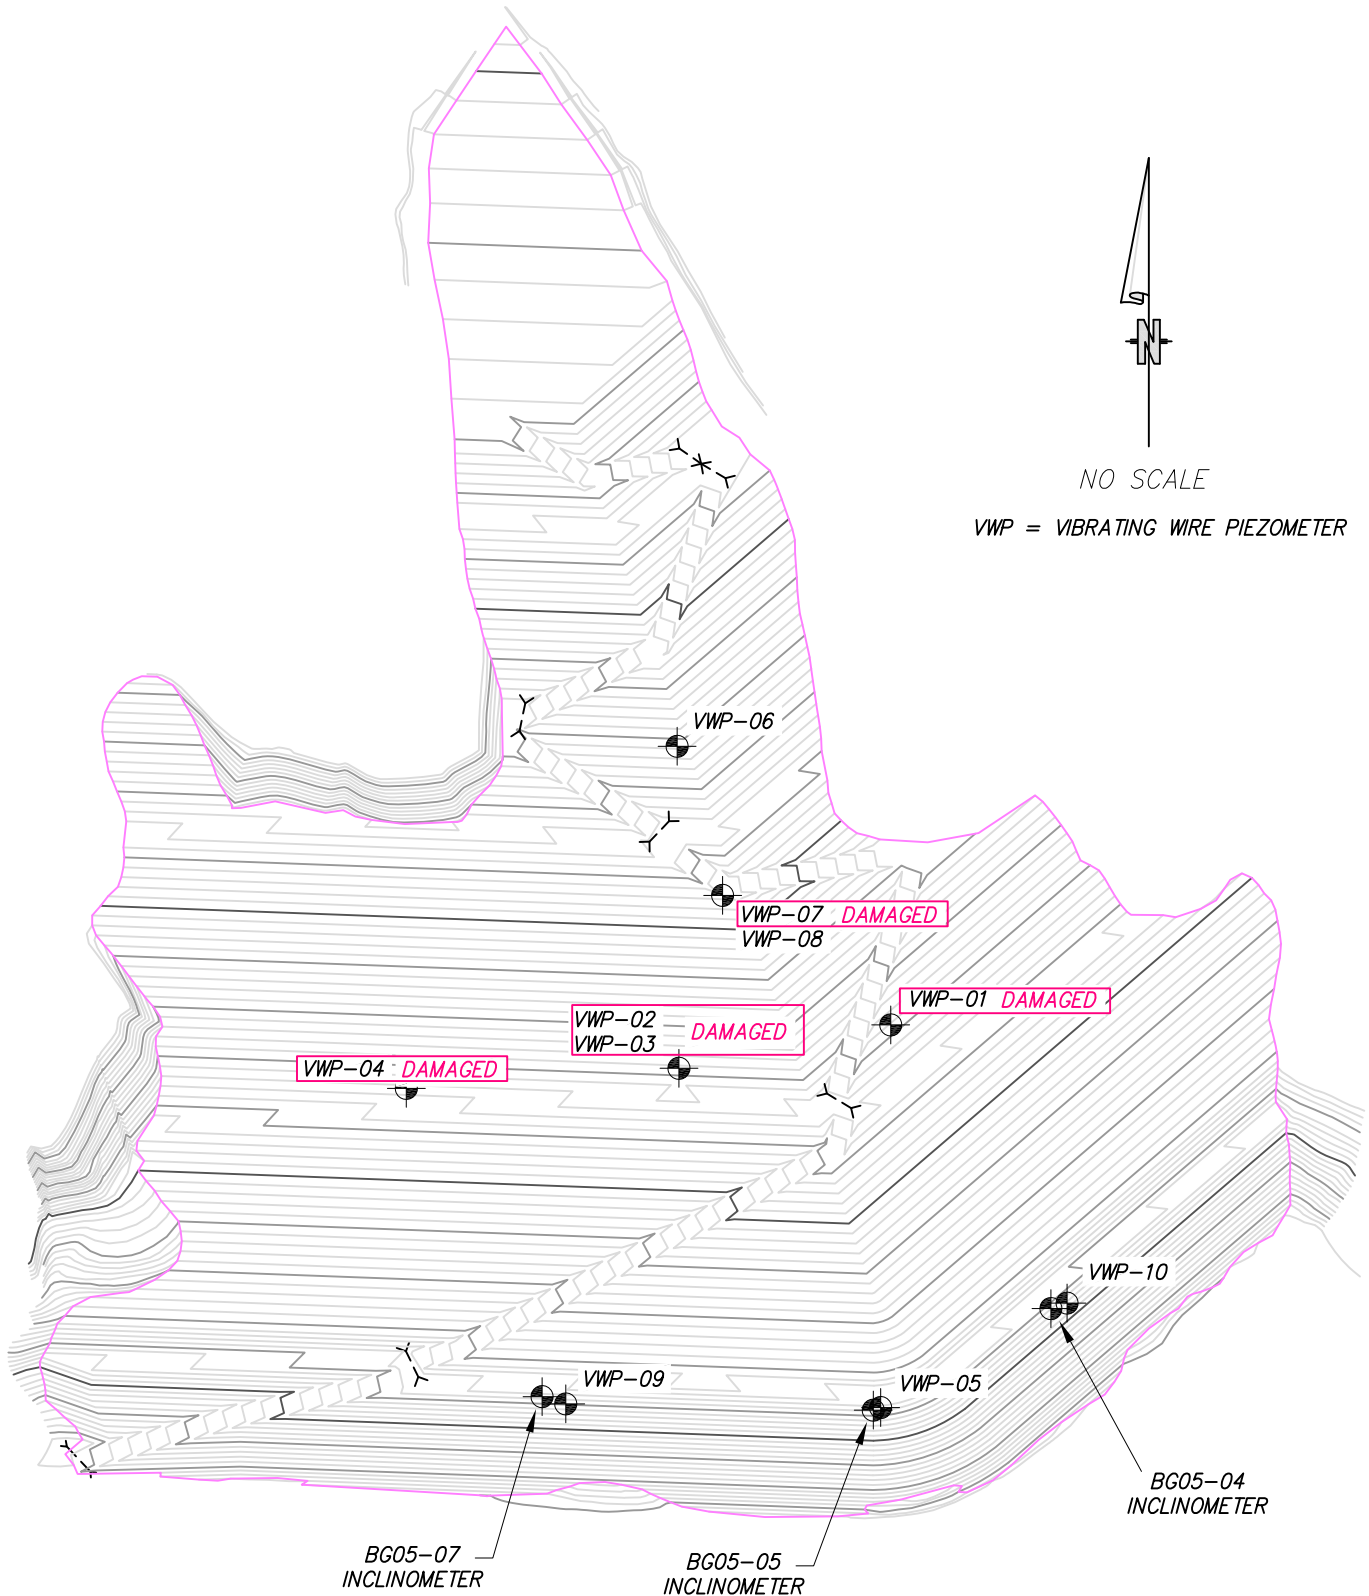
INSTRUMENTATION SITE PLAN

The physical locations of the piezometers are shown on the attached Instrumentation Site Plan (Map 1). As seen on this map, five of the original piezometers were damaged, and some were replaced. Currently, there are five active VWP's, and three of them are adjacent to inclinometers. The graph of historical VWP data from May 16, 2005 through May 21, 2014 is presented in Figure 1. A graph of measured pore pressures of active piezometers is presented on the attached Figure 2 and is presented numerically in Table 1 below.

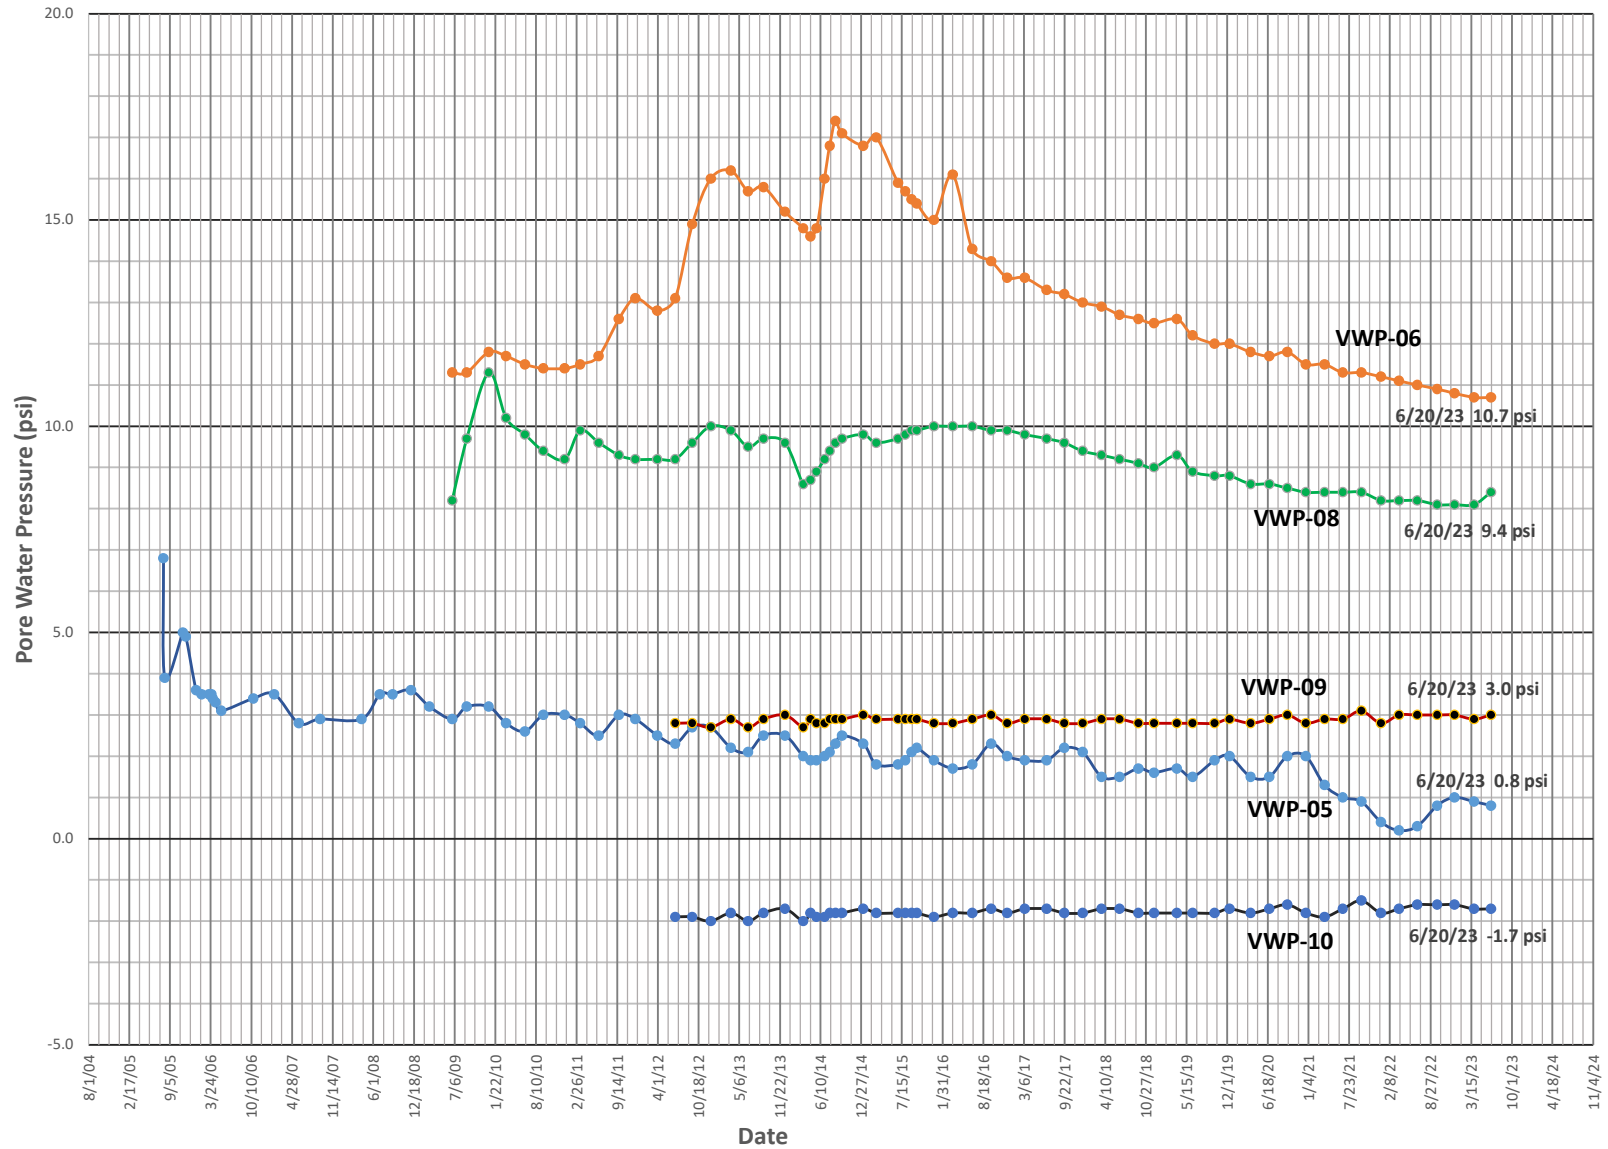
Figure 2 - Bowie Mine #2 - CWDA #2
Active Vibrating Wire Piezometer Data

As seen on Table 1 and Figure 2, the VWP readings and trends are consistent with recent and historic readings. Pore pressure readings changed by small amounts (0.0 to -0.3 psi) for four of the five VWP's since the readings one year ago (Q2 2022), while VWP-05 had a change of 0.5 psi from a year ago. When compared with last quarter (Q1 2023), pore pressures also changed by relatively small amounts (0 to +/-0.3 psi) in all five VWP's. Although four of the five VWP's remain steady or have general declining trends in pore pressure over the life of the VWP's, one of the piezometers (VWP-05) has exhibited pronounced seasonal cyclical behavior for its lifespan, except from mid-2021 to mid-2022 where there was a steady decline in pore pressures. This piezometer generally (but not always) shows low pore pressures for Q1 and Q2 and higher pressures for Q3 and Q4, with a net loss of 6.0 psi over the lifetime of that VWP. The other four VWP's have experienced net changes of +/-0.6 psi or less since installation, meaning current readings are very similar to initial readings. For VWP-09 and VWP-10, pressures have been consistent throughout the lifetime of the piezometers; however, for VWP-06 and VWP-08, they experienced wild fluctuations in pore water pressure in the first half of their lifetimes but have settled to pressures similar to the installation pressures in the past several years.

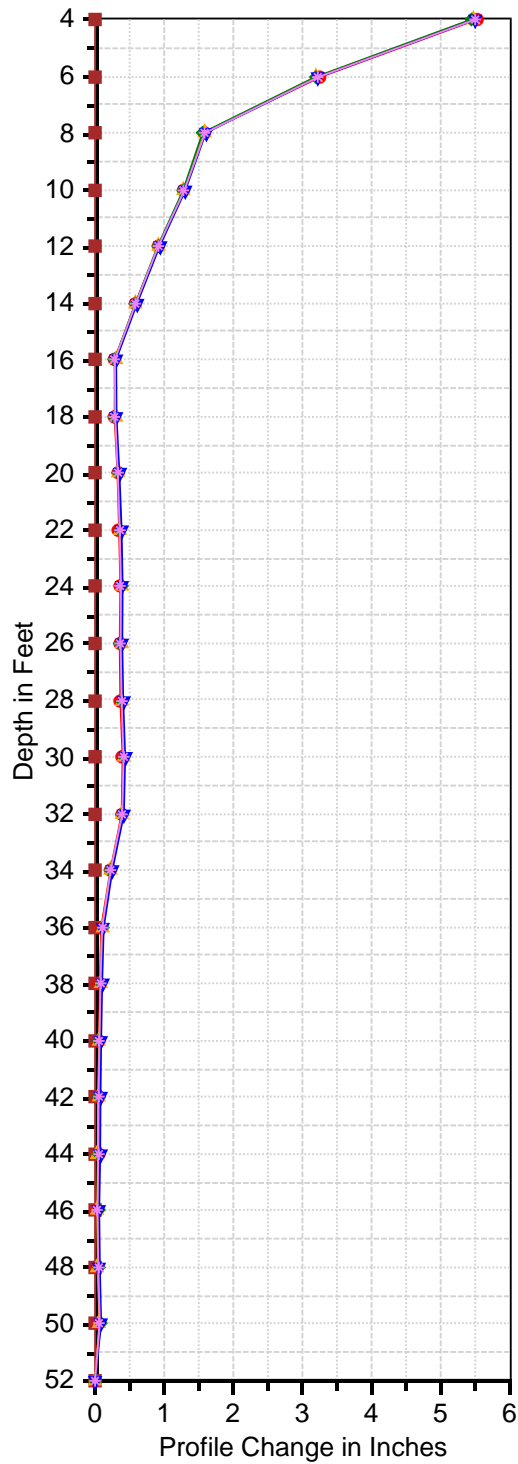
BOWIE BG05_4 A

As described in previous reports, historic displacements indicated on the plots for the approximate upper 12-14 feet of the inclinometers since installation in 2005 are due to placement of cover soil on the face of the waste pile during revegetation operations in late 2006 and early 2007. This man-caused displacement is documented in a report by Buckhorn Geotech dated December 22, 2008, to Bowie Resources called *Revised Stability Evaluations for Coal Mine Waste Disposal Area No. 2, Bowie No. 2 Mine*.

Based on the current inclinometer readings, there has not been evidence of significant downslope movement (Axis A) in any of the inclinometers since 2007 and they are generally consistent with previous readings. Some "noise" which is understood to be relatively common in orthogonal direction (Axis B) readings, was observed over the past few years for all three inclinometers. This can be due to various mechanical or installation causes that are unrelated to slope movement. For example, grout voids, poor grout coverage, or soil settlement around the instrument can all contribute to vibrations and pipe movement that impacts inclinometer readings. Software bias adjustments were applied which filtered this noise. All readings were consistent with previous ones and the "displacement" error was within equipment tolerances and not deemed to be due to slope movement.
