Inspection report for Varra Resources Project 110

MINERALS PROGRAM INSPECTION REPORT

MINE NAME: Varra Resources Project 110 (formerly Dakolios Pit No. 1)	MINE/PROSPECTING ID#: M-1984-036	MINERAL: Sand and gravel and	COUNTY: Weld
INSPECTION TYPE: Monitoring	WEATHER: Cloudy	INSP. DATE: July 20, 2023	INSP. TIME: 08:15
OPERATOR: Varra Companies, Inc.	OPERATOR REPRESENTATIVE: Garrett Varra	TYPE OF OPERATION: 112c - Construction Regular Operation

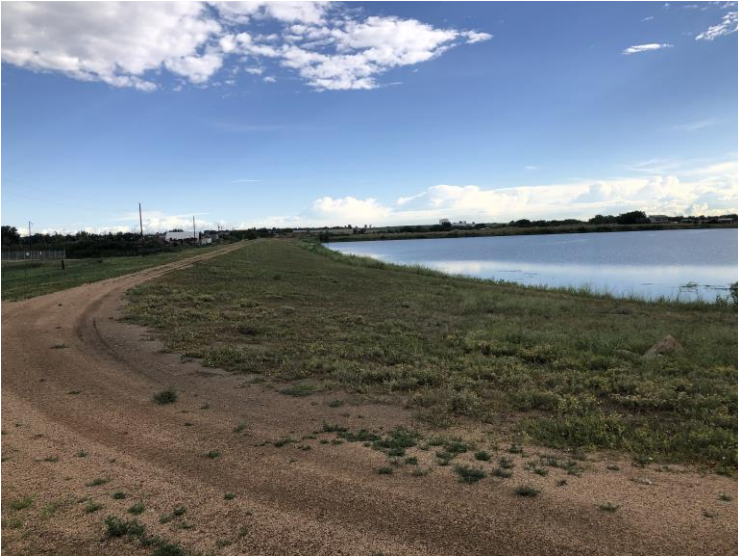
- The southeast portion of the site (Area 4) contains a 24.6-acre reservoir. The reservoir is sealed with an SEO-approved clay liner. The reservoir (excluding the vegetated perimeter) was released from the permit area with AR-01 on 2018.

Pond in Area 4 (southeast portion of site) – looking north from southeast corner

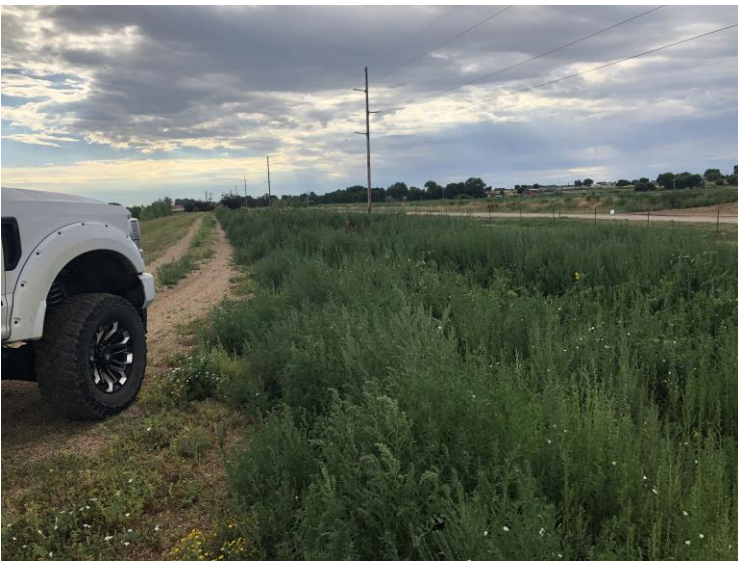
The operator has been controlling weeds with mowing. Some areas still have problems, including the south end of the east pond (Area 4) where kochia is the dominating species. Near the recycling yard, Garret Varra pulled three thistle plants. Knapweed and tamarisk were seen next to St Vrain Creek.

Area 4 (southeast portion of site) – kochia on south side of site

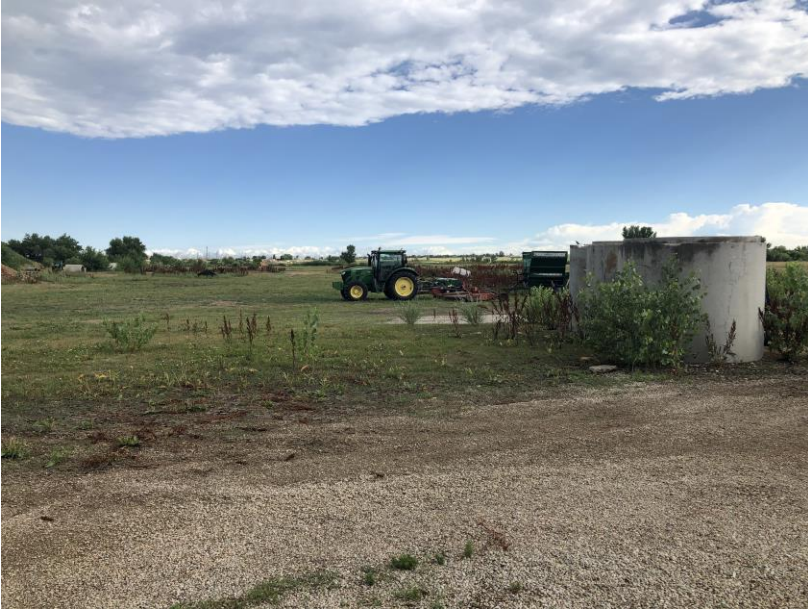
Equipment storage in Area 3 (northeast portion of site)

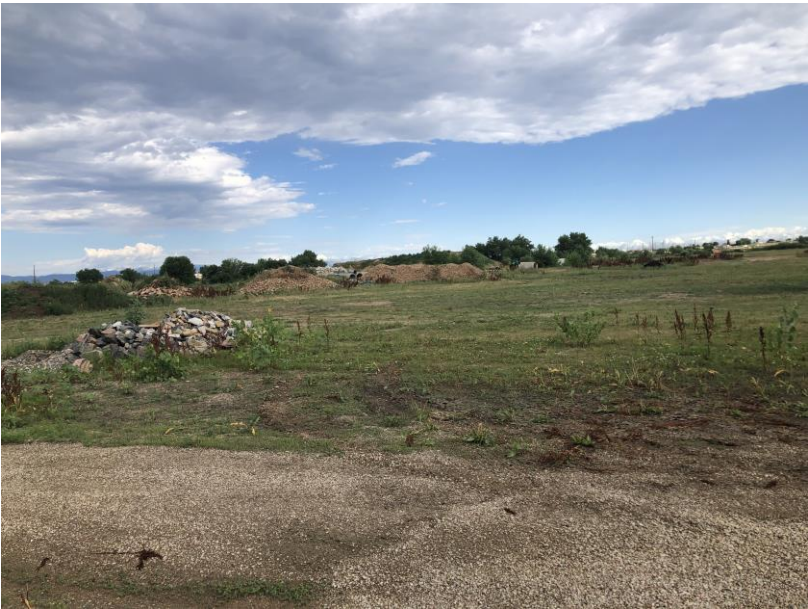
Stockpiles in Area 3 (northeast portion of site)

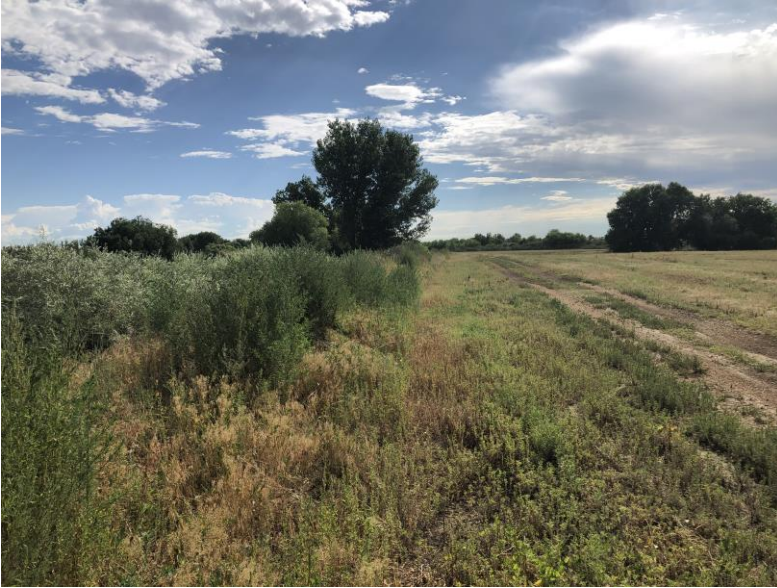
The vegetation cover was good in many areas, including (but not limited to) the storage yard and the buffer around Area 3.

Vegetation buffer (left side of photo) next to Area 3
