Inspection Report, Foidel Creek Mine, C-1982-056

PERMIT INFORMATION

INSPECTION INFORMATION

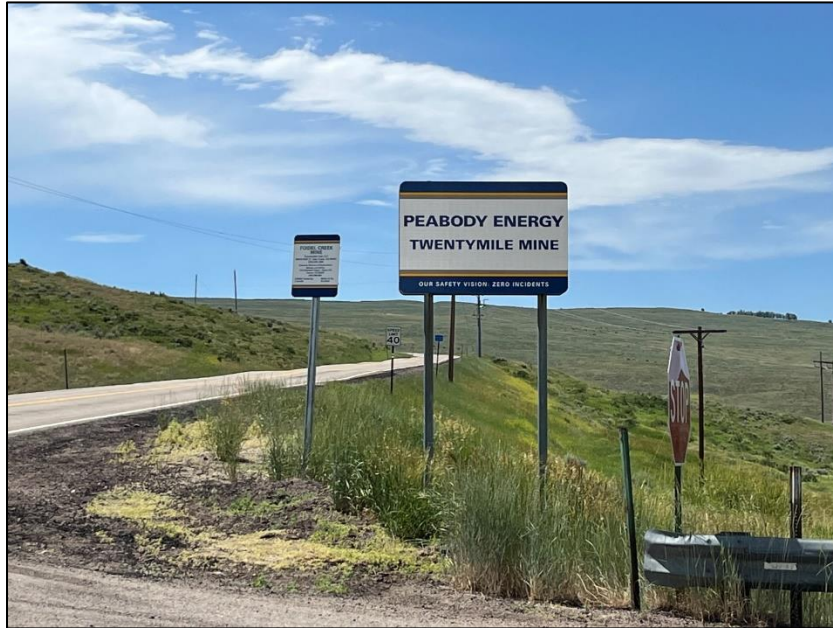
Mine identification markers were observed throughout the site (Photo 1). All information for compliance was present.

Photo 1: Mine sign posted at the entrance road.

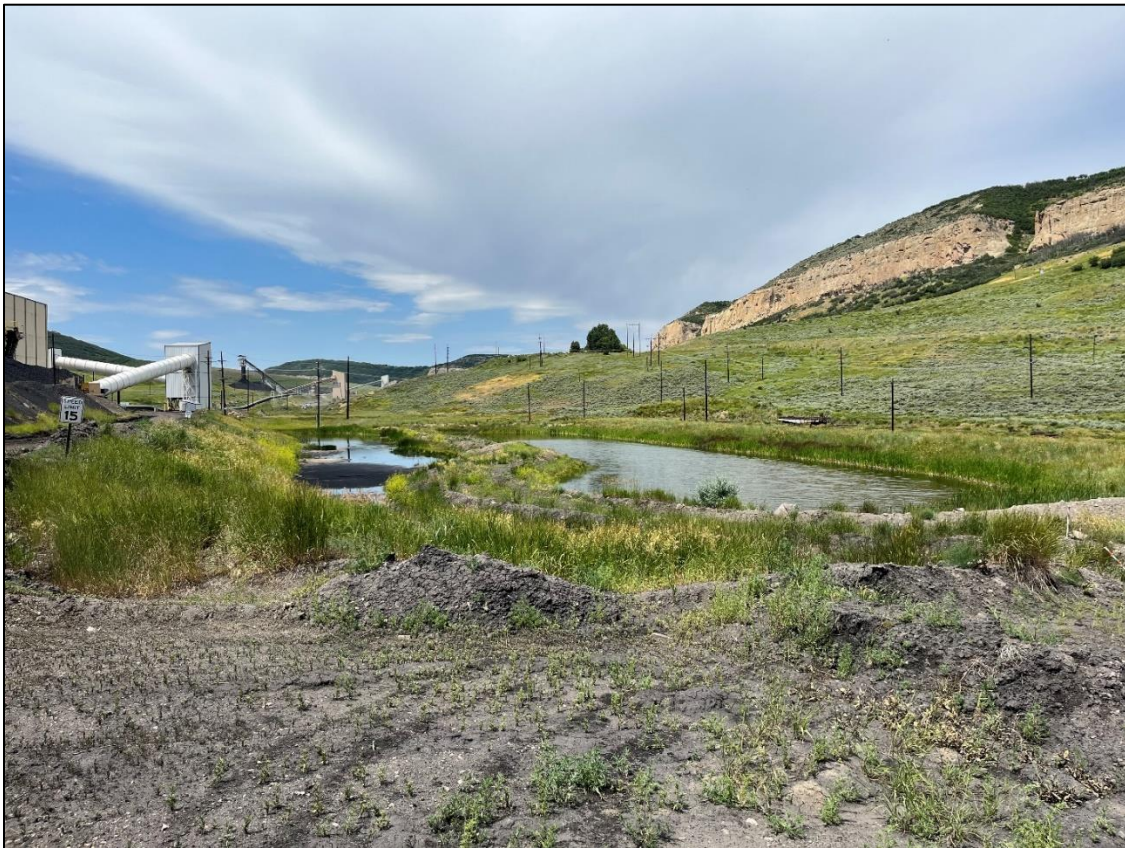
All ponds across the site are scheduled for cleanup in July of this year. Several ponds around the main facilities area will need to be included in this annual cleaning to maintain proper function (Photos 2 and 12).

Photo 2: Pond E, due to be cleaned.

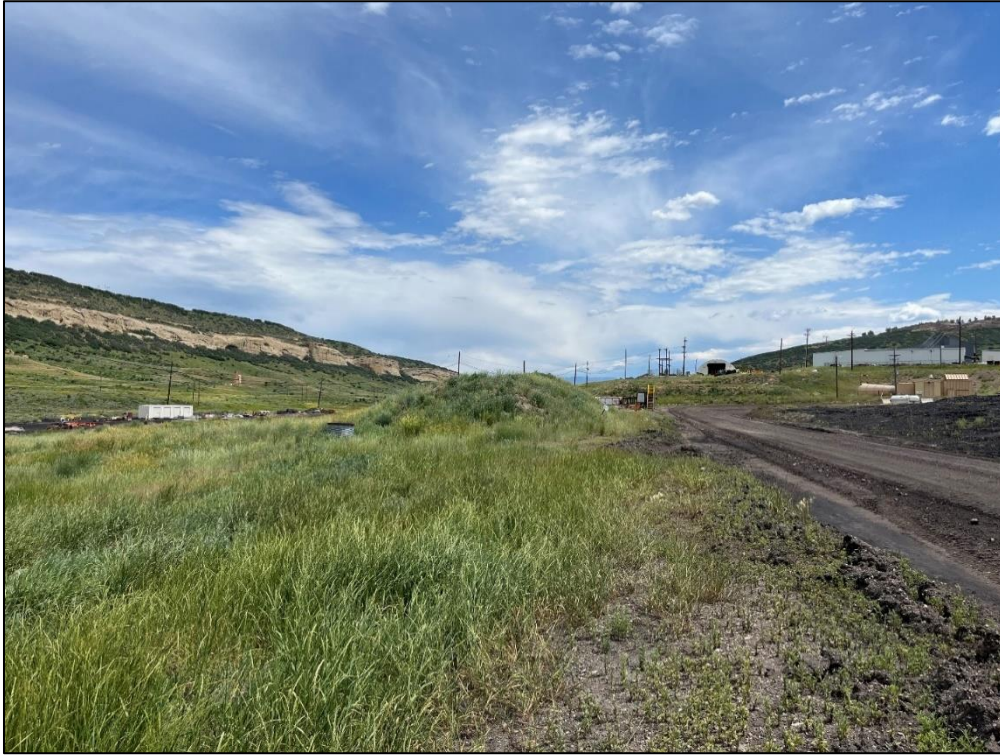
Topsoil piles around the main facilities, Fish Creek borehole, and Tipple area were checked for proper vegetation, stability, and appropriate markers. All piles are properly vegetated and free of disturbance (Photo 3).

Photo 3: Topsoil pile is well vegetated and marked.

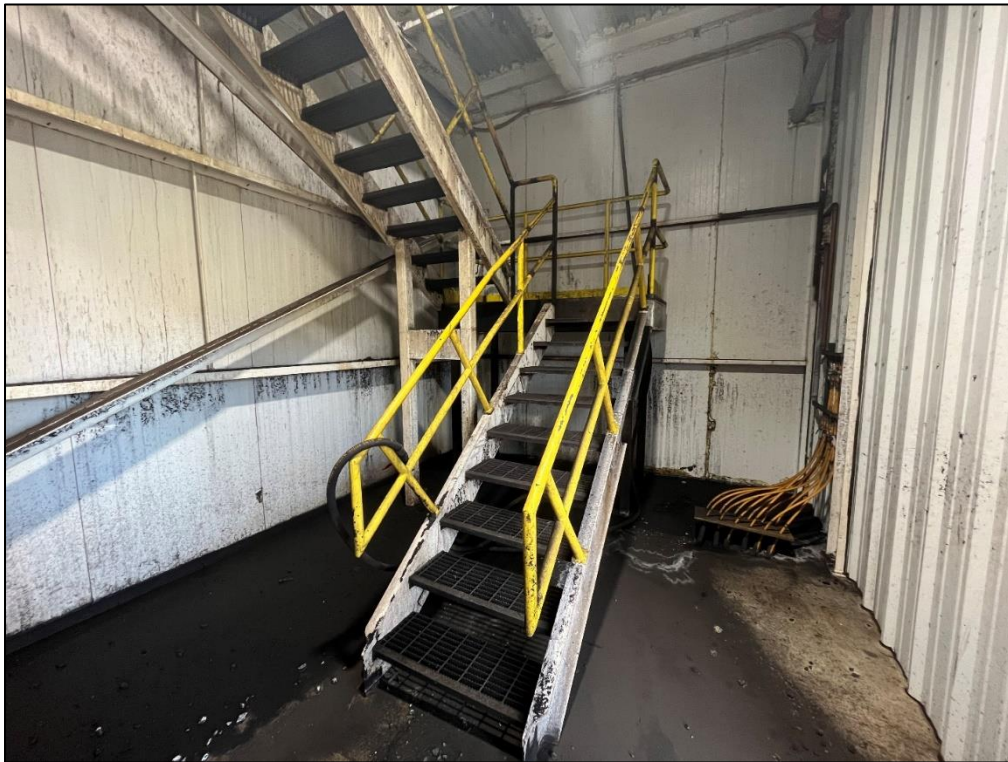
The stoker coal loadout facility has not yet been sealed following a note made in a DRMS inspection report last Fall which pointed out that this wash plant facility was leaking water behind the building (Photos 4 and 5). The building was scheduled for sealing in the spring of this year. The Operator stated that a contractor had recently come to view the project. **Please supply the Division with a firm date of construction completion when one becomes available.** In the meantime, the Operator has been using straw bales and three ditches (Photo 6) behind the building to protect Foidel Creek from drainage and sediment from this facility. After sealing the building, water will continue to report to Pond E through a pump system to be installed behind the stoker loadout building and through the existing building pipe (Photo 7). A few small coal spills were noted around the stoker loadout area. Personnel were actively cleaning up these spills at the time of inspection.

Photo 4: Inside of stocker coal loadout facility, due to be sealed.

- Protect topsoil piles from cattle
- Spray weeds and Reseed the waste pile topsoil pile
- Seal support building near Wash Plant (2023)

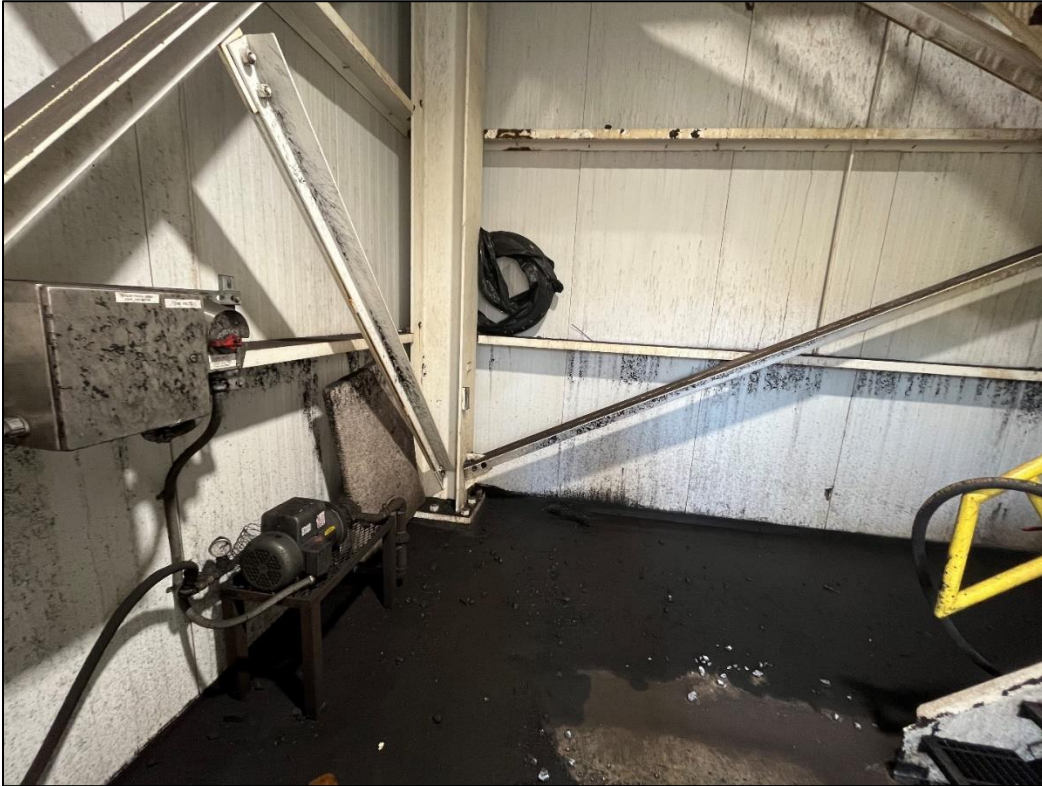
Photo 5: Another view inside the stoker coal loadout wash plant to be sealed.

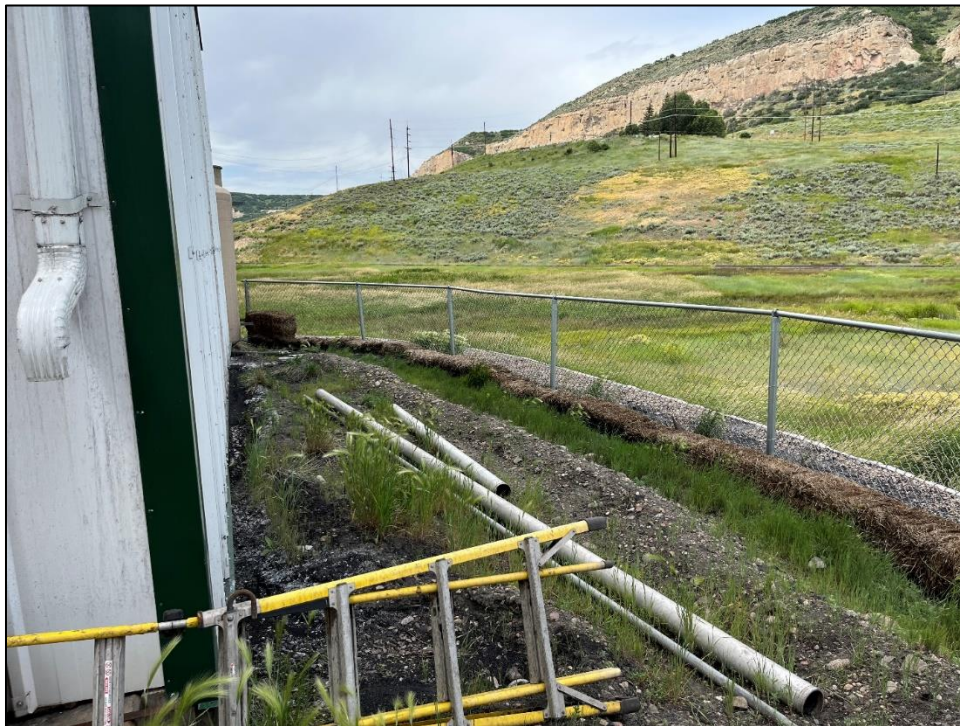
Photo 6: View of the back of the stoker coal loadout building, three ditches have been built to maintain water leakage while the building waits to be sealed.

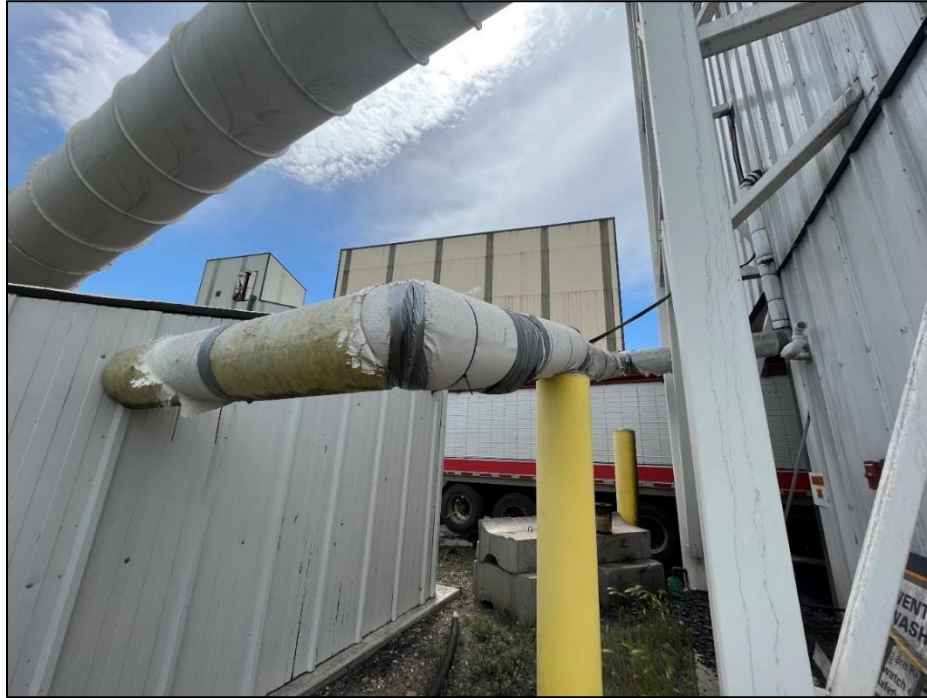
Photo 7: The main supply of water from the stoker coal wash plant operation drains through this pipe into a sump building adjacent.

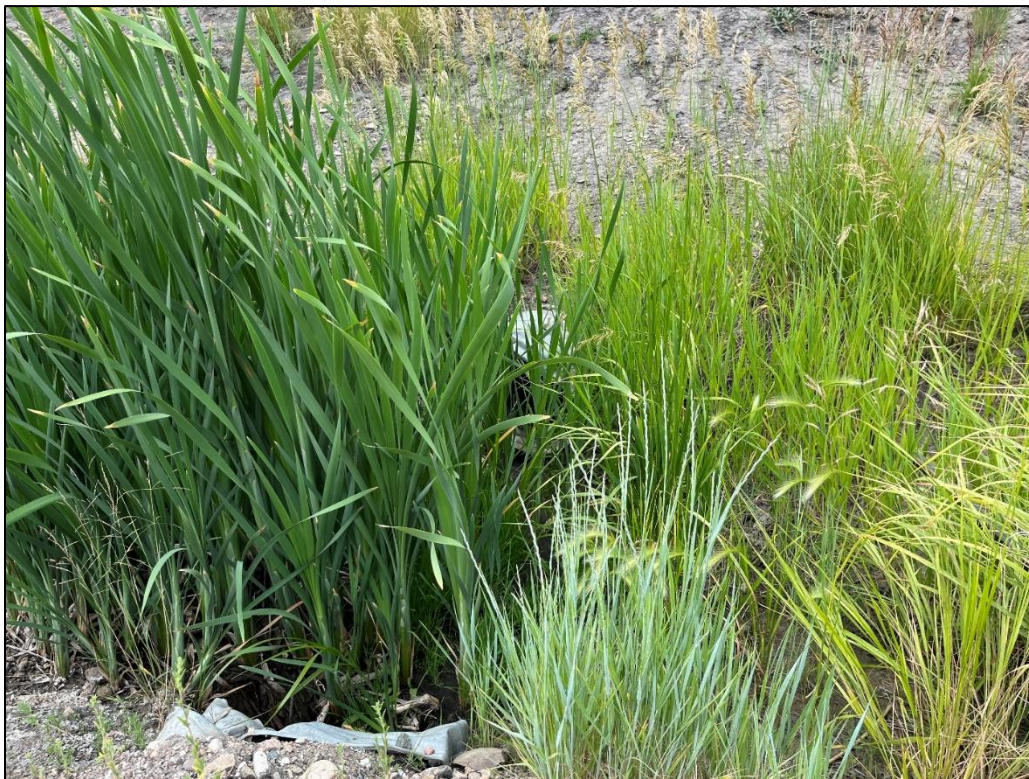
Main facilities ponds were checked for discharge and culverts were inspected for function. Most culverts appear to be functioning, but some are in need of cleanout (Photos 8 and 17). Continue to clean out culverts when vegetation and sediment hinders function.

Photo 8: Culvert for Pond C, in need of cleanout.

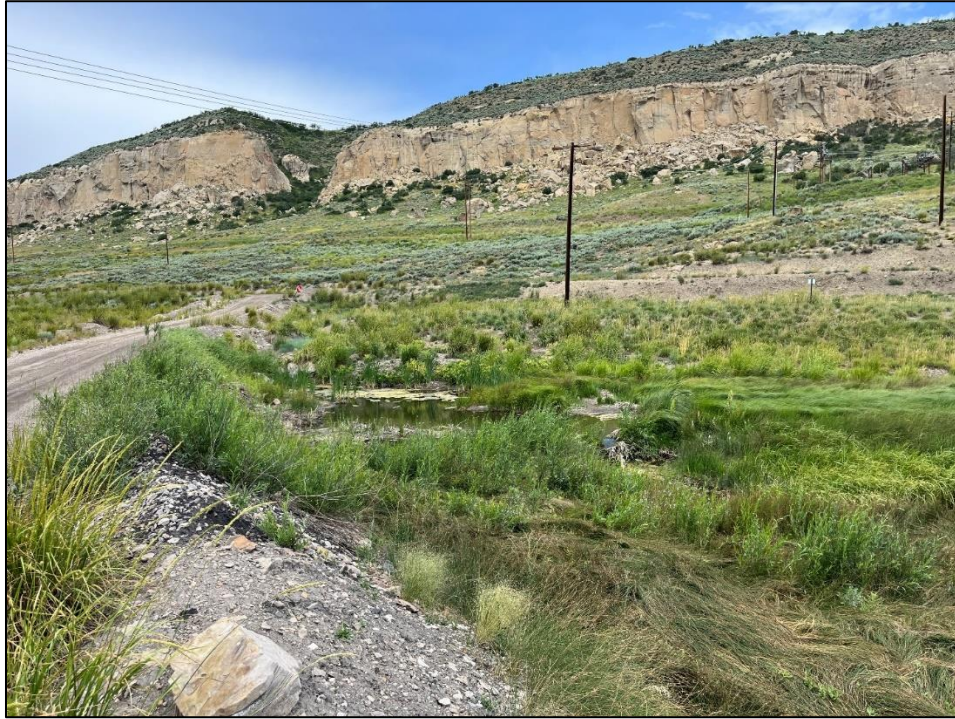
Berms near the train loadout facility main are well maintained to prevent runoff to nearby Foidel Creek. Buffer zone signs are also in place here (Photos 9 and 10).

Photo 9: View W of Foidel Creek near the train loadout.

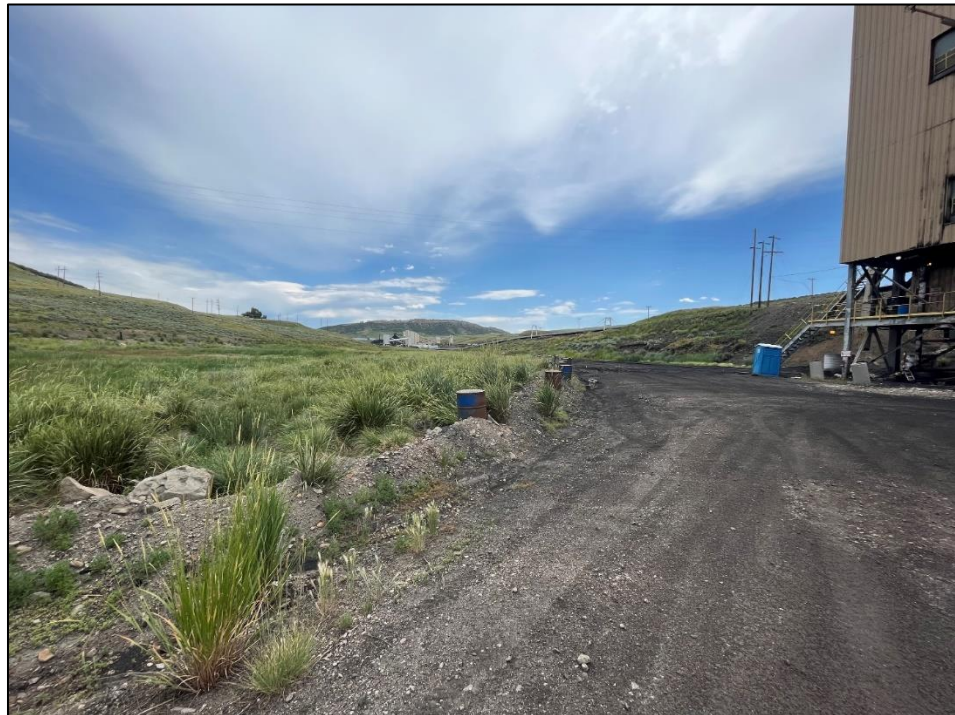
Photo 10: The berm and buffer zone signs are in place at the train loadout facility.

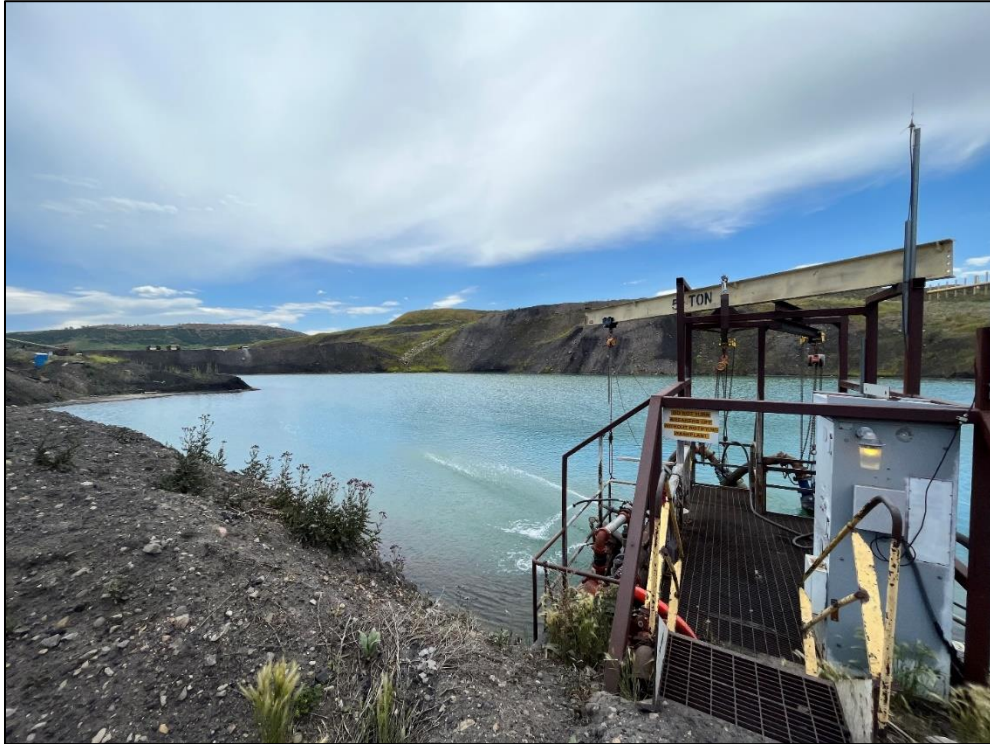
Photo 11: East side of Pond D.

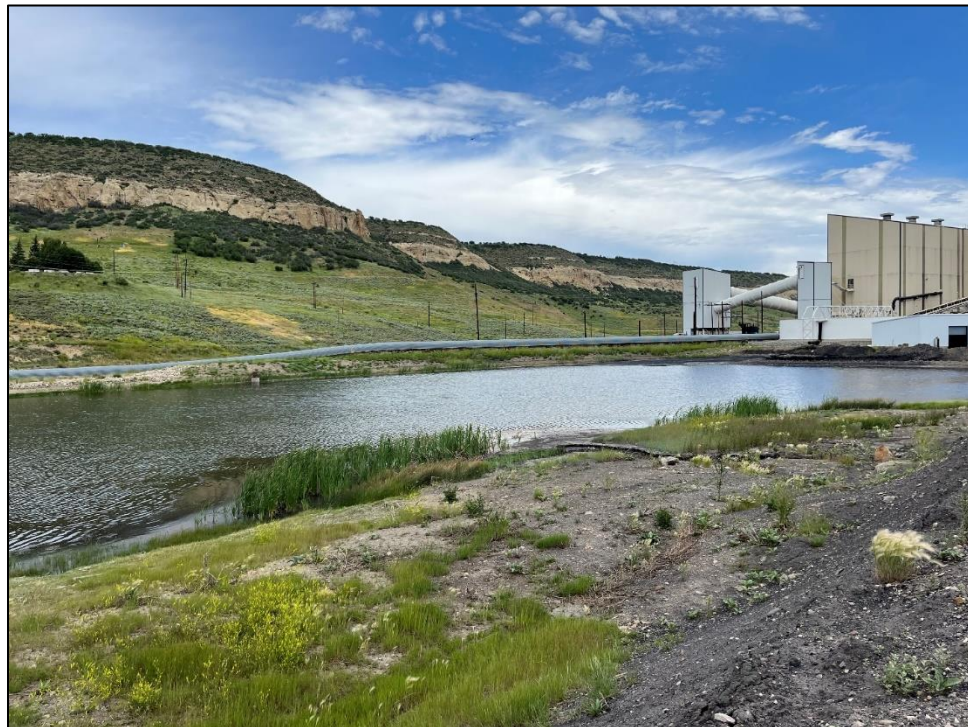
Photo 12: West side of Pond D.

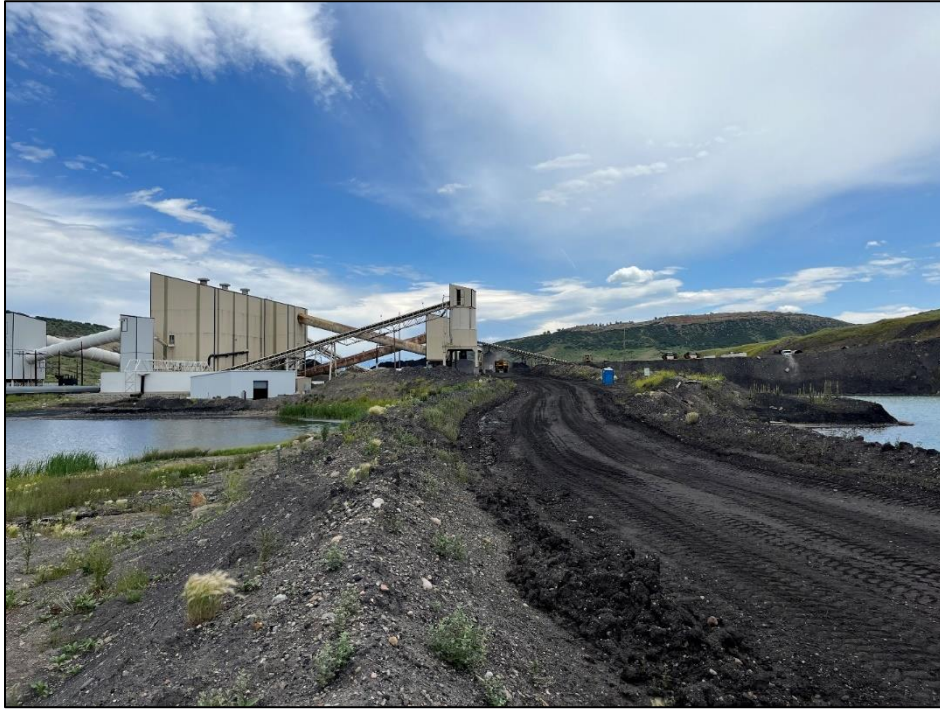
Water trucks were seen running in the main facilities area. Haul roads across the site are well maintained (Photo 13). The Operator noted that the submittal of an MR to create a new internal haul road in this area, as discussed in last month's inspection report, was still a possibility this season. This new road would extend from the foot of Pond D up to the refuse pile, connecting with the refuse pile haul road currently in place and creating a loop.

Photo 13: Roads are well maintained and watered frequently for dust.

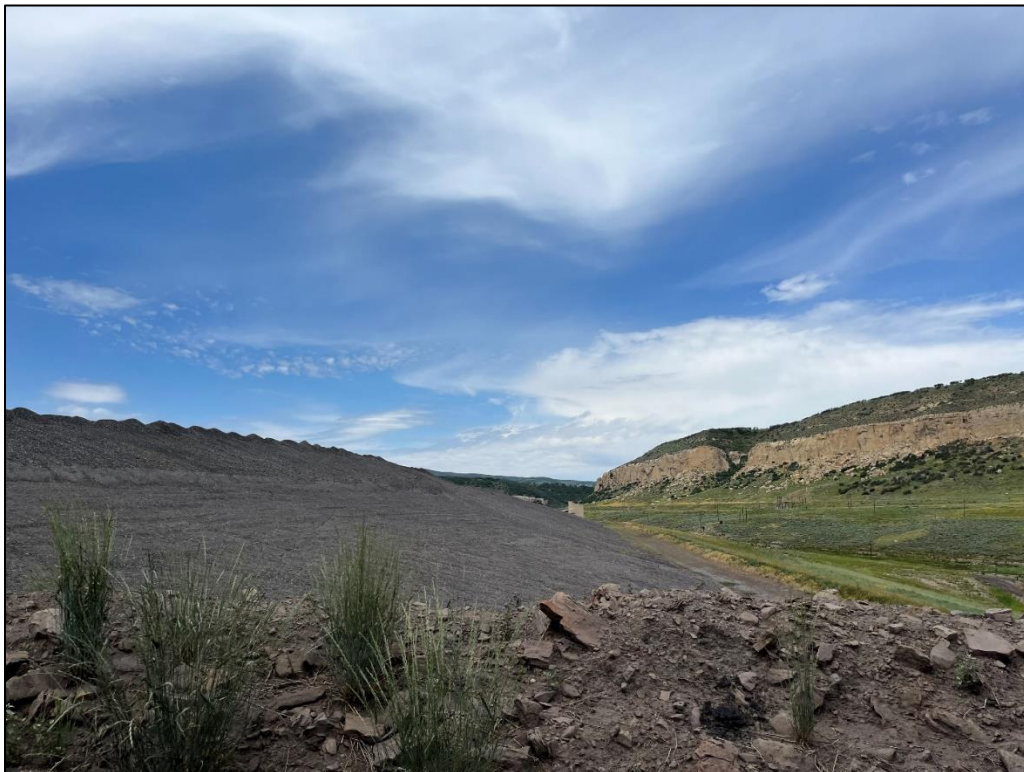
Compaction of refuse material piled throughout the winter continues throughout the summer season. A drag bar is connected to a dozer and is used as the primary compaction tool for this refuse pile. Drainage is functioning properly in this area with no standing water atop the pit. The third lift is still under construction. The second lift is

complete and will be seeded in the current season (Photo 14). Clay overburden material will be taken from the southern portion of the refuse area to cover the pile before adding topsoil from the nearby stockpile to the northeast. Eventually, this refuse face will be built up to meet the ridge of the adjacent, older refuse pile (Photo 15).

Photo 14: View West of the refuse pile, 2nd lift (shown) is compacted and ready to be seeded this season.

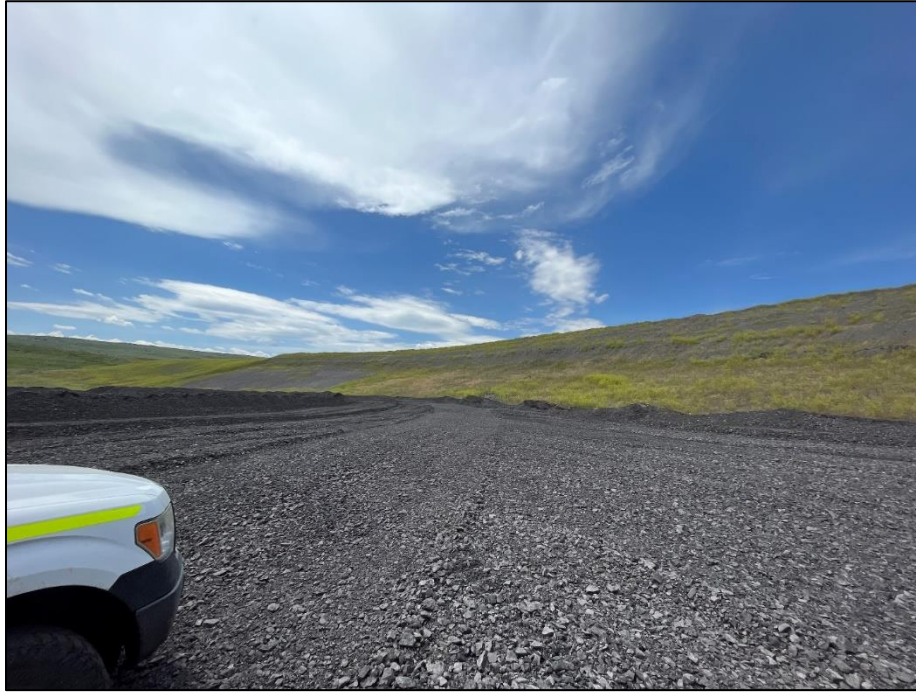
Photo 15: View South from the top of the refuse pile. Current lifts under construction in Photo 14 will eventually be built up to meet the ridge of the older, vegetated refuse pile pictured here.

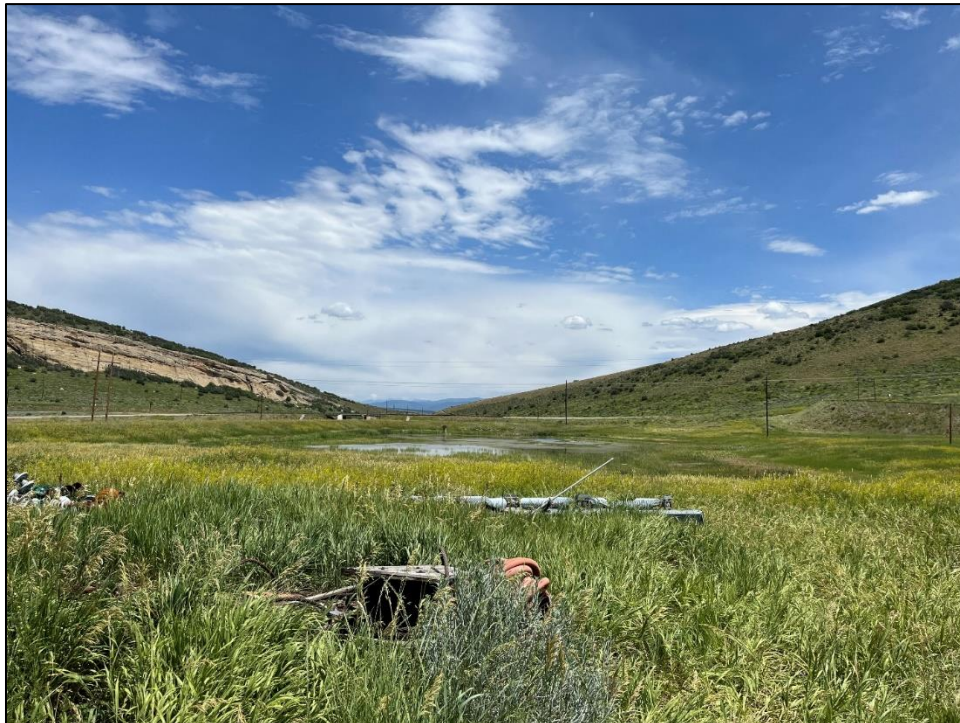
Photo 16: Pond G, will likely be completely dry in the next few months.

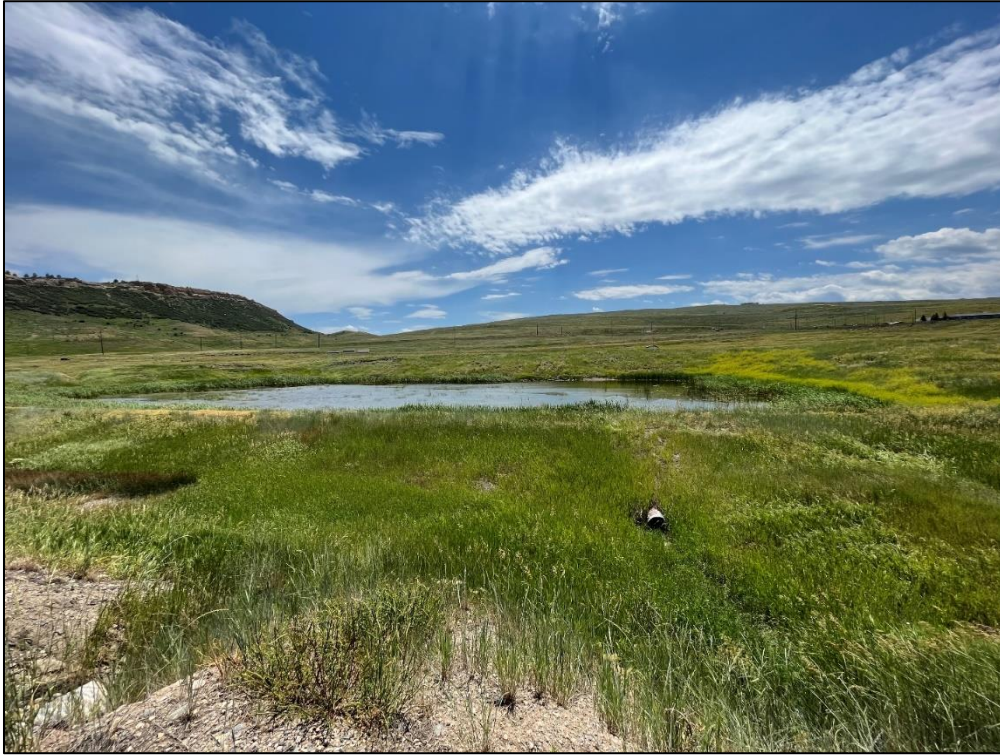
Photo 17: Pond F, culverts to be cleared here.

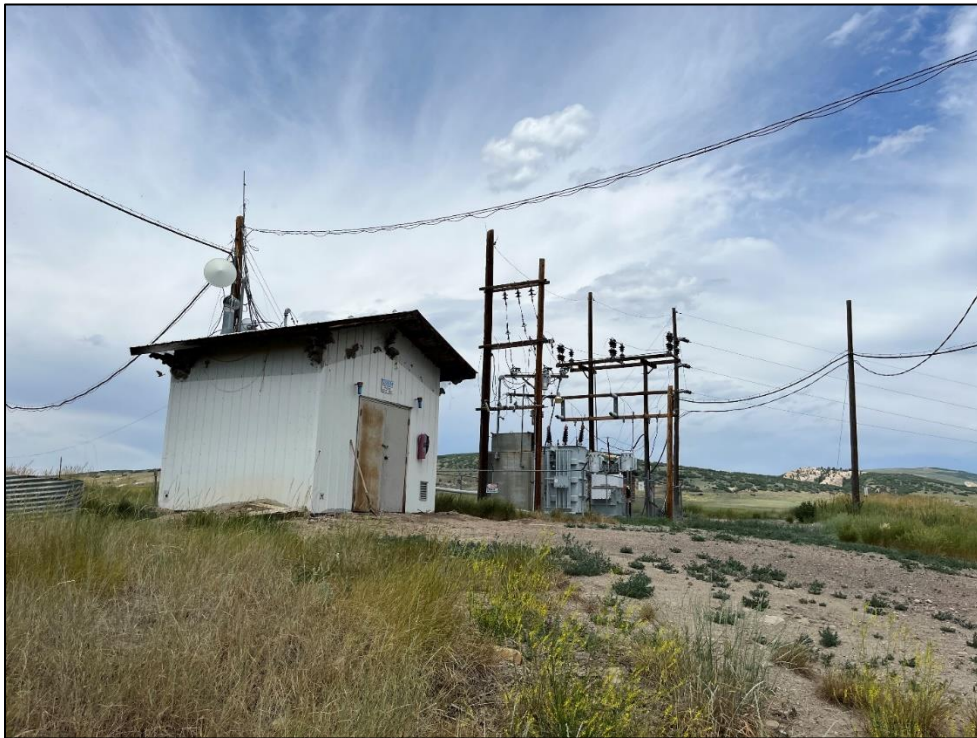
Photo 18: Power system located at the Fish Creek Borehole treatment facility.

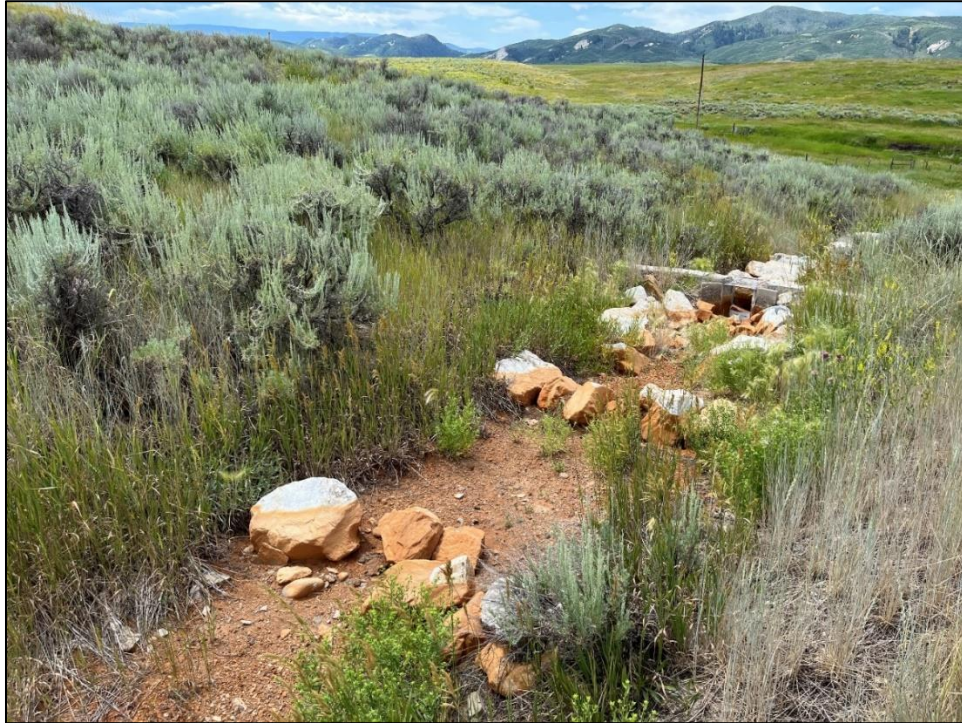
Fish Creek borehole is a water treatment borehole which sits atop one of Foidel's underground reservoirs. Water travels up from the reservoir, through three retention ponds, and through a rock creek (Photo 19) where it is sampled. Water from this sample point eventually discharges to Foidel Creek. It is pumped very infrequently and has not been pumped at all this year as the water quality discharged from this point is of low quality due to high amounts of iron. The Operator stated that an updated system would need to be in place in this area before water is discharged regularly.

Photo 19: Rock creek which to water from the Fish Creek Borehole retention ponds drains. Fish Creek is just below its sampling location. Water from the Fish Creek Borehole is high in Iron.

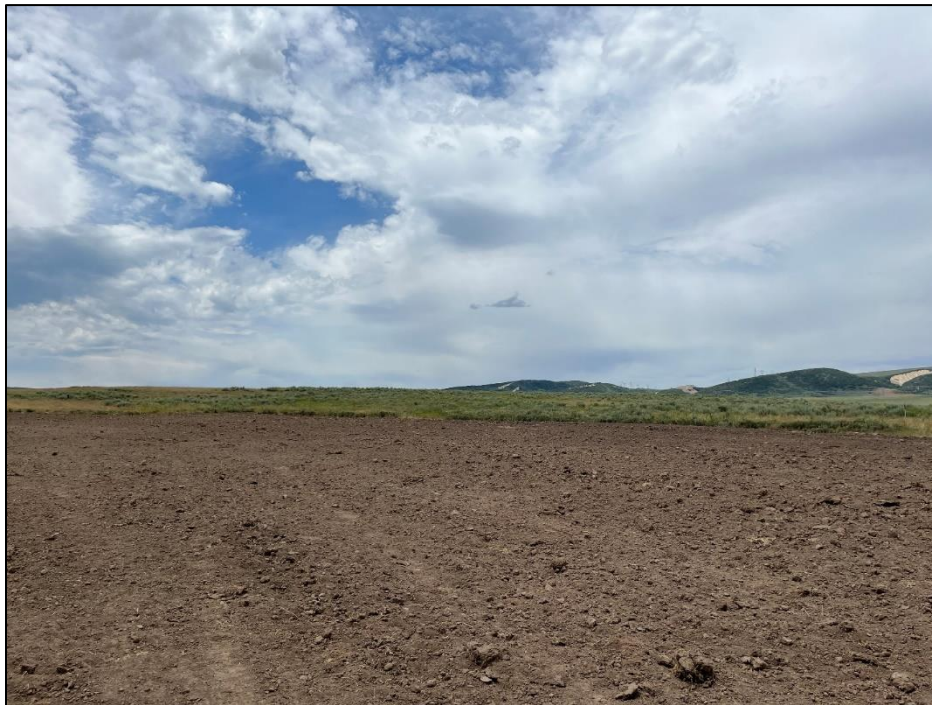
The 13 Left Outby Gate Road Utility Borehole has been fully prepped for reclamation and is set to be seeded this fall (Photo 20). A two-track road which was present before mining operations will remain in this area after reclamation to provide access to a nearby ditch.

Photo 20: The 13 Left Outby utility borehole has been completely reclaimed. It will be seeded in the fall.

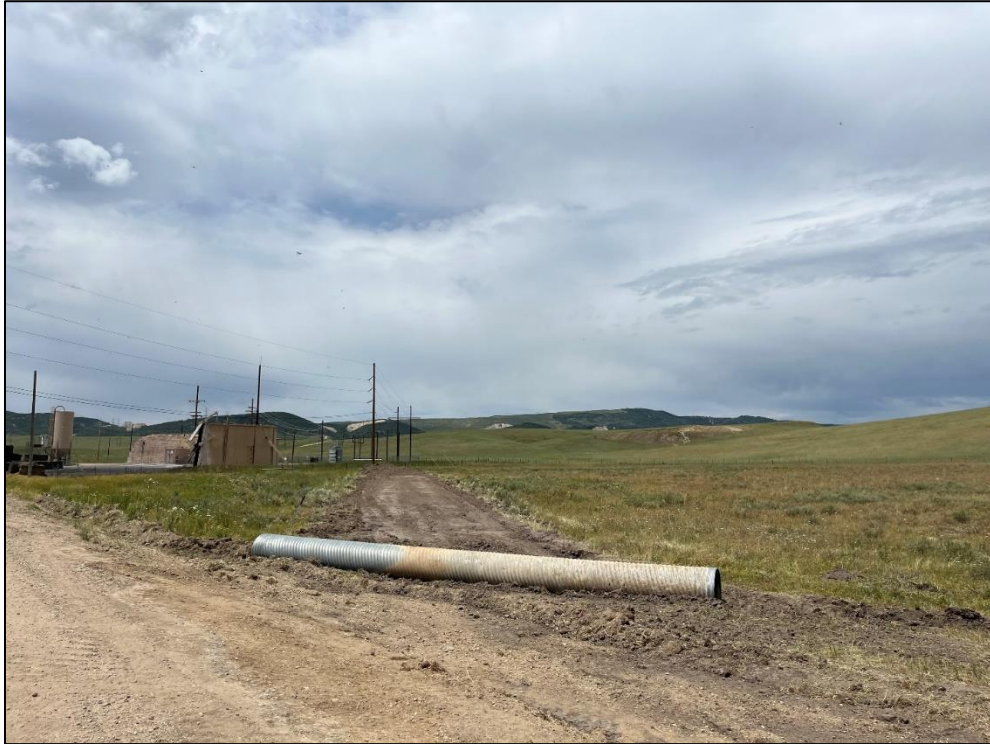
MR322 was issued by the Division on 10/25/2022 and approved the relocation of an internal road. The construction of this new road has begun in the 6MN area (Photo 21). RN-08 is currently in progress with the Division and has been extended to a decision date of **July 28, 2023.**

Photo 21: Construction of the haul road approved under MR322 has begun.

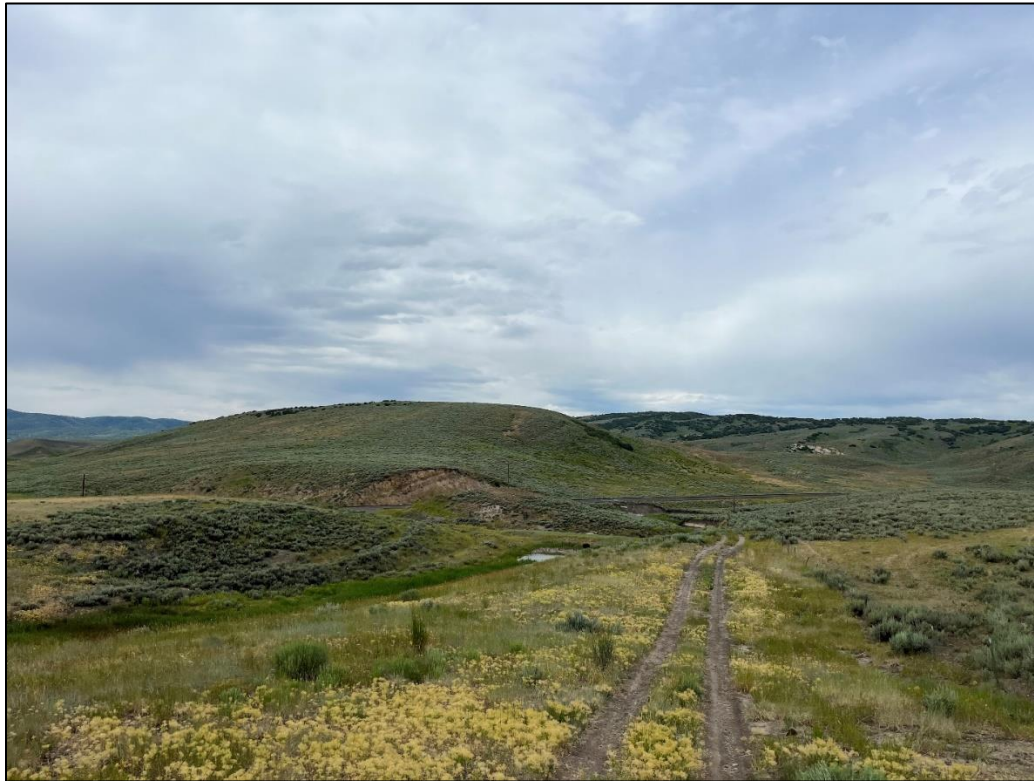
The Fish Creek Tipple Area used to be a train loadout facility. Tracks have been removed and all that remains is the Tipple pond (Photo 22). Water remains in this pond year round. This area is Phase 1 released and has become eligible for Phase 3 release this year after crossing the 10 year period.

Photo 22: The Fish Creek Tipple Area and pond are pictured. The pond holds water year round.
