Division of Reclamation,
Mining and Safety

PERMIT INFORMATION

Permit Number: C-1981-012 Mine Name: New Elk Mine Operator: New Elk Coal Company, LLC Operator Address: Mr. Mark Gray 12250 Highway 12 Weston, CO 81091	County: Las Animas Operation Type: Underground Permit Status: Active Ownership: Private
	Operator Representative Present: Nick Mason
Operator Representative Signature: (Field Issuance Only)

Inspection Start Date: July 19, 2023 Inspection Start Time: 08:00 Inspection End Date: July 19, 2023 Inspection End Time: 12:30		Inspection Type: Coal Partial Inspection Inspection Reason: Normal I&E Program Weather: Clear	
Joint Inspection Agency: None		Joint Inspection Contacts:	
Post Inspection Agency: None		Post Inspection Contacts:	
Inspector(s): Brock Bowles	Inspector's Signature:

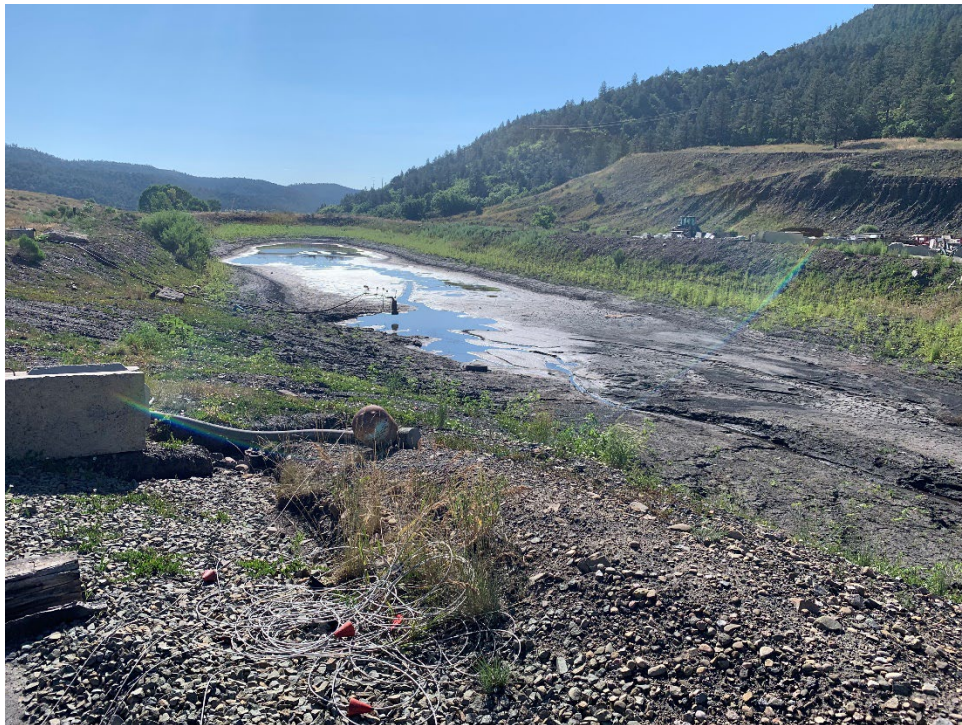
Photo 1 – Pond 7

Pond 7 contained a small puddle of water and was not discharging (photo 1). The primary and emergency spillways were clear of obstructions.

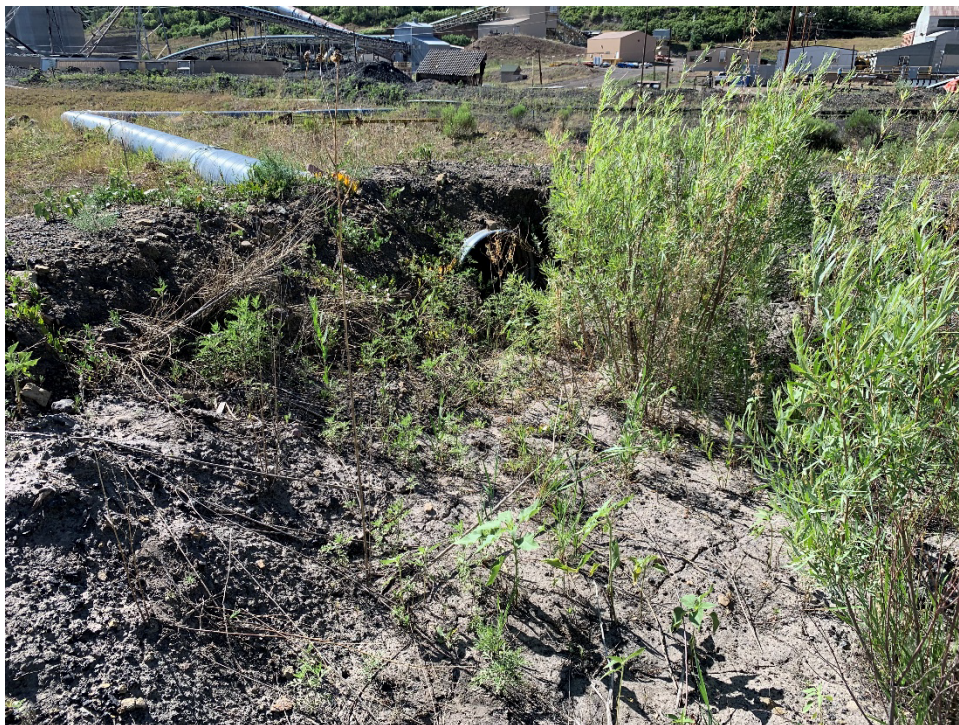
Photo 2 – DWDA#2 sediment trap and culvert C13

The sediment trap on the east end of DWDA #2 contained some water. The embankment was in good condition and culvert C13 was free and clear of obstructions (photo 2).

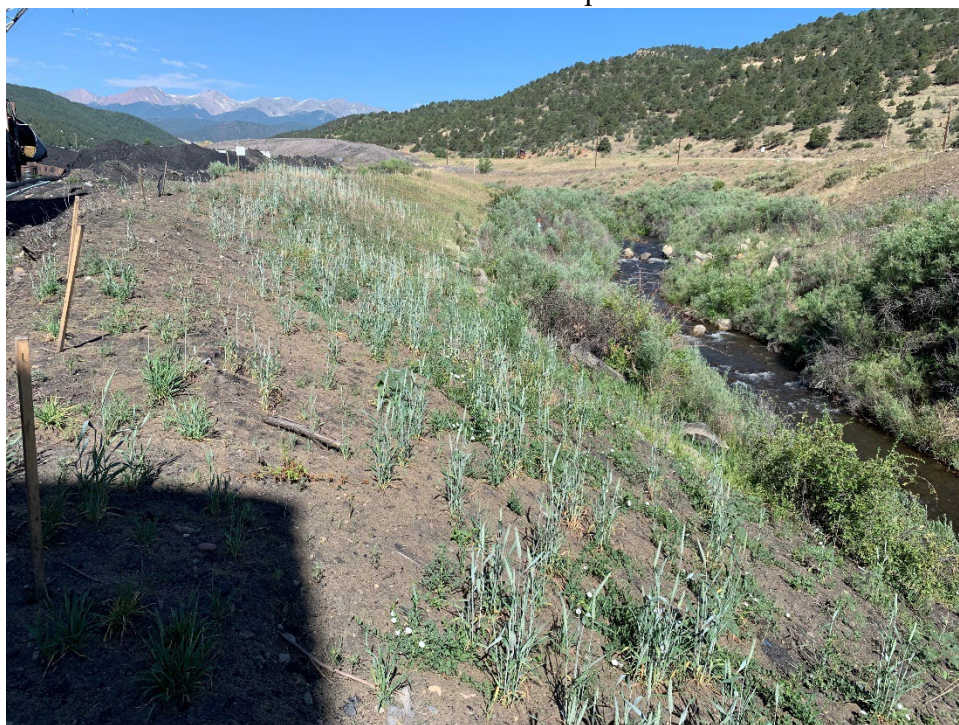
Photo 3 – Hillside north of wash plant

The hillside north of the wash plant is sprouting vegetation (photo 3). The soil appears stable as no erosion features were seen. The berm above the hillside is in good condition and directing water to ditch D32A and Pond 7 as designed.

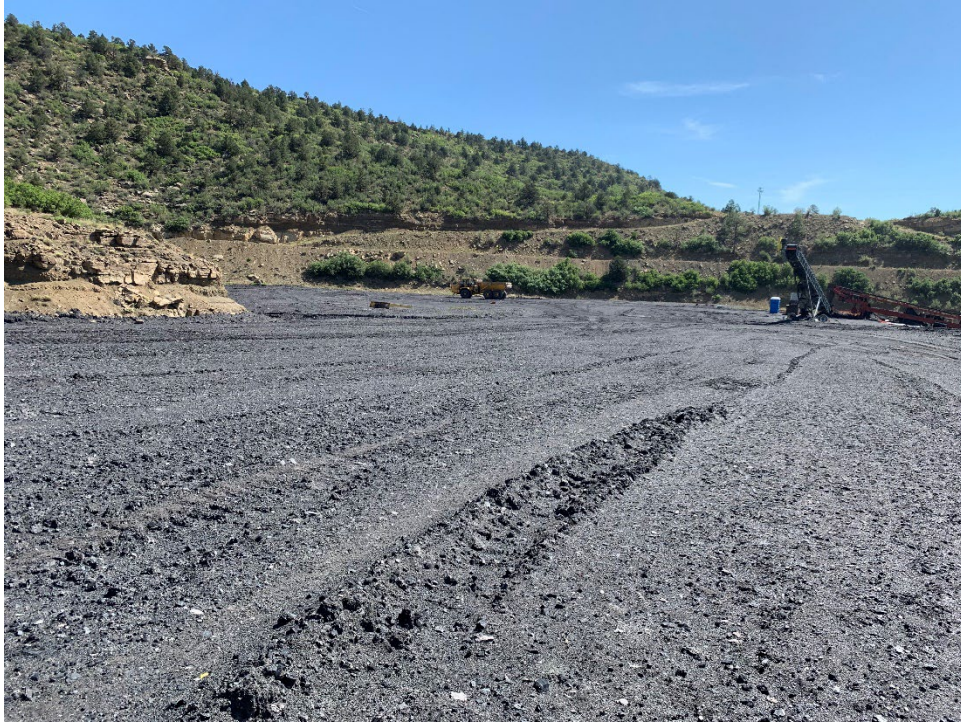
Photo 4 – top of RDA

The top of the RDA was sloped to direct rain water to the perimeter ditch around the pile. No ponding water was seen on top of the pile (photo 4).
