Deserado Mine, C-1981-018, July 18, 2023 Partial Inspection Report

Division of Reclamation,
Mining and Safety

Permit Number: C-1981-018 Mine Name: Deserado Mine Operator: Blue Mountain Energy, Inc Operator Address: Mr Kurtis Blunt 3607 County Road 65 Rangely, CO, 81648	County: Moffat, Rio Blanco Operation Type: Underground Permit Status: Active Ownership: Private
	Operator Representative Present: Kurtis Blunt
Operator Representative Signature: (Field Issuance Only) NA

Inspection Start Date: July 18, 2023 Inspection Start Time: 10:30 Inspection End Date: July 18, 2023 Inspection End Time: 12:00		Inspection Type: Coal Partial Inspection Inspection Reason: Normal I&E Program Weather: Clear	
Joint Inspection Agency: None		Joint Inspection Contacts: NA	
Post Inspection Agency: None		Post Inspection Contacts: todd.jesse@state.co.us 720 688-0626	
Inspector(s): Todd Jesse	Inspector's Signature:

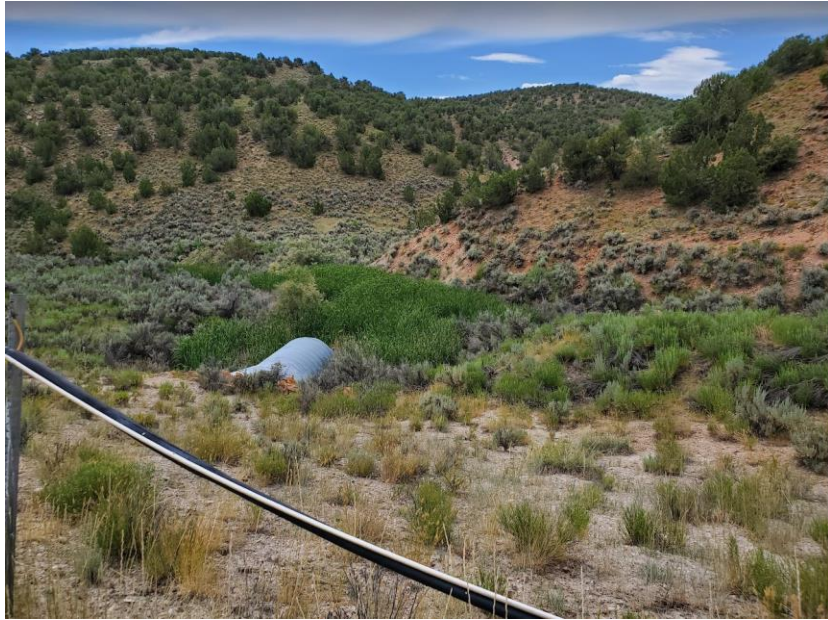
The DP-1 pond is within the facilities area of the mine site. DP-1 was discharging at the time of the inspection. The embankments of the pond have established vegetation and there was no evidence of instability, displacement, cracking, animal activity, seeps or erosion (Photo 1). The outfall was free of obstructions at the time of the inspection (Photo 2). Mine staff regularly checks the outfall to ensure that vegetation to not obstruct the outfall. The pond is designed to be 6 feet deep, but is filling with sediment. The mine anticipates being able to muck out pond DP-1 in the coming months to regain storage capacity in the pond.

Photo 1: View to the south from embankment of DP-1.

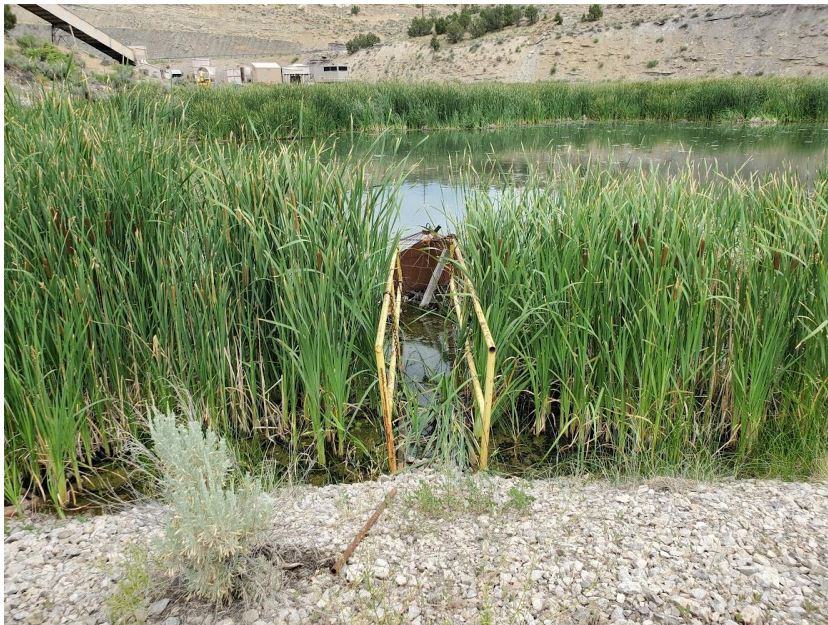
Photo 2: View to the north of DP-1 outfall.

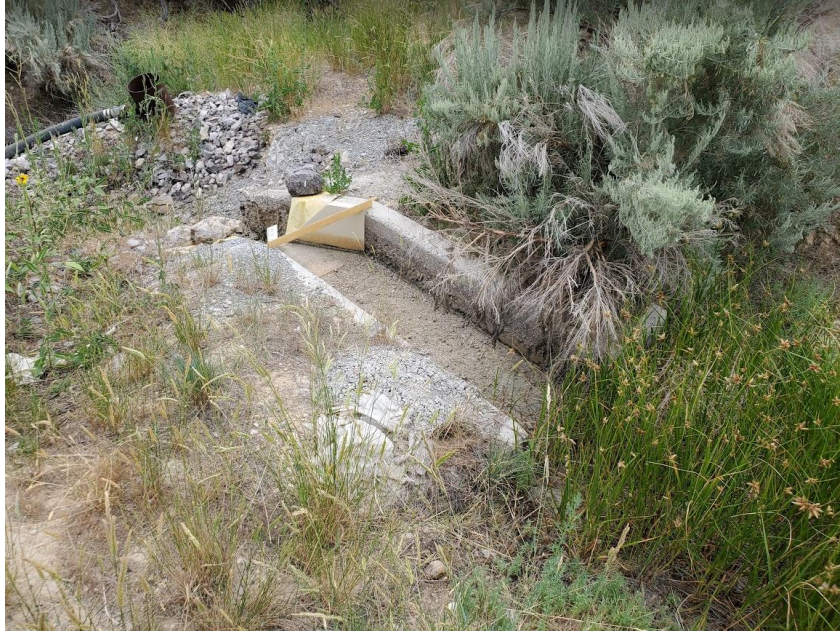
The Last Chance Pond is part of the dewatering system that allows miners to work underground. The pond is part of a passive water treatment system that improves water quality before it is discharged into the environment. At the time of the inspection the pond was not discharging water (Photo 3). The embankment of the

pond is stable with no burrows, cracks, slumping, seeps, obscuring growth or erosional concerns. There were also a large number of song birds around the pond at the time of the inspection.

Photo 3: View to the southeast of Last Chance discharge. Not discharging at time of inspection.

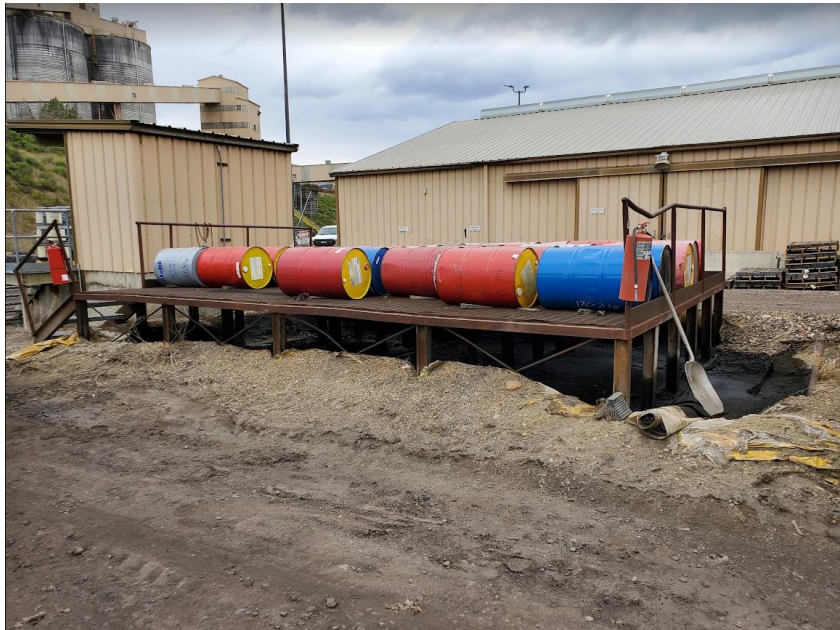
Hydrocarbons are being stored in accordance with best practices. 55 gallon barrels that contain hydrocarbons are being stored on secondary containment in the facilities area near the shops. Barrels are stored on a metal grated platform above a bermed containment (Photo 4). Fuel is stored in double walled tanks near the haul road leaving the facilities area. **There is a small amount of diesel contaminated soil adjacent to the fueling pad (Photo 5). Please remove and dispose of diesel contaminated soil.**

Photo 4: View to the southwest of 55 gallon barrels above secondary containment.

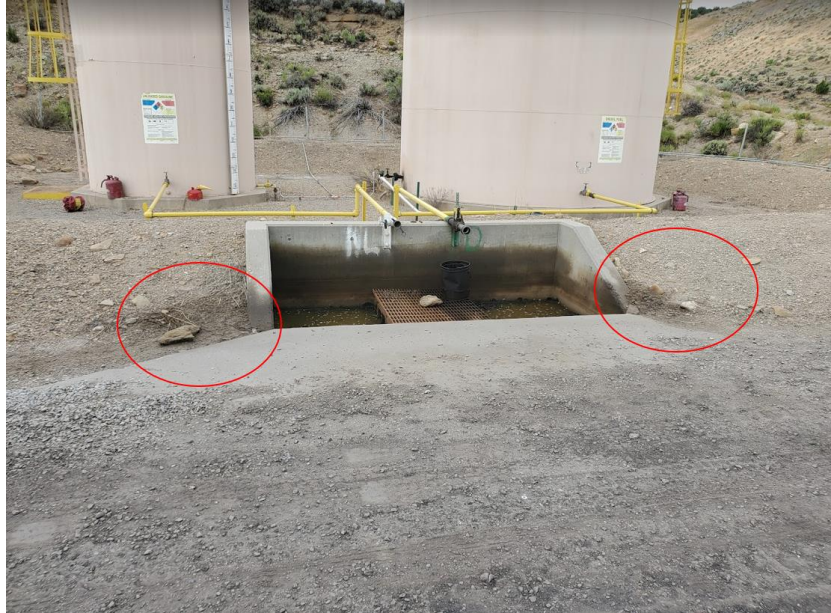
Photo 5: View to the southwest of fueling station. A small amount of diesel contaminated soil can be seen on the edges of the containment structure.

Attached is the Division's report for the inspection for the Deserado Mine conducted July, 2023. The only maintenance item that I noted was the little bit of contaminated soil by the tanks. Please feel free to contact me if you have any questions or concerns.

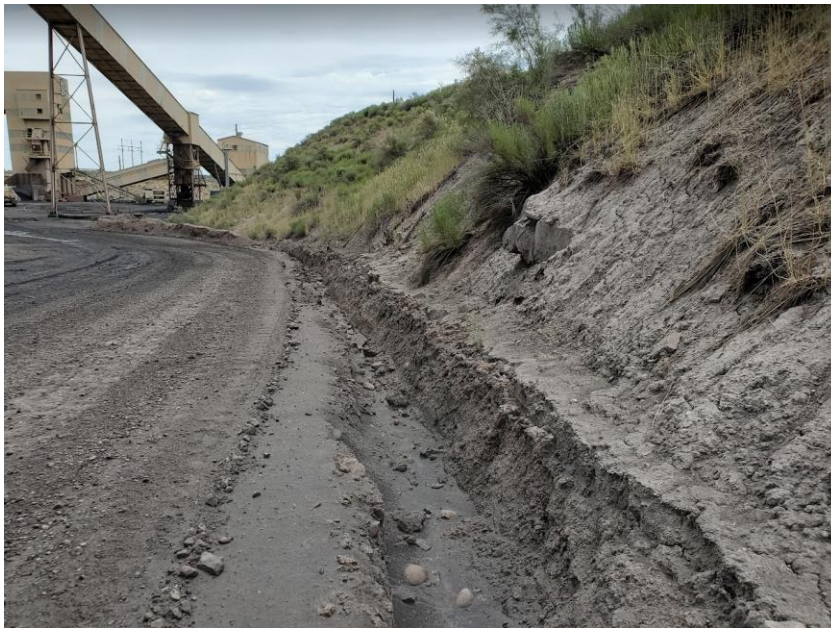
The haul road at the Deserado Mine was well maintained and being sprayed to suppress dust. Ditches and culverts along the main haulage and support roads are clear. Support roads leading to some of the more remote areas of the mine are still undergoing maintenance after the above average snowfall last winter. Roads in the facilities area of the permit are also well maintained and being sprayed for dust suppression. Some of the ditches along roads in the facilities area of the permit boundary are showing minor signs of erosion (Photo 6). This should be monitored and corrected if the erosion increases.

Photo 6: View to the east of ditch along road in facilities area with minor erosion.

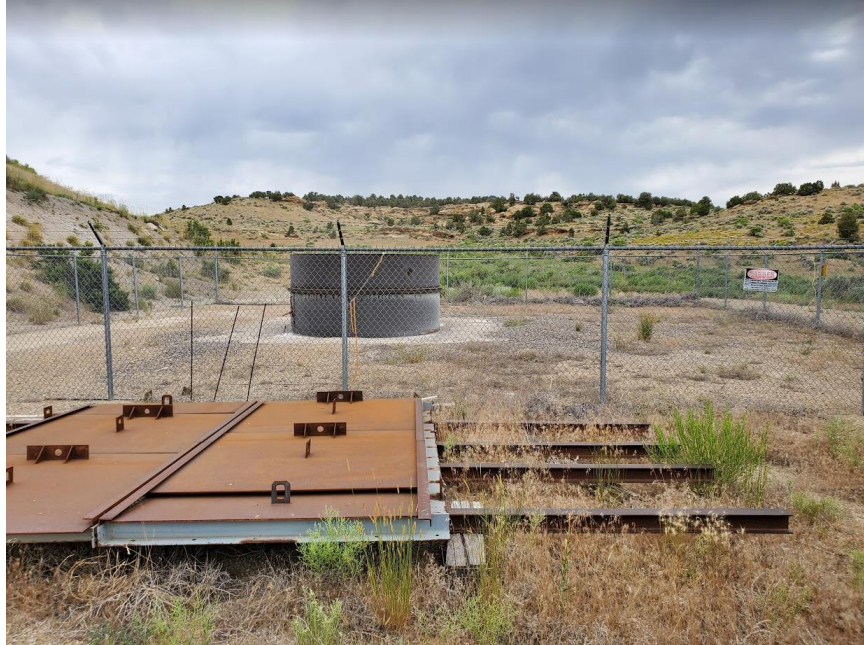
The B Vent Shaft #1 is a vent shaft designed to improve ventilation in the underground workings. The vent shaft is guarded by a chain-link fence to prevent staff and the general public from approaching an open hole. The shaft is also guarded by corrugated tube that reaches roughly 6 feet above ground level. There were no signs of erosion or slumping around the vent shaft pad (Photo 7).

Photo 7: View to the north of B Vent Shaft #1.

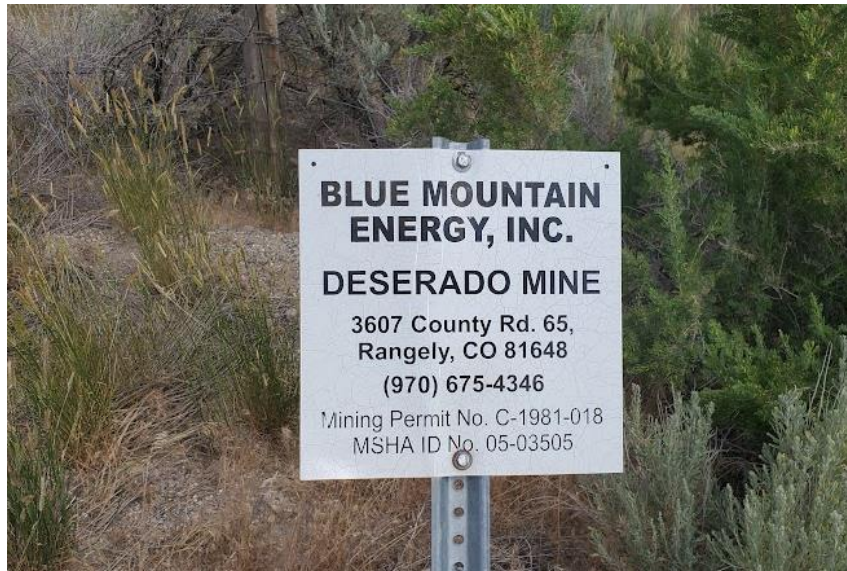
The mine identification signs are posted on the entrance to the permit boundary on CR-65. The signs displayed the current contact information for the permittee and the Division. The signs also include the assigned DRMS permit number. The ID signs were placed in unobstructed locations and the text was clearly legible (Photo 8).

Photo 8: View to the west of Mine ID sign at entrance to permit boundary.
