C-1981-008 New Horizon, July 2023 Partial Inspection Report

Permit Number: C-1981-008 Mine Name: New Horizon Mine Operator: Elk Ridge Mining and Reclamation, LLC Operator Address: Mr Tony Tennyson P.O. Box 628 27646 West 5th Avenue Nucla, CO 81424	County: Montrose Operation Type: Surface Permit Status: Active Ownership: Private
	Operator Representative Present: Tony Tennyson
Operator Representative Signature: (Field Issuance Only)

Inspection Start Date: July 18, 2023 Inspection Start Time: 13:30 Inspection End Date: July 18, 2023 Inspection End Time: 14:40	Inspection Type: Coal Partial Inspection Inspection Reason: Normal I&E Program Weather: Clear
Joint Inspection Agency: None	Joint Inspection Contacts:
Post Inspection Agency: None	Post Inspection Contacts:
Inspector(s): Lucas West	Inspector's Signature:

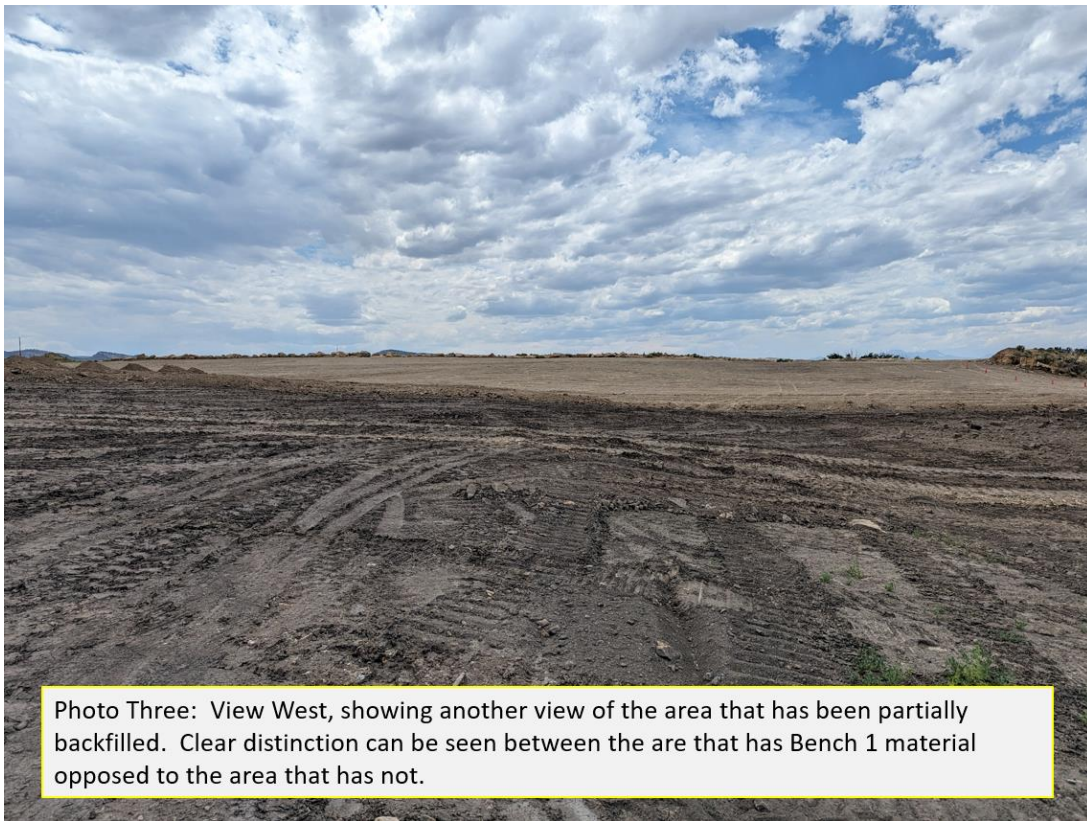
At the time of the inspection, active backfilling operations were taking place in the backfill area adjacent to Pond 013. A majority of the area has already been backfilled with Bench 1 material hauled from the stockpile located near Pond 012. The stockpile near Pond 012 was observed, material was removed from the pile in such a way as to not jeopardize the piles stability, and no evidence of erosion or slumping was observed on the pile. The activity taking place the day of the inspection was pulling from the Bench 1 stockpile in the immediate area. Haul trucks were being loaded via excavator and dumped material was being spread by way of a dozer in the dump area. Photos One through Three show the backfilling operations. In the areas that have already been backfilled and spread, no erosion, settling or slumping was noted. The areas have consistent grade, which appears to match the post reclamation topography in preparation for topsoil placement.

Photo Three: View West, showing another view of the area that has been partially backfilled. Clear distinction can be seen between the are that has Bench 1 material opposed to the area that has not.

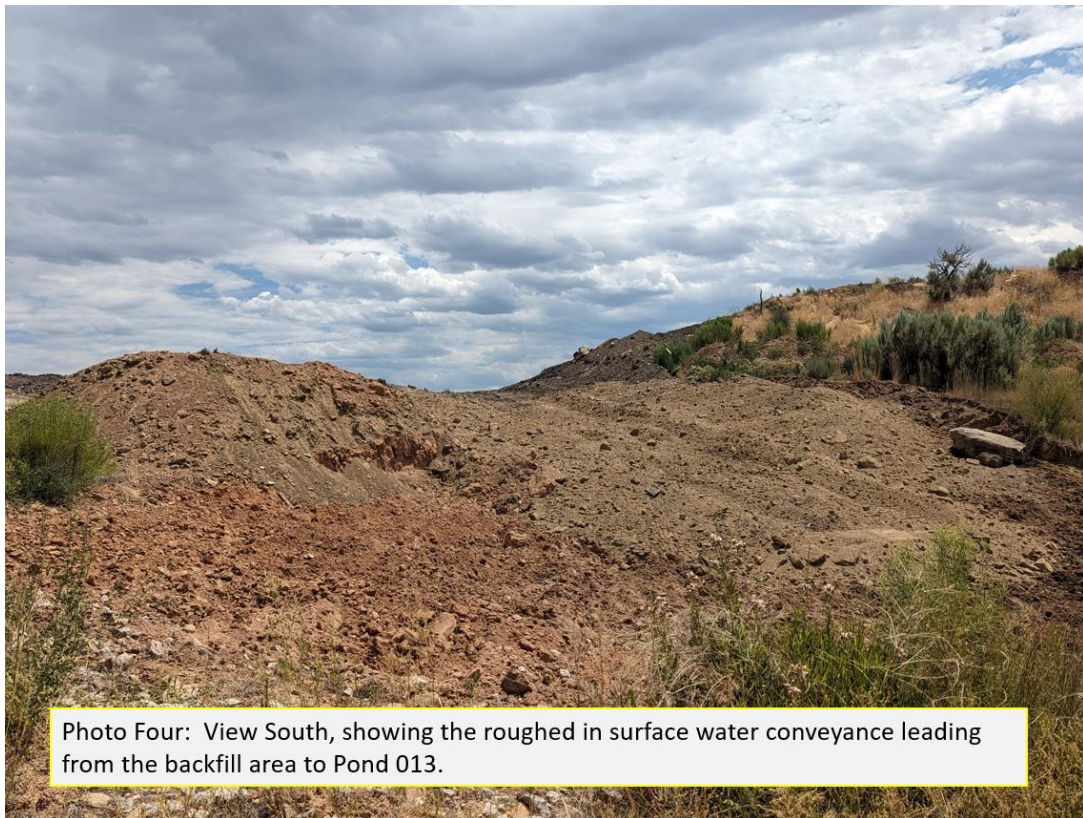
Located to the North of pond one, in accordance with the reclamation plan, a surface water conveyance has been roughed in. This conveyance will direct surface flows from the backfill area towards Pond 013. The location and rough dimensions appear to be consistent with the designs, and the area is in good condition. The conveyance can be seen in Photo Four.

Photo Four: View South, showing the roughed in surface water conveyance leading from the backfill area to Pond 013.

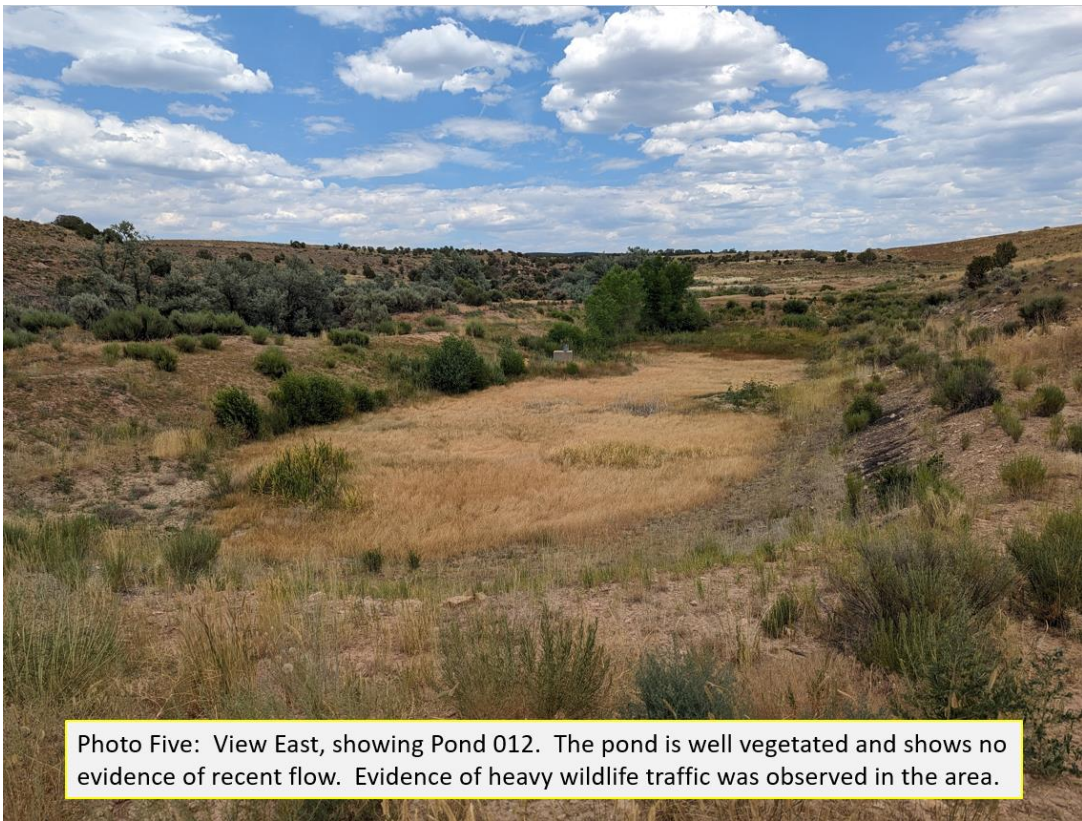
Ponds 012, 013 and 015 were observed during the inspection. Pond 012 contained no water and showed no evidence of recent inflow or holding of water given the dry conditions. The banks and base of the pond are well vegetated and appeared stable at the time of the inspection. Pond 012 can be seen in Photo Five. Similarly, Pond 015 was observed to be dry with no evidence of recent inflow or holding. The area in and around Pond 015 is well vegetated and was stable at the time of the inspection. Pond 013, shown in Photo Six is in good condition, the vegetation and banks appear stable and the baffle curtains appear to be functioning as designed. The inflow

Photo Five: View East, showing Pond 012. The pond is well vegetated and shows no evidence of recent flow. Evidence of heavy wildlife traffic was observed in the area.

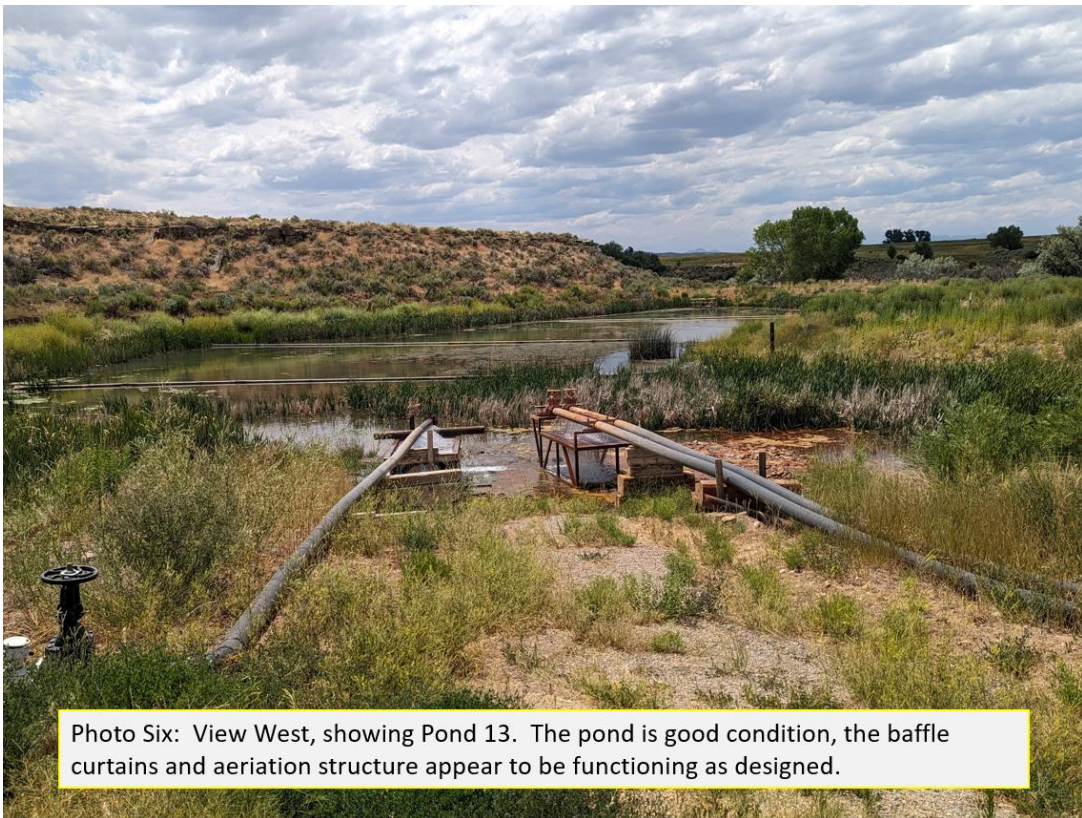
and aeration structure was observed receiving water through both pipes and functioning as designed.

Photo Six: View West, showing Pond 13. The pond is good condition, the baffle curtains and aeration structure appear to be functioning as designed.

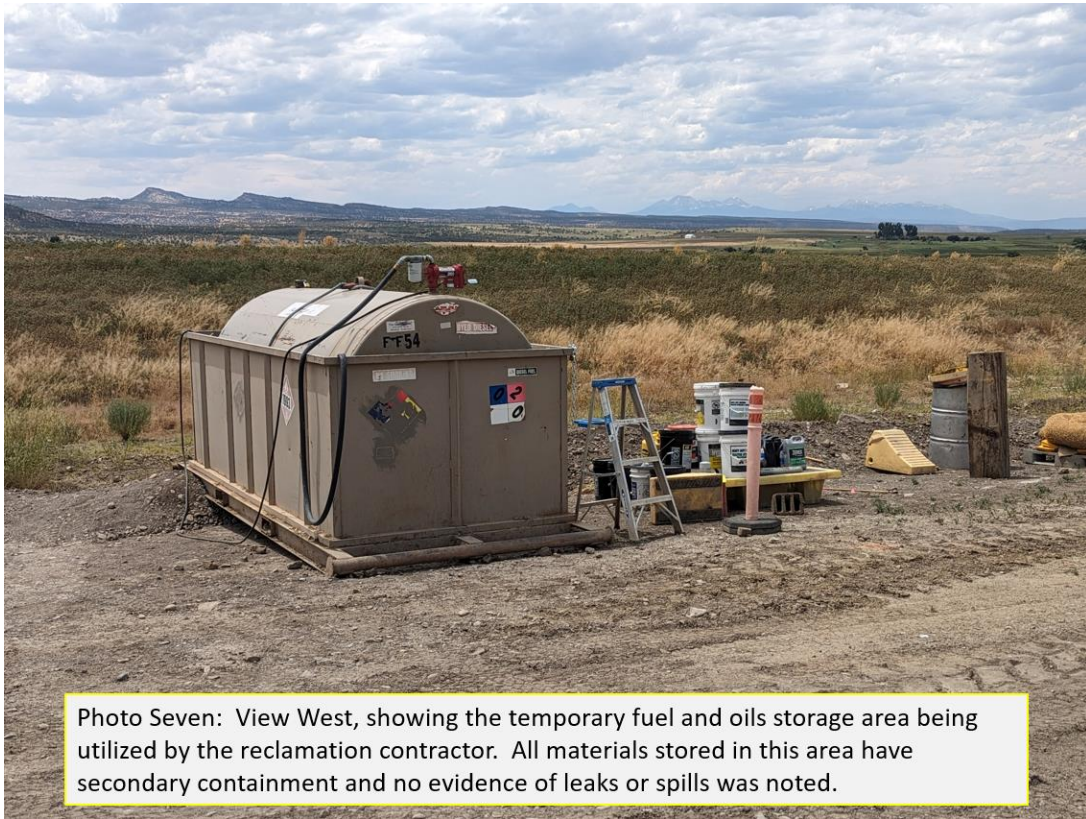
Located near the Johnson Property Topsoil Storage Area, a temporary mobile above ground fuel tank and lubricant storage area was observed that is being utilized by the reclamation contractor. The fuel tank is a skid mounted, double walled tank that is in good condition, miscellaneous oils, lubricants and other materials are being stored adjacent the tank on a spill pallet. No evidence of spills or leaks were observed, and the area is neat and well-kept as seen in Photo Seven.
