BOWIE RESOURCES, LLC
Bowie No. 2 Mine
Coal Mine Waste Bank Nos. 1, 2, & 3 Inspections 2nd Quarter 2023

SUBJECT: CWDA#2 West Gob Pile Blowout Assessment

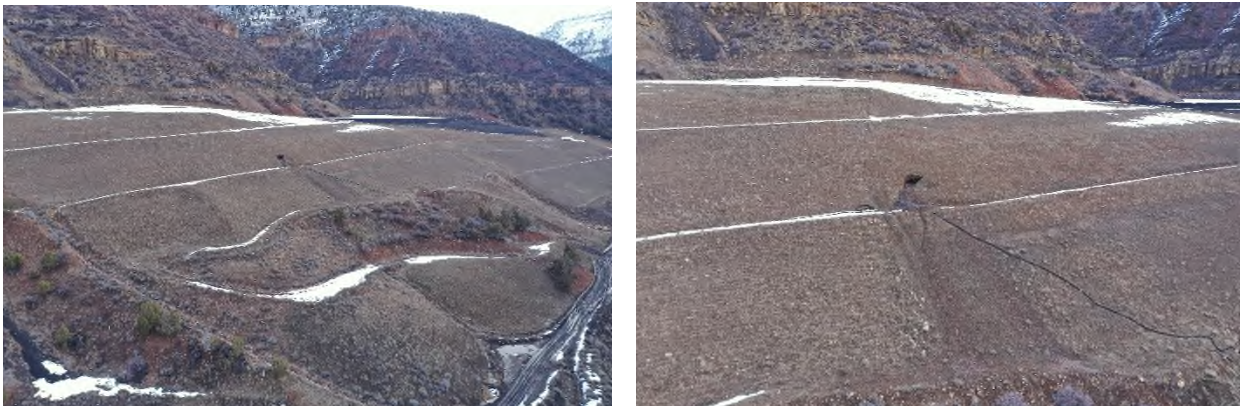
Photo 1 (left) and Photo 2 (right) are drone images of the blowout feature from the west to southwest. (Photos courtesy Huddleston-Berry).

Note the location of the blowout feature roughly mid-gob pile and just above a drain ditch (Photo 1). We understand this feature had blown out before and been repaired, as can be seen by the scar in the slope to the left (west) of the current feature in Photo 2. Also seen in Photo 2 is the black plastic drainpipe laying on the surface of the hillside and extending downslope to the lower right portion of the photograph (to the southeast). Inspection of this pipe on March 29th indicated it was disconnected and not functioning. The following two photographs show the nature of the feature a close-up from the drone and during our March 29th visit.

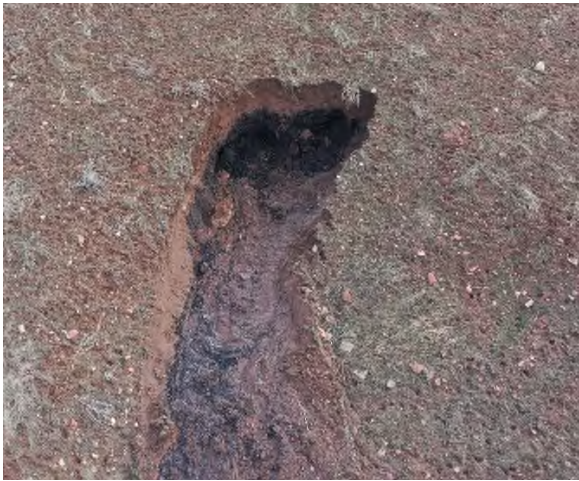
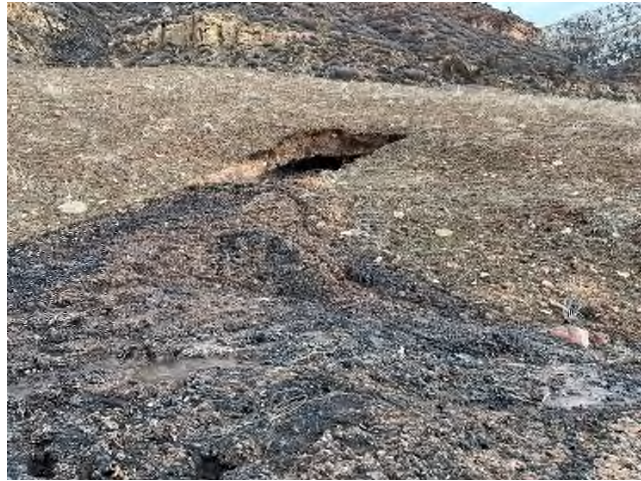
Photo 3 (left) close-up view from the drone. Photo 4 (right) ground view on 3/29/23 looking upslope from the drain ditch area.

Note the muddy, lobate soils in the drainage zone of the blowout in Photo 3 and the mudflow fan developed downslope of the feature. In March, this area was saturated and was impossible to walk upon. Soil tension cracks were noted adjacent to the blowout due to loss of support of the soils. Although the blowout is not a slump type slope failure, it appears to be an area of concentrated groundwater seepage that has created an earthflow failure. The composition of the mudflow fan indicates it contains both black gob pile coal waste and red-brown cover soil (Photos 3 and 4). The following ground view photographs (Photos 5-8) from March 29th show the nature of the blowout, the areas of saturated soils, and the drainage patterns.

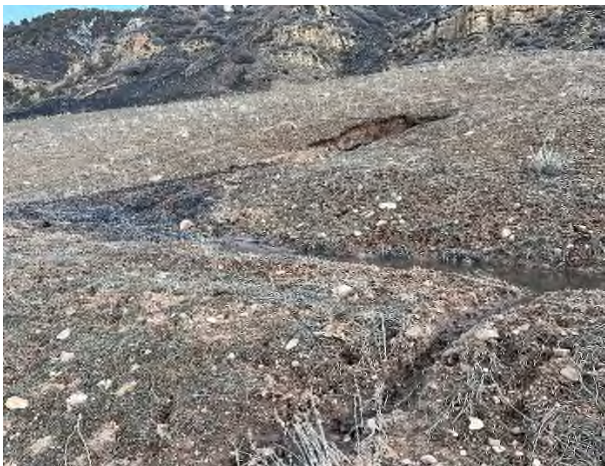
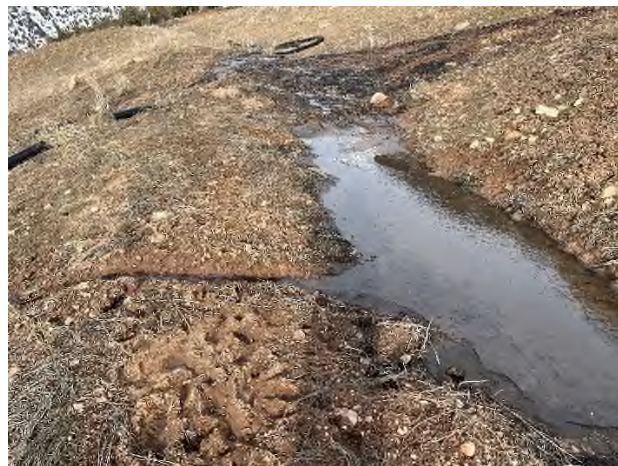
Photo 5 (left) view northwest at the blowout from below the drain ditch. Photo 6 (right) view west along the drain ditch below the blowout. Note the disconnected pipe in the distance on Photo 6.

Both Photos 5 and 6 show the ponded water in the drain ditch below the blowout. Mudflow deposits from the blowout have dammed the ditch and prevent water from draining to the west. This further saturates the slope which could lead to slope failure below the blowout.

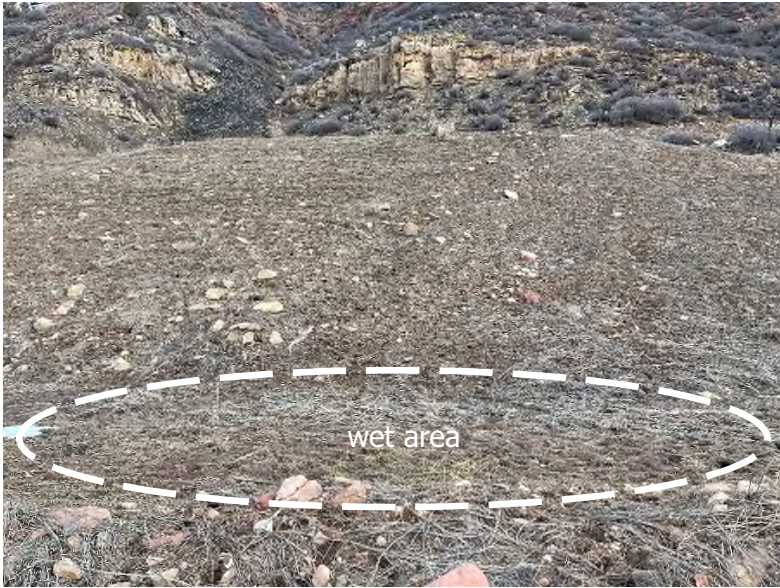
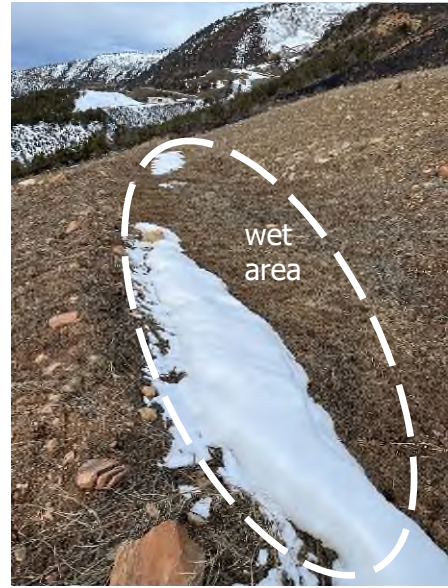
Above the blowout, as seen in Photos 7 and 8, there is another drain ditch with poor drainage. It actually serves as a collection basin, and it was saturated (muddy with standing water) when observed on March 29th. The hillside is heavily used by deer and elk and their hoof prints left deep holes in the muddy soil with standing water in the ditch area. This ditch was mostly filled with slope wash soils, so it does not serve to drain the slope well. It collects runoff and snow (Photo 8). We estimate that standing water could collect in this area to a depth of 6-8 inches in a width of roughly 65-70 feet.

Photo 7 (left) view upslope (north) at the drain ditch above the blowout. Photo 8 (right) view west at snow collected along the drain ditch above the blowout.

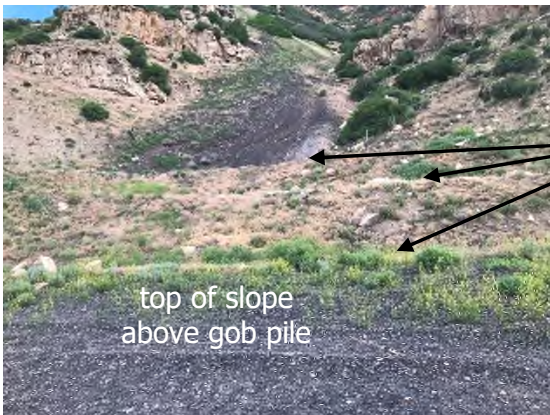
Photo 9. View upslope (north) at drainage swales/ditches above the gob pile. Note the coal-stained drainage channel on the slope above the top ditch. Water could run down this channel and under the gob pile if not sufficiently captured by the drainage channels.

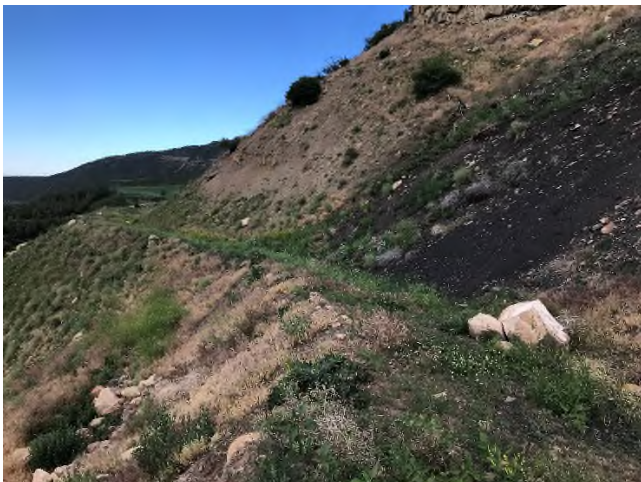
Photo 10. View west at the drainage ditch at the base of the hillside north of the gob pile. This is the uppermost drainage feature. It appears to be mostly intact (although it has some infilling and rockfall) and functions to drain snow and runoff around the gob pile.

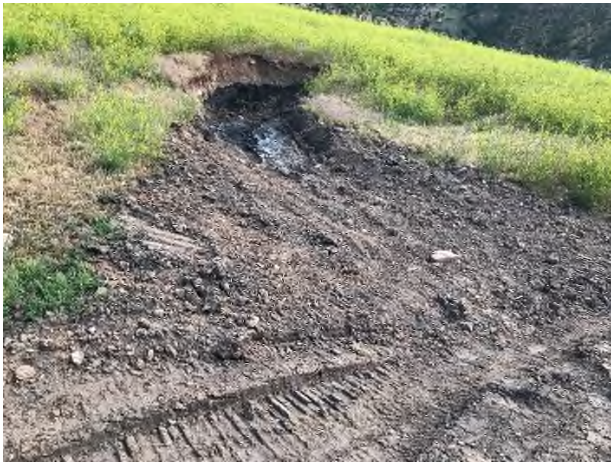
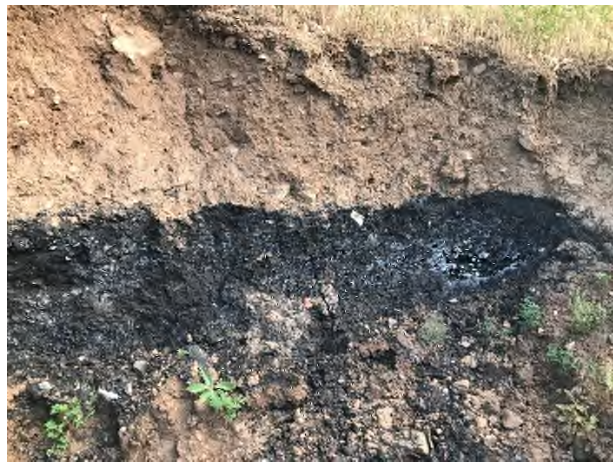
Photo 11 (left) view upslope (northeast) at the blowout and the former mudflow fan that has been mostly removed. Photo 12 (right) is a close-up view of the cover soils and gob material in the blowout headwall.

Both Photos 11 and 12 show the active seepage that continues at the blowout, although the saturated area is much reduced from March. Note in Photo 12 that the seepage appears to be from within the black coal waste material in the lower portion and bottom of the scarp, not in the cover soils above it. During our June 20th site visit, the blowout scarp area was approximately 6-8 feet wide, 20 feet long from scarp to fan material, with 3-4 feet of reddish-brown topsoil cover over roughly 2-feet of exposed gob. Much of the debris fan had been removed/regraded, but it extends into and spreads out laterally into the drain ditch at the toe of the slope. Some tension cracking along the lateral edges of the scarp was observed and continued lateral erosion should be expected. No tension cracks, slumping/bulging, or other signs of slope movement above the head scarp was observed. There is a slight depression to the east of the exiting new scarp that is potentially a small historical slump or seep area, but it is not fresh. No rotational movement was observed around the scarp structure; rather, it is more indicative of an earthflow/mudflow. Photo 13 shows a drainpipe below that blowout that needs improvement.

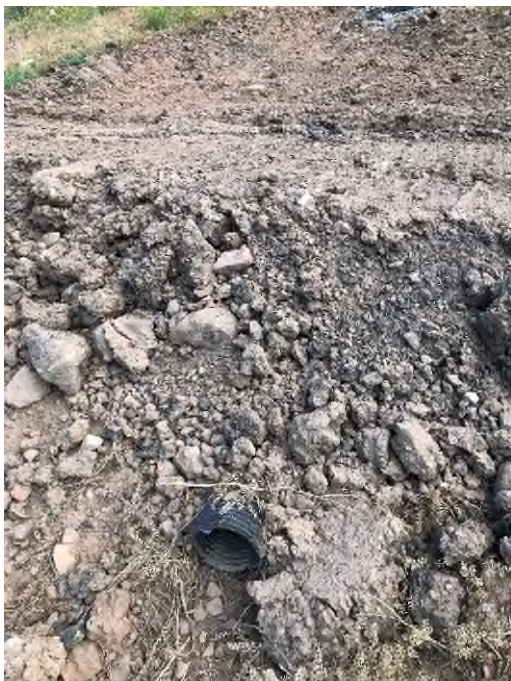
Photo 13. View upslope (north) of the regraded slope below the blowout where a drainpipe was installed below the drain ditch. This pipe drains back into the hillside not out, so it should be corrected. The active seepage from the blowout, although much reduced since March, can be seen at the top right edge of the photograph.

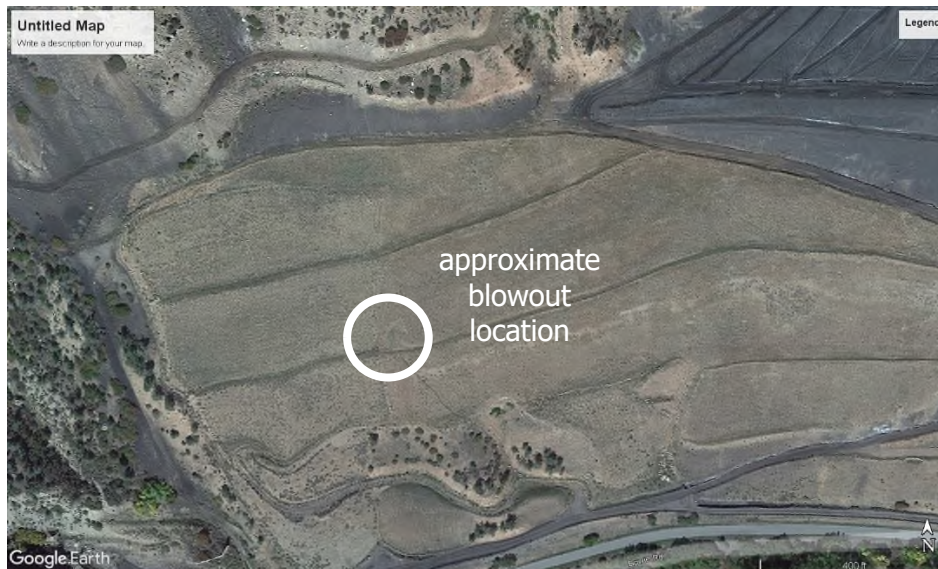
Figure 3. Google Earth image from 10/13/22.

The above Figure 3 from 10/13/22, shows the blowout area on the completed gob pile. The outline of the western cover soil shape seen in Figure 2 can be faintly seen in Figure 3. The black drainpipe installed after the first blowout failure can also be seen oriented to the southeast from the blowout area. These images suggest a possible drainage feature at the base of the gob pile as well as a potential structural/drainage weakness at the seam between two phases of the gob pile construction of the cover soils. This seam may be a pathway for vertical movement of water within the pile. Additionally, the relict drainage feature may be carrying water downslope under the pile from drainages higher on the hillside above the pile (see Photo 9).
