File: June 2023 Monitoring Summary

Date: July 31, 2023

**Reference: June 2023 Geotechnical Monitoring Summary Pikeview Quarry**

PIKEVIEW QUARRY SLOPE  
MONITORING

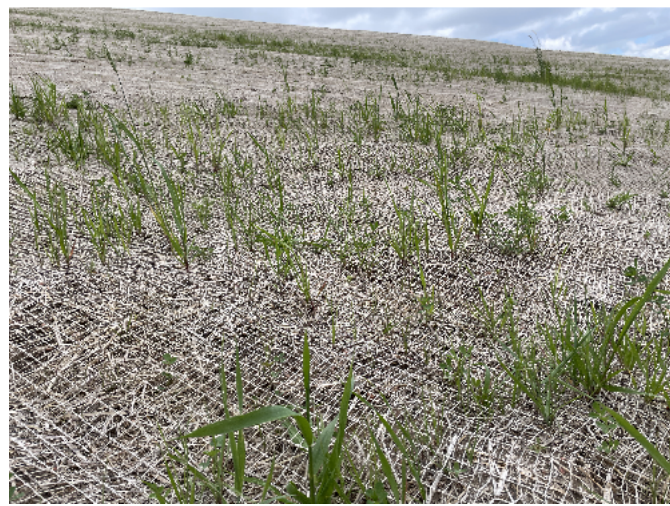
6. Vegetation growing within erosion blanket.

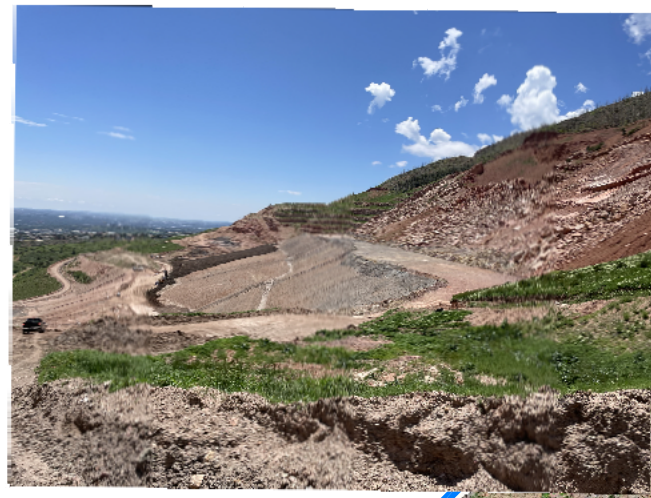
- The slope below the first bench has been placed to the final grade, and this slope was traversed on foot and examined for cracks or signs of instability by Stantec engineers. No cracks or signs of instability were identified.

5. View south of first bench and slope.

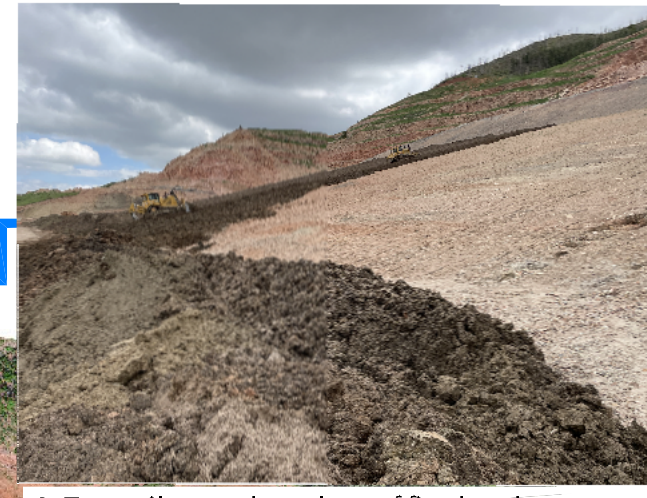
- Topsoil was placed on the buttress slope below the first bench.

4. Top soil spread on slope of first bench.

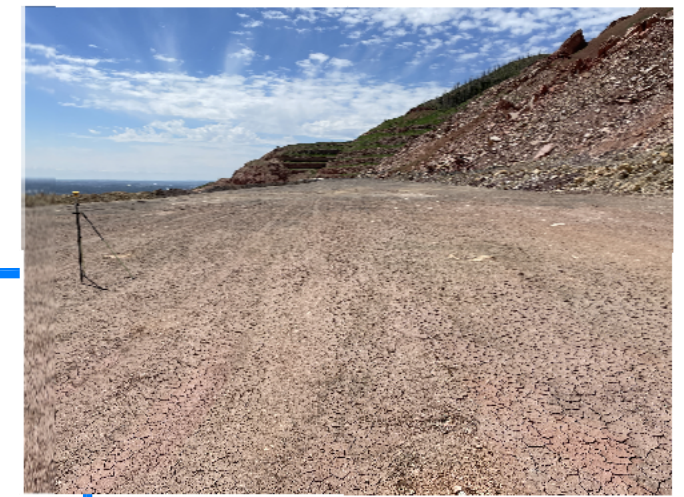
3. Compacted floor of first bench.

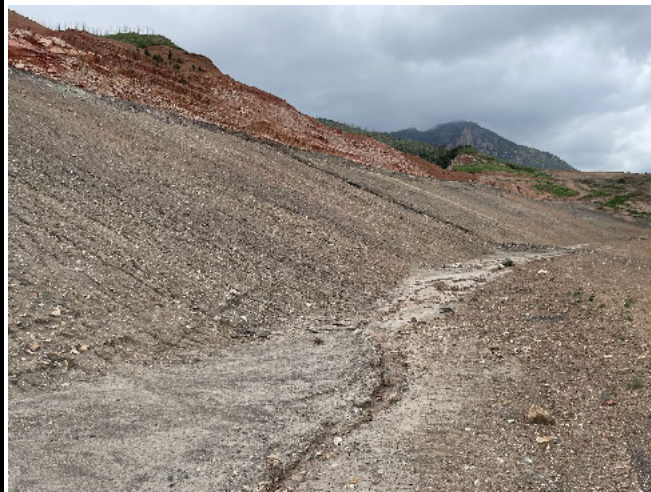
7. No cracking on buttress slope.

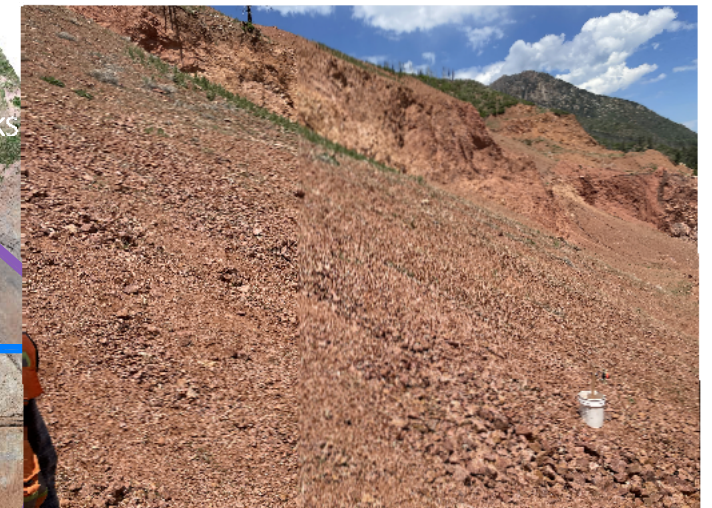
- The surficial slumping and cracking on the loose fill that was observed in May 2023 showed no signs of continued movement.
- A safety buffer zone is being kept between the active work areas and the toe of the slide to stop any rocks that might come loose during grading operations. Compacted fill is placed in the buffer zone as the buttress fill is placed.

2. No continued signs of cracking or slumping.

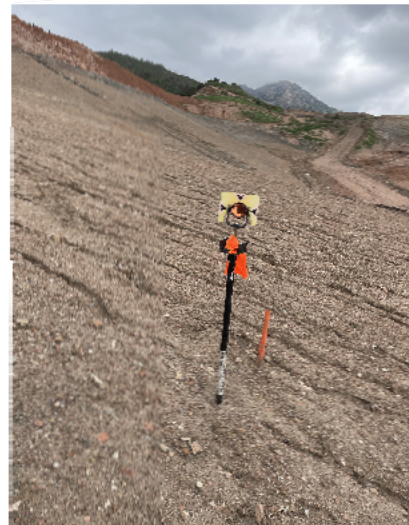
8. New prism installation.

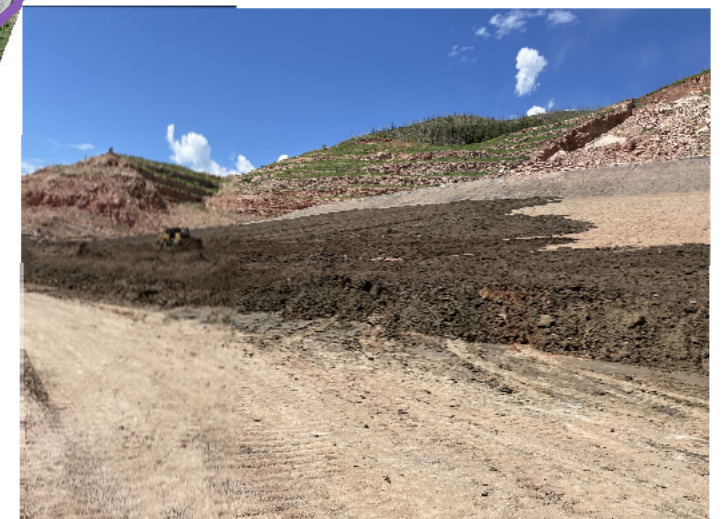
1. Top soil spread on slope of first bench.

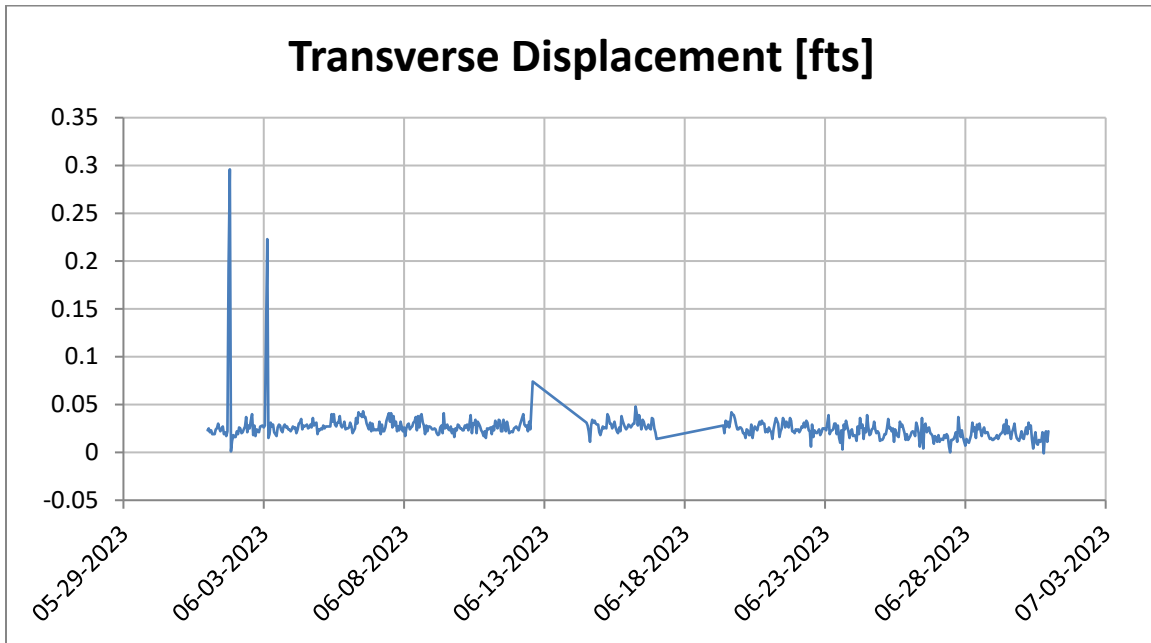
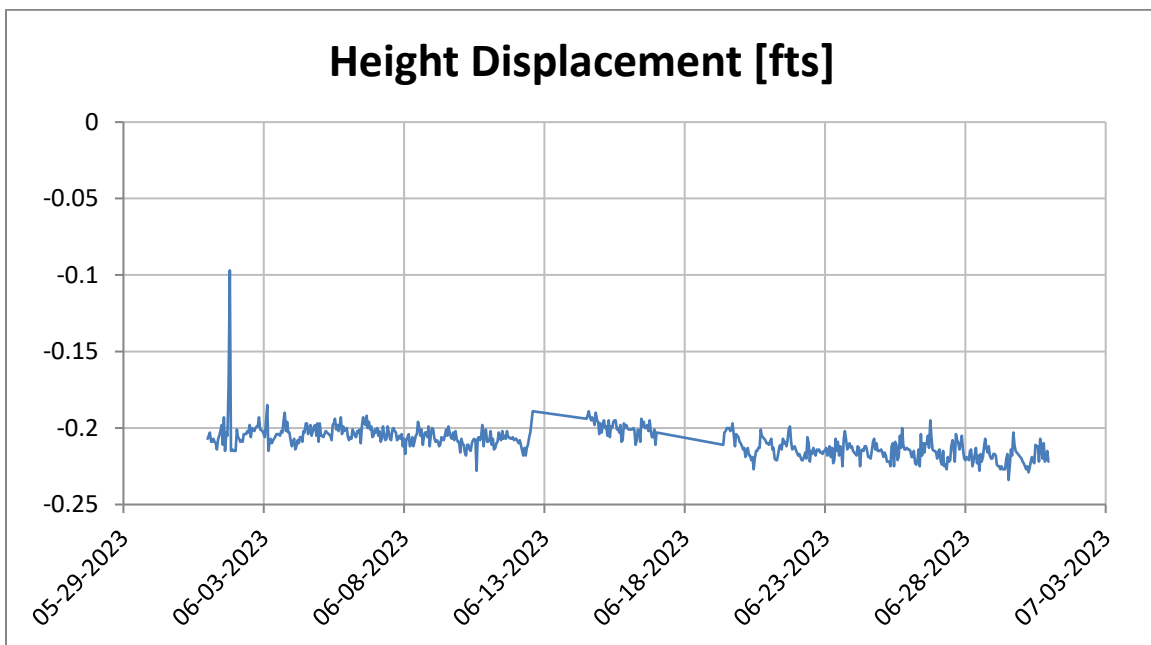
## Prism BR1

1. Survey accuracy is  $\pm 0.016$  feet.
2. Alert threshold is  $\pm 0.35$  feet.
3. Transverse displacement is in the horizontal direction. Positive direction means closer to the robotic station.
4. Height displacement is in the vertical direction. Positive direction means higher in elevation.
5. Prism records slope creep movements.

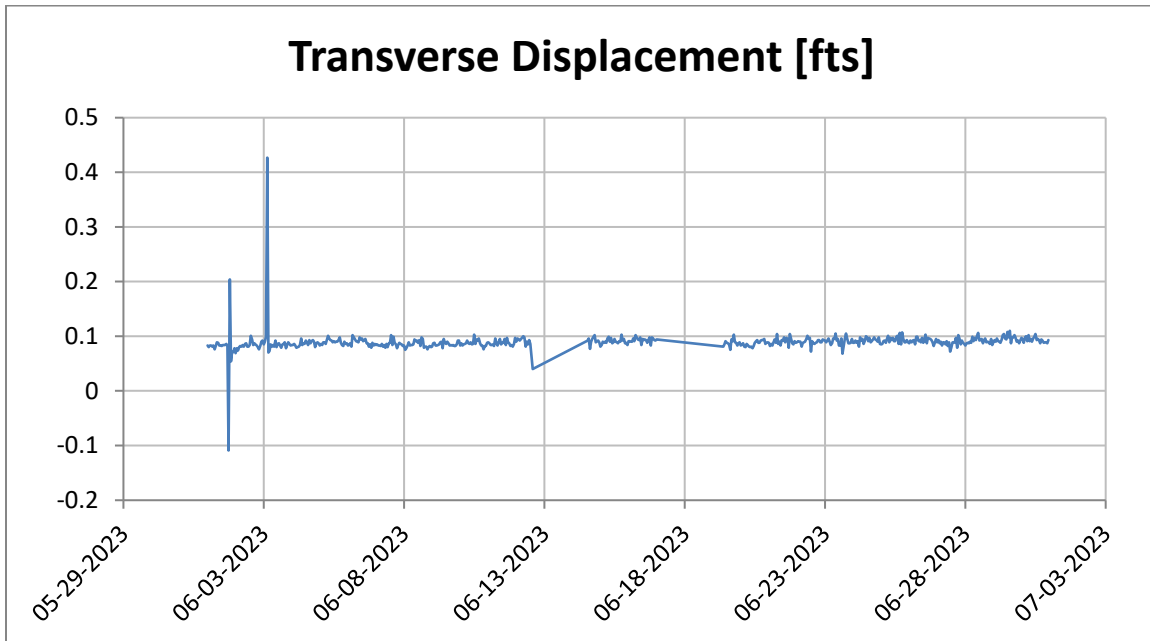
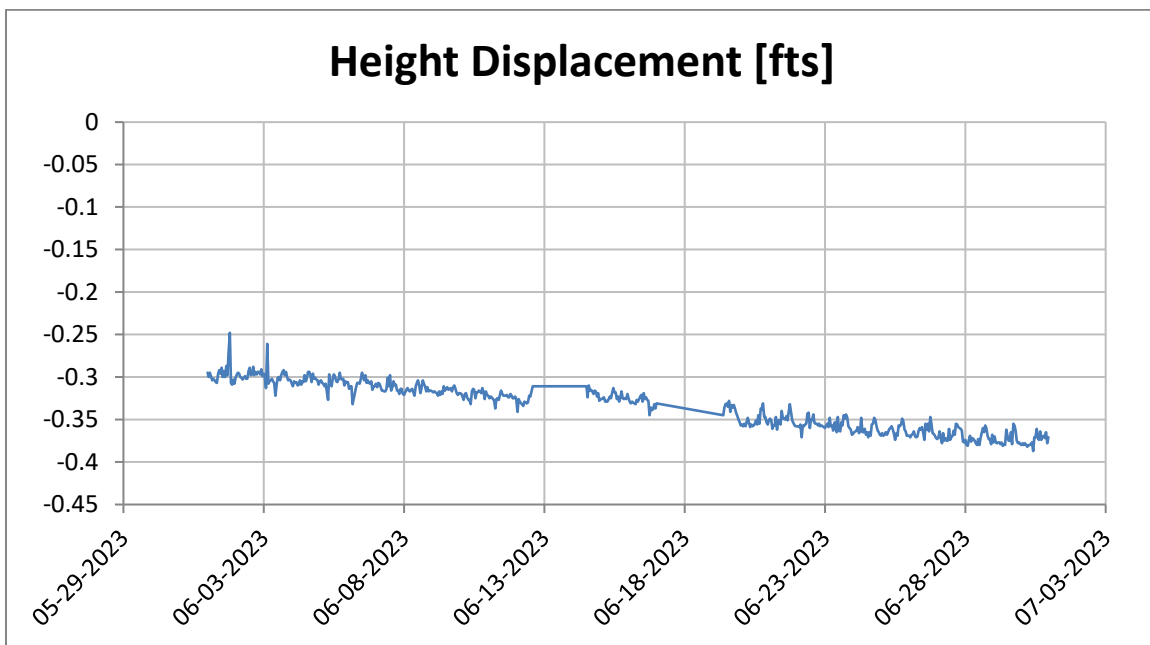
## Prism BR2

1. Survey accuracy is +/-0.016 feet.
2. Alert threshold is +/-0.35 feet.
3. Transverse displacement is in the horizontal direction. Positive direction means closer to the robotic station.
4. Height displacement is in the vertical direction. Positive direction means higher in elevation.
5. Prism records slope creep movements.

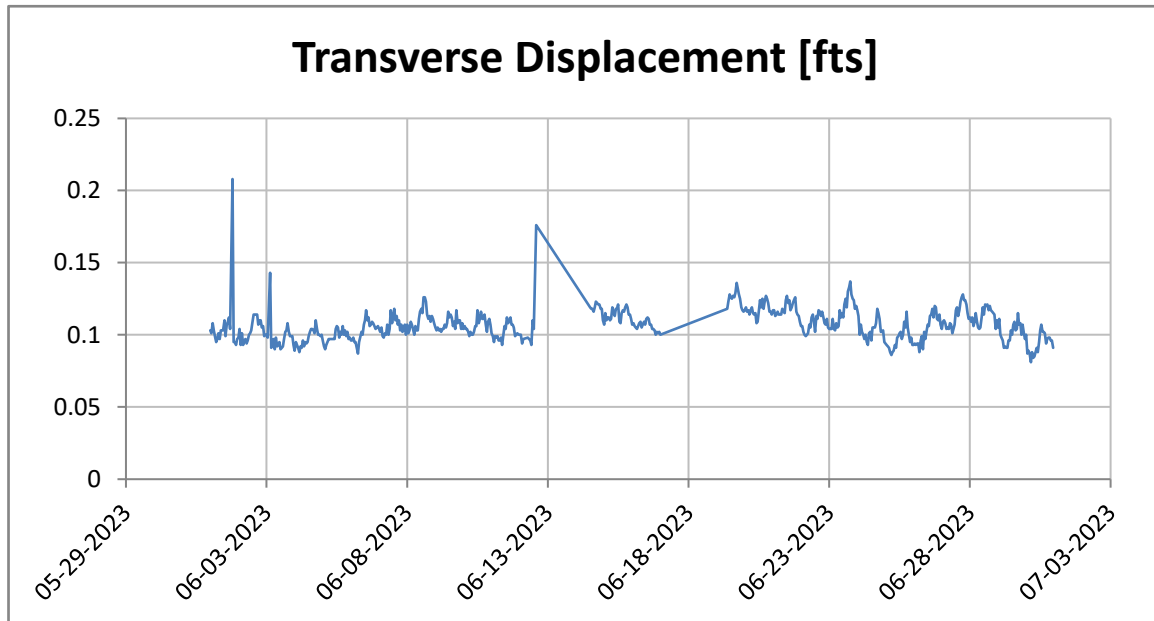
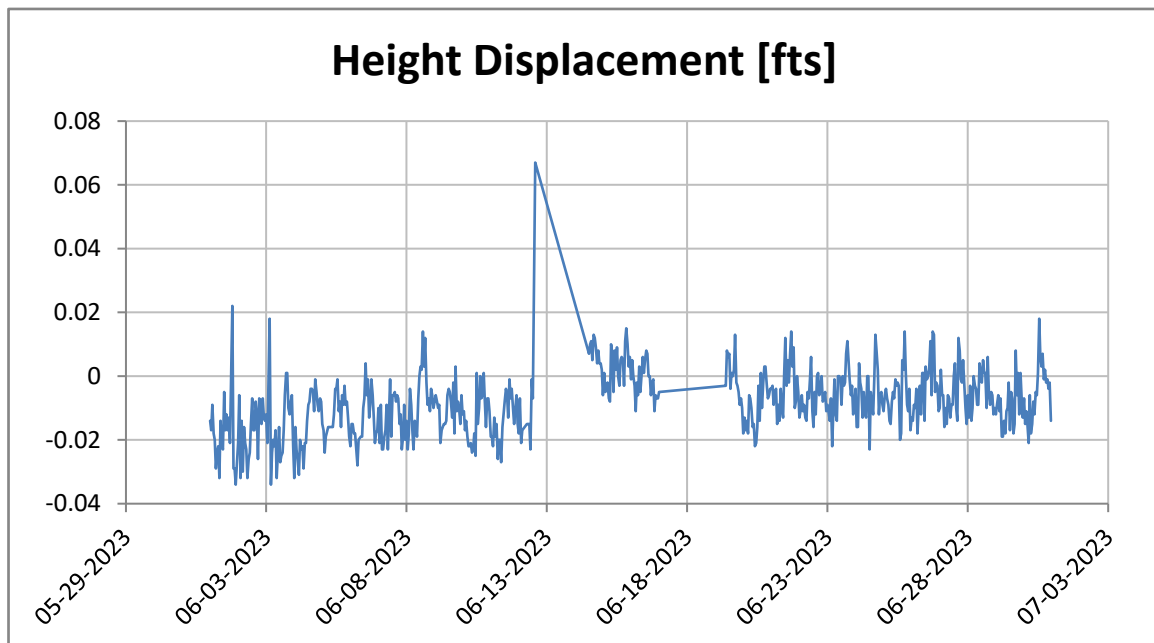
## Prism P33

1. Survey accuracy is  $\pm 0.016$  feet.
2. Alert threshold is  $\pm 0.35$  feet.
3. Transverse displacement is in the horizontal direction. Positive direction means closer to the robotic station.
4. Height displacement is in the vertical direction. Positive direction means higher in elevation.
5. Regression limit alerts received on June 1, June 2, June 3, and June 12.

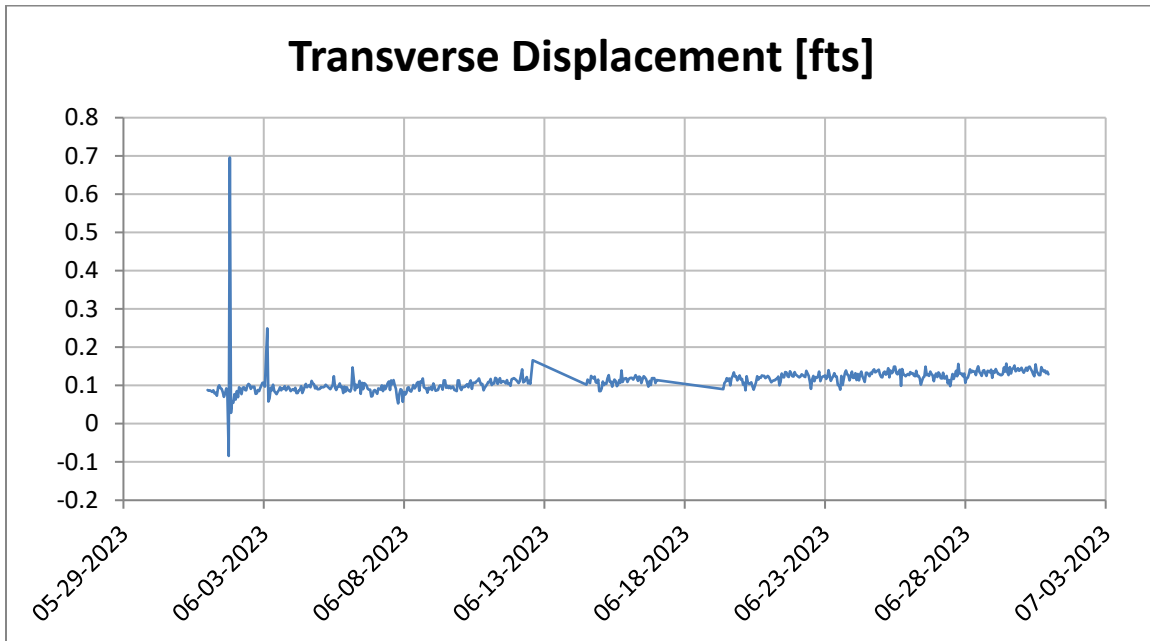
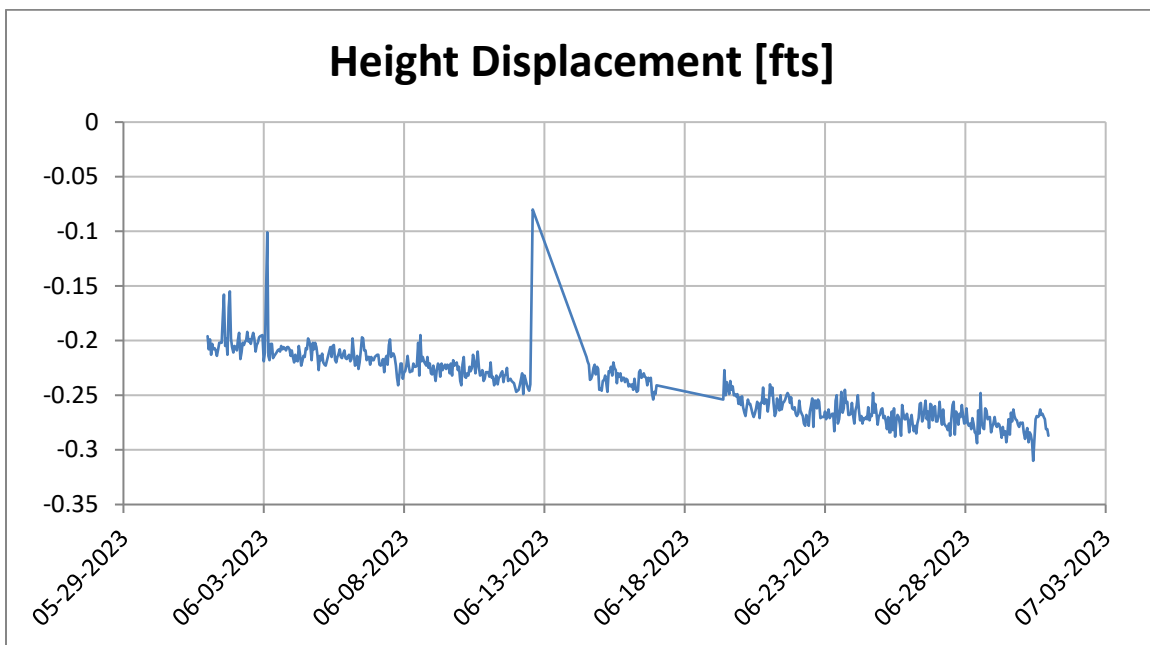
## NP3

1. Survey accuracy is  $\pm 0.016$  feet.
2. Alert threshold is  $\pm 0.35$  feet.
3. Transverse displacement is in the horizontal direction. Positive direction means closer to the robotic station.
4. Height displacement is in the vertical direction. Positive direction means higher in elevation.
5. Prism records slope creep movements.

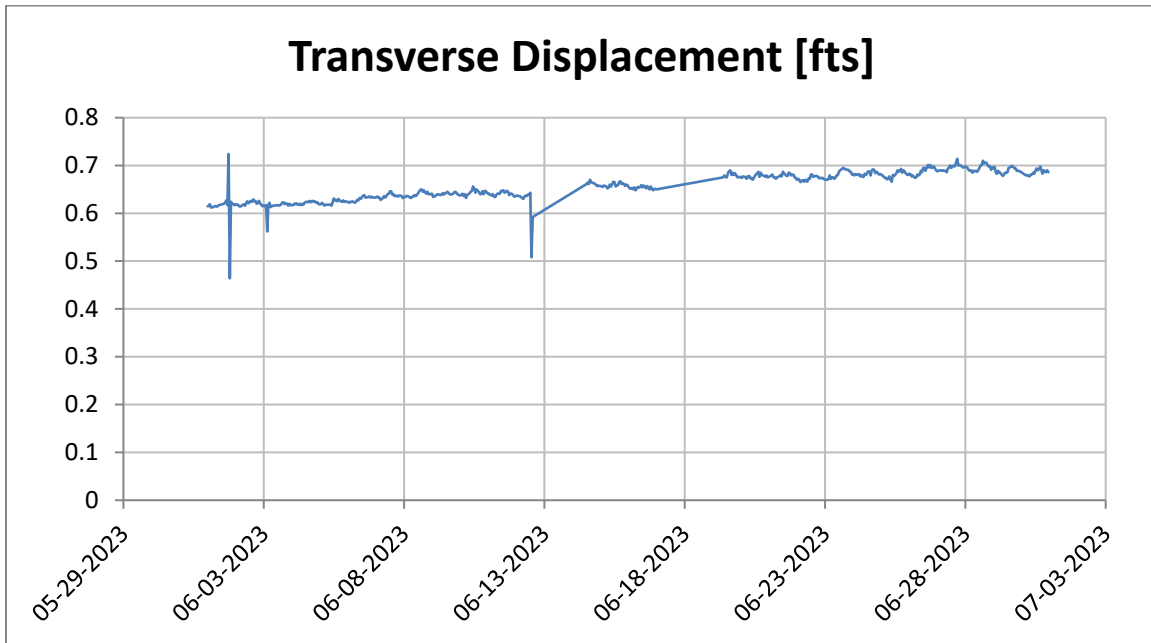
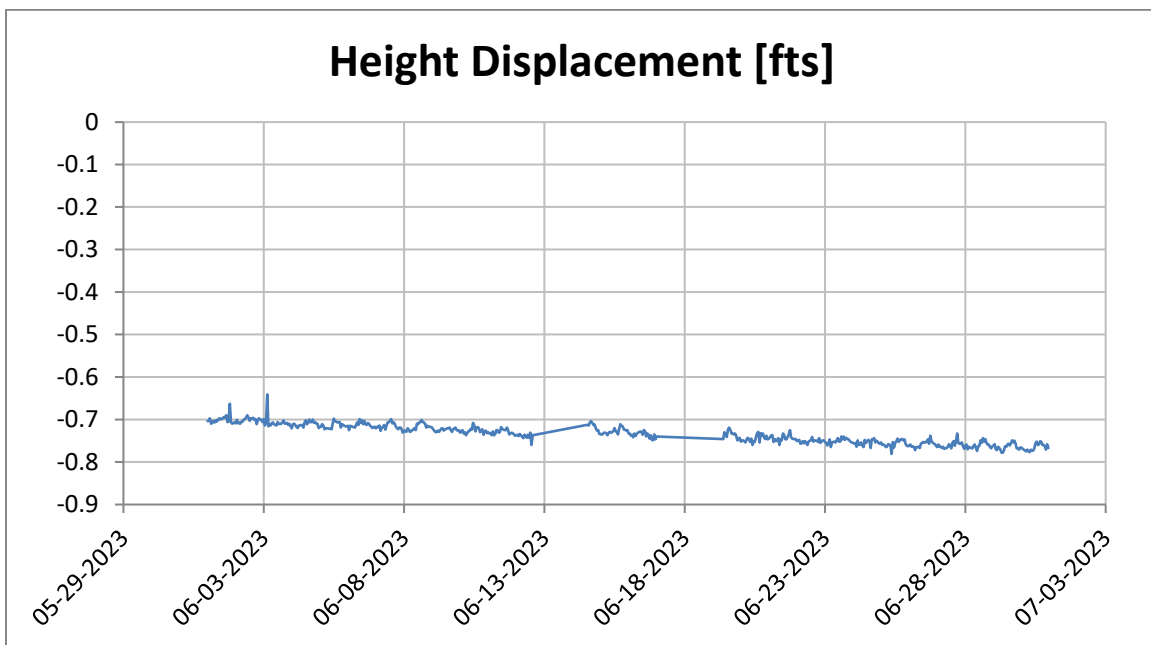
## NP66

1. Survey accuracy is  $\pm 0.016$  feet.
2. Alert threshold is  $\pm 0.35$  feet.
3. Transverse displacement is in the horizontal direction. Positive direction means closer to the robotic station.
4. Height displacement is in the vertical direction. Positive direction means higher in elevation.
5. Prism records slope creep movements.
6. Regression limit alerts received on June 1 and June 12.

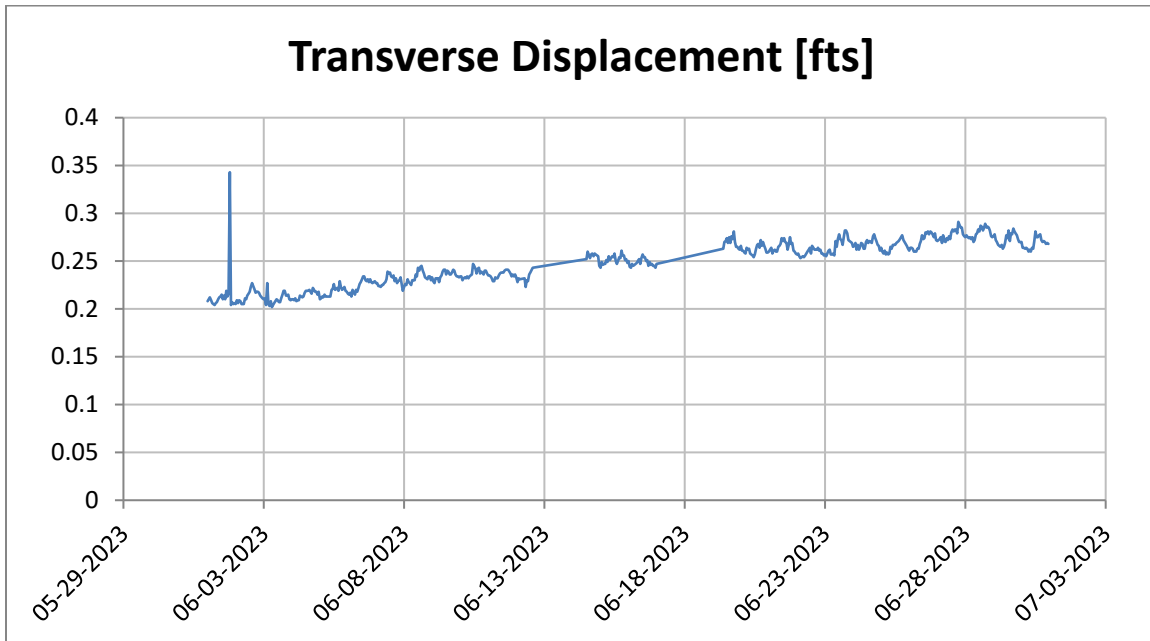
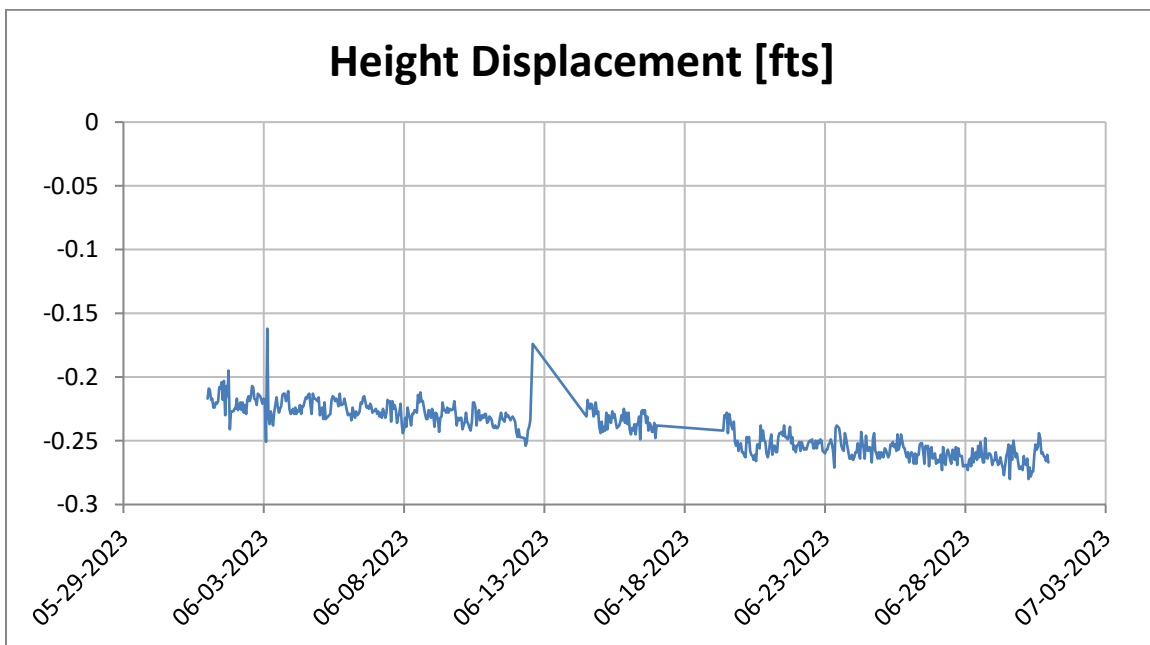
## P69A

1. Survey accuracy is  $\pm 0.016$  feet.
2. Alert threshold is  $\pm 0.35$  feet.
3. Transverse displacement is in the horizontal direction. Positive direction means closer to the robotic station.
4. Height displacement is in the vertical direction. Positive direction means higher in elevation.
5. Prism records slope creep movements.
6. Regression limit alerts received on June 1, June 2, and June 12.

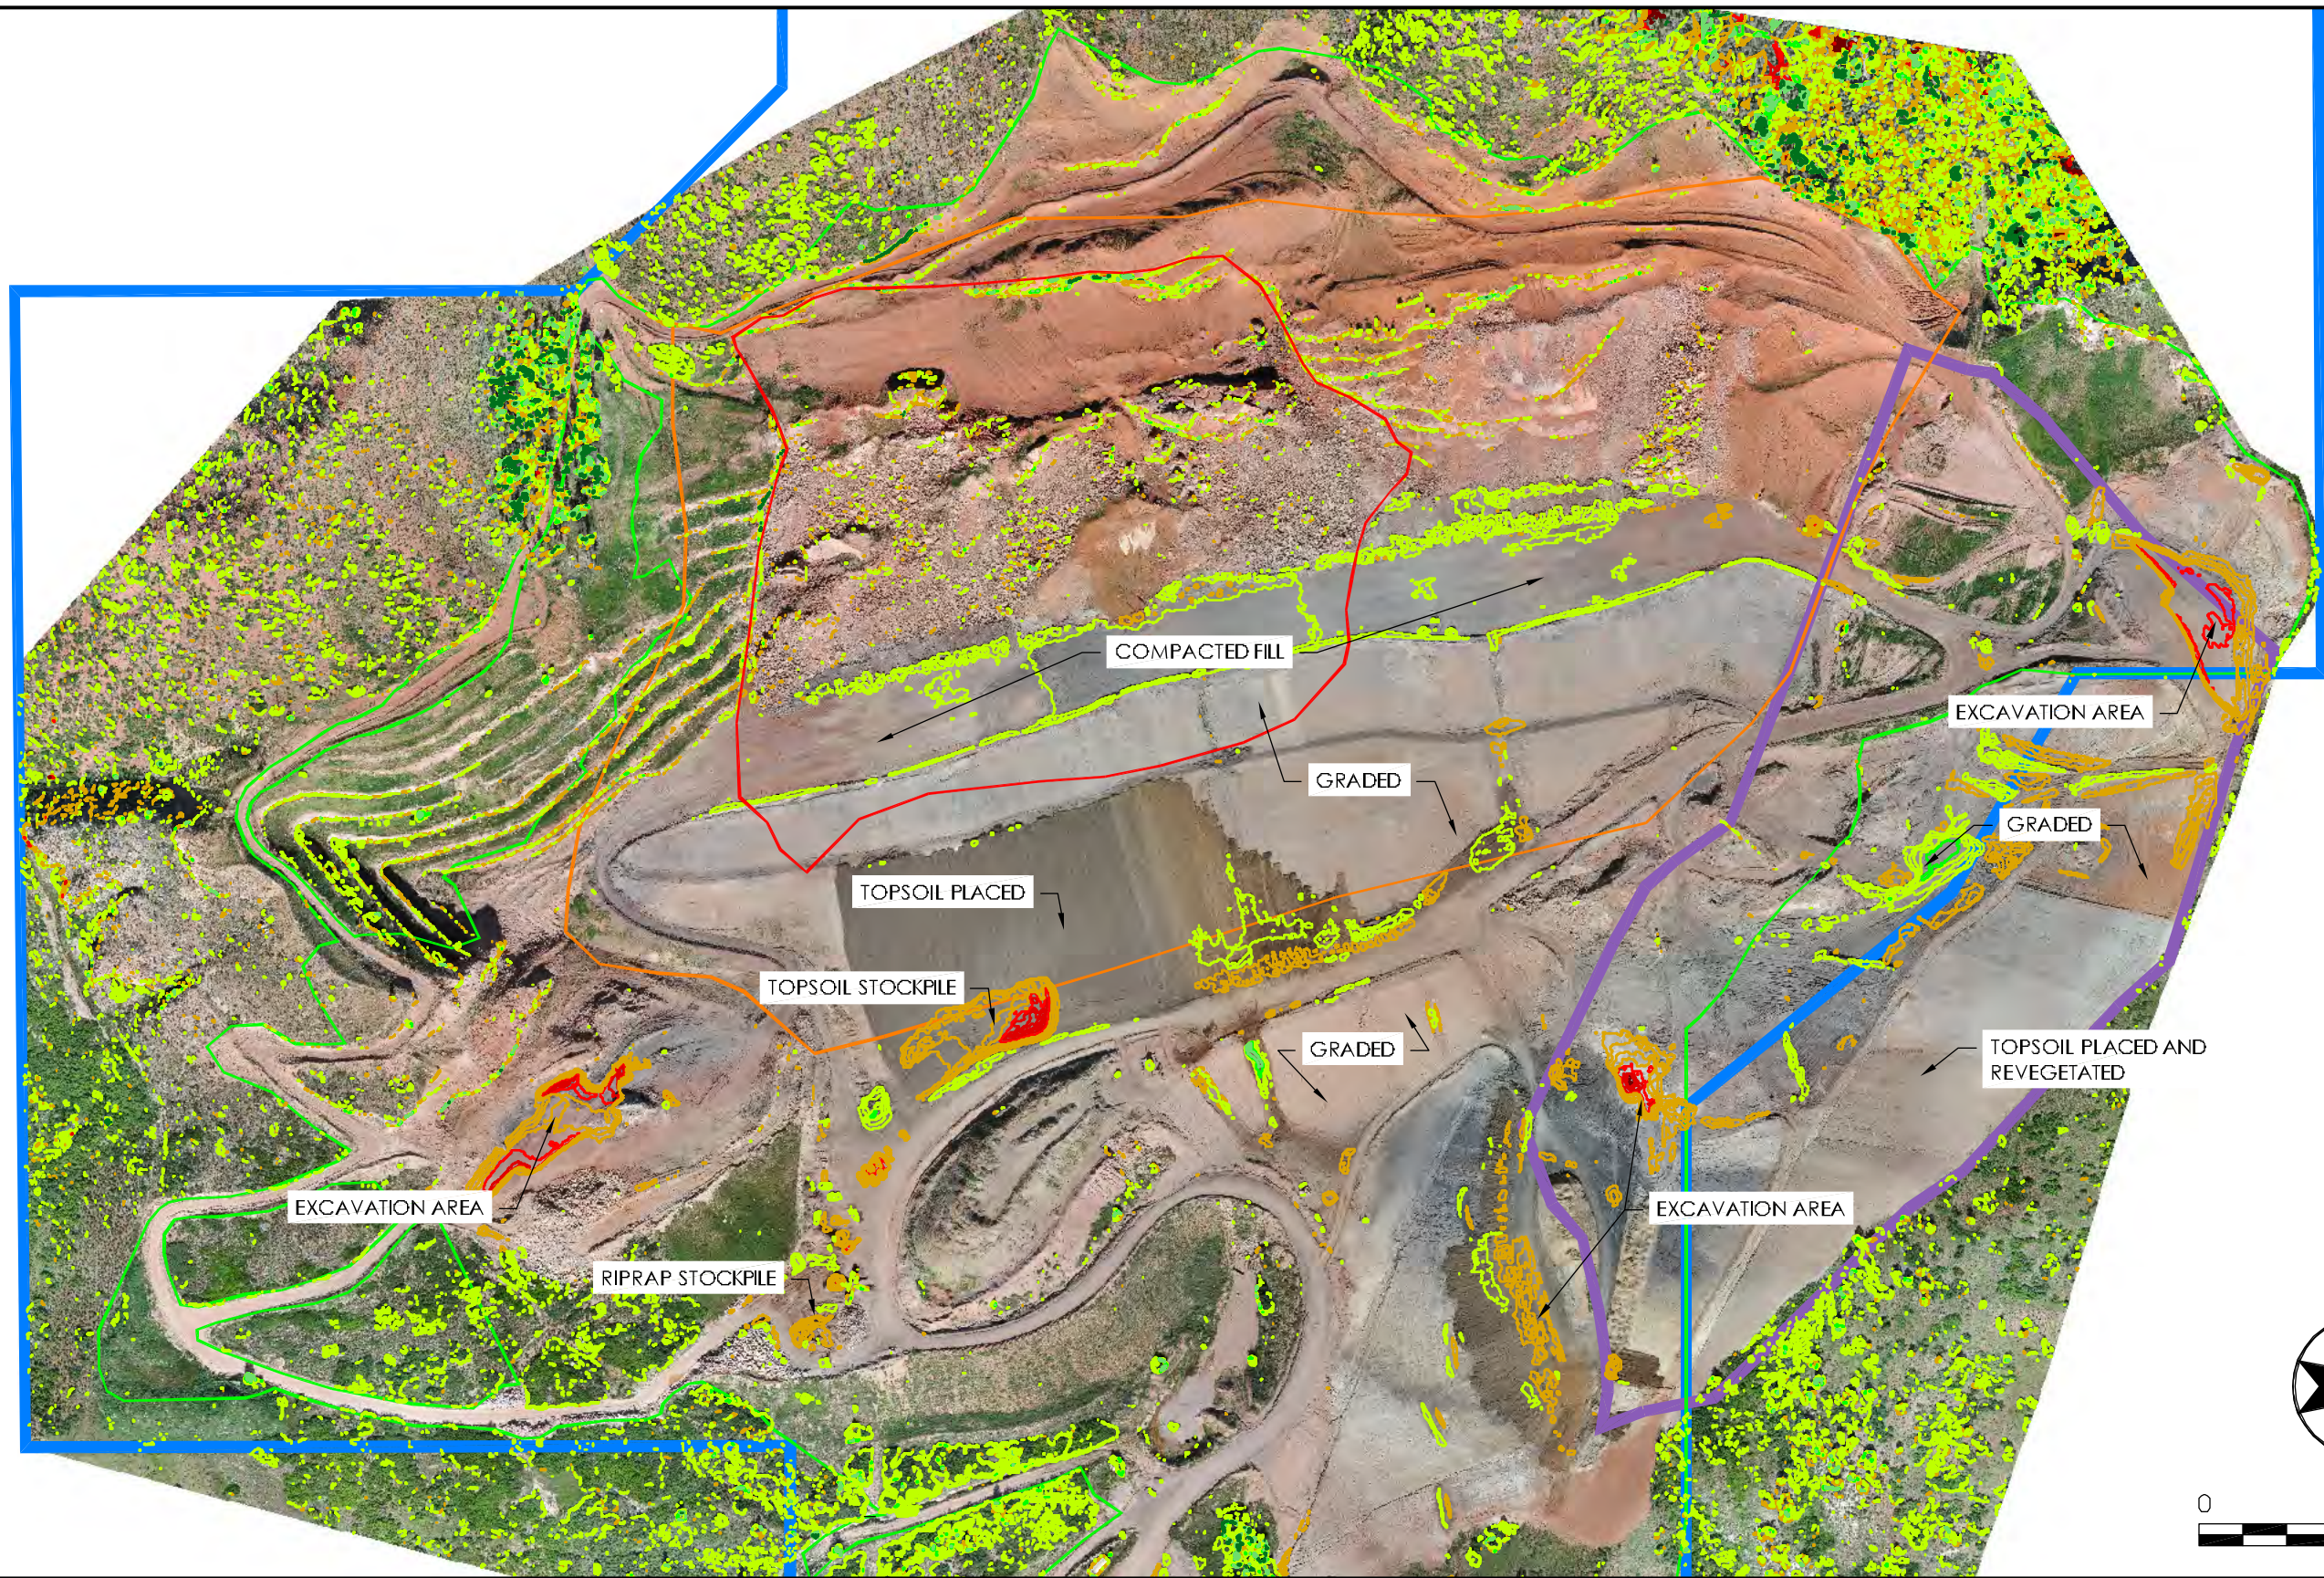
Figure No.  
5

The June topography was also compared to the May topography to identify changes in the site topography. Comparison of the two surveys showed the placement of the fill material at the toe of the landslide. Fill material is excavated from the North and South Borrow Areas or imported from offsite projects. No slope movements or other changes in topography were identified. The current imagery and topography are included in Figures 1 and 3, and the comparison surface is included as Figure 5 in Appendix C.

As previously reported in the September 2020 monitoring report, there are limitations with the method of comparing drone surveys from different months. The drone data indicate changes in the slopes along each of the reclamation benches, buildings, and areas with trees or shrubs. These areas are stable, and the changes are the result of survey limitations on or near vertical slopes.
