C-2010-089 New Horizon North, July Partial Inspection Report

C-2010-089 July 2023 Partial Inspection Report.pdf

PERMIT INFORMATION

INSPECTION INFORMATION

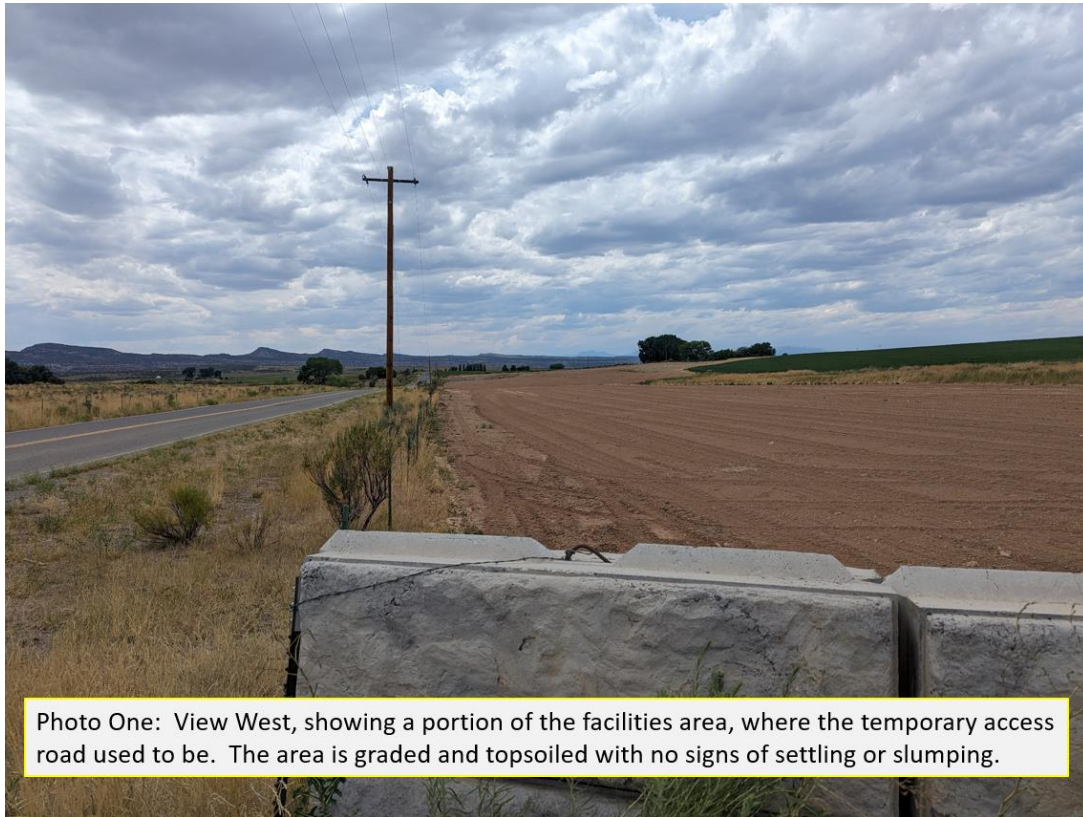
At the time of the inspection, all backfilling, grading and topsoil replacement tasks had been completed. The temporary access road across the facilities area has been removed, the area graded and topsoiled as seen in Photo One. In the southwest corner the grading has been blended with the approved post reclamation stock pond shown in Photos Two and Three. The stock pond contained no water at the time of the inspection and showed no evidence of recent flows. All ditches leading to both ponds have been backfilled and topsoiled. The Pond 002 area has been completed and can be seen in Photo Four. All of the recently completed areas exhibit positive drainage and no evidence of settling, slumping or erosion was noted.

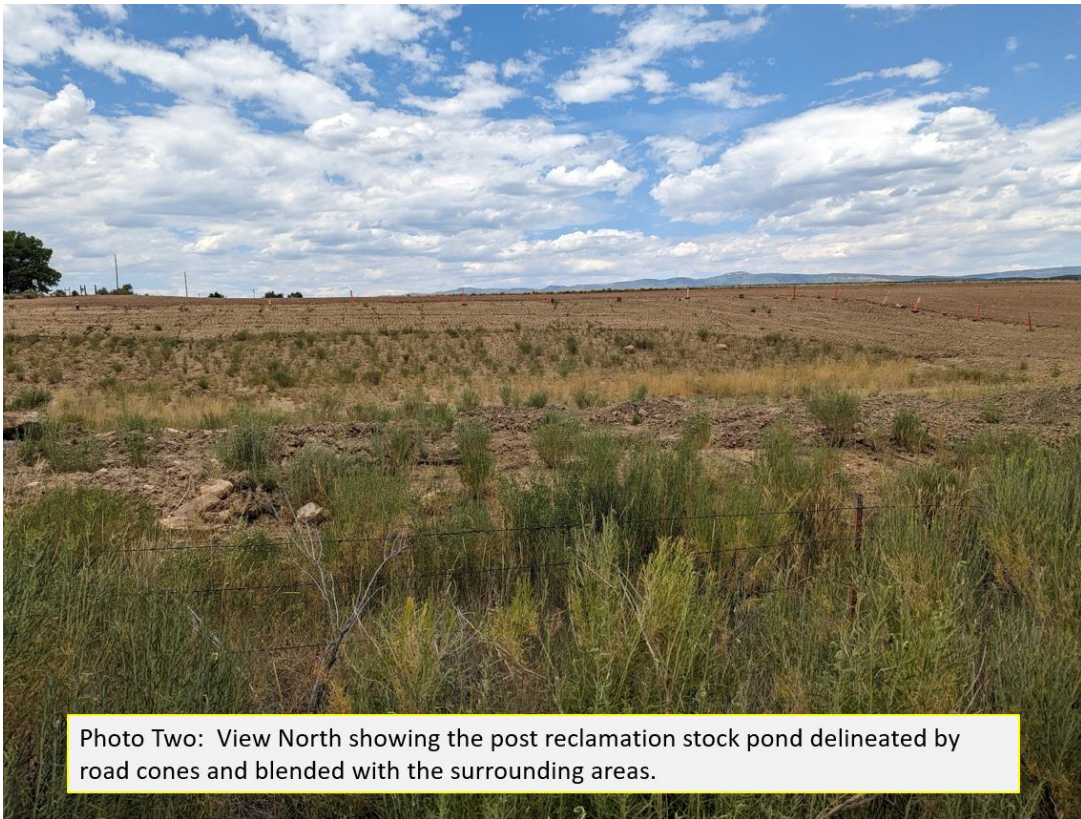
Throughout the site, various post reclamation features have been approved to remain on site. Such features include but are not limited to the stock pond and gravel stockpile located in the southwest area of the site, topsoil stockpile on the east side of site and concrete blocks around the entrances to the site. All features were observed to be in good condition with no problems noted. Overall, the Operator and its contractor has done an excellent job with the reclamation of the site.

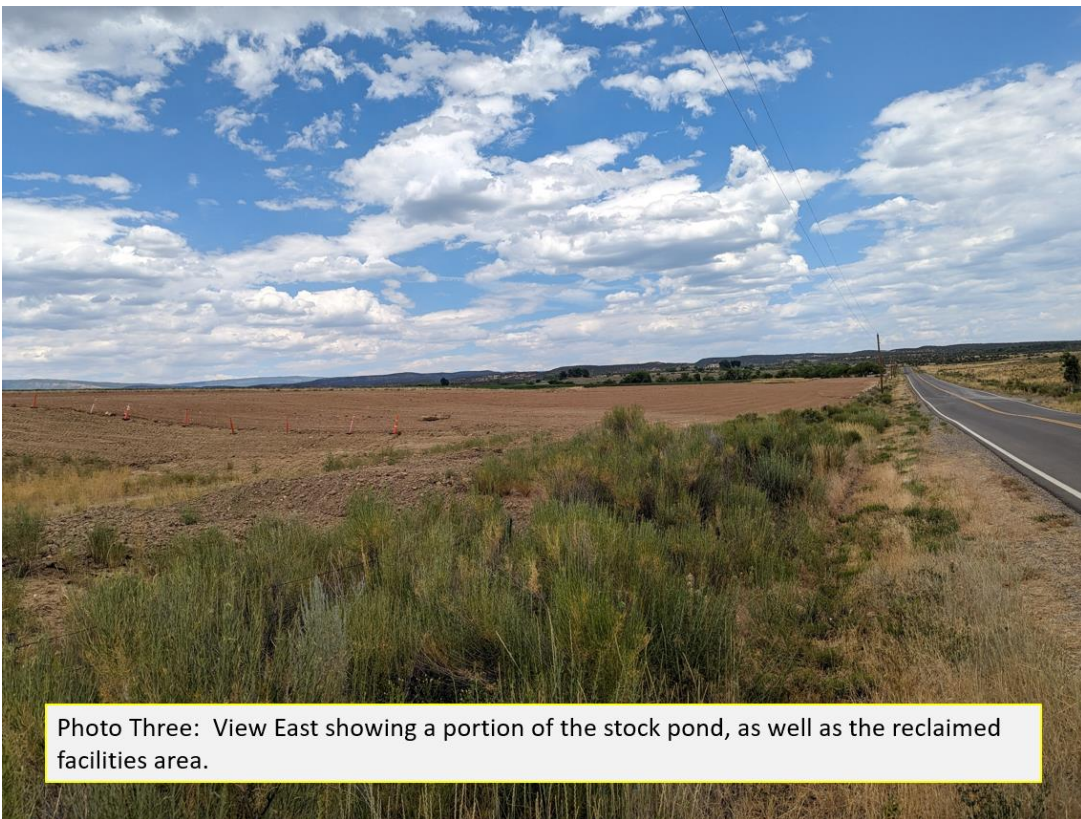
The backfilled and graded areas have not yet been seeded. Onsite discussions with the Operator indicate

that seeding will happen later in the fall, prior to the first snow to increase the chance of spring revegetation success.
