MINERALS PROGRAM INSPECTION REPORT
PHONE: (303) 866-3567

MINE NAME: Urie Gravel Pit	MINE/PROSPECTING ID#: M-2009-038	MINERAL: Gravel	COUNTY: Rio Blanco
INSPECTION TYPE: Monitoring	WEATHER: Clear	INSP. DATE: July 24, 2023	INSP. TIME: 11:15
OPERATOR: Urie Rock Company	OPERATOR REPRESENTATIVE: Elaine Urie	TYPE OF OPERATION: 112c - Construction Regular Operation	
REASON FOR INSPECTION: Normal I&E Program	BOND CALCULATION TYPE: Complete Bond	BOND AMOUNT: \$91,600.00	
DATE OF COMPLAINT: NA	POST INSP. CONTACTS: DRMS	JOINT INSP. AGENCY: None	
INSPECTOR(S): Amy Yeldell	INSPECTOR'S SIGNATURE:

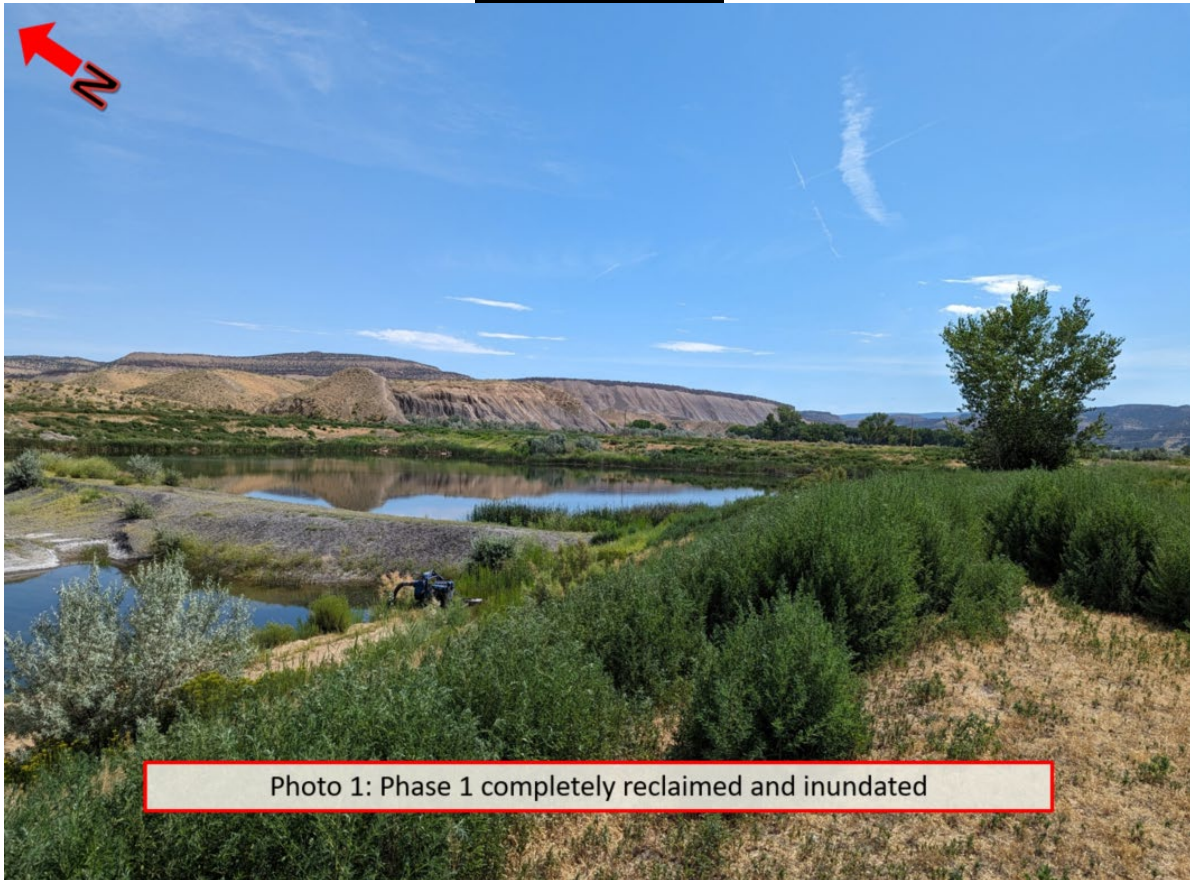
Phase 1 is completely graded and all slopes are a 3H: 1V or less. A berm separates Phase 1 and 2 (Photo One).

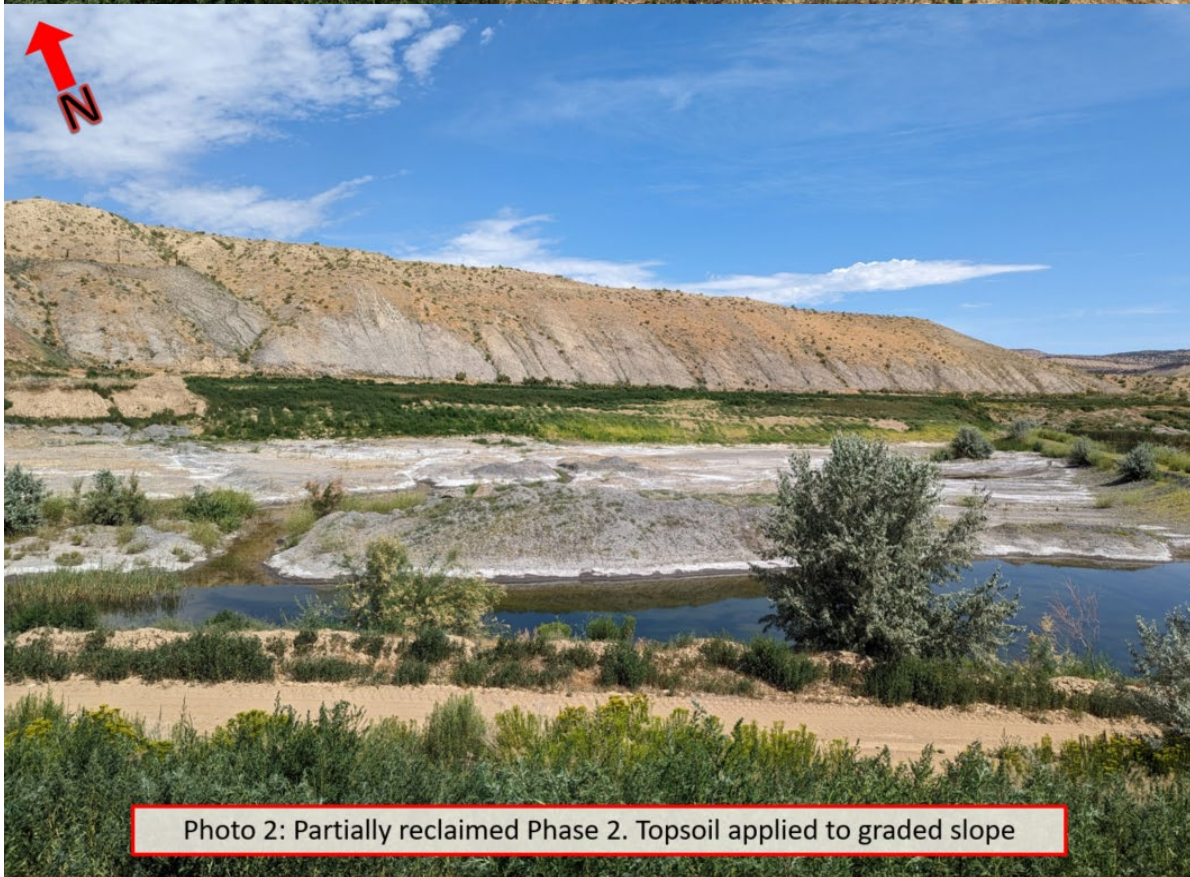
Phase 2 has been partially graded. The eastern half of the north and south slopes and the east slope adjacent to Phase 1 have all been graded to a 3H: 1V or less (Photo Two). A portion (400 LF) of the northwest slope is at approximately 1H: 1V and 20 feet deep. The west and southwest slope of phase 2 adjacent to the stockpile area is at a 2H:1V and estimated to be 500 LF (Photo Three).

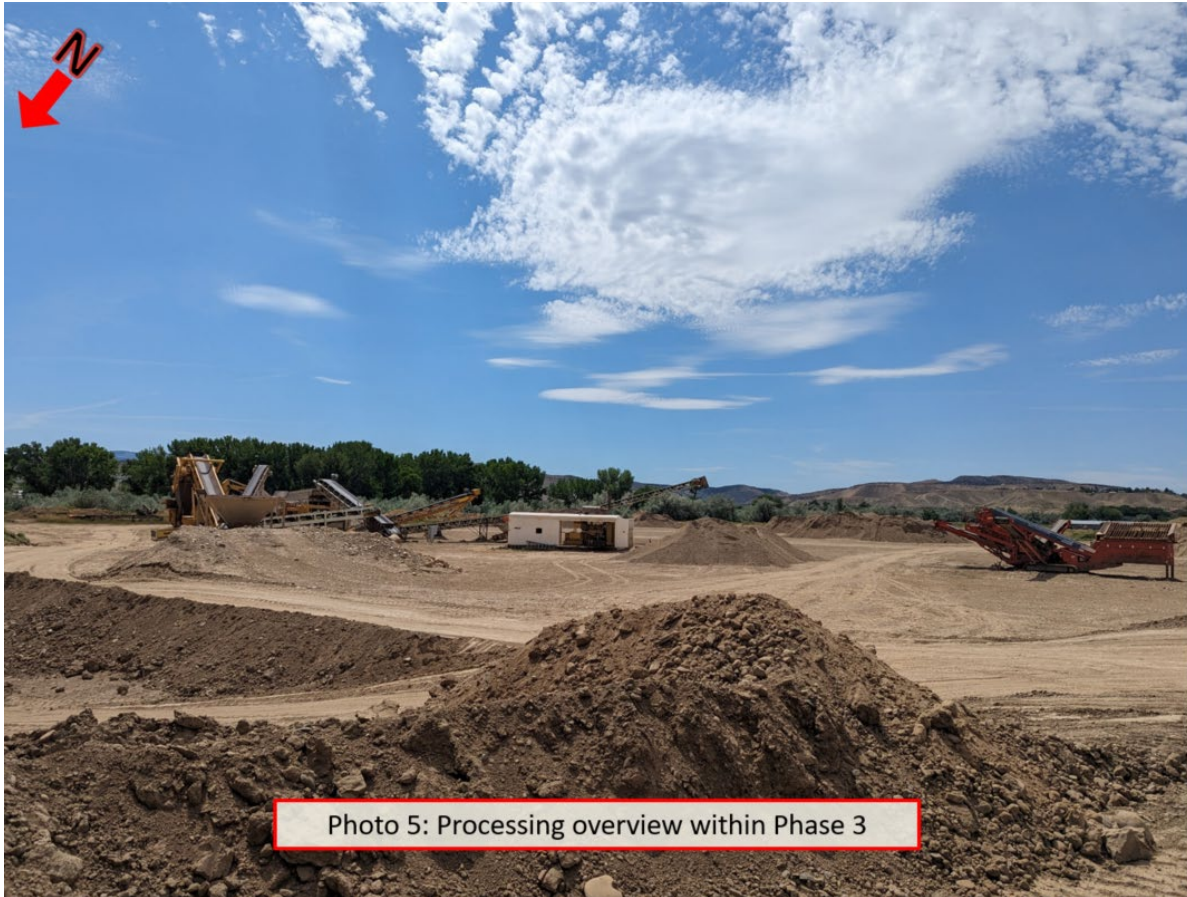
Located within Phase 3 is the processing area. This includes the scale, office, and crusher plant. No other

Photo 5: Processing overview within Phase 3

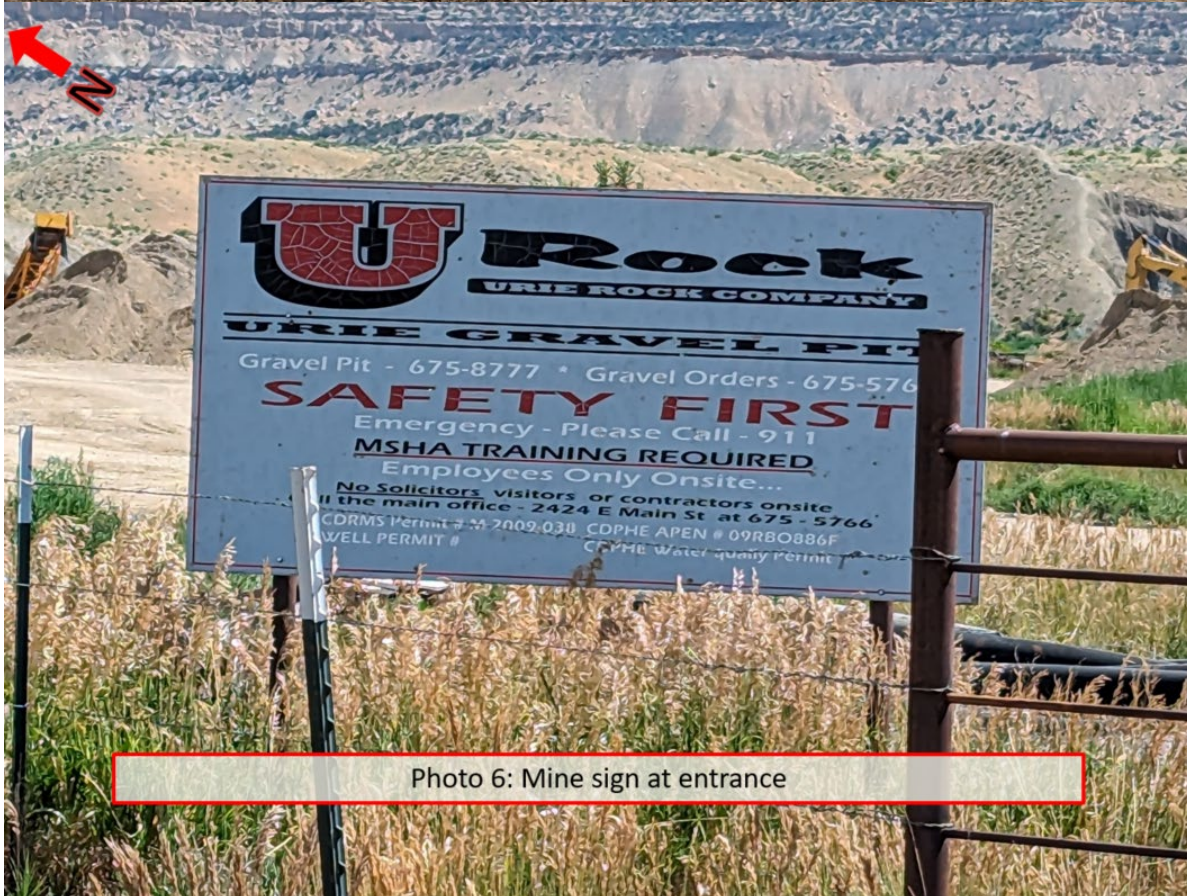
A mine sign was posted at the entrance to the mine site as required by Rule 3.1.12(1) (Photo Six). The information depicted was correct/ up to date and the sign was of sufficient size. The permit boundary of the affected land was clearly delineated by t-posts with white PVC markers pursuant to Rule 3.1.12(2).

Photo 6: Mine sign at entrance
