**Inspection complete Seneca**

<b>Permit Number:</b> C-1982-057 <b>Mine Name:</b> Seneca II-W Mine <b>Operator:</b> Seneca Property LLC <b>Operator Address:</b> Ms. Miranda Kawcak 29515 Routt County Road 27 Oak Creek, CO 80467	<b>County:</b> Routt <b>Operation Type:</b> Surface <b>Permit Status:</b> Permanent Cessation <b>Ownership:</b> Private
	<b>Operator Representative Present:</b>  Miranda Kawcak
<b>Operator Representative Signature: (Field Issuance Only)</b>

<b>Inspection Start Date:</b> 26 July, 2023 <b>Inspection Start Time:</b> Noon <b>Inspection End Date:</b> 27 July, 2023 <b>Inspection End Time:</b> 11:30 a.m.		<b>Inspection Type:</b> Coal Complete Inspection <b>Inspection Reason:</b> Normal I&E Program <b>Weather:</b> Partly Cloudy	
<b>Joint Inspection Agency:</b>  None		<b>Joint Inspection Contacts:</b>	
<b>Post Inspection Agency:</b>  None		<b>Post Inspection Contacts:</b>	
<b>Inspector(s):</b>  Robin Reilley, GISP	<b>Inspector's Signature:</b>

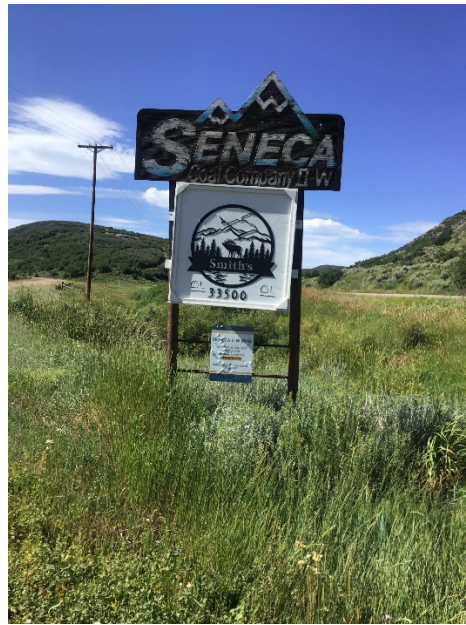
- The mine site identification signs observed at the mine access points, the main gate, and the secondary gate were intact, displaying all required information: mine name, operator name, address, phone number, DRMS permit number and contact information.

***Photo 1:** Mine identification sign at the main site entrance off the County Road.*

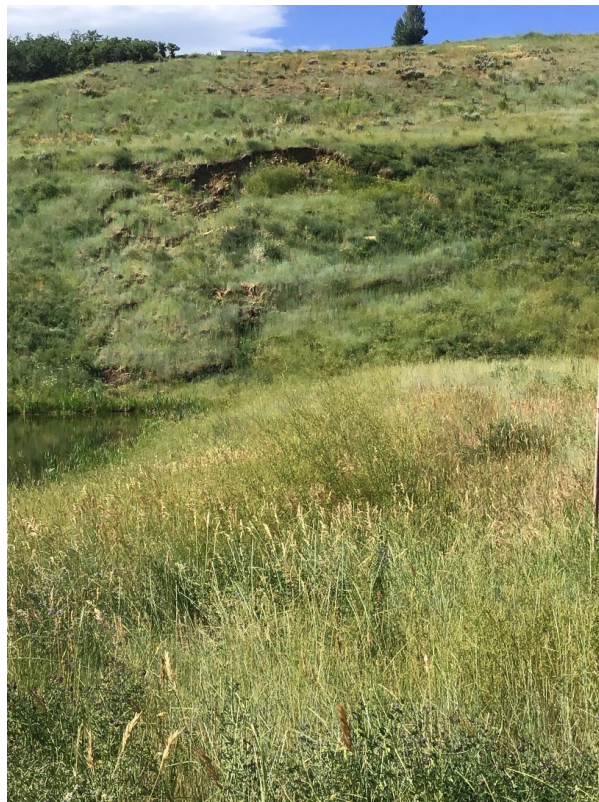
Established slump at Pond 6 was noted. The new slide (spring 2023), downstream from the slump appears to encompass approximately 1/3 of an acre. A crack exists between the two area.

***Photo 2:** Slump at pond 6.*

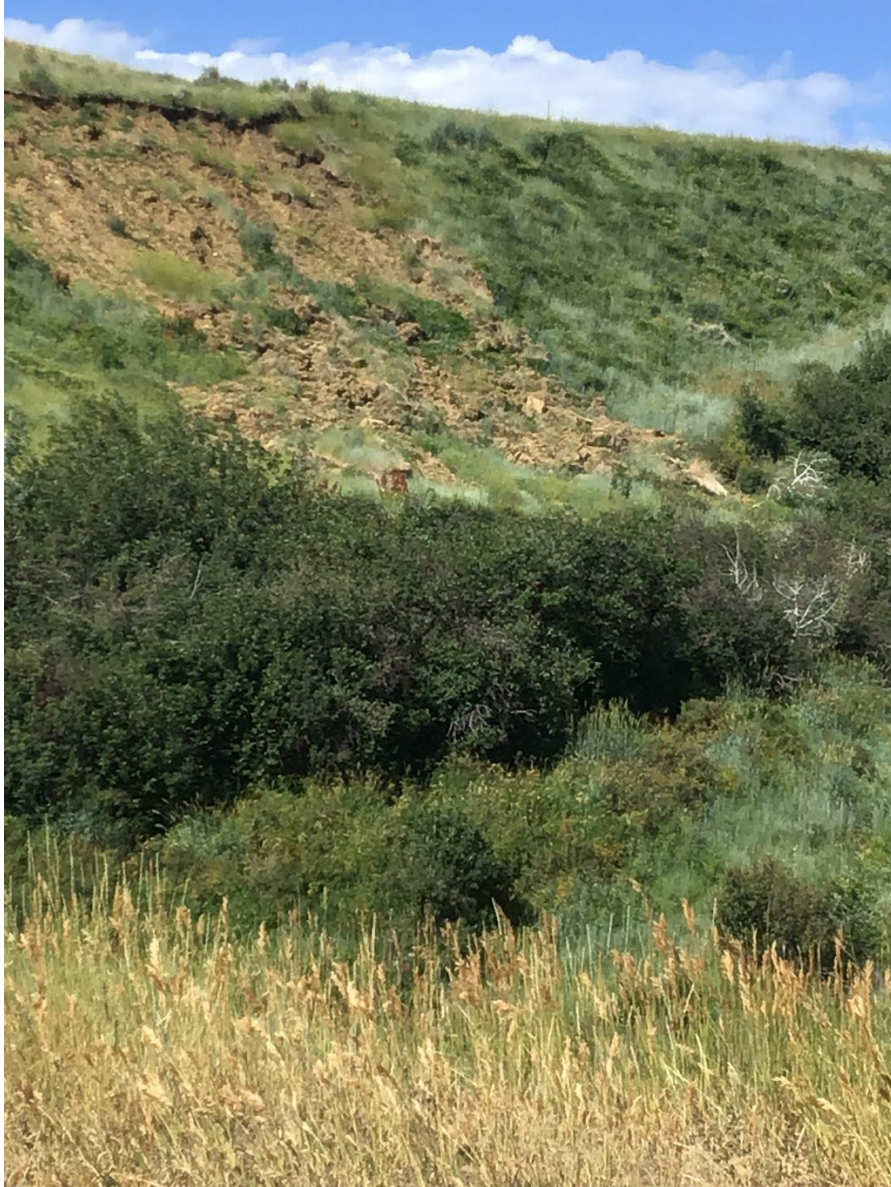
***Photo 3:** New slide of approximately 1/3 of an acre (Spring 2023), downstream of Pond 6.*

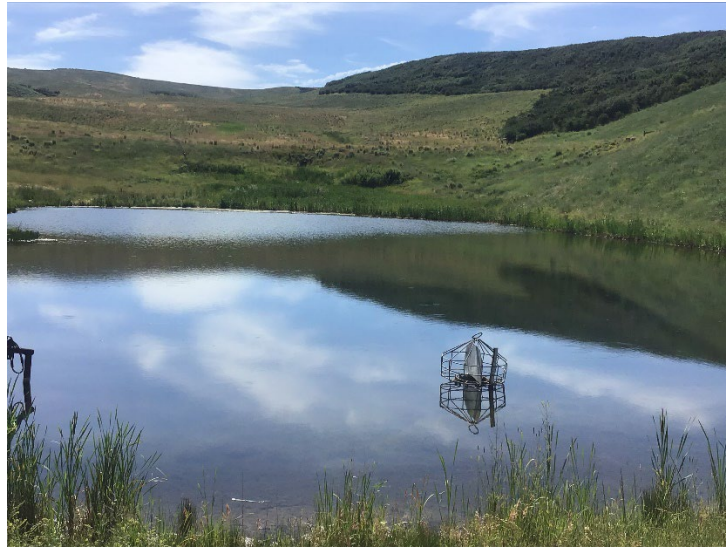
- Ponds 6, held clear water and was discharging at the time of inspection. Slumps at pond 6 had what to do approx 1/3 acre
- Pond 16 was discharging clear water. Significant bottom vegetation appears to thrive. Tall grasses encompass the drainage to the flume.
- Pond 17 held turbid water and was discharging at the time of inspection. Some algae and aquatic grasses were present around perimeter.

*Photo 4: Pond 6 looking south east.*

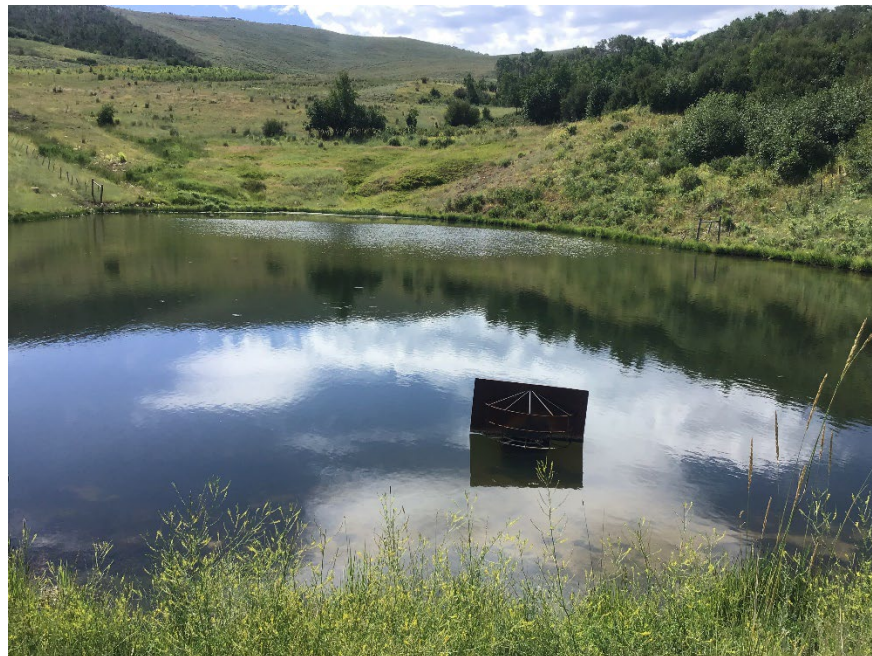
*Photo 5: Pond 16 looking south east.*

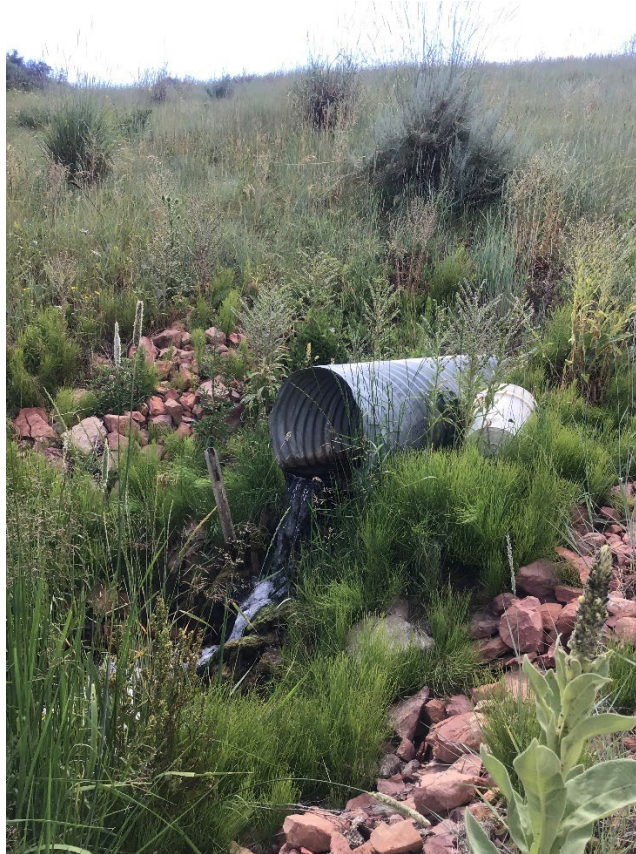
*Photo 6: Pond 16 discharge through culvert.*

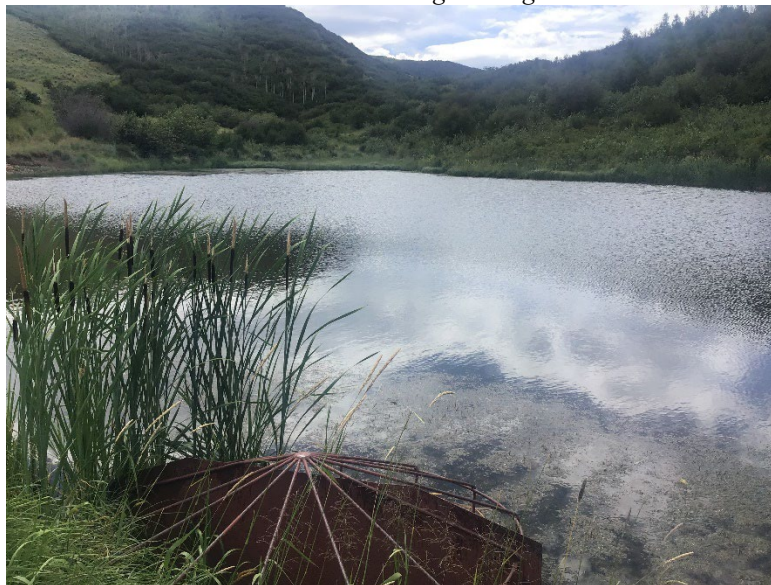
*Photo 7: Pond 17 discharge structure.*
