Inspection Williams Fork July 2023

PERMIT INFORMATION

Permit Number: C-1981-044 Mine Name: Williams Fork Mines Operator: Moffat County Mining, LLC Operator Address: MS Miranda Kawcak 29515 Routt County Road #27 Oak Creek, CO 80467	County: Moffat Operation Type: Underground Permit Status: Active Ownership: Private Operator Representative Present: Miranda Kawcak
Operator Representative Signature: (Field Issuance Only) This report was issued electronically from the Divisions' Denver Office.

INSPECTION INFORMATION

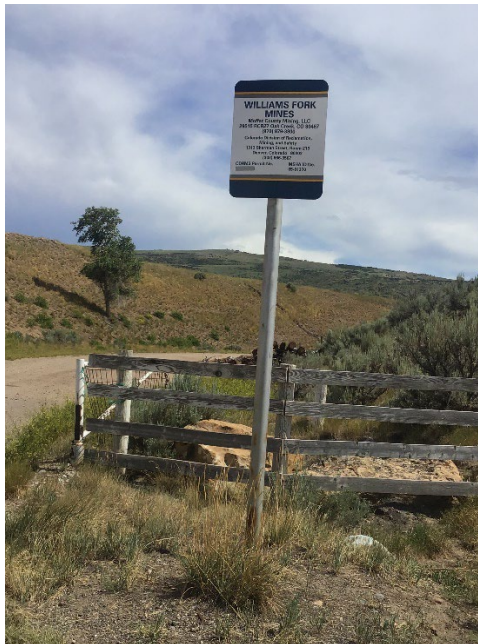
Photo 1: Mine Identification sign at main entrance.

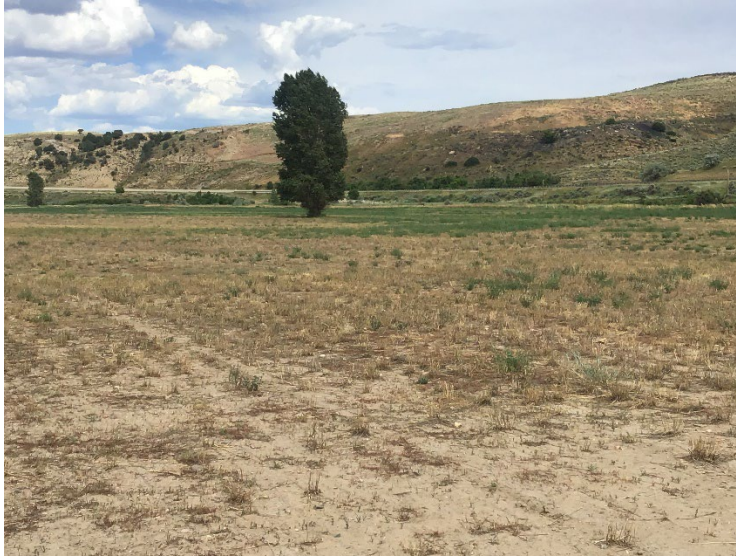
Photo 2: Bottom lands at south end of site looking north.

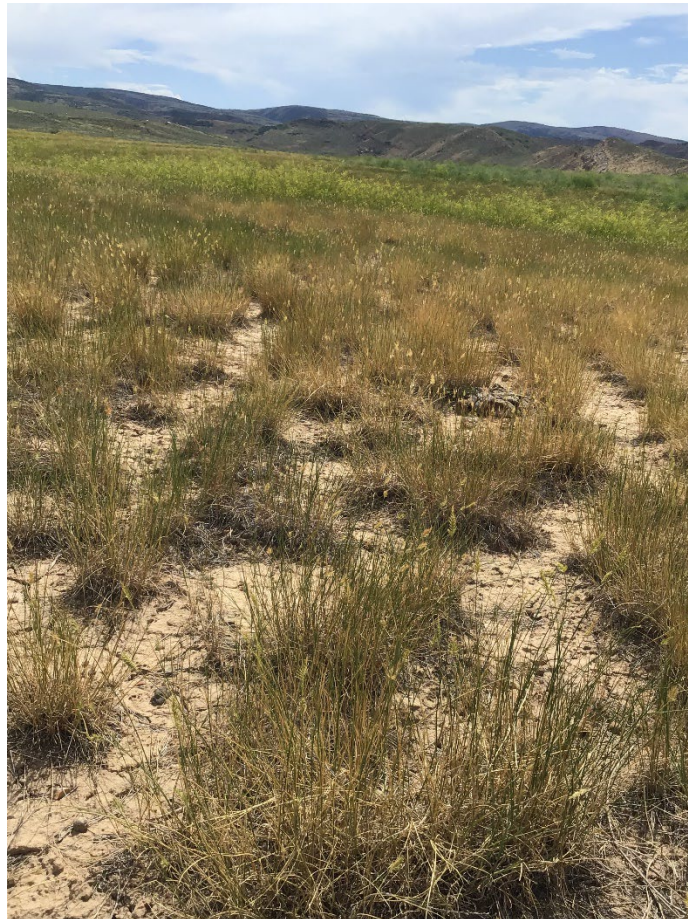
*Photo 3: Bottom lands at north end of site looking west.
Bright green alfalfa is notable in background.*

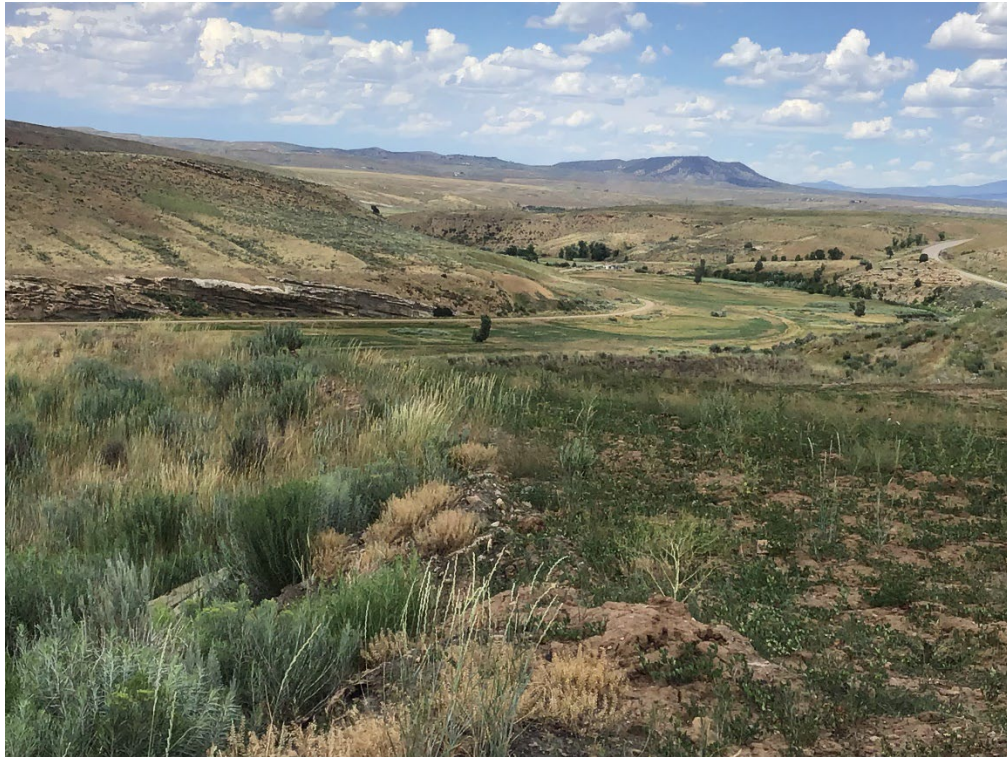
Photo 4: Overview of Williams Fork cropland from 5A Portal looking north.

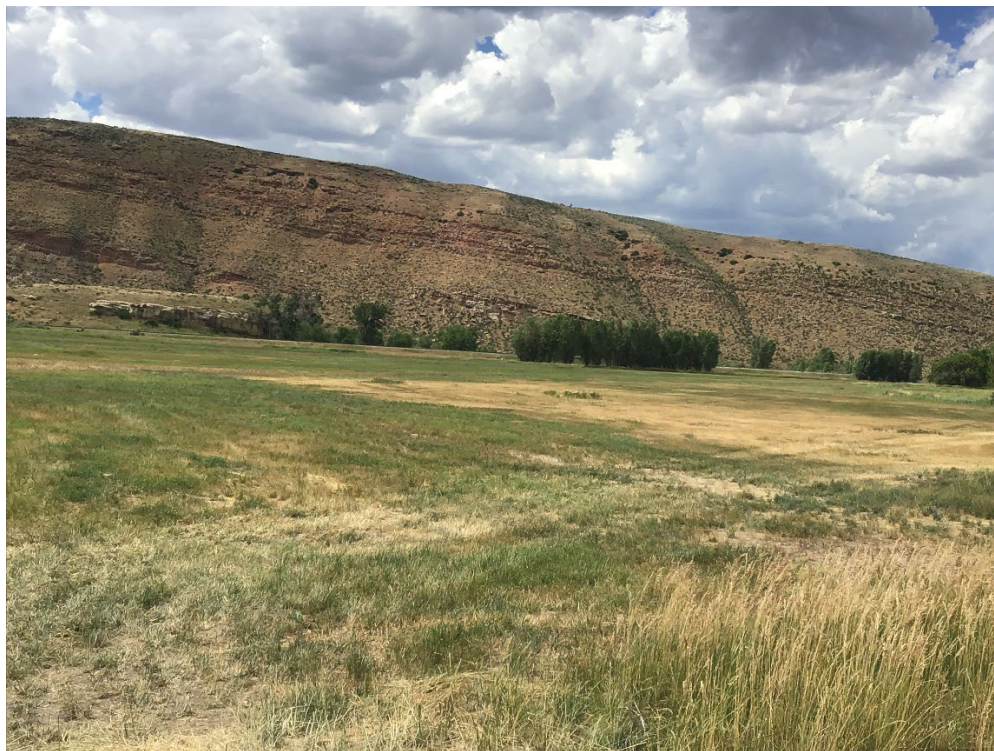
Photo 5: Overview of Williams Fork cropland from 5A Portal looking northwest.

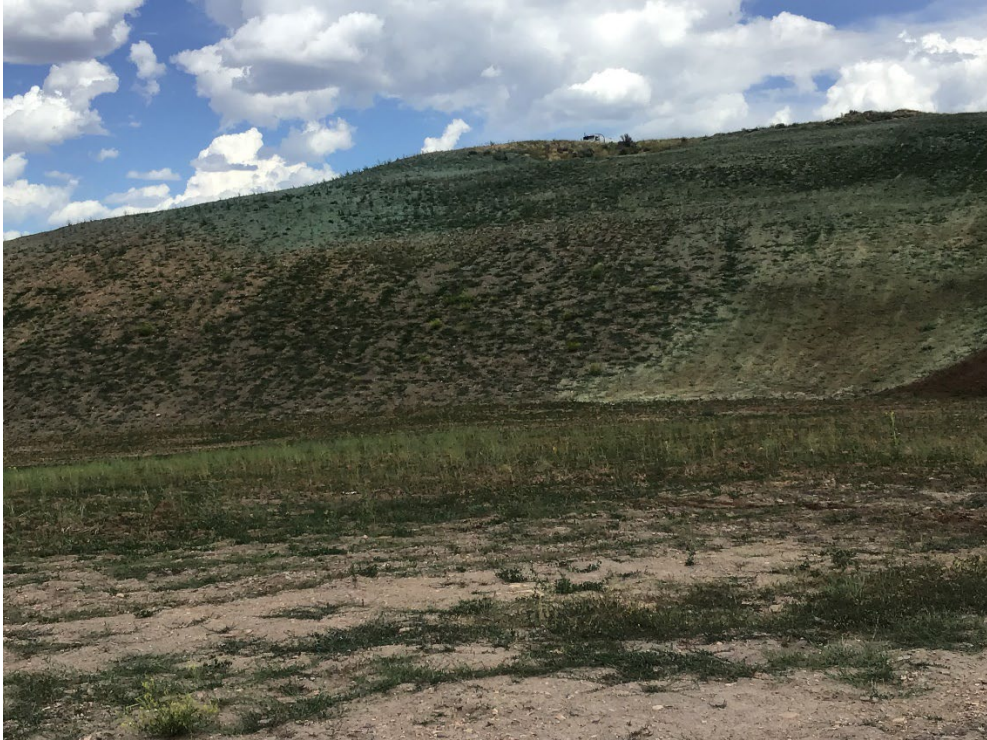
- Reclamation, (topsoil and seeding) has been completed and hydroseeding at the 5A Portal was occurring at the time of inspection.

1. All in one straw mulch with seeds spread over $\frac{1}{3}$ acre
2. All in one bio organic with seeds and bark mixed with the best topsoil component over $\frac{1}{3}$ of an acre
3. Blue mulch comprises mulch and seed and is spread over $\frac{1}{3}$ of an acre
4. 4 acres with added humate and fertilizer.

Photo 6: Hydroseeding at 5A Portal sections of different mixes of $\frac{1}{3}$ acre from right to left:

- *Seeded all in one straw mulch*
- *Seeded all in one bio organic with bark mixed with the best topsoil component.*
- *Blue mulch and seed.*

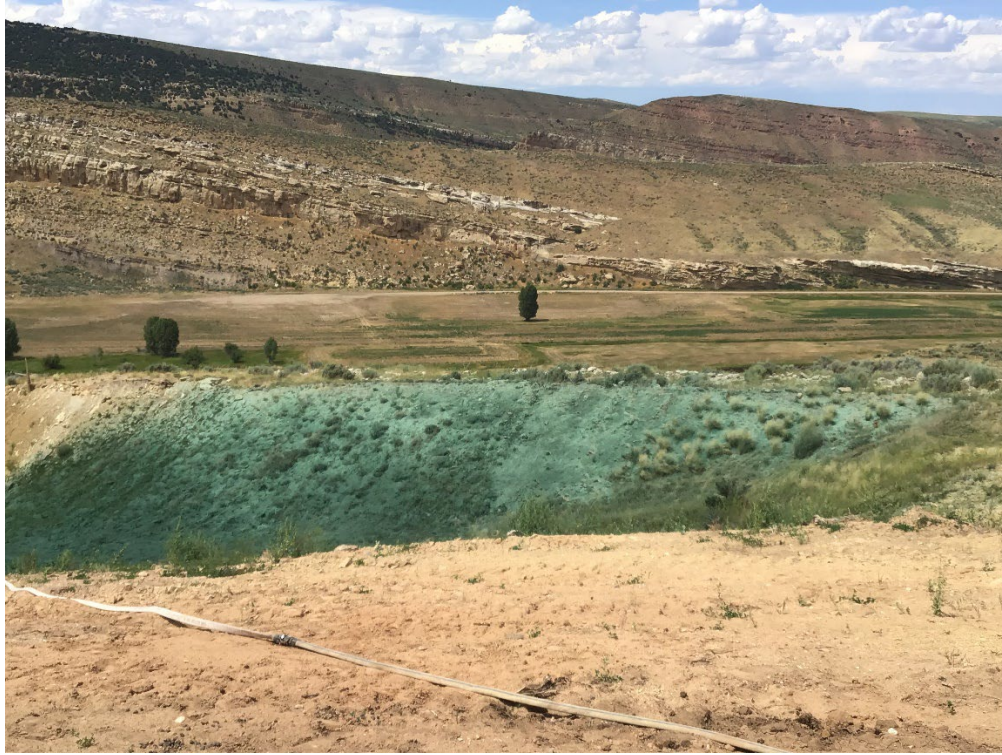
Photo 7: Hydroseeding at 5A Portal south facing slope from above.

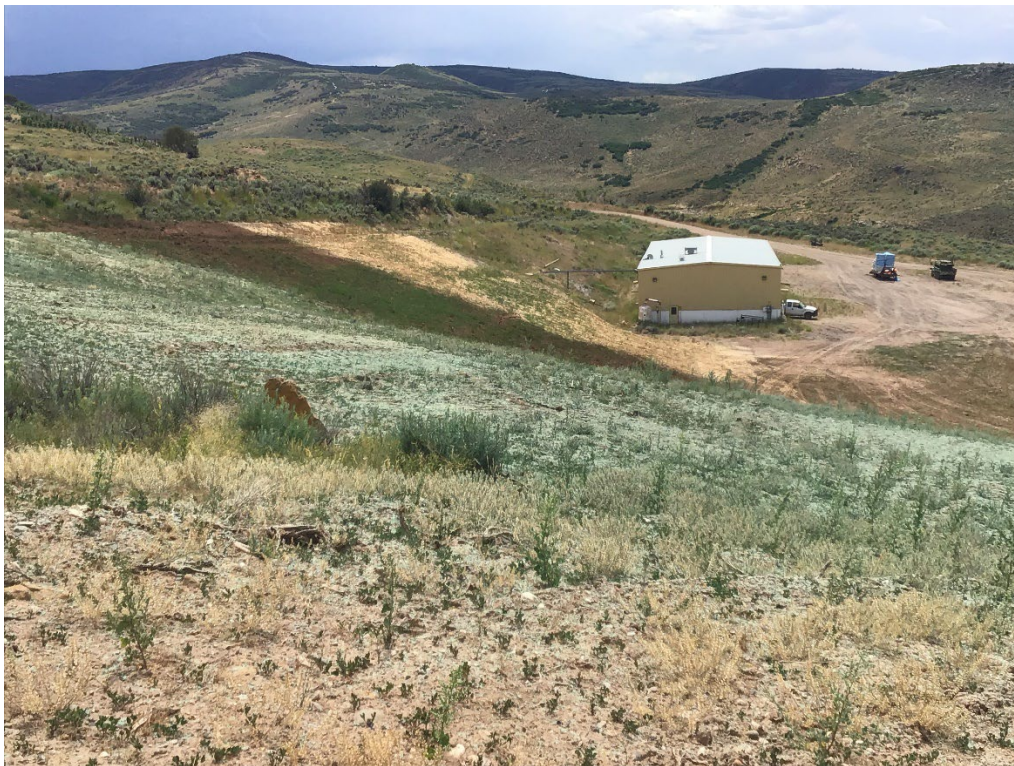
Photo 8: Hydroseeding at 5A Portal south west facing slope from above.
