## Inspection Complete Yoast 2023 07 July

### PERMIT INFORMATION

<b>Permit Number:</b> C-1994-082 <b>Mine Name:</b> Yeast Mine  <b>Operator Address:</b> Seneca Property LLC Ms Miranda Kawcak 29515 Routt County Road No. 27 Oak Creek, CO 80467	<b>County:</b> Routt <b>Operation Type:</b> Surface <b>Permit Status:</b> Permanent Cessation <b>Ownership:</b> Private  <b>Operator Representative Present:</b>  Miranda Kawcak
<b>Operator Representative Signature: (Field Issuance Only)</b>  This report was issued electronically from the Divisions' Denver Office.

<b>Inspection Start Date:</b> 26 July 2023 <b>Inspection Start Time:</b> 12:30 p.m. <b>Inspection End Date:</b> 27 July 2023 <b>Inspection End Time:</b> 10:00 a.m.	<b>Inspection Type:</b> Coal Complete Inspection <b>Inspection Reason:</b> Normal I&E Program <b>Weather:</b> Clear
<b>Joint Inspection Agency:</b>  None	<b>Joint Inspection Contacts:</b>
<b>Post Inspection Agency:</b>  None	<b>Post Inspection Contacts:</b>
<b>Inspector(s):</b>  Robin Reilley, M.S. GISP	<b>Inspector's Signature:</b>

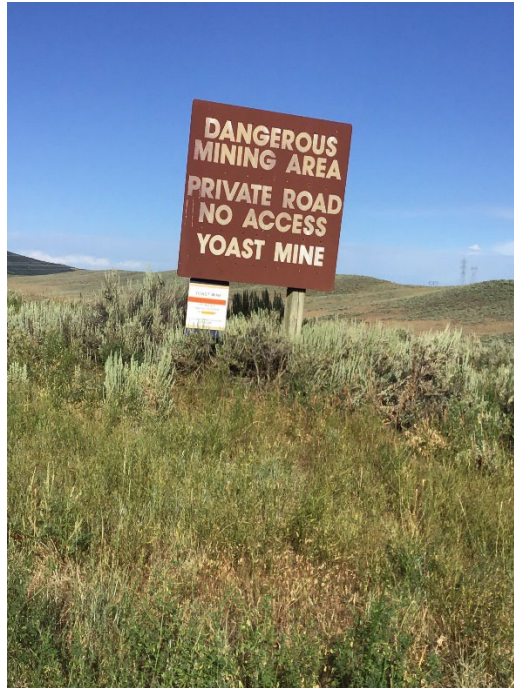
- The mine site identification signs observed at the mine access point at the main gate was intact, displaying all required information: mine name, operator name, address, phone number, DRMS permit number and contact information.

***Photo 1:** Mine identification sign at the site entrance off the Twenty Mile Road*

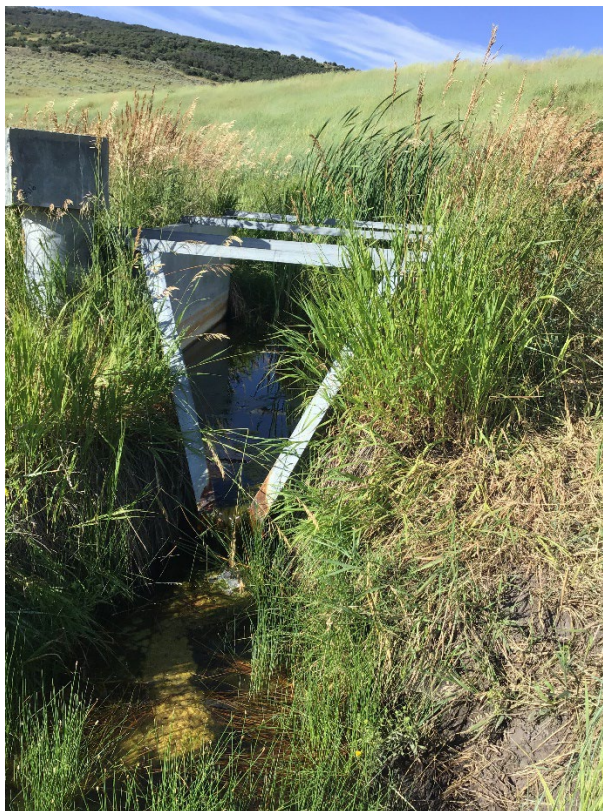
***Photo 2:** Flume at Pond 10, discharging a trickle.*

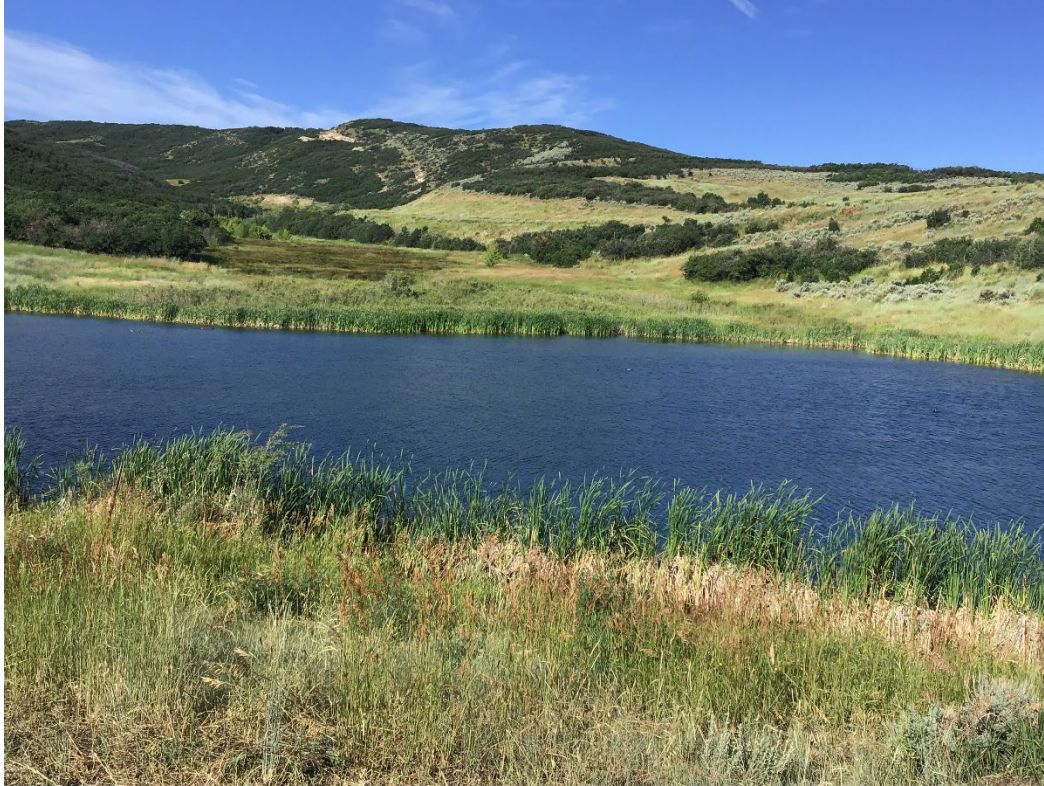
*Photo 3: Pond 10 looking south.*

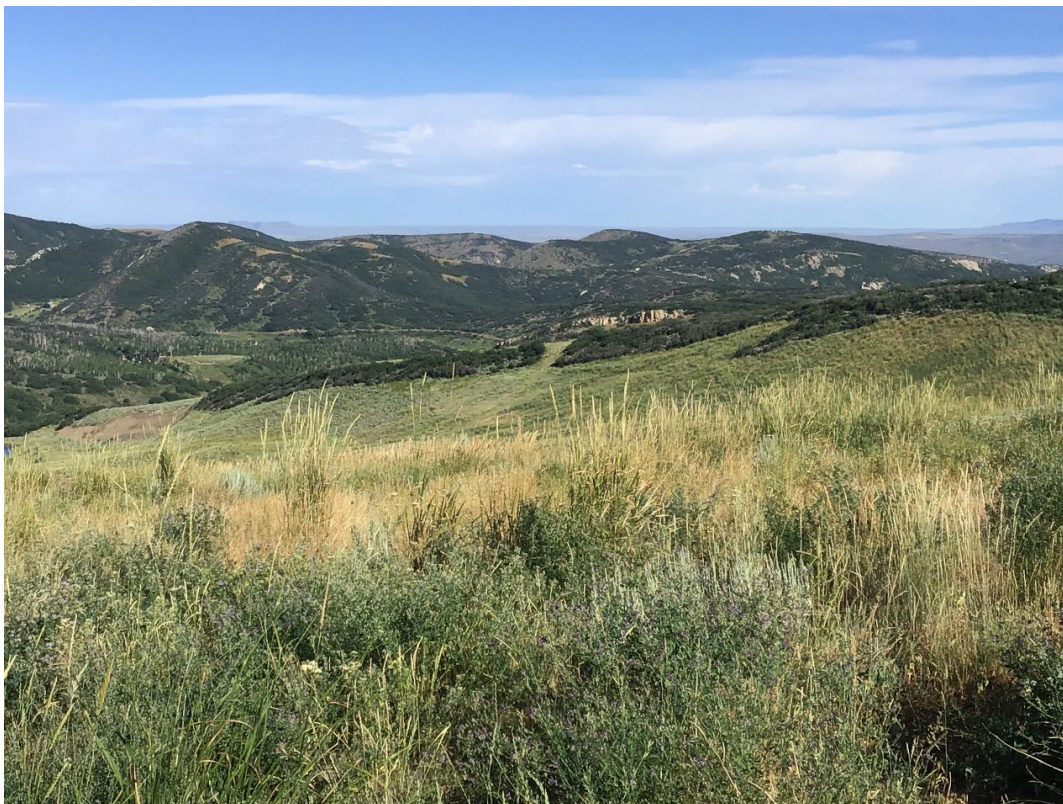
Reclamation has been completed at the site with the exception of the hillside above Pond 12.

*Photo 4: Slope in the distance above Pond 12 waiting final bond release in 2024.*

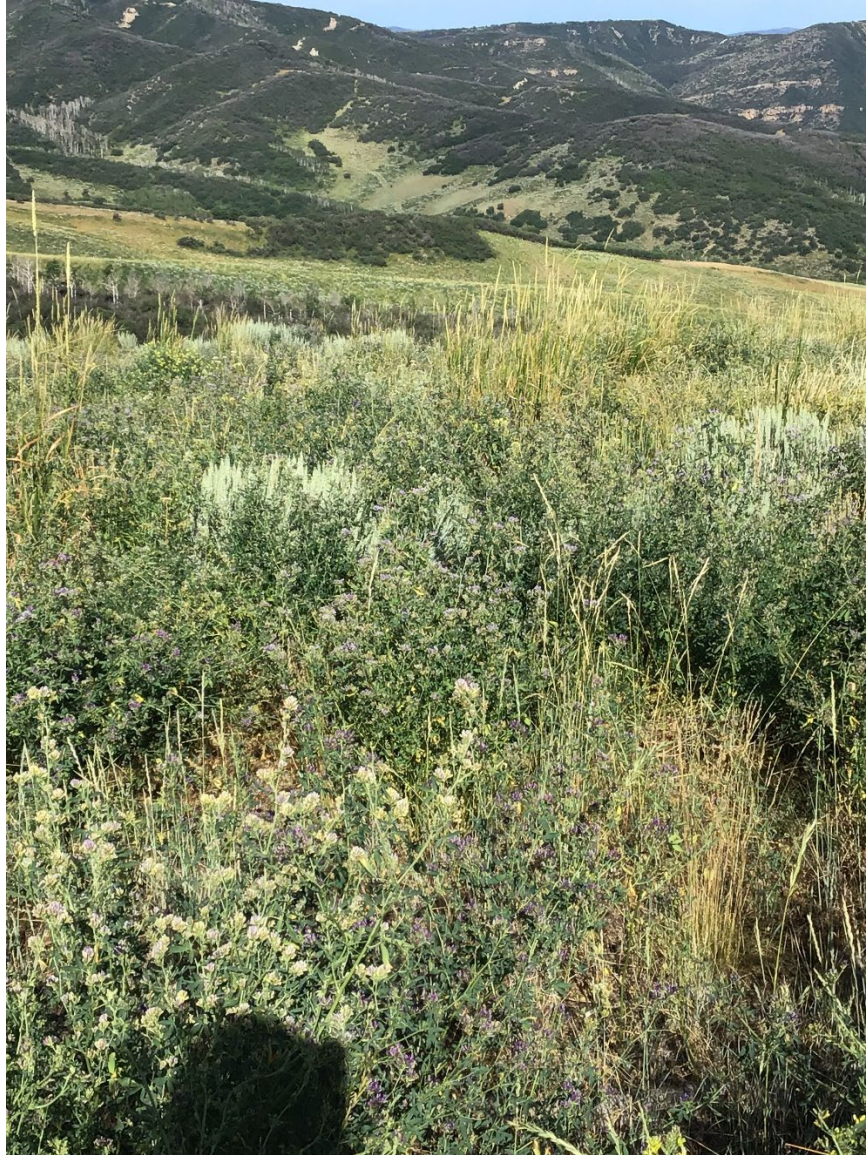
*Photo 5: Overview of vegetation diversity.*

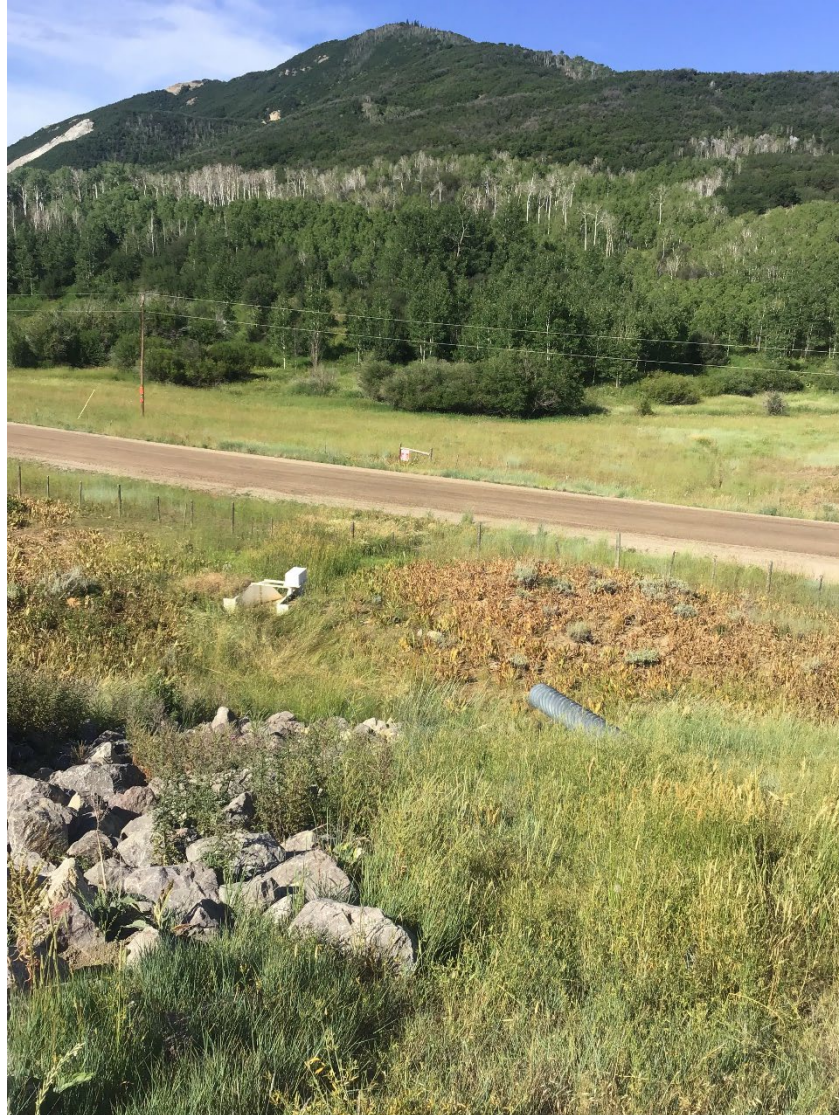
*Photo 6: Pond 13 discharge culvert and flume below, no discharge.*

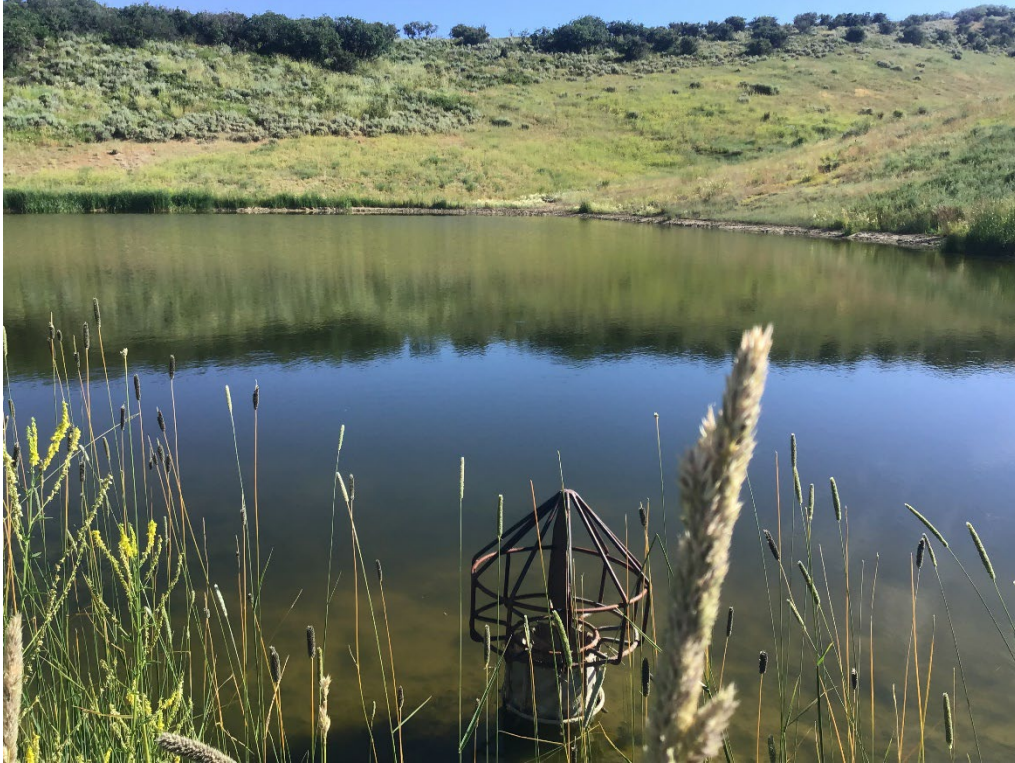
***Photo 7:** Reclamation overview Pond 13 discharge structure looking east.*

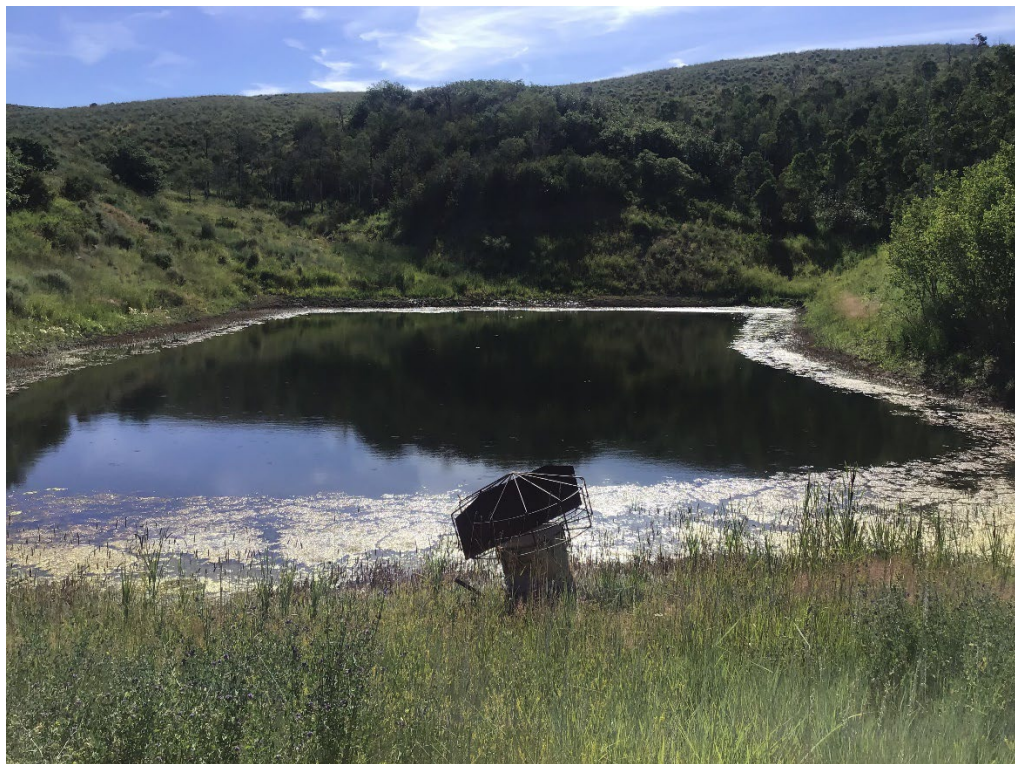
- Pond 10 appeared full and was discharging clear water through the flume.
- Stock ponds held water at the time of inspection.
- Pond 12 was discharging clear water through flume at the time of inspection.
- Pond 13 held turbid water and was not discharging through its culvert.
- Pond 14 looking east. Drop structure is cracked and water is flowing in structure but not reaching flume. Some algae was present around the water surface perimeter.

***Photo 8:** Reclamation overview Pond 14 discharge structure and algal ring around perimeter of water surface, looking east.*

Pond 14 drop structure is cracked and water is flowing into structure. Structure requires sealing.

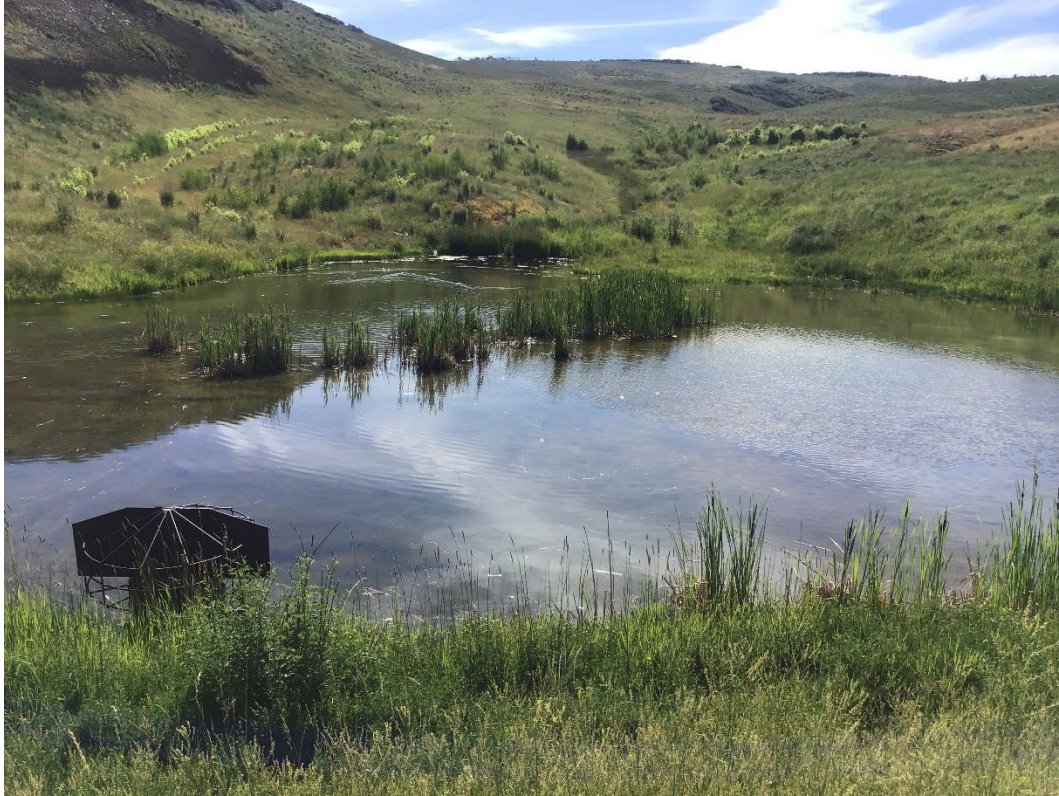
***Photo 9:*** Pond 12 looking toward hillside (east), where reclamation is not yet bond released.

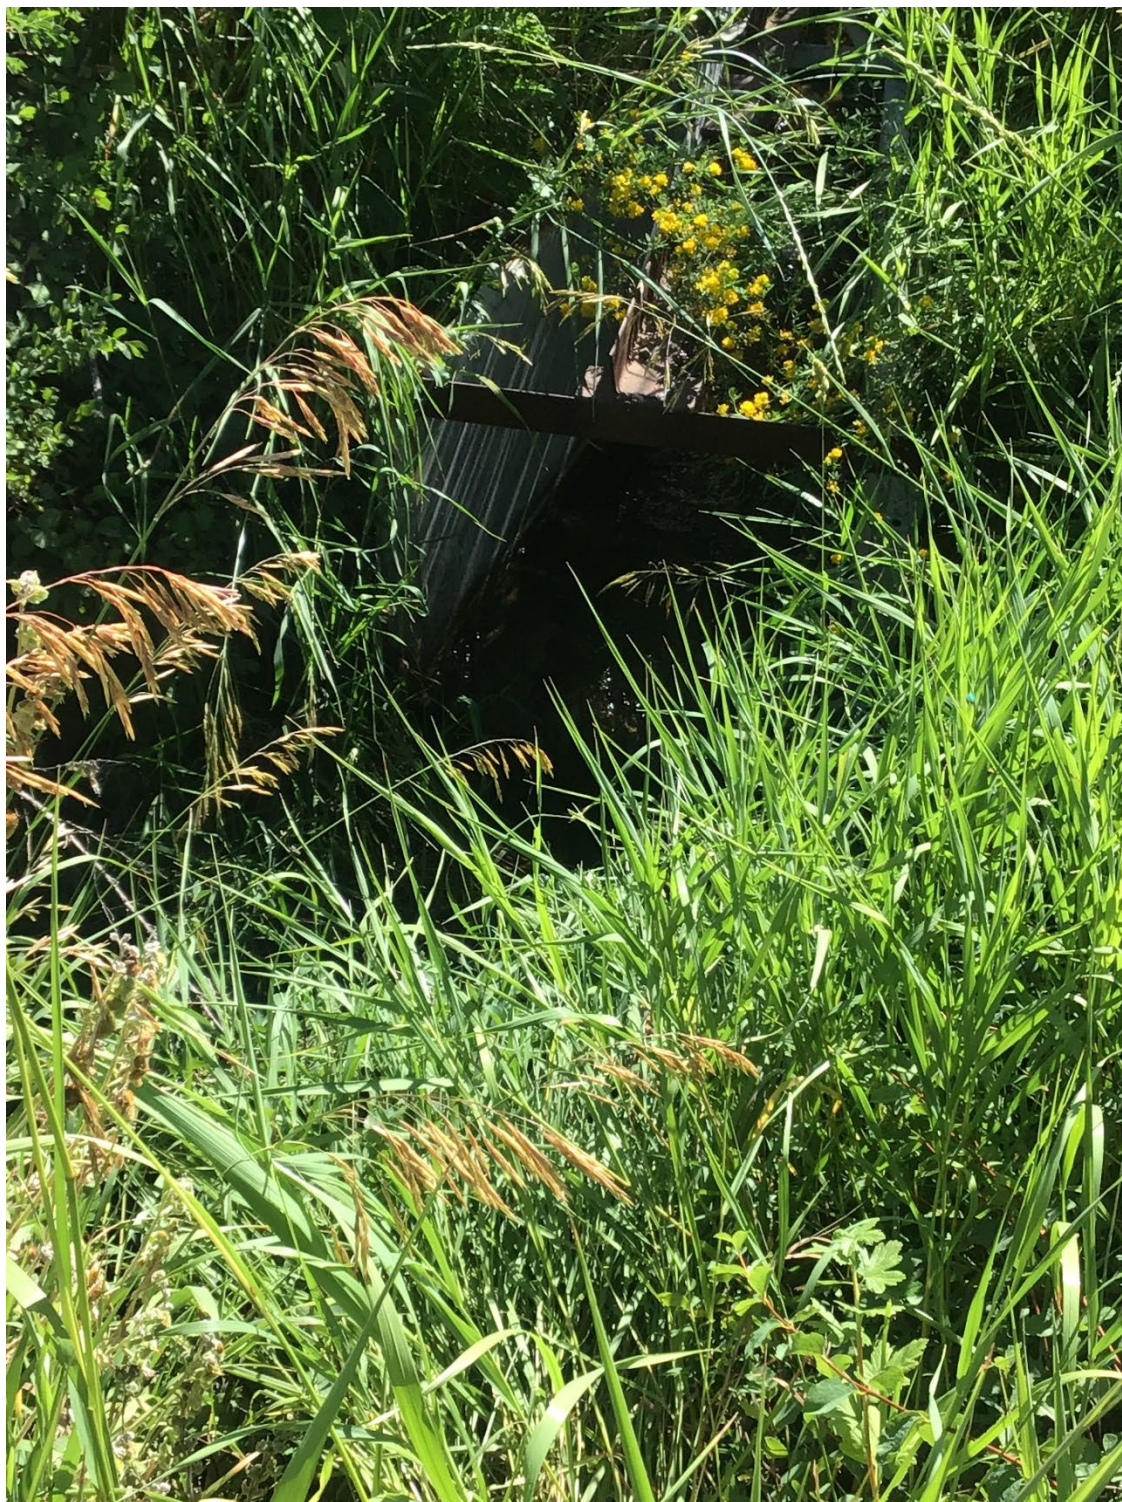
*Photo 10: Pond 12 discharge through Pond 12 flume.*
