Colowyo Mine Inspection Report

PERMIT INFORMATION

Permit Number: C-1981-019 Mine Name: Colowyo Coal Mine Operator: Colowyo Coal Company L.P. Operator Address: Mr Tony Tennyson 5731 State Highway 13 Meeker, CO 81641	County: Moffat, Rio Blanco Operation Type: Surface Permit Status: Active Ownership: Private
	Operator Representative Present: Tony Tennyson and Juan Garcia
Operator Representative Signature: (Field Issuance Only)

Inspection Start Date: July 27, 2023 Inspection Start Time: 07:30 Inspection End Date: Inspection End Time:	Inspection Type: Coal Partial Inspection Inspection Reason: Normal I&E Program Weather: Clear	
Joint Inspection Agency: None	Joint Inspection Contacts: None	
Post Inspection Agency: None	Post Inspection Contacts: None	
Inspector(s): Zach Trujillo	Inspector's Signature:

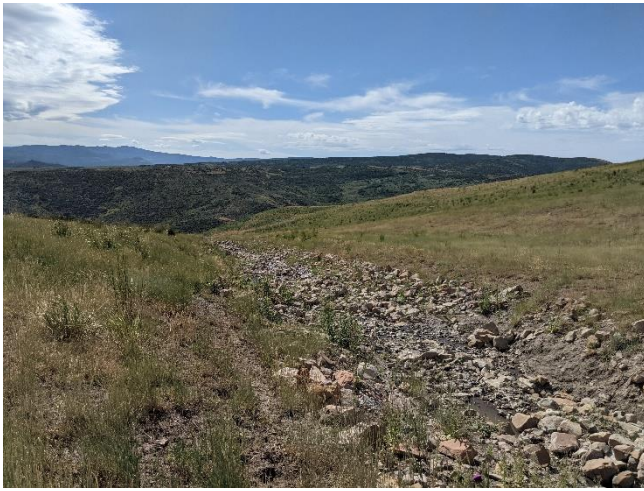
The Final East Pit Ditch was inspected from stock pond EP 2 to the intersection with the South Collection Ditch. The ditch remains in need of repair from the 2022 storm event however no additional cutting can occur as the previous cutting has reached bed rock. Water was held in EP1 and EP2 however no flows were occurring. The Final East Pit Ditch remains in an unchanged condition and successfully directs all surface runoff to the South Collection Ditch. The Final East Pit Ditch is scheduled for repair after the construction of Section 15 Pond and Ditch. The South Collection Ditch remains stable with no issues.

Final East Pit Ditch – Reach 2.

Currently, Colowyo is constructing the Section 15 Ditch and Section 15 Pond which was approved with TR-158. The new ditch and pond will help collect surface runoff upslope from the Final East Pit Ditch and relieve some of the surface flows that are currently flow to it. Colowyo representative stated that after the construction of Section 15 Ditch and Pond, that the maintenance to the Final East Pit Ditch will be conducted along with the additional stock tanks that were approved under TR-158.

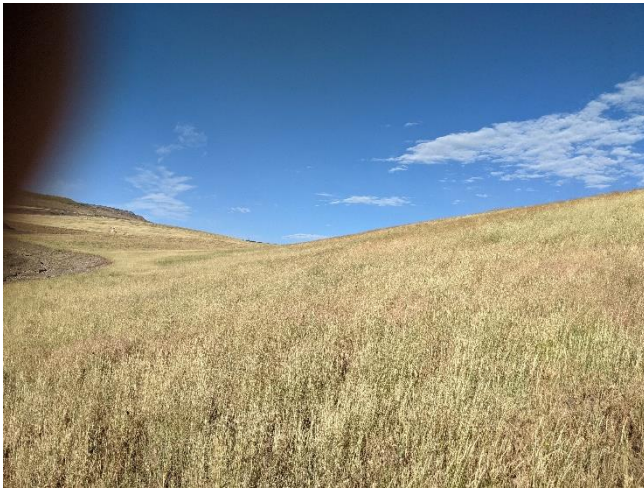
WP026.

These parcels are associated with the requested Phase II Bond Release under SL-22. Each of the parcels were well vegetated with no visible erosion.

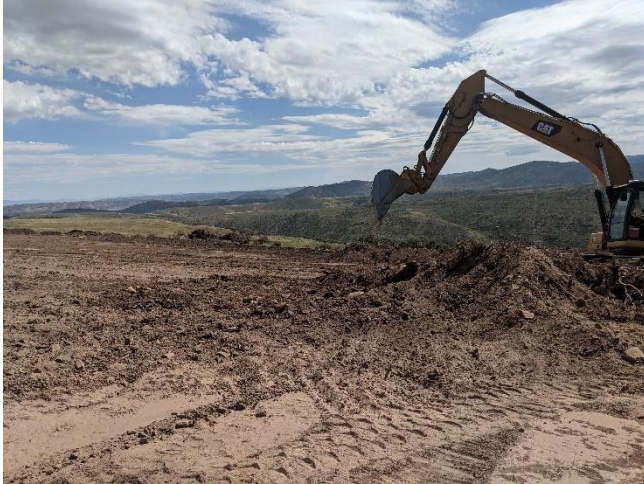
New topsoil stripping operations were occurring along the disturbance footprint of the Section 15 Ditch and Pond. The topsoil was actively being transported and placed along Topsoil Pile 16D located just south of the East Pit.

Topsoil stripping from Section 15 Pond.

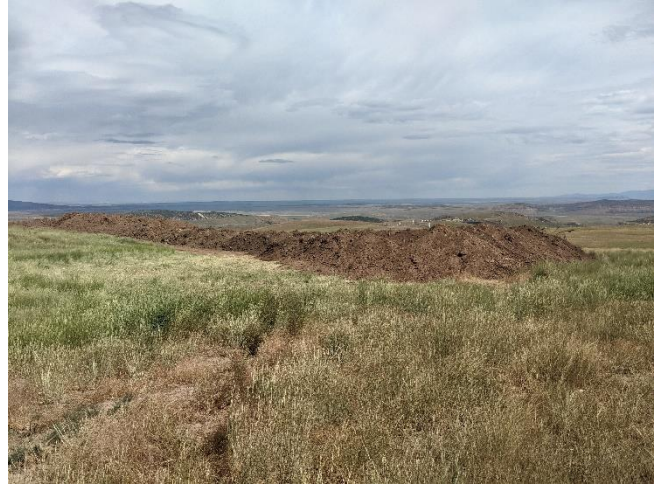
Since placement was still occurring, the new topsoil addition has yet to be shaped and seeded. Topsoil Pile 16D is fully surrounded by a containment berm to ensure topsoil is maintained within the pile footprint.

Topsoil placement on 16D from Section 15 Pond.

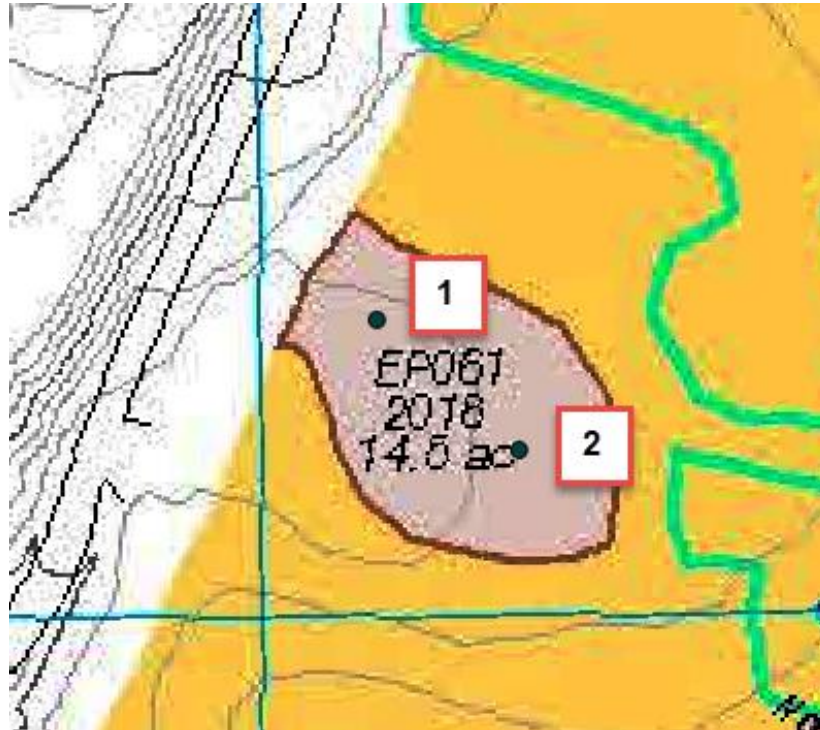
EP061.

Parcel	Hole #	Depth (in)
EP061	1	6
	2	5
WP026	3	9
	4	7
	5	6
WP027	6	7
	7	9
	8	10
WP028	9	7
	10	6
WP029	11	6
	12	6
	13	8

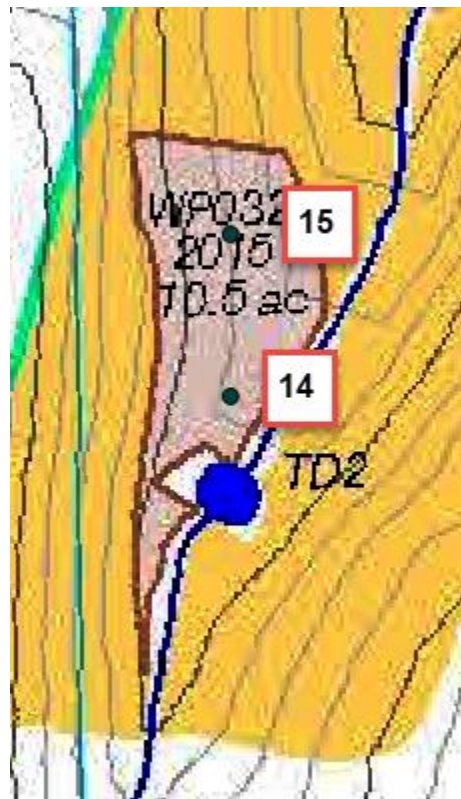
WP032.

WP032	14	9
	15	6

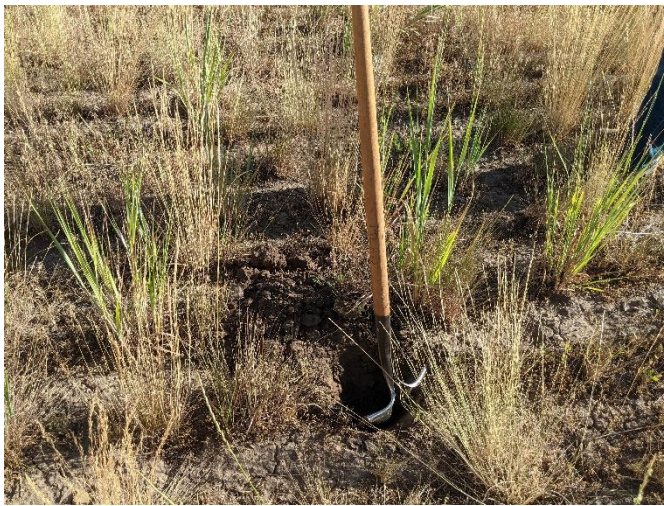
As noted earlier in this reports Summary, topsoil depth verification holes were dug in preparation for Phase II Bond Release inspection for the SL-22 application. Each parcel was walked to random locations in which holes were dug until soil profiles changed from topsoil to spoil. The depths of topsoil for each hole was then measured and documented. The following table and figures are associated to the topsoil verification holes dug during the inspection:

Topsoil verification hole.
