**MINERALS PROGRAM INSPECTION REPORT**  
**PHONE: (303) 866-3567**

<b>MINE NAME:</b> Bulldog Mine Operation	<b>MINE/PROSPECTING ID#:</b> M-1977-215	<b>MINERAL:</b> Lead and silver	<b>COUNTY:</b> Mineral
<b>INSPECTION TYPE:</b> Monitoring	<b>WEATHER:</b> Clear	<b>INSP. DATE:</b> July 6, 2023	<b>INSP. TIME:</b> 11:00
<b>OPERATOR:</b> Rio Grande Silver, Inc.	<b>OPERATOR REPRESENTATIVE:</b> Randy McClure	<b>TYPE OF OPERATION:</b> 112d-2 - Designated Mining Operation	
<b>REASON FOR INSPECTION:</b> Normal I&E Program	<b>BOND CALCULATION TYPE:</b> None	<b>BOND AMOUNT:</b> \$163,228.13	
<b>DATE OF COMPLAINT:</b> NA	<b>POST INSP. CONTACTS:</b> None	<b>JOINT INSP. AGENCY:</b> None	
<b>INSPECTOR(S):</b> Todd Jesse	<b>INSPECTOR'S SIGNATURE:</b>

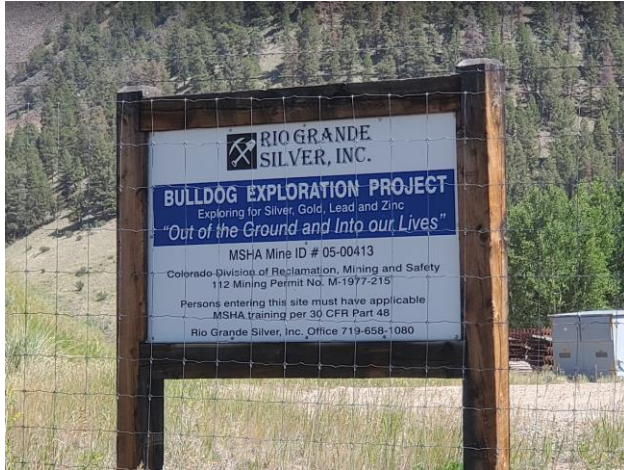
The proper Mine Identification Sign was posted at the entrance to the site and throughout the various areas of the permit boundaries. The main facilities adjacent to the office include a core logging building, maintenance shop, fuel storage building and material storage. Wildlife frequent the area and a deer was observed in the facilities area resting in the shade during the inspection. The core logging building was in immaculate condition and very well kept in anticipation of upcoming exploration programs. The shotcrete batch plant was removed from site and the building that housed it is now used for a maintenance and storage building. Like the core logging building, all other structures in the facilities area are in good condition and very well kept. On site fuel storage is an above ground diesel tank. The tank is double walled and set within a lined containment structure providing tertiary spill containment. A spill pad has been installed in the front of the building to prevent spills. Propane used for heat in the winter is also stored in pressurized tanks in the facilities area. The tanks are located on stable pads that show no signs of slumping or erosion. The propane tanks are protected by guard rail to prevent them from being hit by vehicles. There were no state listed invasive species observed in the facilities area.

View to the north showing proper Mine ID signage at the entrance

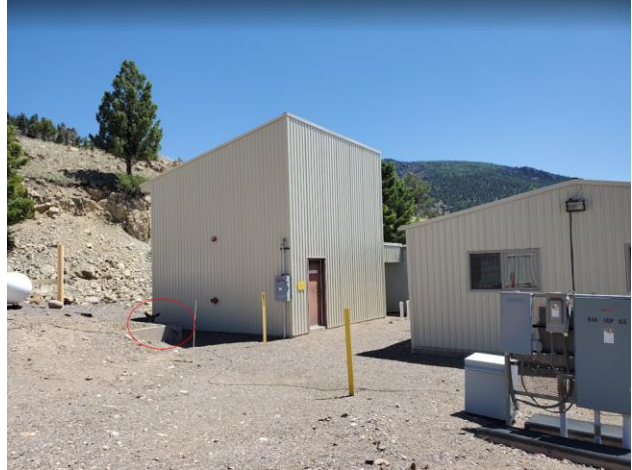
View to the northeast showing good housekeeping in facilities and a deer resting in the shade of the building.

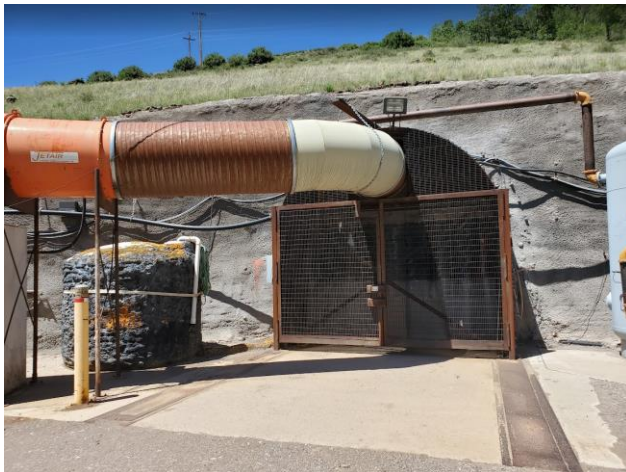
The 9400 Level portal is the main access and ore removal for underground workings. The main portal was secure at the time of the inspection. The vent fan was not operating at the time of the inspection because there is no work being done underground at this time. The portal door is in excellent condition and shows no signs of damage or vandalism. There are no signs of settling, slumping, or erosion above or around the portal. The operator sprayed for Canada Thistle in this area in 2022. The treatment appears effective as no state listed invasive species were identified in the area.

View to the west showing the 9400 Level Portal. Gate is secure and well kept.

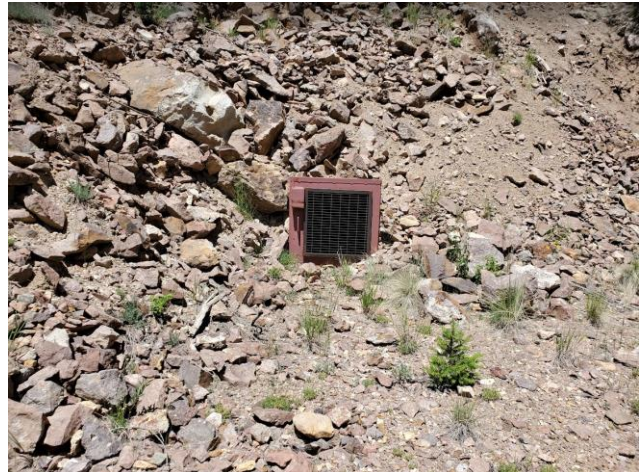
The 9700 Level Portal has been reclaimed and is not used in operations. The bat gate at the portal was secured at the time of the inspection. The portal closure is stable. There are no signs of displacement around the gate. The slopes above and adjacent to the closure are stable and show no signs of slumping or erosion. Weed treatment in the area appears to be effective. The Annual Report indicated that there was invasive species treatment in this area during 2022. No state listed invasive species were observed in the treatment area. Approximately a mile to the north of the 9700 Portal is the Windy Gulch Vent Shaft. The Windy Gulch Vent Shaft is surrounded by chain link fence with a locked gate to prevent unauthorized entry and vandalism. The shaft is in good condition. The collar and closure show no evidence of displacement, settling, slumping, or erosion. A number of groundwater monitoring wells were also observed while in route to these outlying areas of the permit. The wells are well marked and protected by posts to prevent the wells from being struck by a vehicle. The wells are also capped and secured to prevent contamination or tampering from the general public.

View to the west showing 9700 Portal closure.

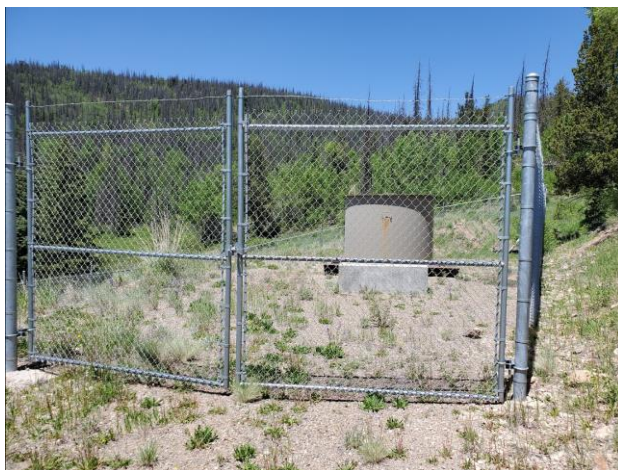
View to the northwest of the Windy Gulch Vent Raise. The raise is well protected.

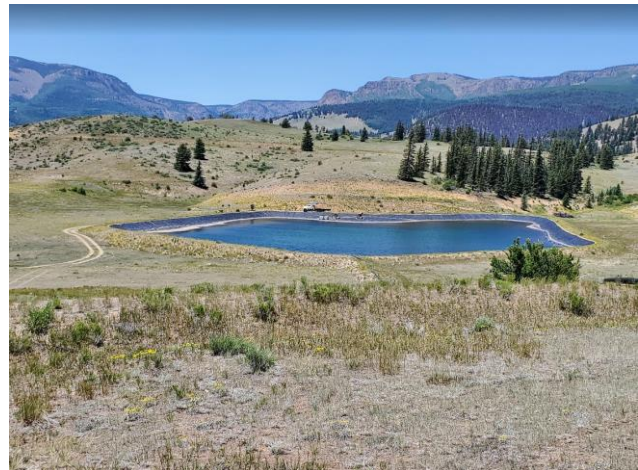
The Tailings Pond 2 area lies approximately 1.5 miles to the south of the main facilities and office area. This area consists of the lined Tailings Storage Facility (TSF) that was utilized during active mining operations. Active tailings deposition in this facility has not occurred in some time. The TSF shows no signs of structural instability such as displacement, cracking or erosion. Within the TP-2 facility lies a lined contact water pond that was used to help dewater the mine during maintenance. There is still water in the pond even though the mine is not being actively dewatered. The pond is lined with HDPE liner that still appears to be good condition after winter snows. Evaporators are on site at TP-2, but were not in use at the time of the inspection. Adjacent to the TSF is a cleared pad utilized to store core samples from recent drilling projects. The pad is well kept with no signs of instability. This core may be buried as approved under a technical revision in the future.

View to the southwest showing TP-2. Evaporators are on the far side of the pond.
