MINERALS PROGRAM INSPECTION REPORT
PHONE: (303) 866-3567

MINE NAME: Schwartzwalder Mine	MINE/PROSPECTING ID#: M-1977-300	MINERAL: Uranium	COUNTY: Jefferson
INSPECTION TYPE: Monitoring	WEATHER: Clear	INSP. DATE: July 26, 2023	INSP. TIME: 13:30
OPERATOR: Colorado Legacy Land, LLC	OPERATOR REPRESENTATIVE: Paul Barnes	TYPE OF OPERATION: 112d-2 - Designated Mining Operation

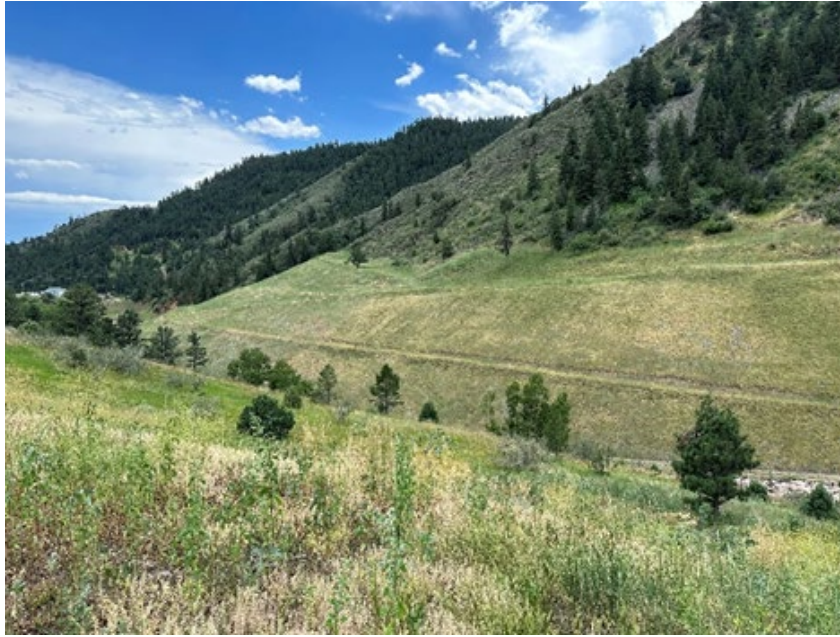
No problems were seen with the North Waste Rock Pile or the South Waste Rock Pile (Photo 1). The diversion ditch above the north pile was intact and clear of debris (Photo 2). At the southeast end of the south pile, no material was seen that looks like the result of new excavation. No earth-moving work was taking place during the inspection. A small puddle at the southeast corner appeared to be from recent storms (Photo 3).

1. View of the SWRP, photo taken from the NWRP

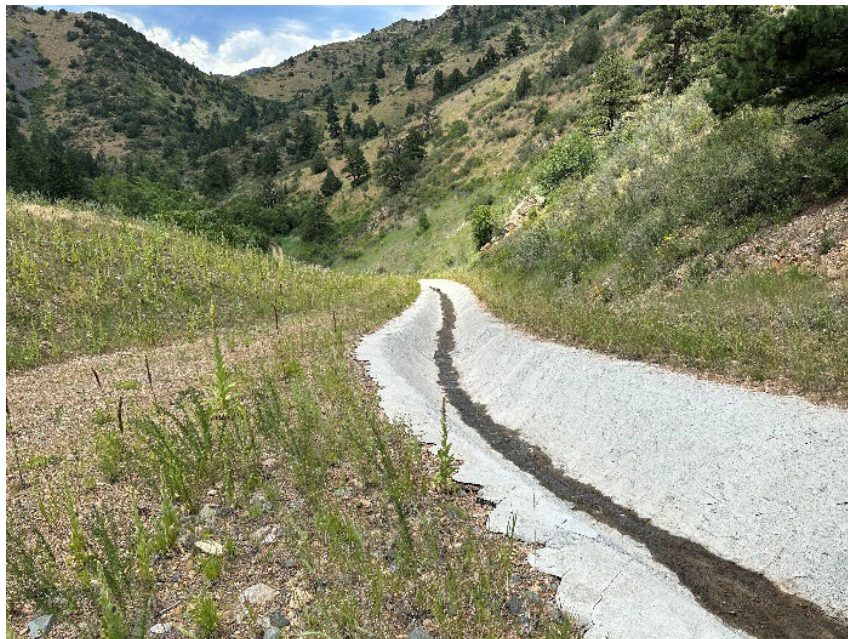
2. Stormwater Diversion Channel on the NWRP.

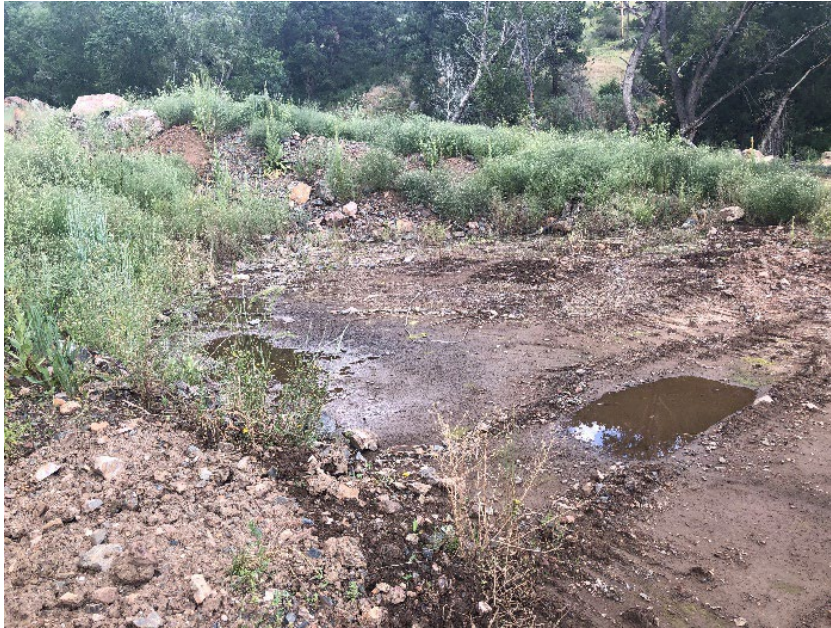
3. View of excavated area on the east side of the SWRP.

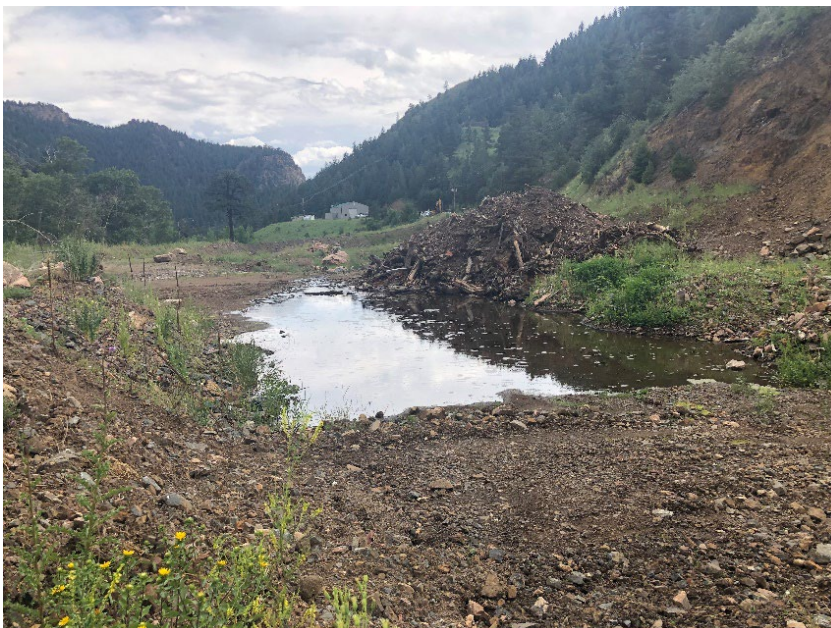
The excavations on either side of the road to the water treatment plant contained significant water (Photos 4 and 5). This is cited as a problem requiring corrective action by the operator. Namely, the water needs to be pumped to the plant for treatment.

4. Ponded stormwater adjacent to the Black Forest portal.

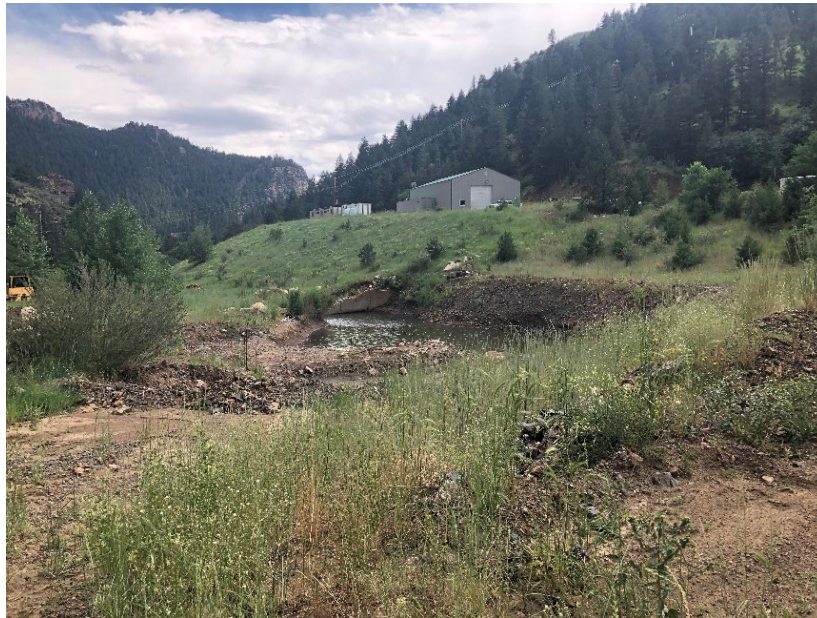
5. Ponded stormwater in excavated pit below WTP.

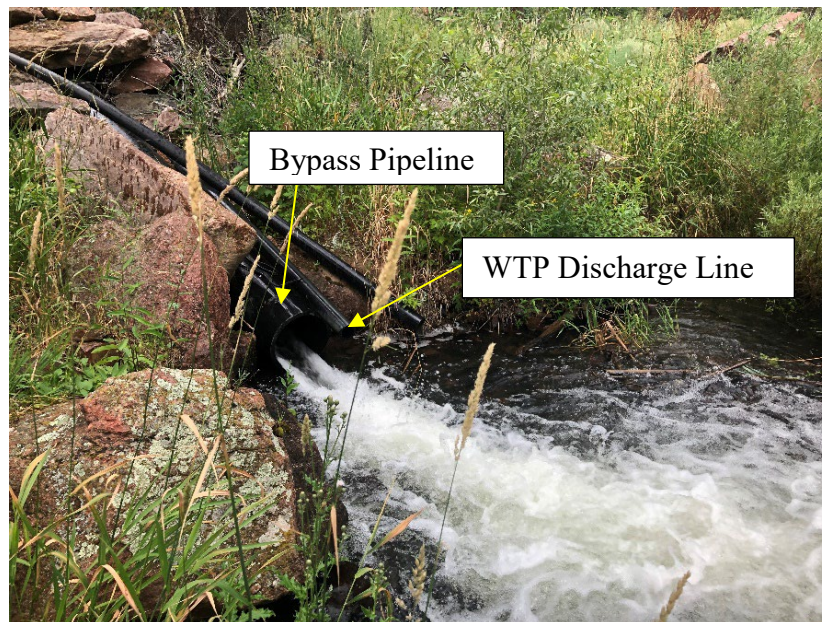
The diversion of water in Ralston Creek was operating during the inspection, and no flow was seen in the creek bed as it passes through the center of the site. A large amount of flow was seen discharging from the lower end of the bypass pipe (Photo 6).

The Operator informed the Division the water treatment plant was not operational at the time of the inspection and the Division verified there was no discharge of treated water into Ralston Creek. The Operator's representatives did not provide a timeframe for resuming active water treatment at the mine. According to the Operator, the water treatment plant was offline to reconfigure part of the treatment system. In addition, no prior notice had been provided to the Division in regards to the status of the water treatment plant. The water treatment plant was designated as an Environmental Protection Facility under Amendment No. 6 and the operation of the facility ensures that the mine pool is maintained at the regulatory limit of 150' below the Steve level portal. The regulatory limit for the elevation of the mine pool is a permit condition which was developed to ensure that contaminated mine pool water did not communicate with Ralston Creek, which is a drinking water source for the cities of Denver and Arvada. As noted in the June 2023 Inspection Report, the mine pool transducer was found to not be operational when the water treatment plant resumed treating water this season. As such, the Operator cannot adequately demonstrate the mine pool is being maintained at or below the regulatory limit.

6. Bypass Pipeline discharging Ralston Creek Flows, no discharge from WTP.

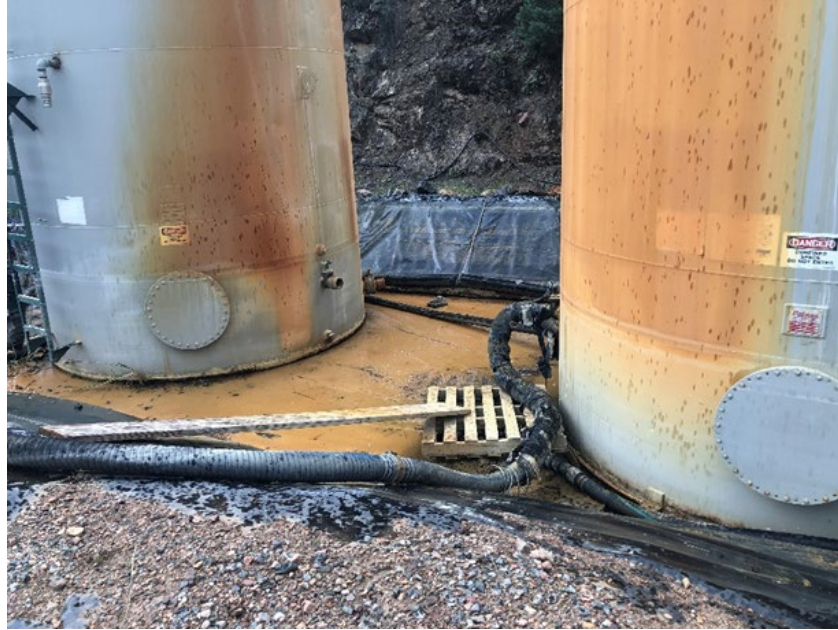
7. View of secondary containment for Backfill Slurry Tank and Reactor Tank.
