Re: Inspection SL2 Superior S&G

MINERALS PROGRAM INSPECTION REPORT
PHONE: (303) 866-3567

MINE NAME: Superior S&G Pit	MINE/PROSPECTING ID#: M-1979-189	MINERAL: Sand and gravel	COUNTY: Arapahoe
INSPECTION TYPE: Surety Release Inspection	WEATHER: Clear	INSP. DATE: 31 July, 2023	INSP. TIME: 12:45 p.m.
OPERATOR: City of Aurora	OPERATOR REPRESENTATIVE: Brian Green	TYPE OF OPERATION: 112c - Construction Regular Operation	
REASON FOR INSPECTION: Normal I&E Program	BOND CALCULATION TYPE:	BOND AMOUNT: \$0.00	
DATE OF COMPLAINT: NA	POST INSP. CONTACTS: None	JOINT INSP. AGENCY: None	
INSPECTOR(S): Robin Reilley, GISP	INSPECTOR'S SIGNATURE:

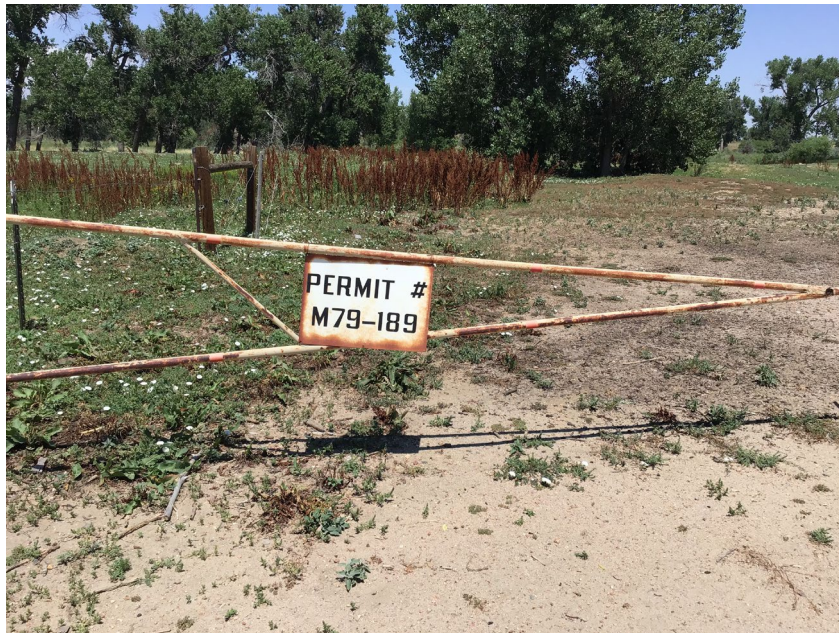
The permit identification sign required as per rule 3.1.12(1) located at the Quincy entrance was old, only displaying the permit number. As the site is scheduled for full release this does not pose a problem as once released, the sign will be removed.

*Photo 1: Mine site identification sign, Quincy St. entrance
at west end of site,*

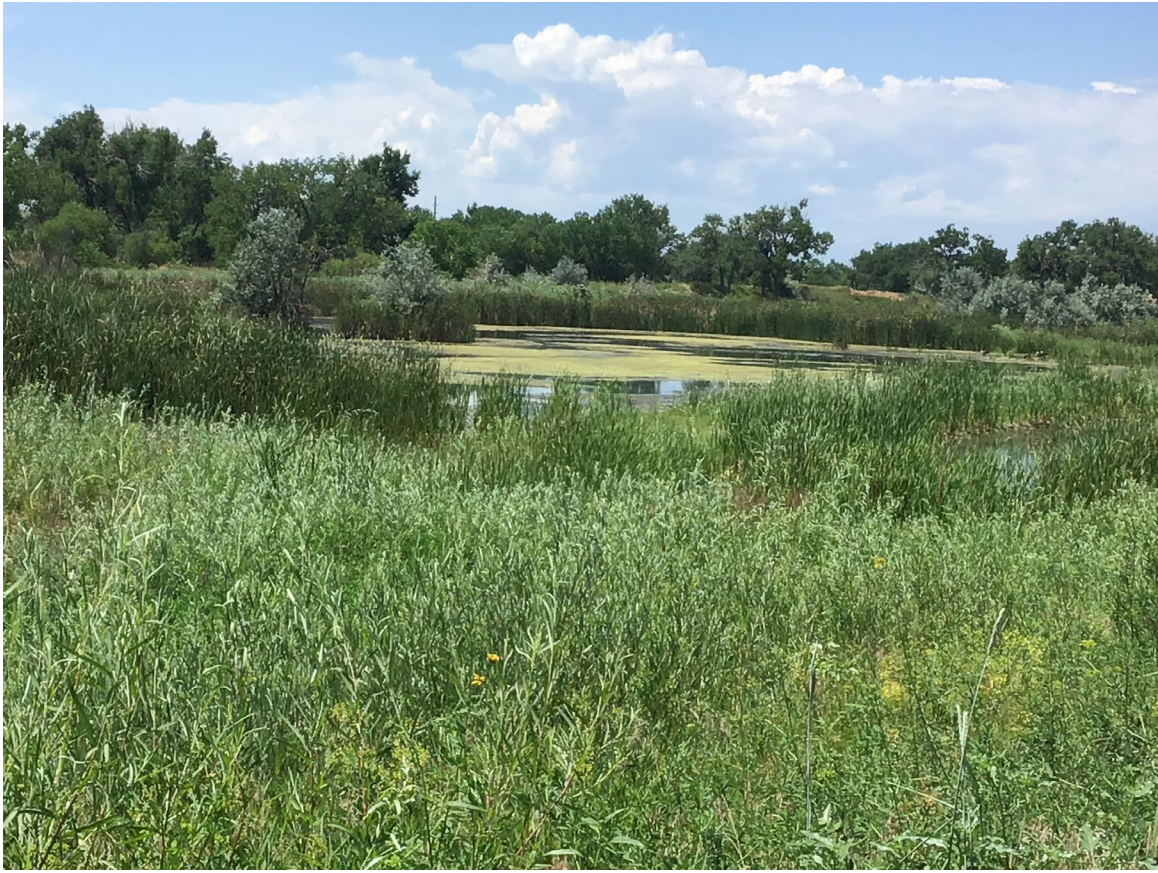
Photo 2: East reclamation area pond exhibiting riparian vegetation.

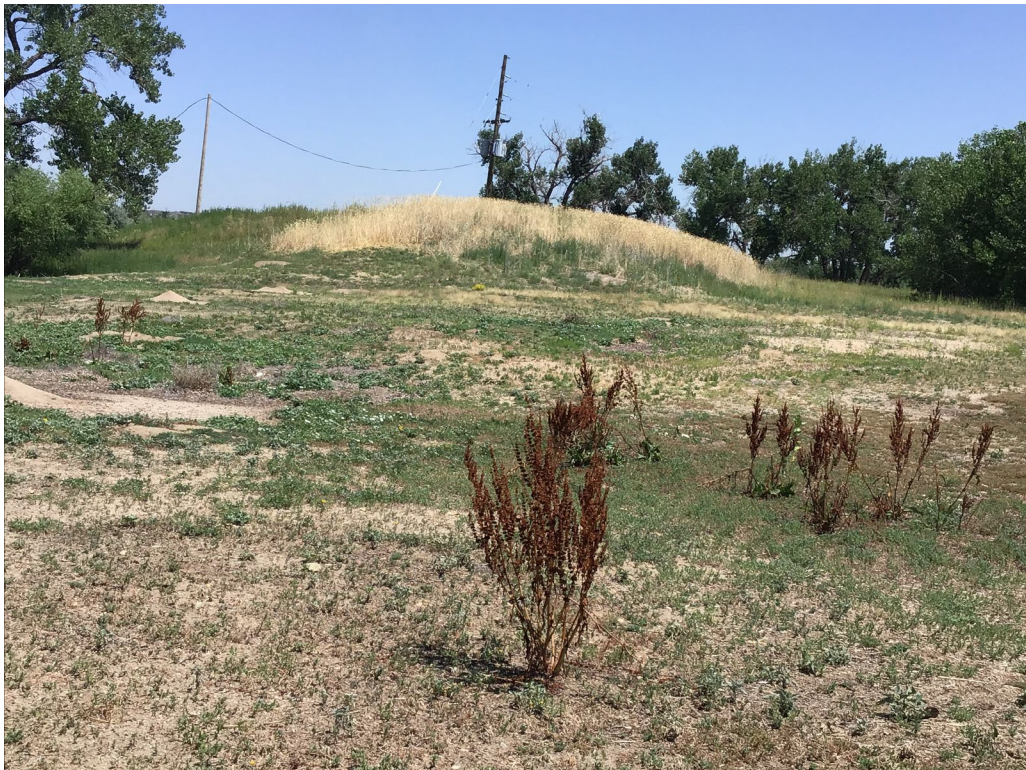
The spoil pile height had been graded to a lower elevation and is covered with green and dried vegetation appears stable. An overburden stockpile located at the north east corner of the site had been gently sloped, vegetated and contained with a silt fence. The pile will remain as a permanent pile as is. Grading appears to have been conducted as per the permit. No concerning erosional features were observed on spoil piles or pond banks. Slopes are shallow exhibiting a 3H to 1H ratio. Murphy and Coal Creeks showed evidence of high flow from spring and summer rains.

Photo 3: Spoil pile exhibiting a cover of barley.

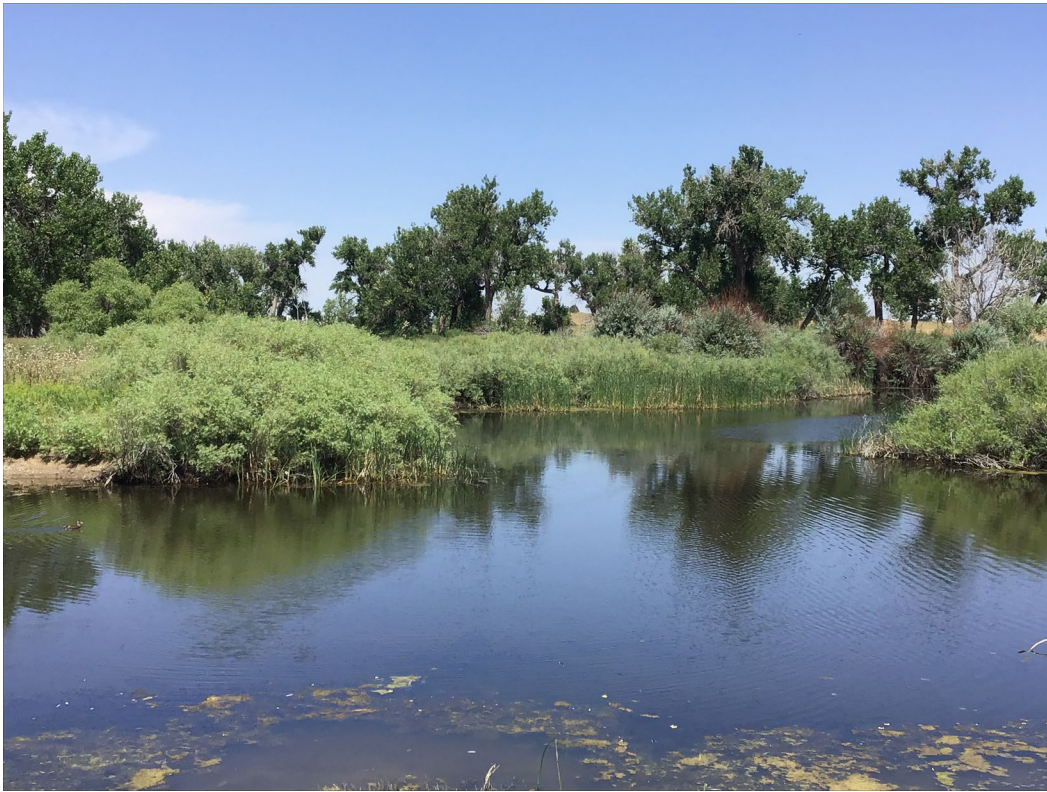
Photo 4: East reclamation area pond looking west.

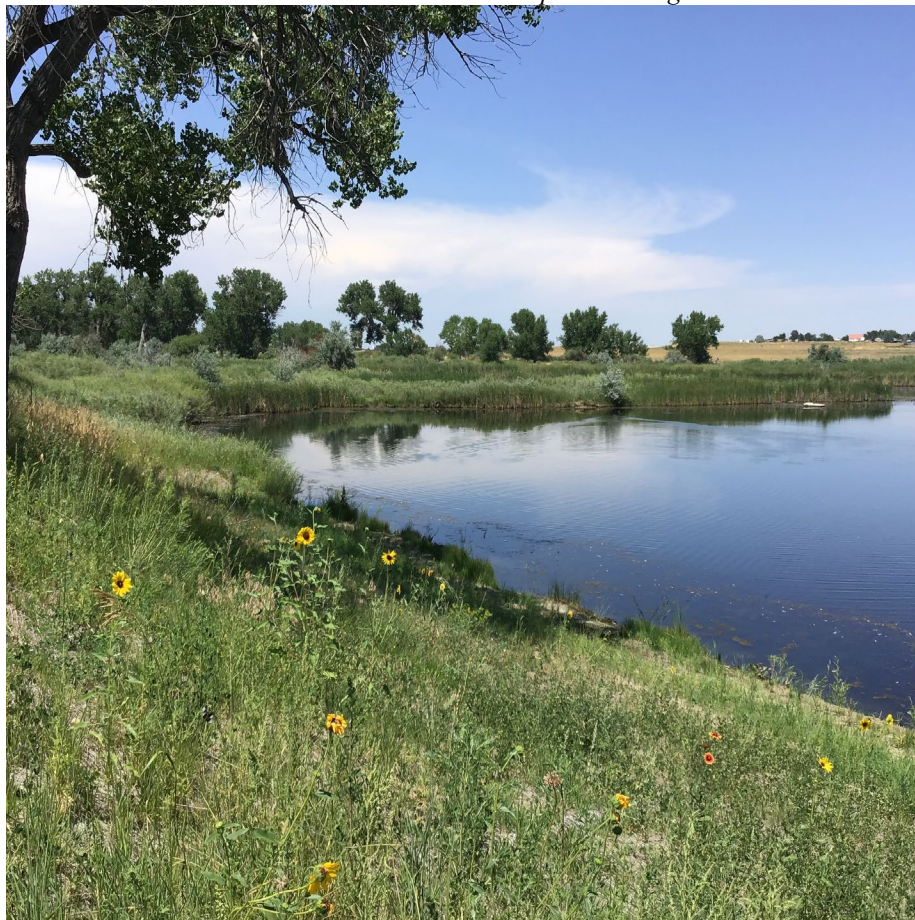
Photo 5: Sloped and vegetated banks of west reclamation area looking west.

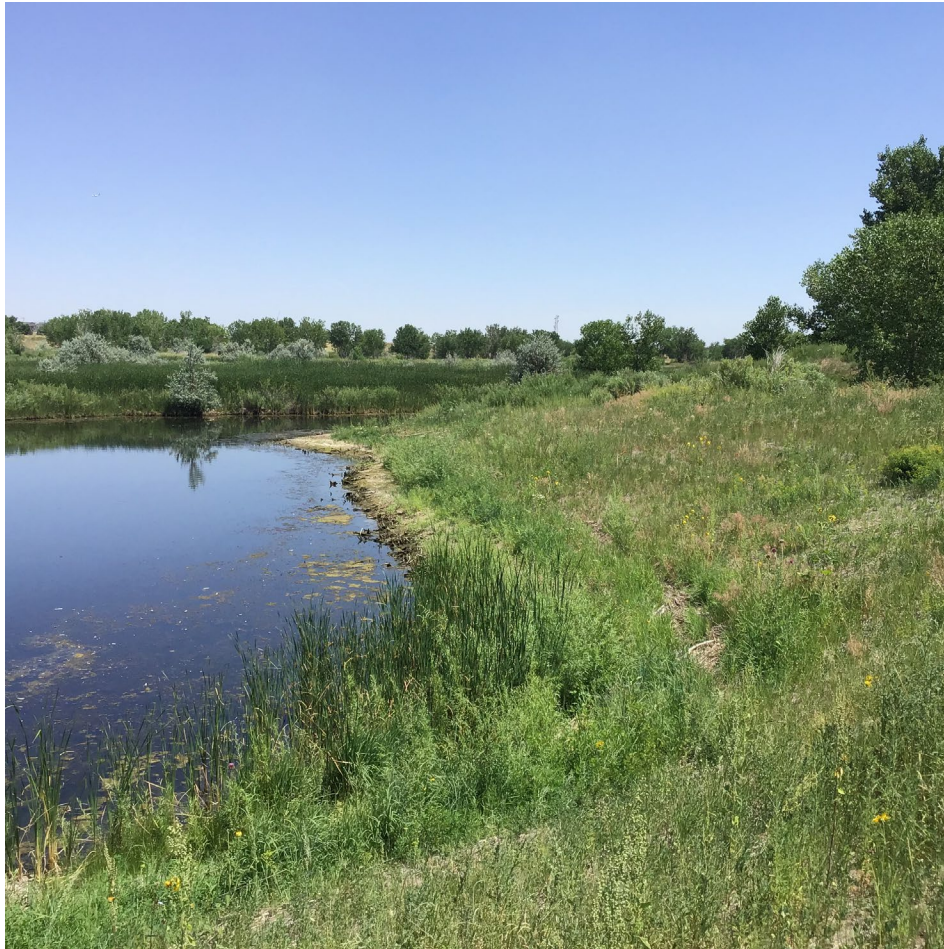
Photo 6: *Sloped and vegetated banks of west reclamation area looking east.*

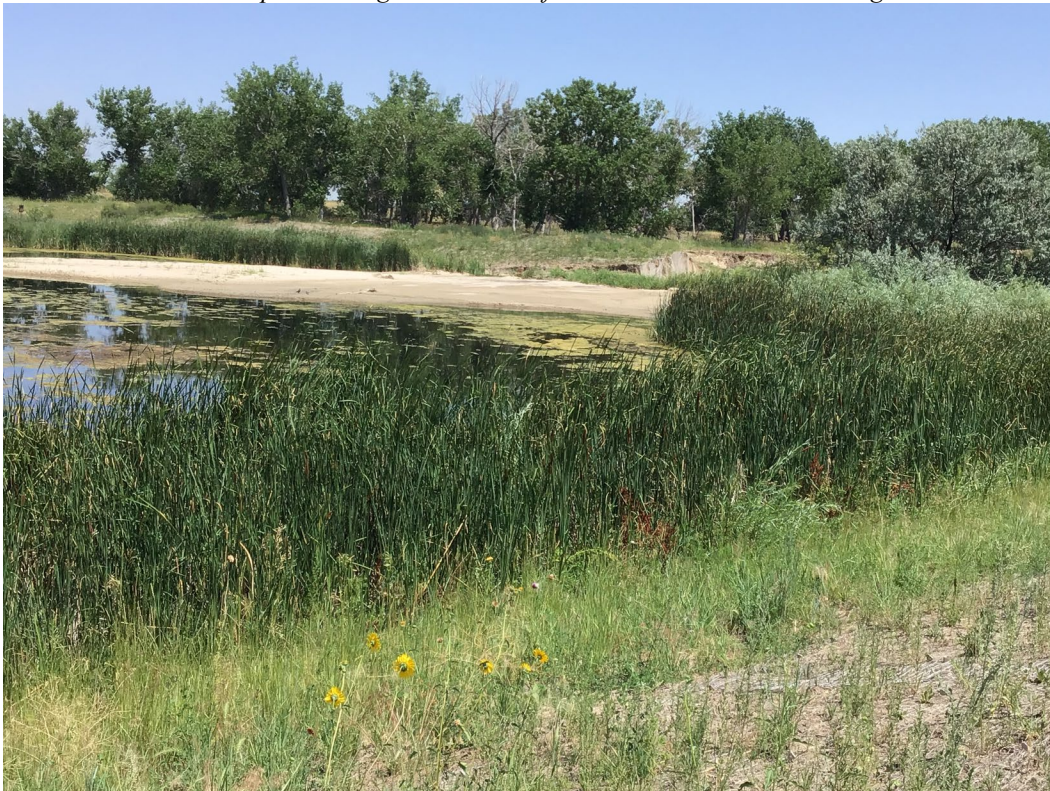
Photo 6: *Confluence of Murphy Creek with Central Pond, exhibiting a depositional sandbar.*
