MINERALS PROGRAM INSPECTION REPORT
PHONE: (303) 866-3567

MINE NAME: Big Red Park	MINE/PROSPECTING ID#: M-2014-038	MINERAL: Gravel	COUNTY: Routt
INSPECTION TYPE: Monitoring	WEATHER: Cloudy	INSP. DATE: July 18, 2023	INSP. TIME: 09:30
OPERATOR: Routt County	OPERATOR REPRESENTATIVE: Tanner Carolous	TYPE OF OPERATION: 110c - Construction Limited Impact	
REASON FOR INSPECTION: Normal I&E Program	BOND CALCULATION TYPE: None	BOND AMOUNT: \$0.00	
DATE OF COMPLAINT: NA	POST INSP. CONTACTS: None	JOINT INSP. AGENCY: None	
INSPECTOR(S): Hunter Ridley	INSPECTOR'S SIGNATURE:

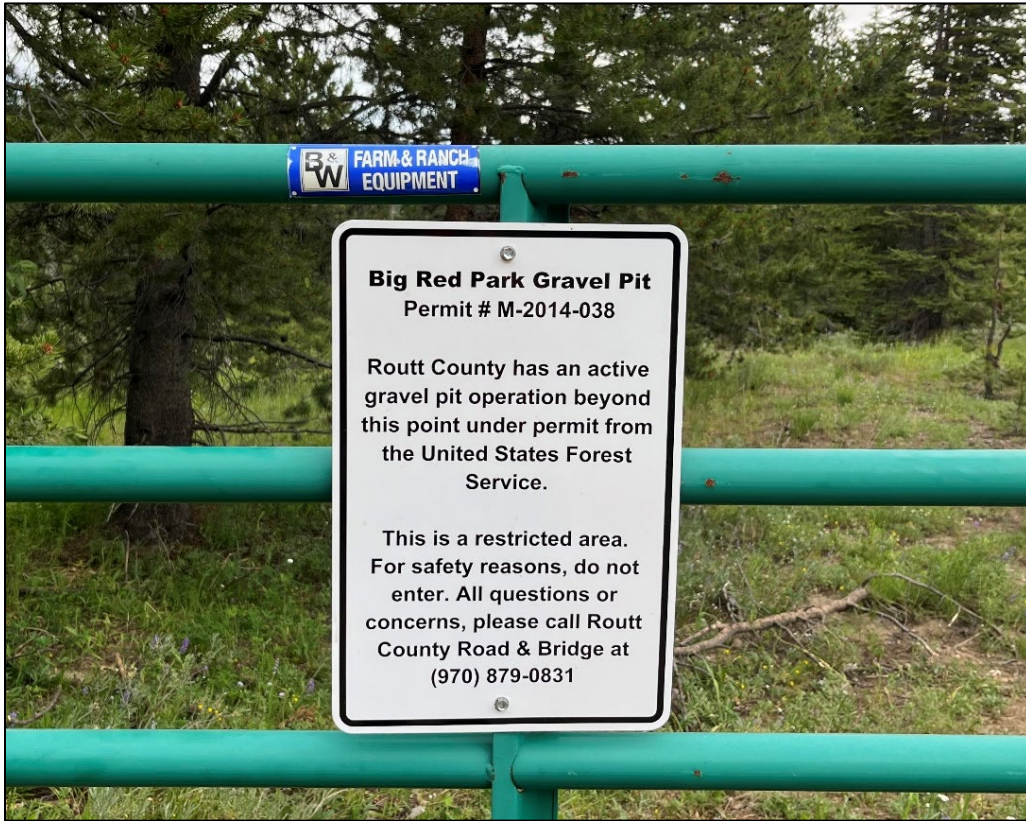
The mine identification sign is in place and in compliance with Rule 3.1.12. The mine sign is located at the main entrance and is attached to a locked gate (Photo 1). The permit boundary is marked by poles staggered around the site's perimeter. Phase 2 of mining has begun. Approximately 2-3 acres have been disturbed (Photo 2). The pit was inactive at the time of inspection. The Operator stated that the pit would likely be active this fall. No reclamation has yet occurred. The life of the mine will be dependent on market conditions. After reclamation, the site will be reused as a Forest Service campsite.

Photo 1: A mine sign is posted at the site's entrance gate.

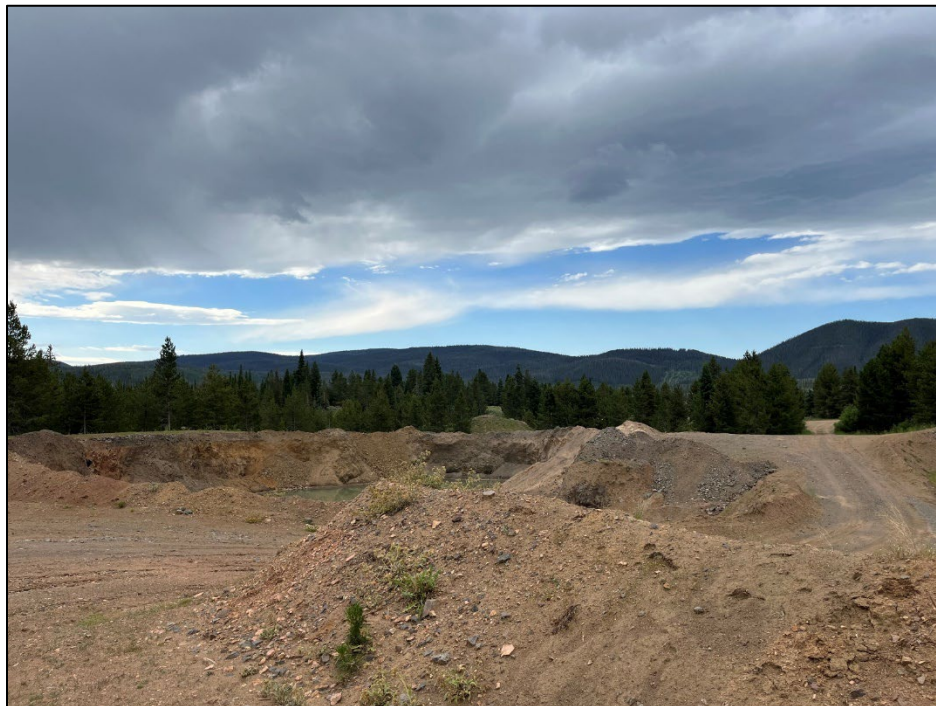
Photo 2: View southwest into the excavated pit.

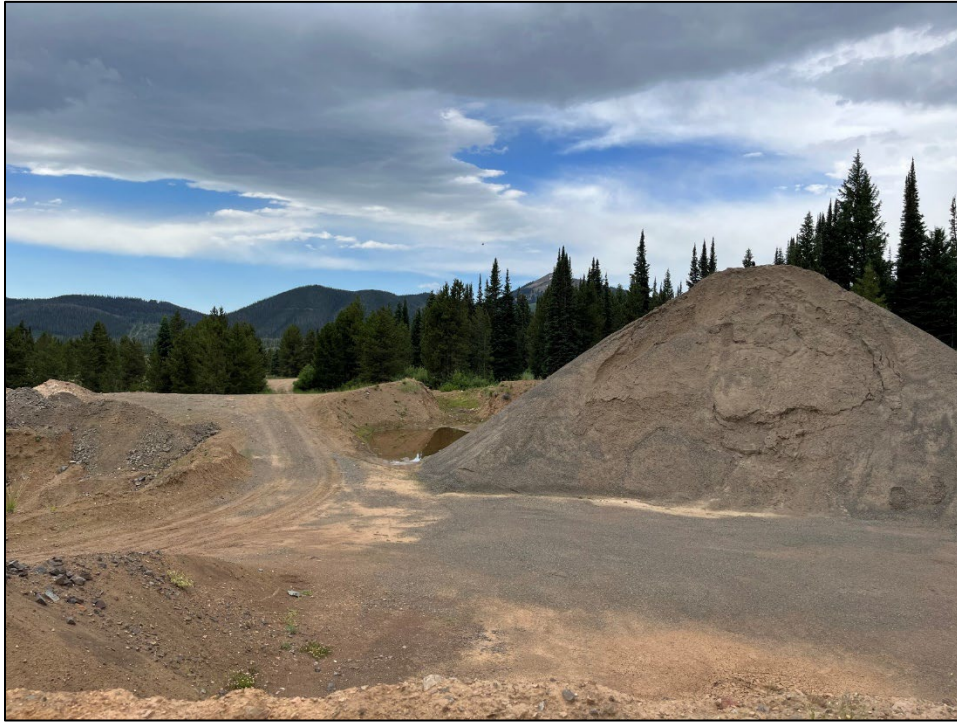
A large stockpile of crushed material located on the pit floor (Photos 3 and 5). Processing equipment is usually placed to the north of the excavation area when the pit is active (Photo 4). A small wetland area is located adjacent to this processing area and is bordered off (Photo 4). This area will not be mined. After rain events, the excavated pit area collects stormwater which infiltrates back into the ground (Photo 6).

Photo 3: View south of the pit's main road entrance and stockpile.

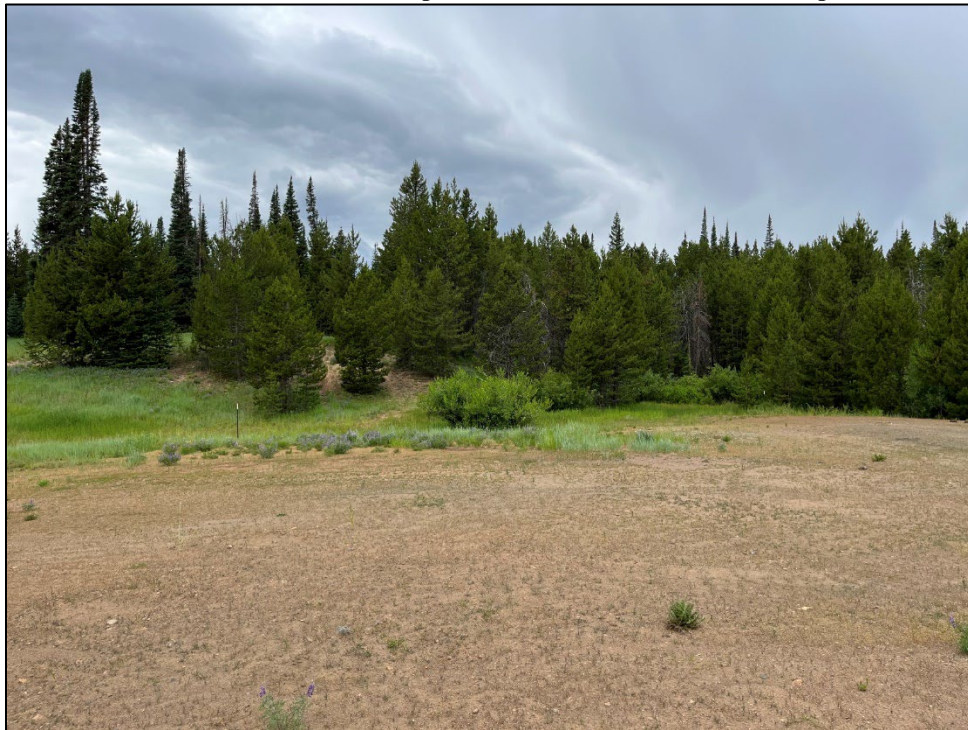
Photo 4: View west of the wetland area. This area is marked by signs and avoided by all mining activity.

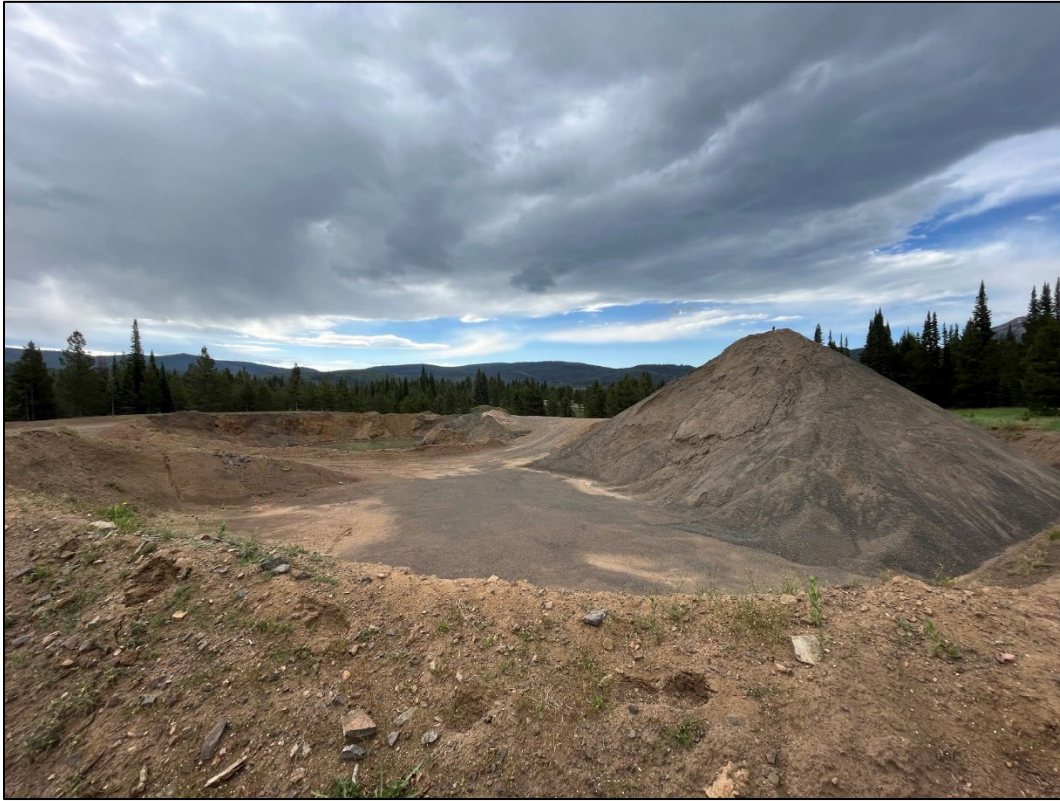
Photo 5: Overview of the pit floor, excavated 'highwall', and stockpiles.

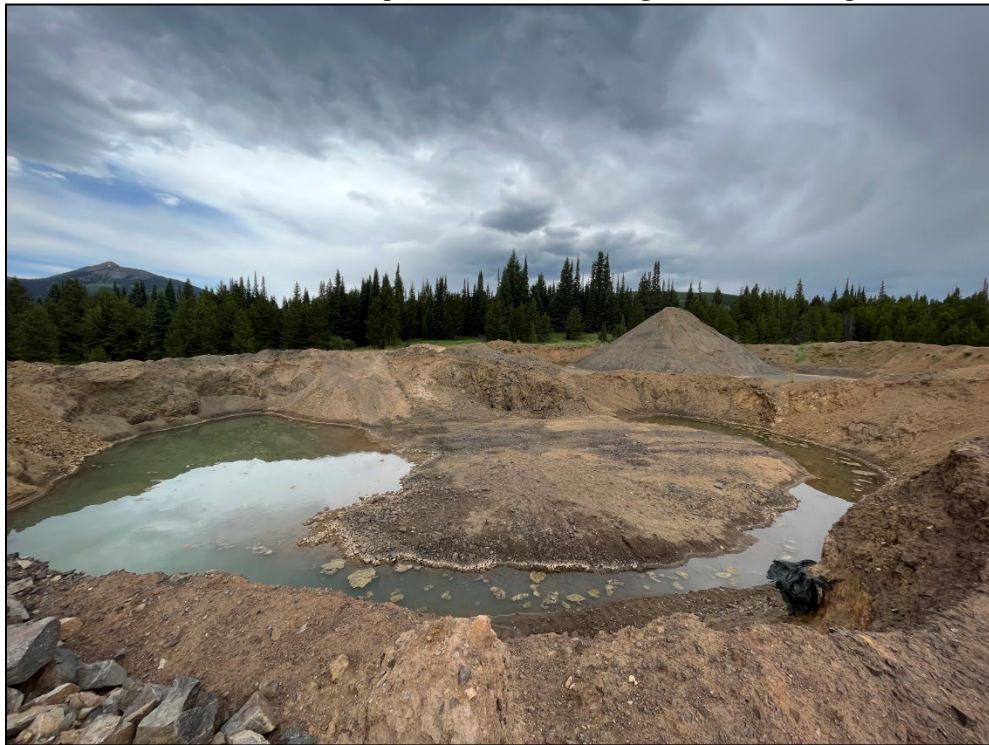
Photo 6: View inside the excavated area. All captured stormwater and snowmelt infiltrates back into the ground.

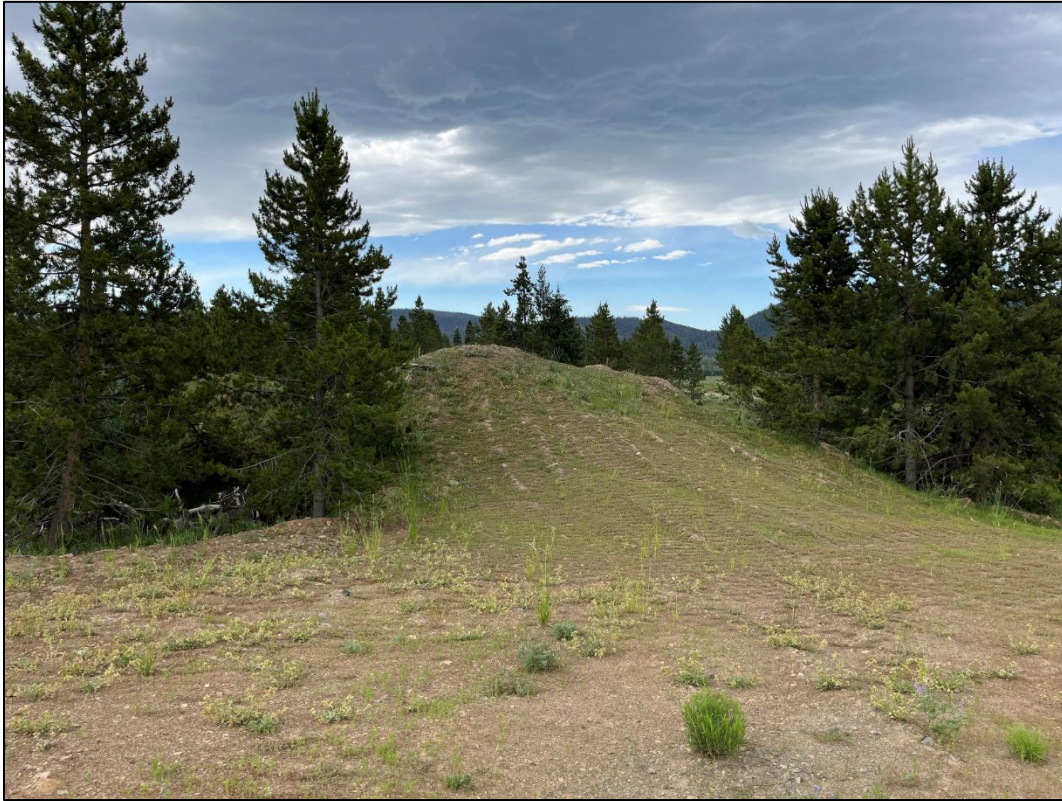
The area is surrounded by a stormwater berm. This berm was reestablished with the start of Phase 2 mining. Water from around the site drains to a culvert under the entrance road (Photo 8). A topsoil pile is located in the southeastern corner of the pit and is well vegetated (Photo 7). Since the area naturally contains a limited amount of topsoil, overburden and fines have also been stored here for use in reclamation.

Photo 7: Topsoil pile located in the southeastern corner of the pit.

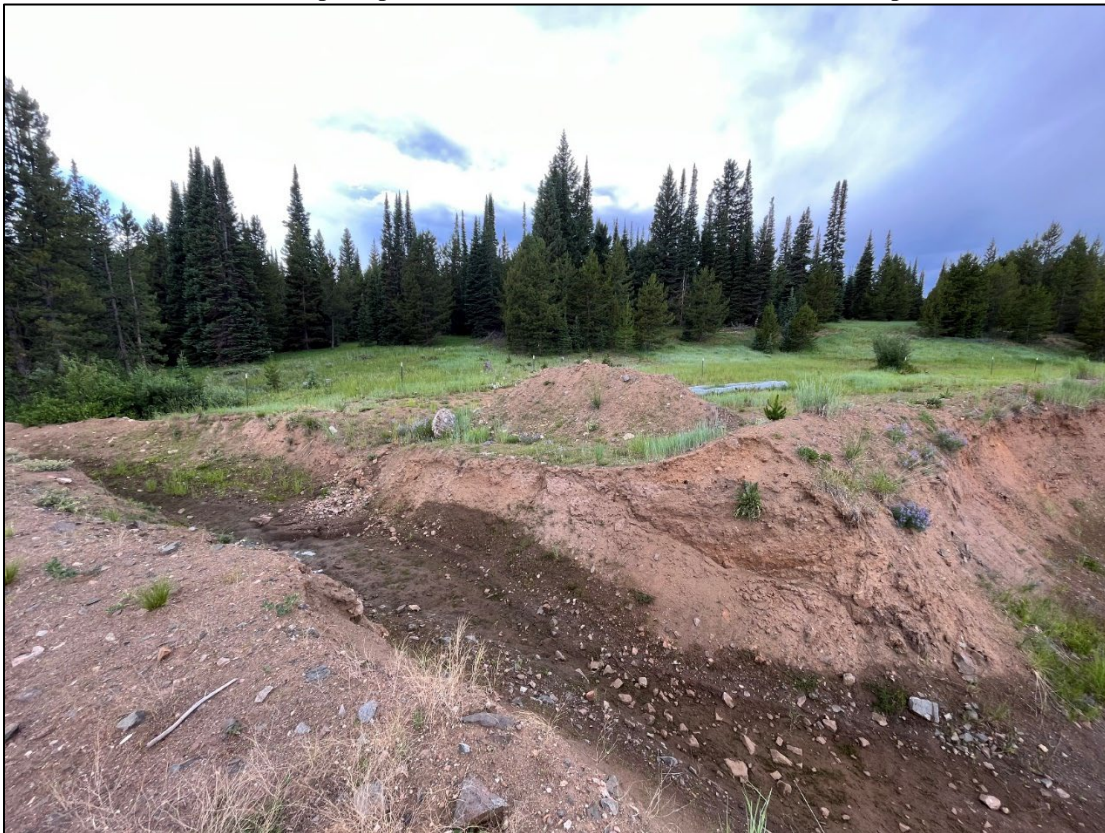
Photo 8: Water from the site is diverted through the stormwater berm and under the main entrance road.
