MINERALS PROGRAM INSPECTION REPORT
PHONE: (303) 866-3567

MINE NAME: Wedding Bell Project (Groundhog Area)	MINE/PROSPECTING ID#: P-2021-008	MINERAL: Vanadium and uranium	COUNTY: San Miguel
INSPECTION TYPE: Monitoring	WEATHER: Clear	INSP. DATE: July 11, 2023	INSP. TIME: 10:23
OPERATOR: Standard Minerals Inc.	OPERATOR REPRESENTATIVE: Tony Adkins	TYPE OF OPERATION: MP - Mineral Prospecting	
REASON FOR INSPECTION: Normal I&E Program	BOND CALCULATION TYPE:	BOND AMOUNT: \$6,163.00	
DATE OF COMPLAINT: NA	POST INSP. CONTACTS: None	JOINT INSP. AGENCY: None	
INSPECTOR(S): Lucas West	INSPECTOR'S SIGNATURE:

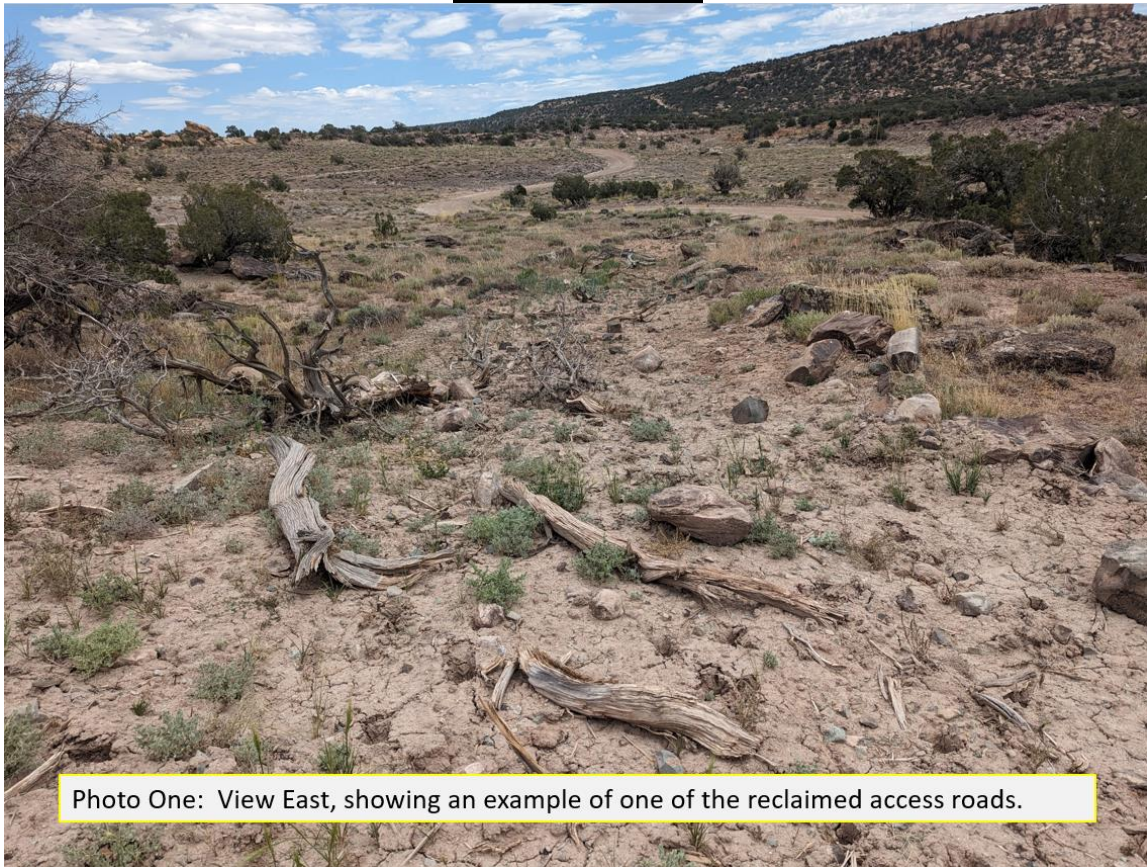
The pads were identified as 012/012a and 013. As of the date of the inspection all affected lands including the access road, have been graded and received initial revegetation efforts. An example of the access road can be seen in Photo One, the area was graded and nearby rocks and branches were spread to blend it with adjacent undisturbed lands. All areas of the access road exhibit positive drainage and no evidence of settling, slumping or erosion was noted. Reclamation species were identified in these areas and the vegetative covers ranges from sparse to dense and diverse, however this mimics the adjacent undisturbed areas and is considered sufficient for reclamation. Similar to the access roads the drill pads have been graded, seeded and had native materials such as rocks and tree limbs spread across them. Pad 012/012a can be seen in Photo Two and Pad 013 can be seen in Photo Three. Both pads exhibit positive drainage and no evidence of erosion was noted. The vegetative cover of pad 012/012a ranges in density, however given the growth media that was present on site prior to disturbance, which was replaced during reclamation, this appears consistent with adjacent undisturbed lands. The vegetative cover on Pad 013 however, was more sparse given its slope aspect and gradient and could use at least one more season to monitor vegetative success. Throughout the site, no state listed noxious weeds were identified, and on site discussions with the Operator's Representative indicate that hand pulling and removal efforts have been employed on site.

Photo One: View East, showing an example of one of the reclaimed access roads.

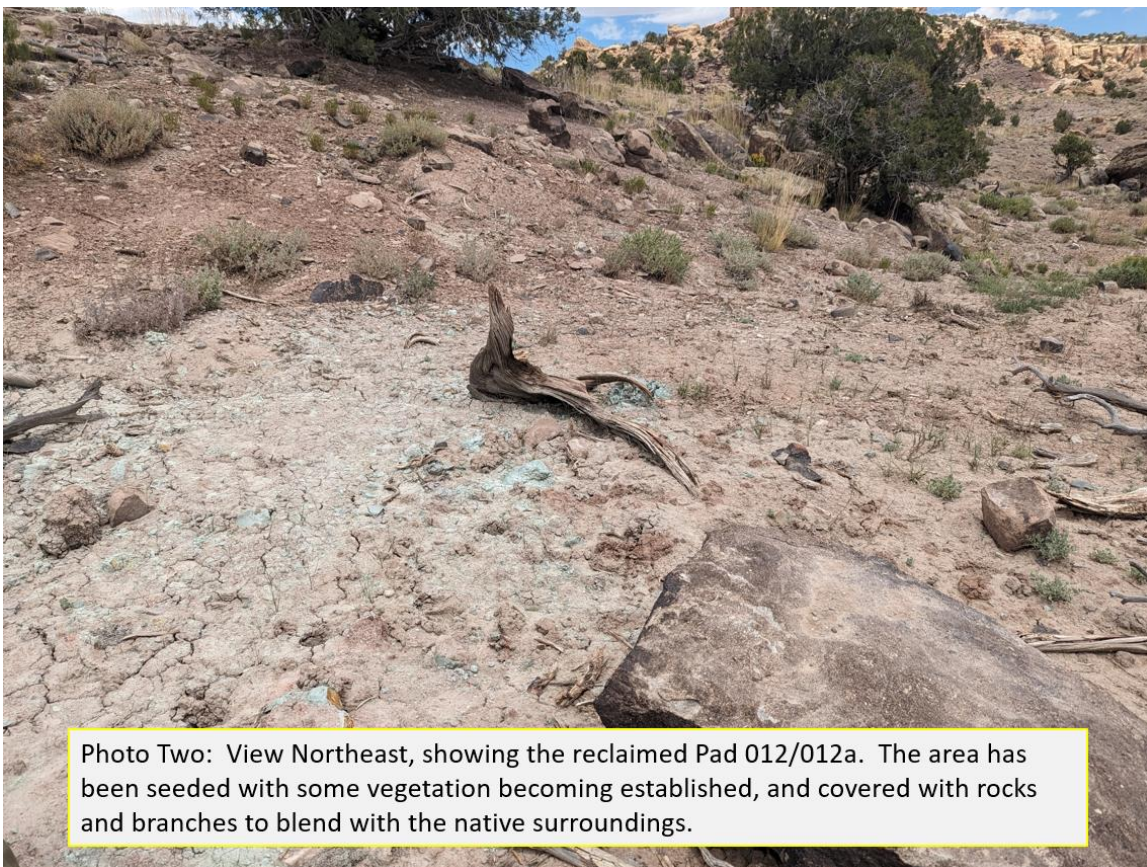
Photo Two: View Northeast, showing the reclaimed Pad 012/012a. The area has been seeded with some vegetation becoming established, and covered with rocks and branches to blend with the native surroundings.

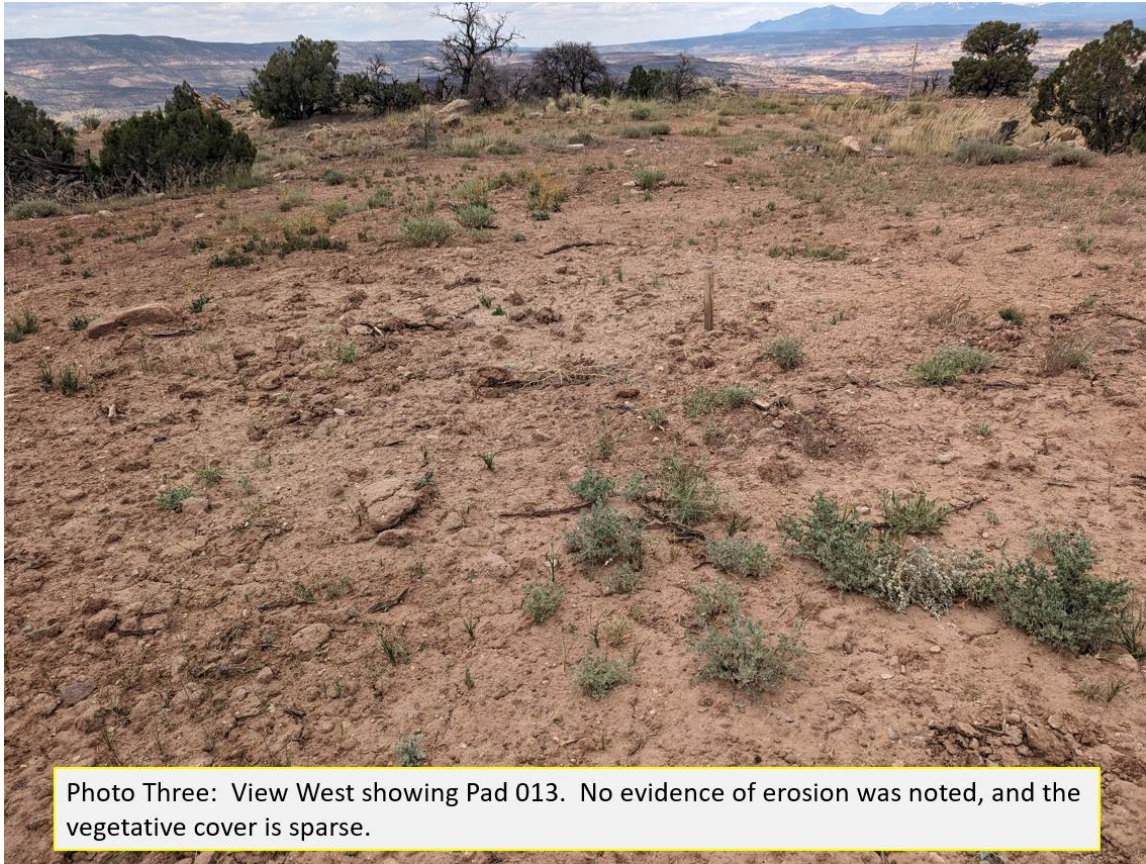
Photo Three: View West showing Pad 013. No evidence of erosion was noted, and the vegetative cover is sparse.
