MINERALS PROGRAM INSPECTION REPORT
PHONE: (303) 866-3567

MINE NAME: Wamsley Pit	MINE/PROSPECTING ID#: M-2011-027	MINERAL: Gravel and sand	COUNTY: Jackson
INSPECTION TYPE: Monitoring	WEATHER: Cloudy	INSP. DATE: July 19, 2023	INSP. TIME: 10:00
OPERATOR: Richard L Wamsley dba- RLW Enterprises	OPERATOR REPRESENTATIVE: Richard Wamsley	TYPE OF OPERATION: 110c - Construction Limited Impact	
REASON FOR INSPECTION: Normal I&E Program	BOND CALCULATION TYPE: Partial Bond	BOND AMOUNT: \$8,800.00	
DATE OF COMPLAINT: NA	POST INSP. CONTACTS: None	JOINT INSP. AGENCY: None	
INSPECTOR(S): Hunter Ridley	INSPECTOR'S SIGNATURE:

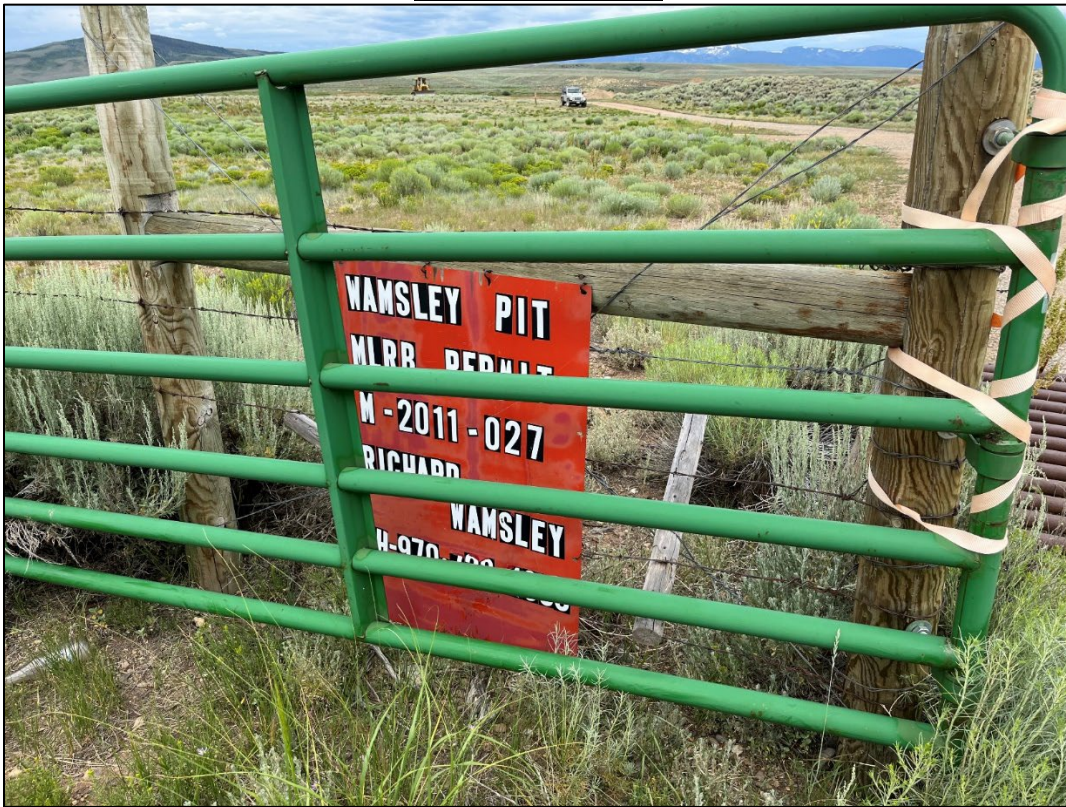
The required mine sign and boundary markers were observed as required by Rule 3.1.12. The mine sign was located on the entrance gate to the site off Highway 14 (Photo 1) and the permit boundary was delineated with wood posts (Photo 2). The proposed post-mining land use for the site is general agriculture. No noxious weeds were observed during the inspection. However, an abundance of sweet clover, a weedy species, was noted across the site (Photo 4). The Operator is encouraged to follow the permit approved weed control plan to manage all weedy species and promote the growth of native vegetation.

Photo 1: Mine sign posted at the gate to the entrance road.

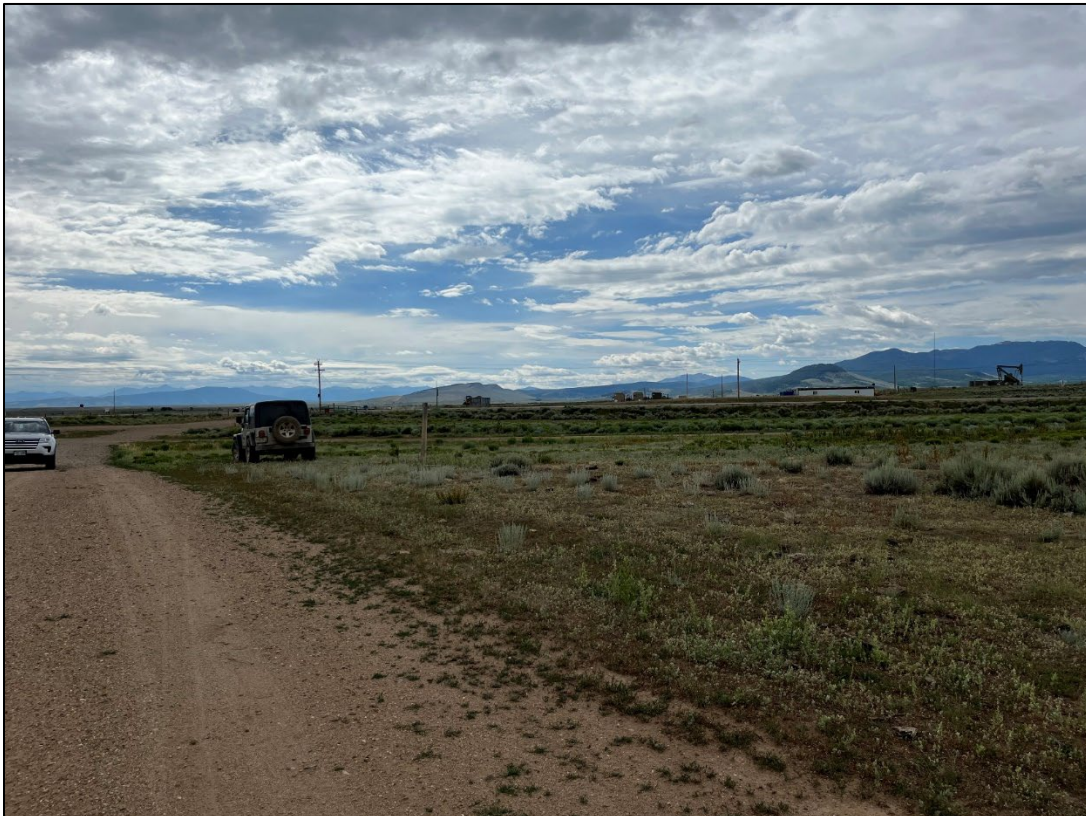
Photo 2: View south of pit entrance, wooden post delineate the permit boundary.

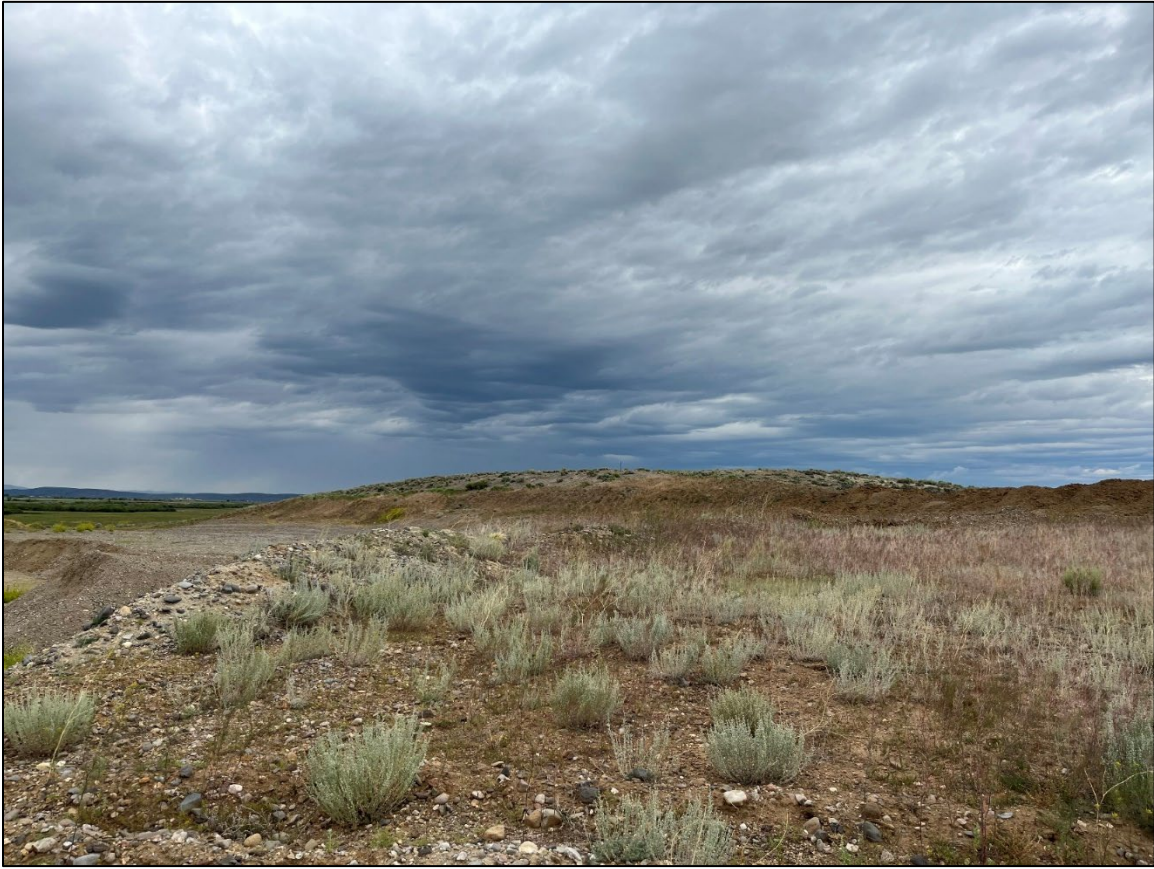
Topsoil piles are situated along the eastern, western, and northern edges of the pit (Photos 3, 4, and 5). These piles were mostly vegetated with volunteer native species including some annual weeds. No reclamation has occurred at the site to date. Topsoil is not being sold from the pit. The Division encourages the Operator to continue to save topsoil for final reclamation, rather than sell topsoil.

Photo 3: View east at the top of the excavated pit, a topsoil pile is visible.

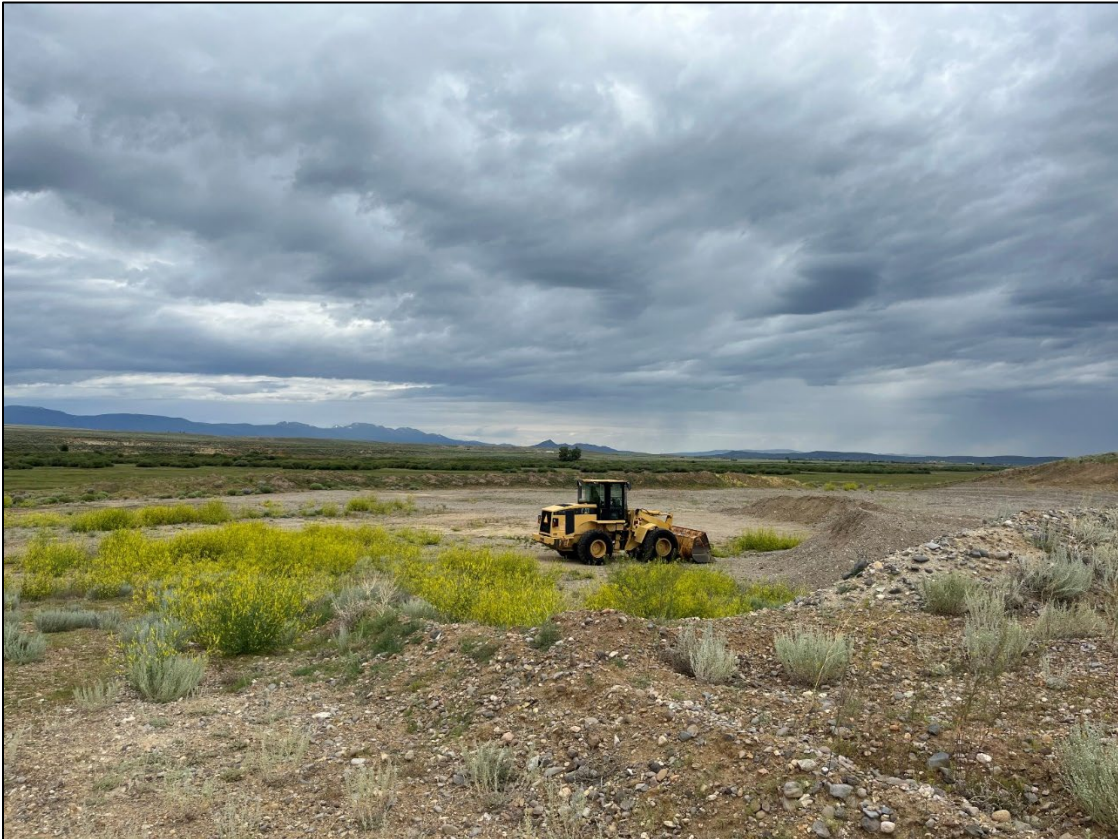
Photo 4: View north of the dozer onsite and stockpiled material. Topsoil piles line the northwestern edge.

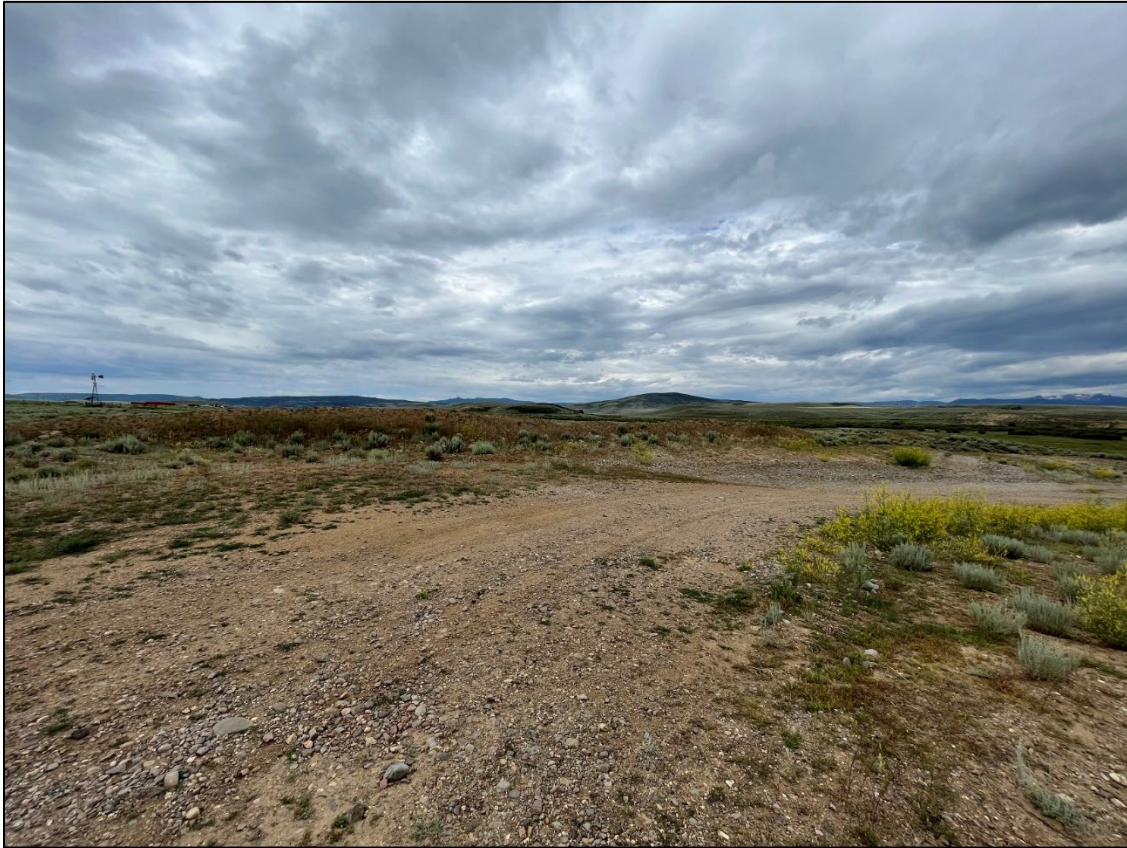
Photo 5: View west of a vegetated topsoil pile.

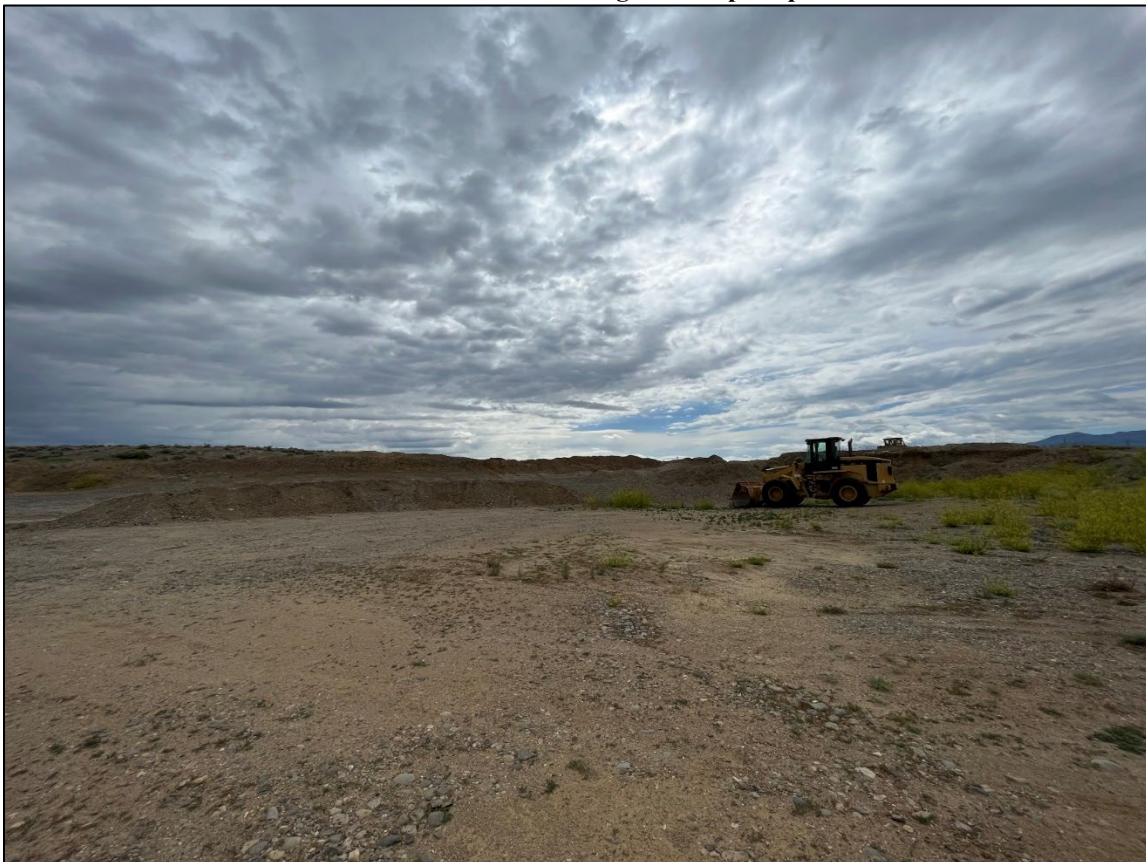
The mining excavation will create a flat area with 3H:1V slopes along all sides of the site. Mining is progressing from the southeast corner and moving west across the site. Two dozers were located on-site (Photo 6). No processing equipment was seen on-site. The site is used as a source of pit run material only. The eastern and southern highwalls were estimated at 8 feet in height at an approximately 2H:1V to vertical slope (Photos 6 and 7). The Operator previously created a passive storm water path through the site which diverts all storm water away from the pit and follows the original path of flow. The pit floor was dry and no erosion features were observed during the inspection.

Photo 6: View east of the currently excavated slope and stockpiled material.

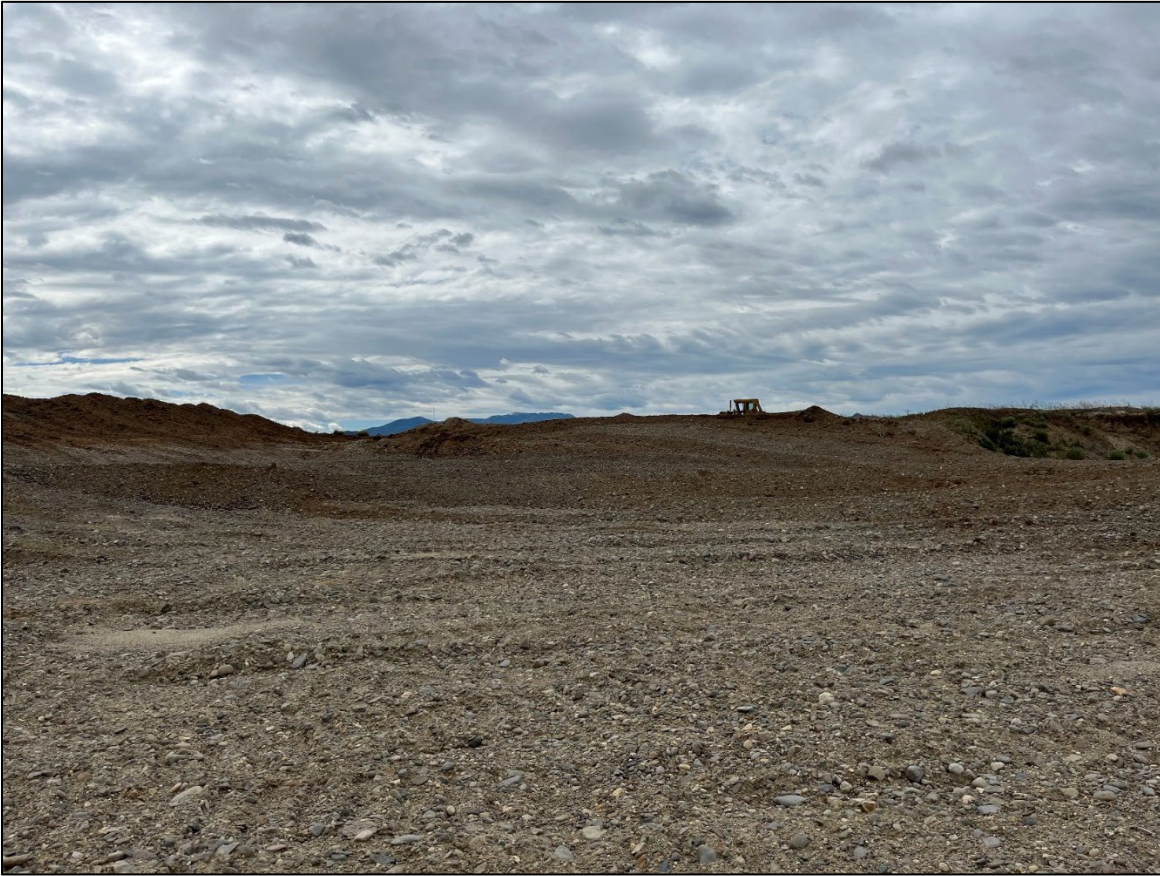
Photo 7: View south of the two highwalls, slopes are stable, some volunteer vegetation is noted.
