**Minerals and Geology Program
Inspection Report
San Juan National Forest
Tres Rios Field Office
29211 Hwy 184
Dolores, CO 81323**

Type of Operation	228 A Plan of Operations	Project Name	La Plata Copper
Serial Number	0213-POO-2021-02	Company/Org.	Metallic Minerals
Conditions	Mostly Dry, Warm, Mostly Sunny	Others Present	None
Inspection Time	12 to 4 PM	Inspected By	James Blair
Ranger District	Columbine	Legal	T4N, R11W, Sec 04, 09
Inspection Date	7/27/2023	Report Date	8/2/2023
Author Signature		Mgmt. Acknowledgement

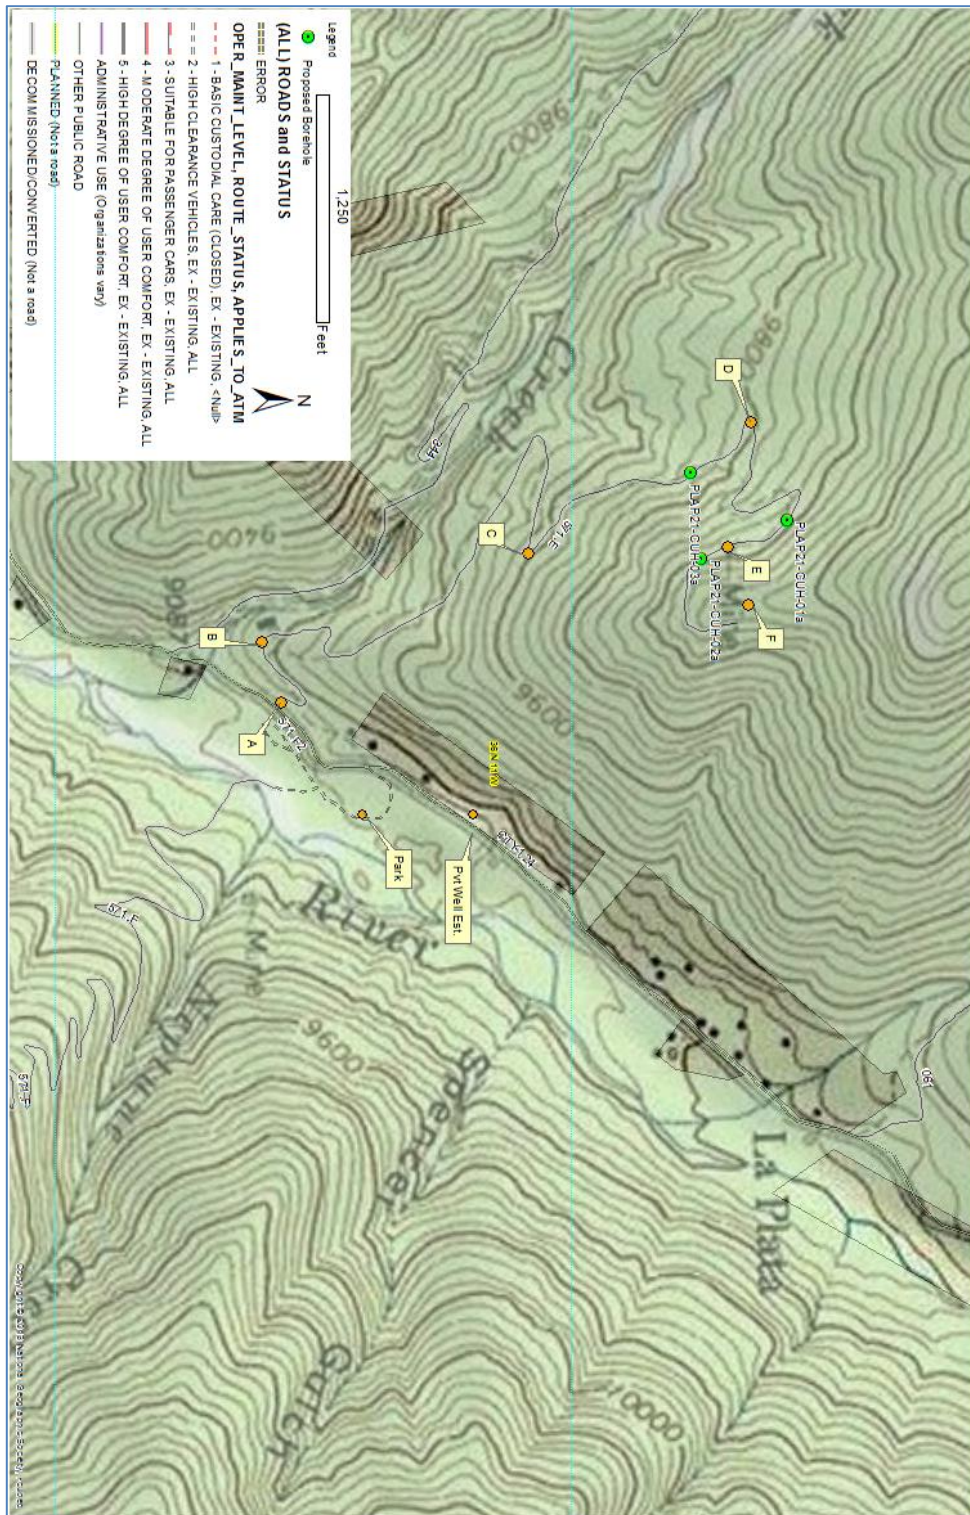
Figure 1: Map showing locations of proposed boreholes and selected features identified in report. The unshaded polygons are private lands, which are presumably patented mining claims. A= junction with main road. B = Mineralized outcrop. C Hairpin turn. D = Stock Pond. E = Abandoned Mine Features. F = End of road at ridge crest above top hole and AML Features. Proposed drill pad locations noted by site numbers. Parking location and the approximate location of the private residence/well are also identified.

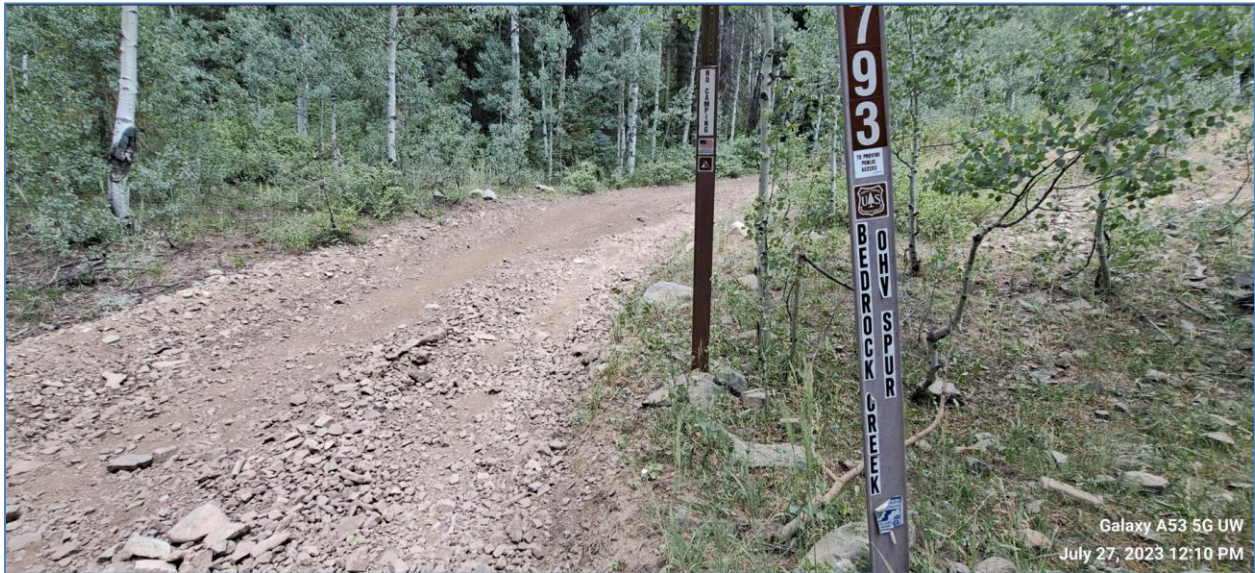
Figure 2: Forest Route 793. Bedrock Creek OHV Spur road that is to be the access to the site. This photo was taken at the bottom near the intersection with the La Plata Canyon Road. The view is looking north at location A on Map.

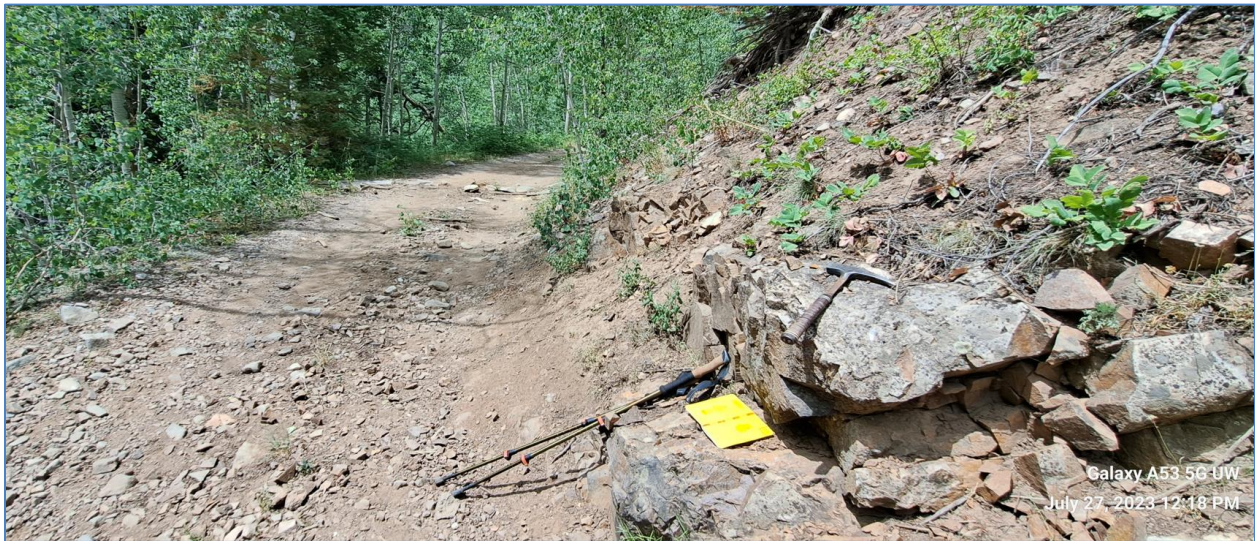
Figure 3: Lowest in-place rock outcrop observed during inspection. The rock appeared to be hydrothermally altered, intermediate composition igneous intrusive with sulfide mineralization visible on fresh surfaces which appeared to include pyrite, and possible galena and chalcopyrite. Hammer for scale. View is looking north at location B on the map.

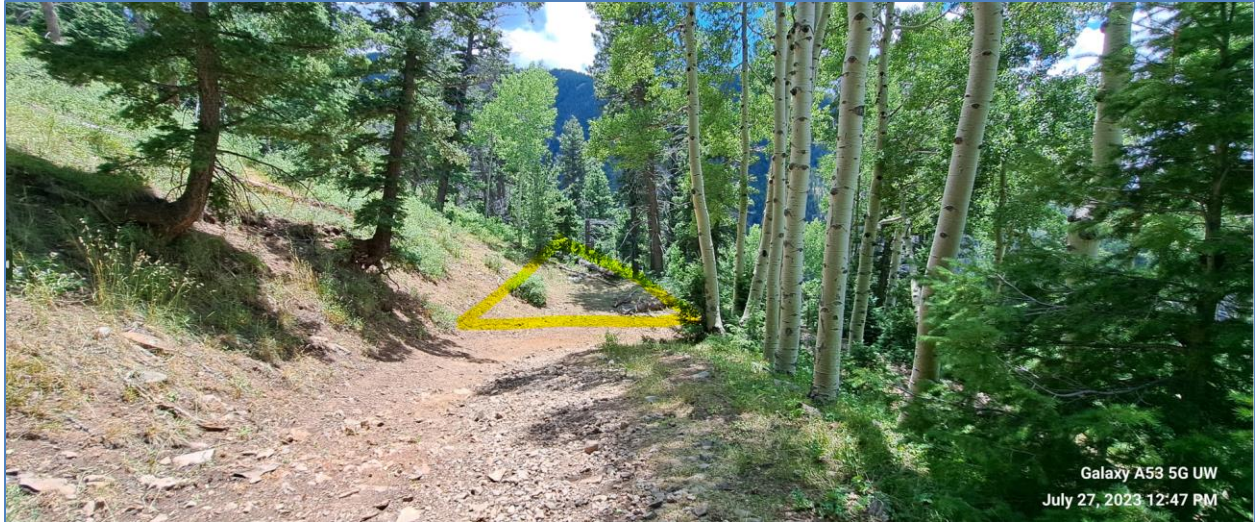
Figure 4: Photo looking east and downhill at the 2nd hairpin turn from the bottom. There is a large turnout that is overgrown at the point of the hairpin turn. This is a photo-point to compare after the drilling is completed. I don't think the turnout is reclaimed so much as there has been some volunteer vegetation from lack of travel due to the tight turning radius of UTVs (yellow). View is looking southeast at location C on the map.

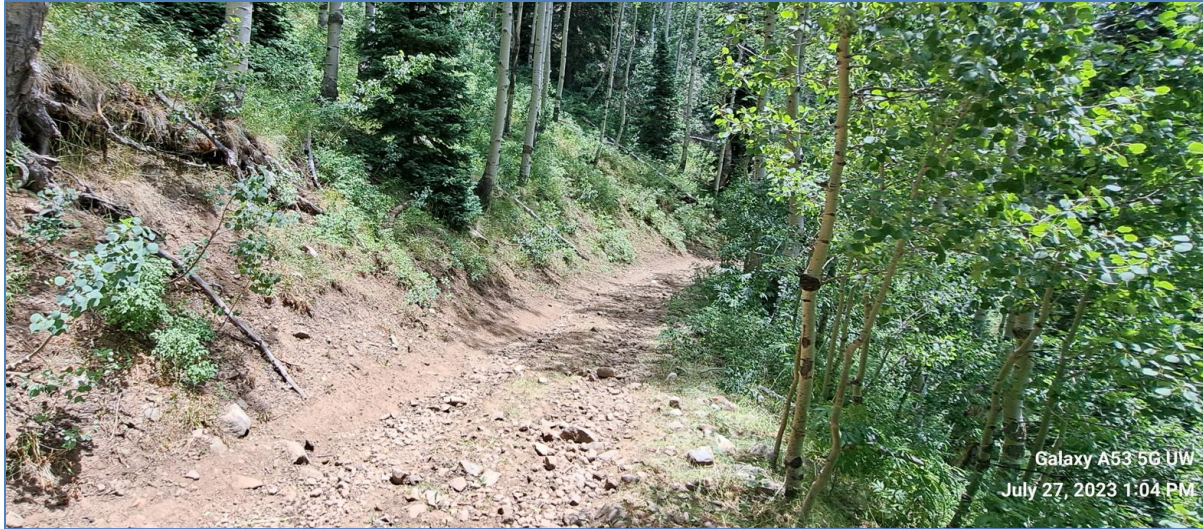
Figure 6: Borehole CUH-03a proposed location looking downhill to the east. There is nothing remarkable about the location that can be observed at the surface. The point is labeled on the map.

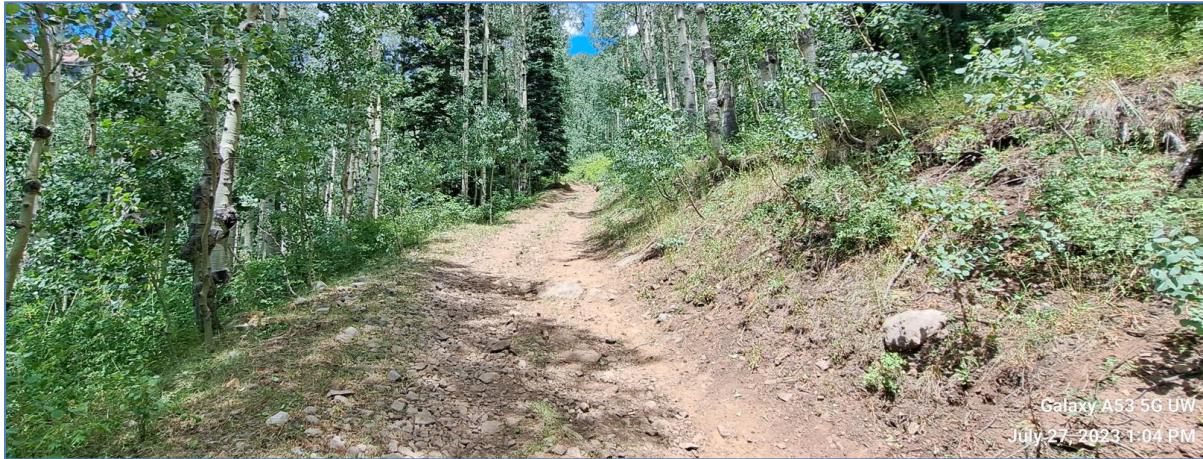
Figure 7: Proposed Borehole CUH-03a. The view is looking uphill to the west. The location is labeled on the map.

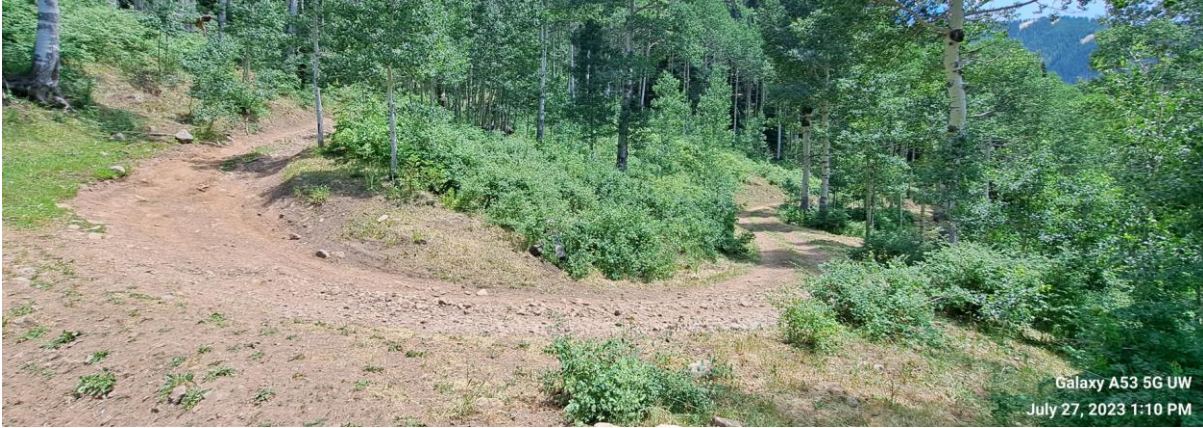
Figure 8: Hairpin Turn by stock pond between CUH-03a and CUH-01a looking east from location D.

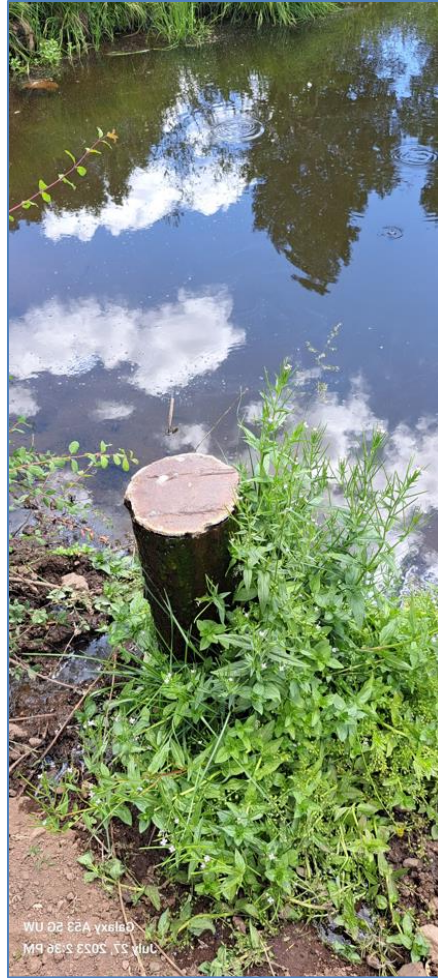
Figure 9: Stock pond located at hairpin in previous photo. There is what appears to be a leaking, capped off well or borehole casing that is seeping water out of the welded cap. Location D on map.

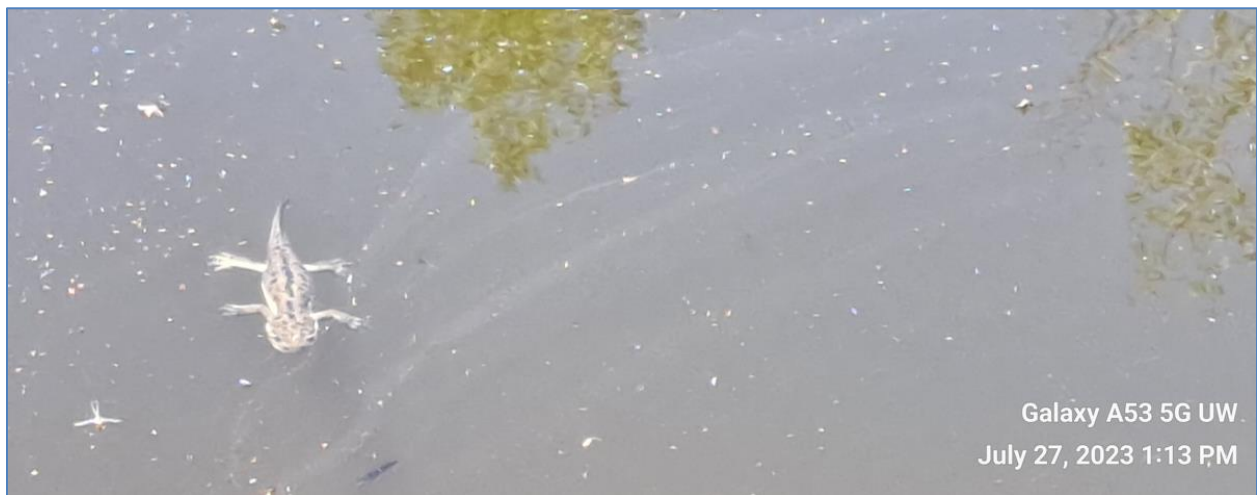
Figure 10: Aquatic stage of western barred salamander found in pond. Location D on Map.

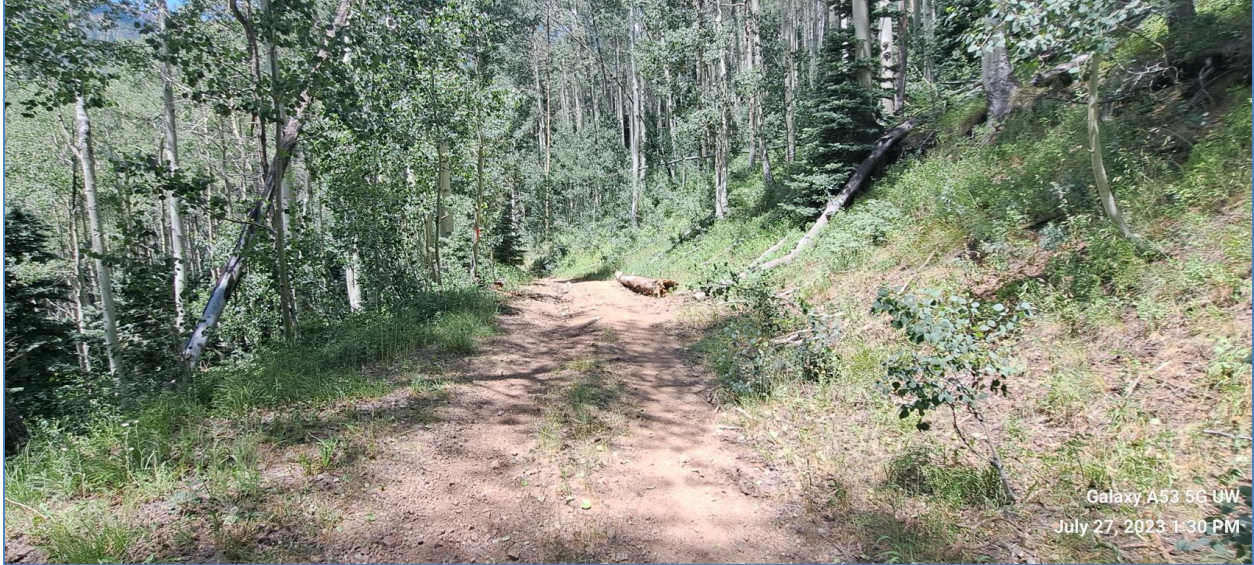
Figure 11: CUH 01a. View looking northwest and downhill at CUH-01a.

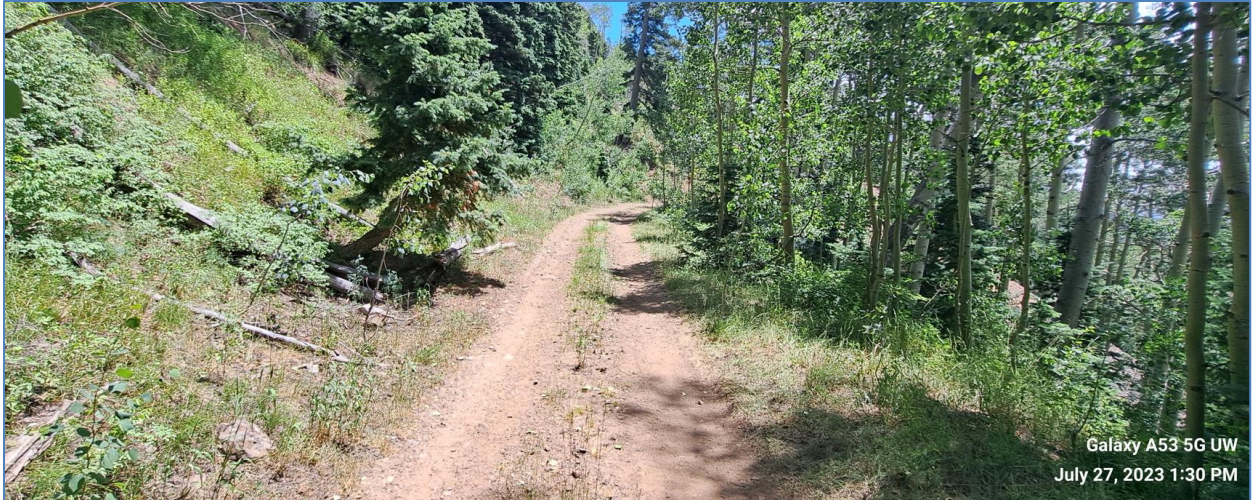
Figure 12: view looking southeast and uphill from CUH-01a.

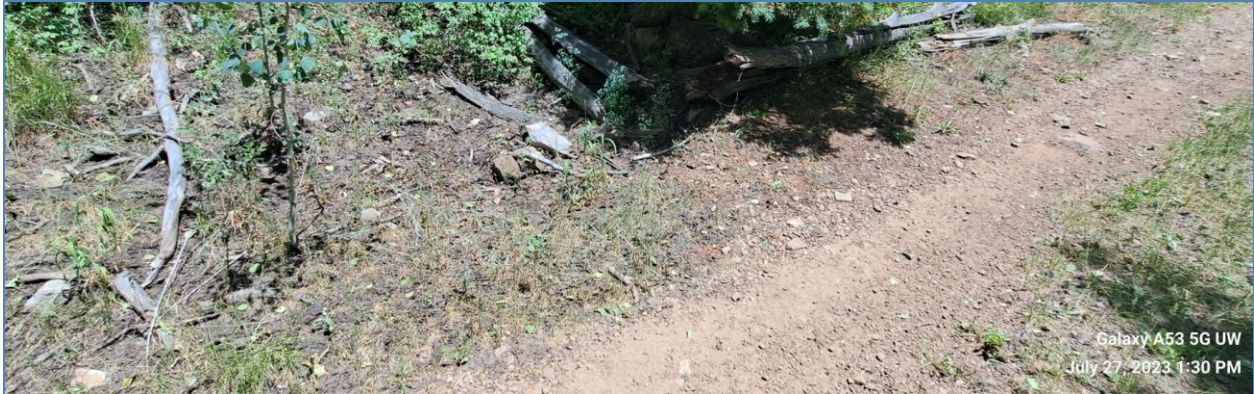
Figure 13: Ground surface at CUH-01a.

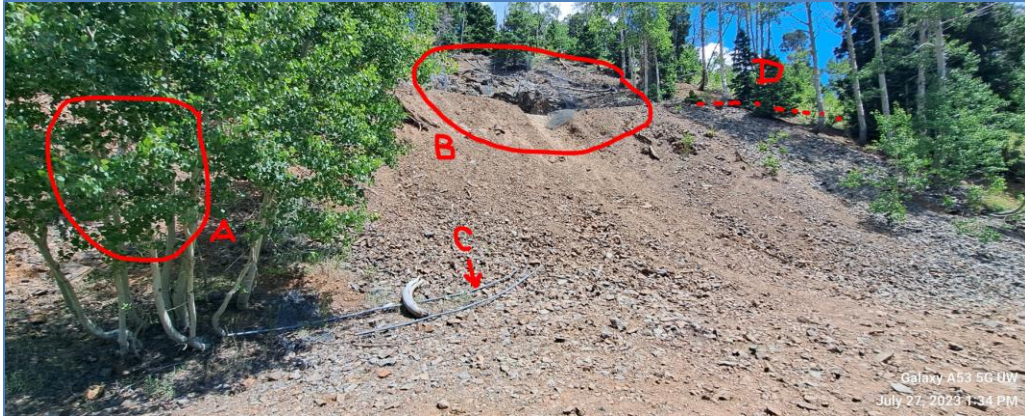
Figure 14: Abandoned mine features located just west of CUH-02a. There is a partially collapsed adit about 6 feet wide by 4 feet high (A) that presumably connects underground to a large “glory hole” – a large open stope mined to the surface (B). Fencing around the open stope has been torn down (C). Safe foot access to the opening of the stope is shown by the dashed line at D. Photo is looking east at location E on the map.

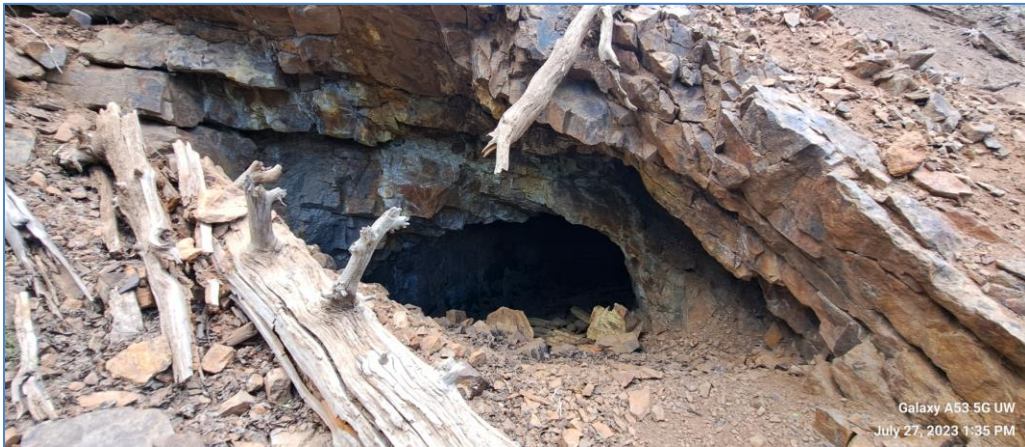
Figure 15: Partially Collapsed Adit (A). Location E on the map.

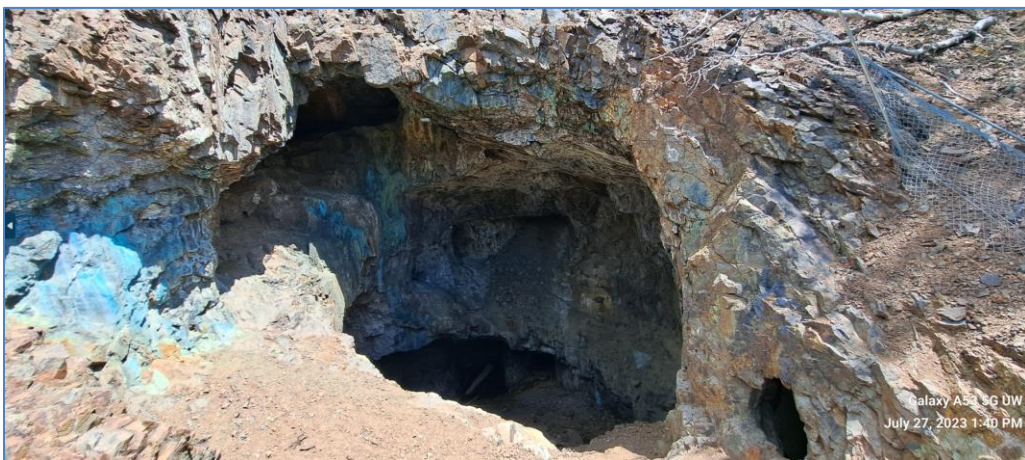
Figure 16: Large daylighted stope. You can see downed fence. Size is ~30 feet wide by unknown depth. Location E on the map.

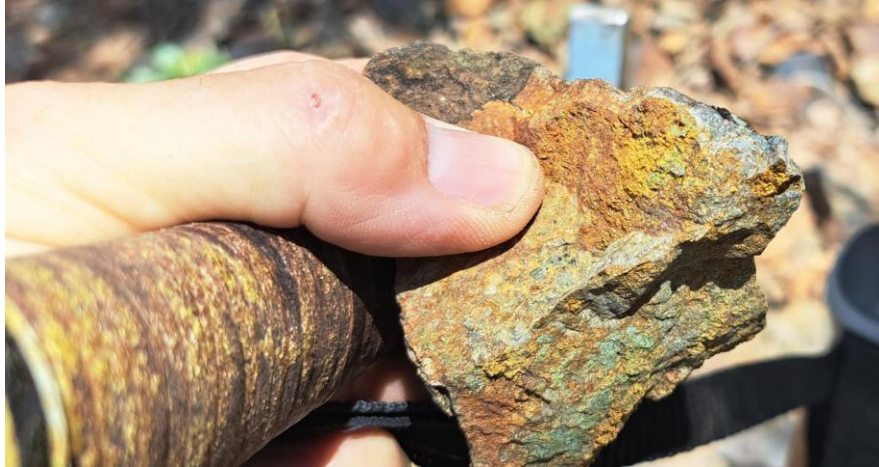
Figure 17: Specimen of copper mineralized rock found at the mine opening near CUH-02a. Location E on the map.

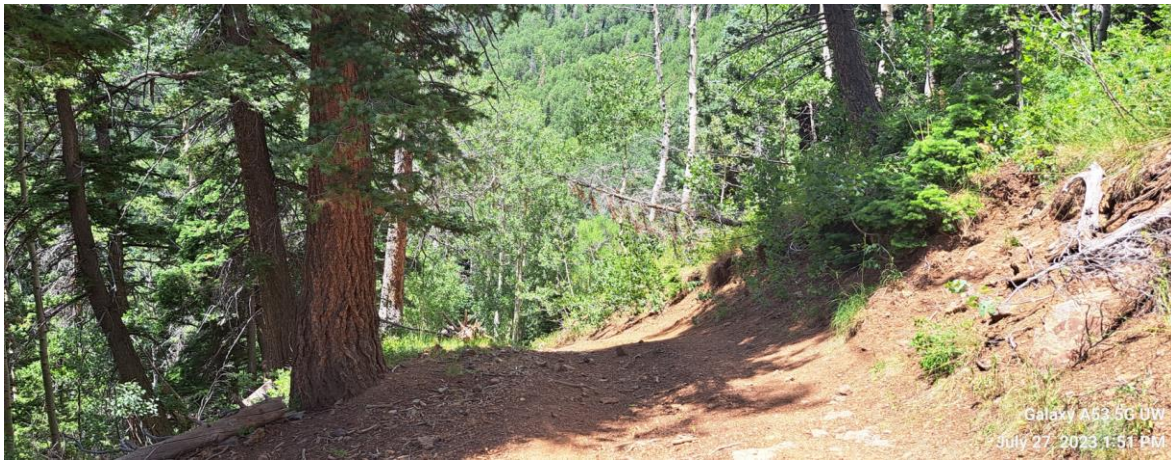
Figure 18: Site CUH-02a looking downhill to the north towards the mine opening about 50 yards away.

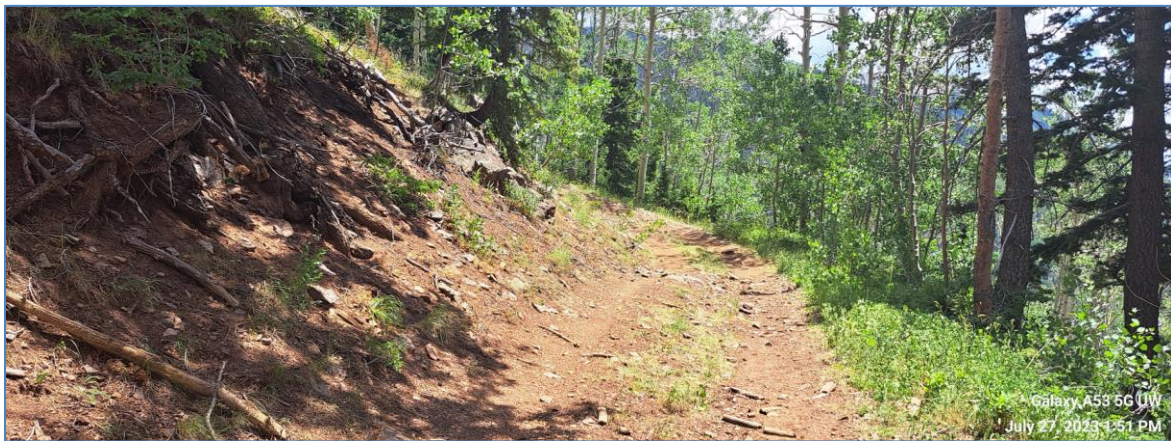
Figure 19: View of CUH-02a looking uphill to the south.

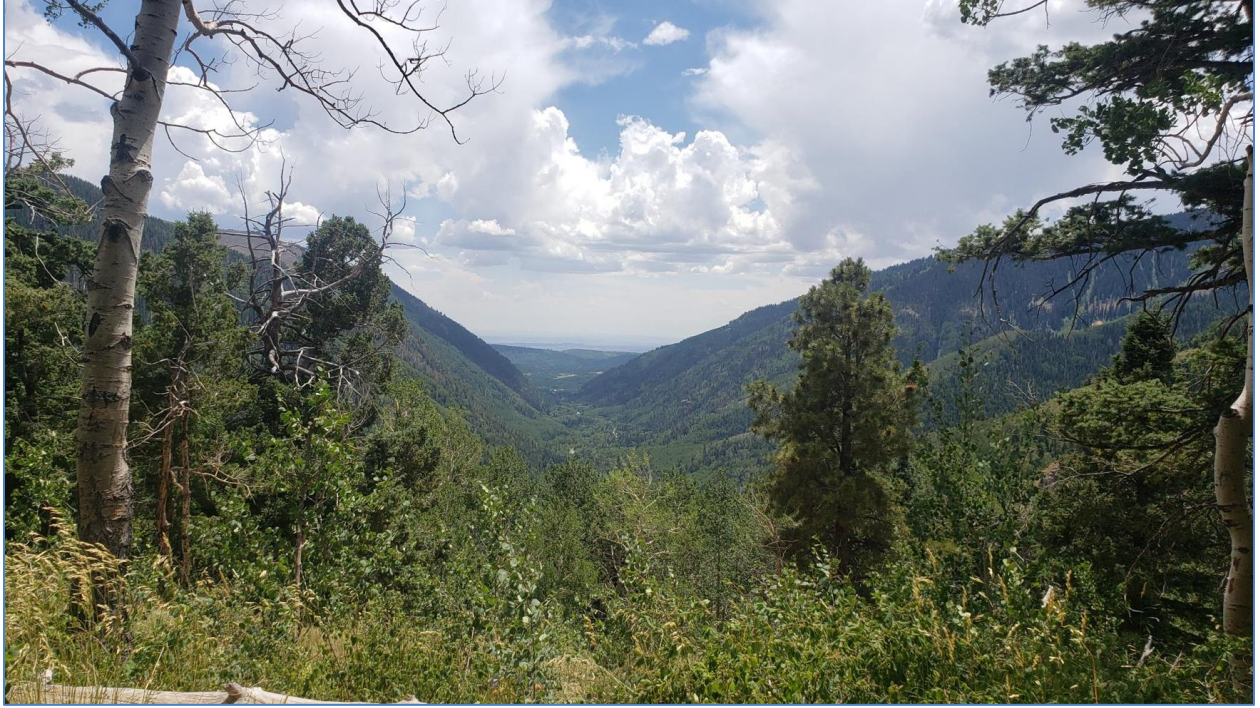
Figure 20: The view looking south from the top of the hill and down La Plata Canyon at location F.
