MINERALS PROGRAM INSPECTION REPORT
PHONE: (303) 866-3567

MINE NAME: Frentress Gravel Pit	MINE/PROSPECTING ID#: M-2011-017	MINERAL: Sand and gravel	COUNTY: Routt
INSPECTION TYPE: Monitoring	WEATHER: Clear	INSP. DATE: July 17, 2023	INSP. TIME: 11:30
OPERATOR: J. Quarter Circle Mineral Co., LLC	OPERATOR REPRESENTATIVE: Bruce Johnson and Ryan Domson	TYPE OF OPERATION: 110c - Construction Limited Impact	
REASON FOR INSPECTION: Normal I&E Program	BOND CALCULATION TYPE: Partial Bond	BOND AMOUNT: \$17,414.53	
DATE OF COMPLAINT: NA	POST INSP. CONTACTS: None	JOINT INSP. AGENCY: None	
INSPECTOR(S): Hunter Ridley	INSPECTOR'S SIGNATURE:

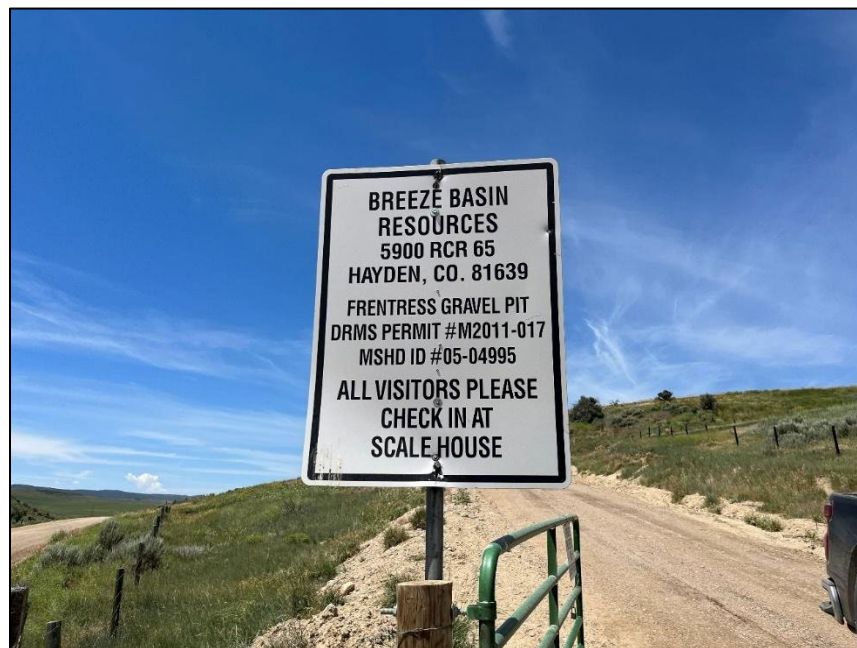
The mine identification sign and affected area boundary markers are in place and in compliance with Rule 3.1.12. The mine sign is located at the bottom of the pit access road (Photo 1). Pit corners are marked by white striped poles (Photo 3). The site was recently re-surveyed in 2022. A scale and scale house are located south of the pit (Photo 2). This scale house contains various safety equipment and personal protection equipment for use by mine workers. Fuel on site is stored in secondary containment (Photo 11).

Photo 1: A mine sign is posted at the site's access road.

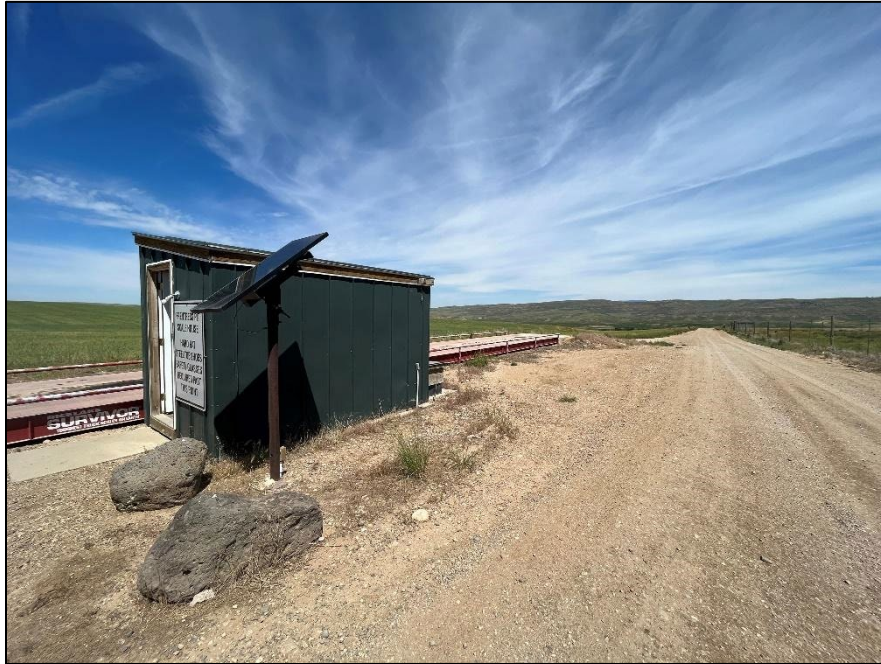
Photo 2: A scale and scale house are located down the road from the pit.

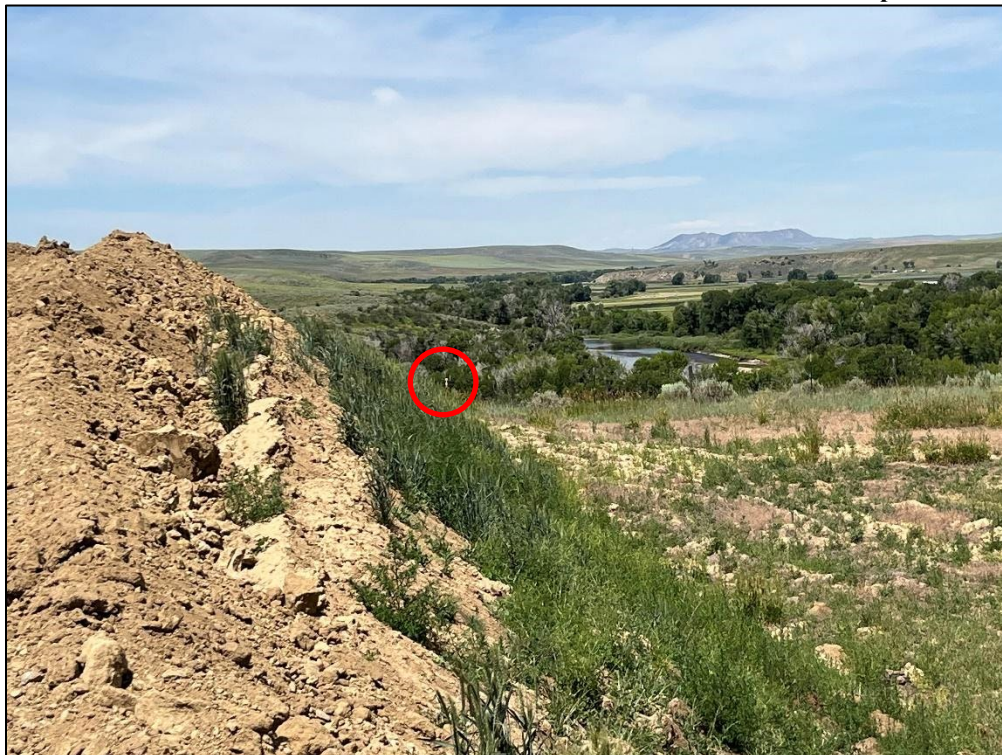
Photo 3: Permit boundaries are marked at the pit's corners by a white striped pole.

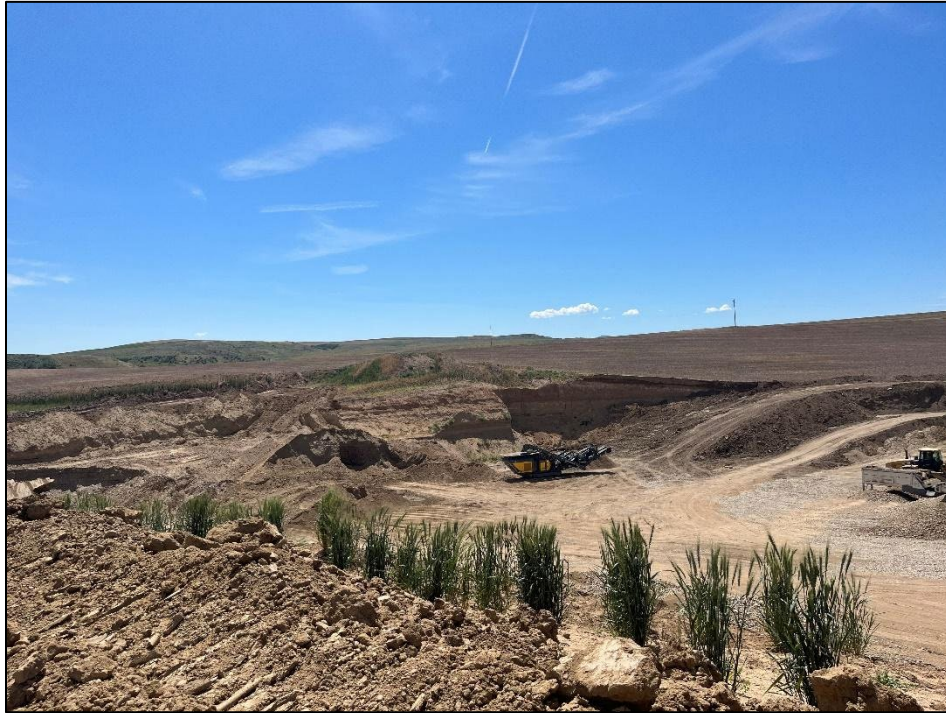
The access road to the site as well as internal haul roads are well maintained. A water truck was noted to be running at the time of inspection. Overburden is stored on the northern portion of the pit (Photo 9). Topsoil is stored and bermed on the southern and eastern pit edges (Photos 4 and 5). The Operator stated that topsoil has not been sold for many years. The Division encourages the Operator to continue to preserve topsoil in an effort to maintain enough topsoil onsite for proper reclamation. While topsoil piles appear to have some vegetation growing on them, this is all volunteer vegetation and is mainly comprised of weeds. The Operator also stated that topsoil is not regularly seeded. Pursuant to Rule 3.1.9, "If such topsoil is not replaced on a backfill area within a time short enough to avoid deterioration of the topsoil, vegetative cover or other means shall be employed so that the topsoil is protected from erosion, remains free of any contamination by toxic or acid-forming material, and is in a usable condition for reclamation". **Therefore, the Division is citing a problem for failure to protect topsoil from erosion.** Please submit documentation to the Division that topsoil piles have been appropriately seeded by the corrective action due date. Please note that the approved reclamation plan currently states that reseeding will be performed as per the NRCS Reclamation Plan (attached). The Division also encourages the Operator to continue to spray for weeds throughout the season and follow the weed plan which was approved under TR2.

Photo 4: View looking to the southeastern corner of the pit. A highwall is located in this corner and topsoil is bermed on this eastern edge.

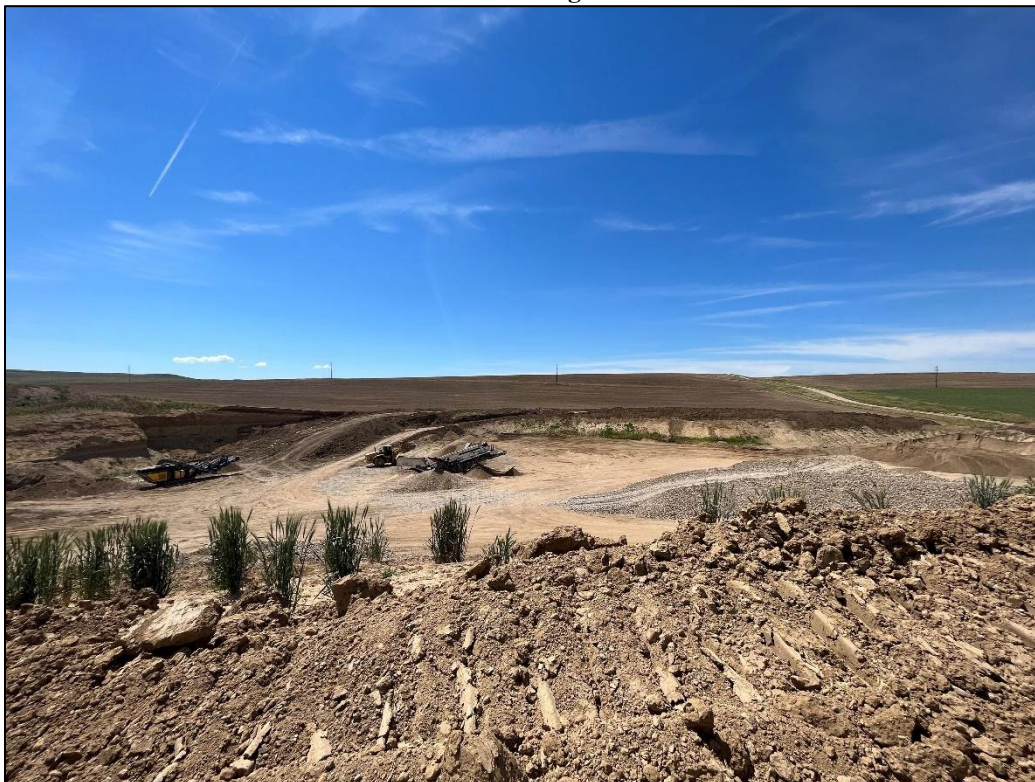
PROBLEM/POSSIBLE VIOLATION: Problem: The topsoil stockpiles do not have established vegetation on them and are therefore susceptible to erosion. Rule 3.1.9(1) states if topsoil is not replaced into the backfill area within a time short enough to avoid deterioration of the topsoil, vegetative cover or other means shall be employed so that the topsoil is protected from erosion.

Photo 5: View south of pit boundary. Topsoil is bermed along the pit edge. Topsoil is currently un-vegetated.

CORRECTIVE ACTIONS: The operator shall seed the stockpiles with the seed mix that was submitted as part of the approved Reclamation Plan. If no seed mix has been provided, the operator shall submit a seed mix for approval as a technical revision to the permit along with the appropriate \$216 revision fee to the Division by the corrective action date. The Operator shall demonstrate compliance by submitting seed tags, a bill of sale or photographs of seeding activities. The Operator may also request a follow up inspection.

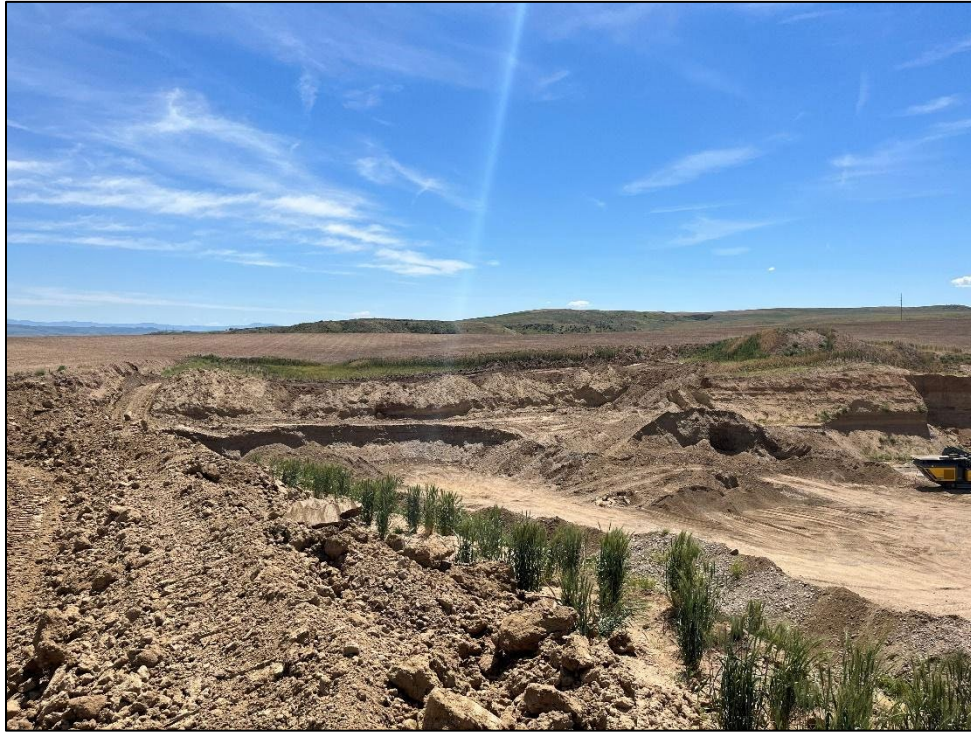
The Operator stated that approximately 6-7 acres of the 9.9 permitted have been disturbed to date. The far northeastern corner of the pit has yet to be stripped and mined (Photo 6). The 2022 Annual Report for the Frentress Gravel Pit stated, in error, that 9.9 acres were currently disturbed and 1.0 acres were planned to be disturbed in the upcoming year. The Division encourages the Operator to complete the Annual Report using accurate acreage so as to avoid confusion during future inspections. A true increase in acreage past 9.9 acres would require a conversion of the permit to a 112c operation.

Photo 6: View of the far northeastern corner of the pit which remains unmined.

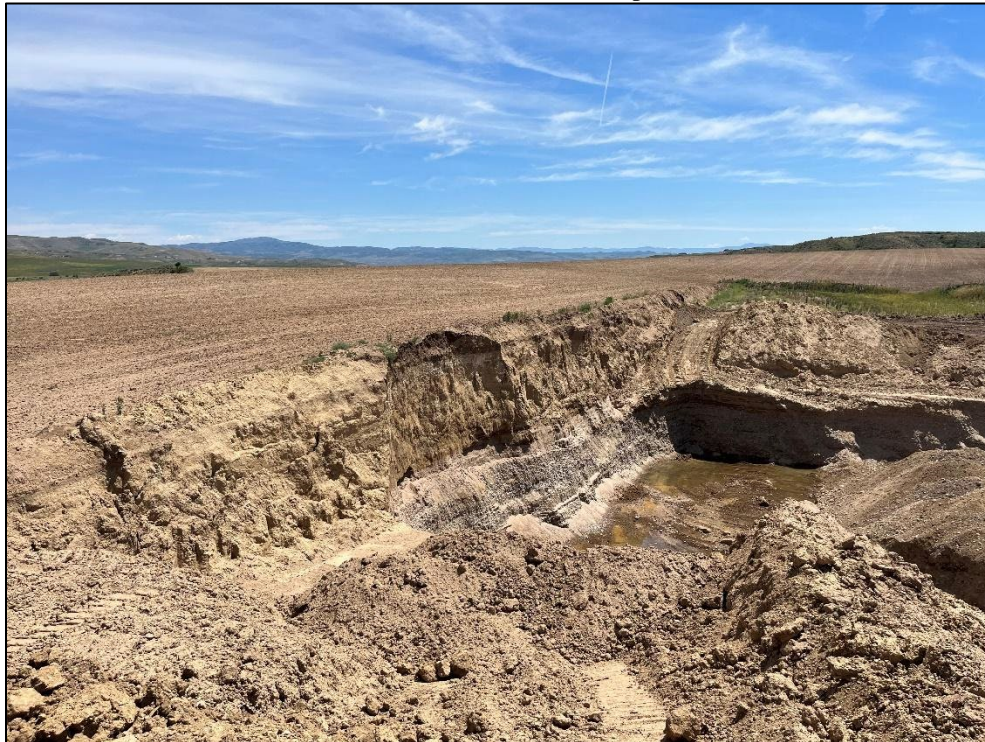
PROBLEM/POSSIBLE VIOLATION: Problem: A slough in the highwall was observed on-site. This is a problem at this time for failure to stabilize highwalls pursuant to Rule 3.1.5(3).

Through conversation with the operator, the excavated highwall was approximated to be 200' long by 25' high, with excavation being carried out in benches. The Operator stated that contemporaneous reclamation would occur on the highwall, i.e. the current bench will be filled in before starting work on the next. Aggregate is being mined to bedrock and is moving from east to west across the site. The current processing area will also be eventually mined out (Photo 9). The highwall has sloughed slightly in the northeastern corner of the pit (Photos

7 and 8). The Operator stated that is was likely operator error rather than instability of the highwall material, as sloughing had never previously occurred anywhere else in the pit. **The Division is citing this as a problem for failure to protect the affected land from erosion pursuant to Rule 3.1.5(3).** Please submit photographic documentation to the Division that the highwall has been repaired by the corrective action due date. The edge of the highwall is approximately 10 feet from the permit boundary, with the overburden berm taking up 5 of those feet. The Division encourages extreme caution when operating close to the permit boundary to avoid accidental offsite damage and possible violation.

Photo 7: Northeastern corner of the highwall. Some sloughing is evident along this wall. Highwall is ~ 10' away from the permit boundary.

CORRECTIVE ACTIONS: The operator shall provide photo documentation to the Division verifying the highwall has been repaired, and that the site has been reconstructed and stabilized to prevent further damage by the corrective action date.

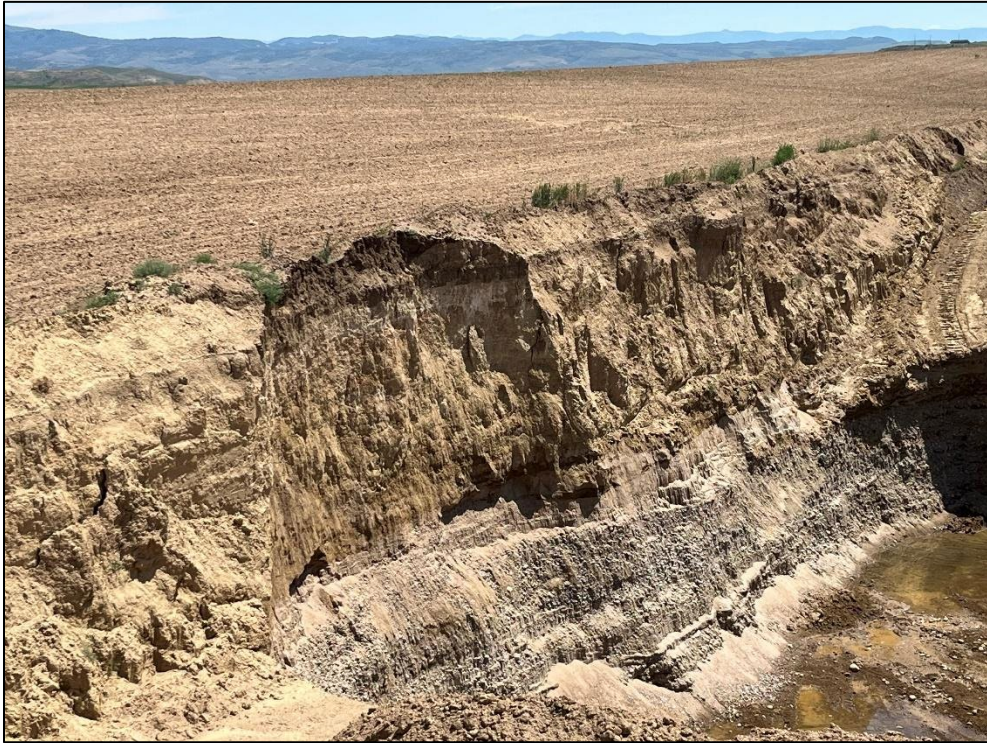
Photo 8: Sloughing has occurred along the northern highwall.

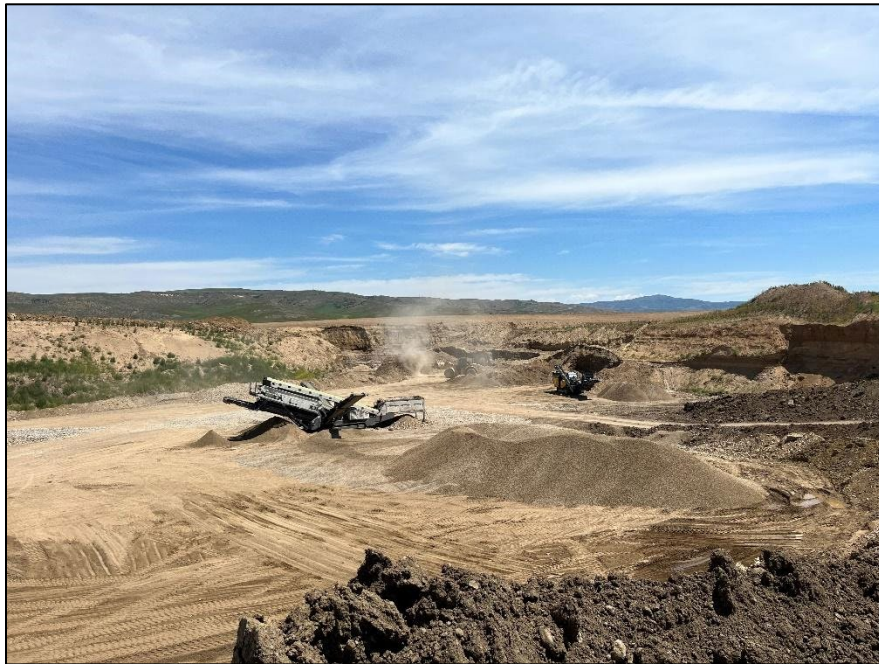
Photo 9: View looking northeast of the pit floor, stockpiles, a crusher, and a large overburden pile to the north.

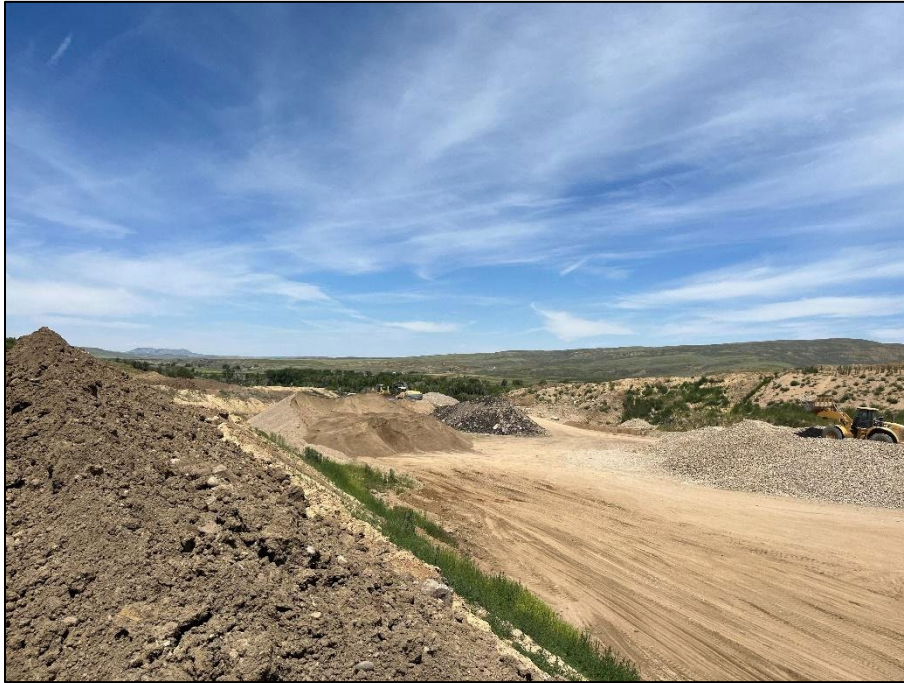
No reclamation has been completed to date at the site. Any impounded stormwater or snowmelt infiltrates through the pit floor. There is a stockpile of recycled asphalt located on the pit floor (Photo 10). This is brought into the site for crushing purposes and will be removed on an as needed basis. No recycled asphalt will be used as fill material for the site's reclamation.

Photo 10: Stockpiles are located on the pit floor.

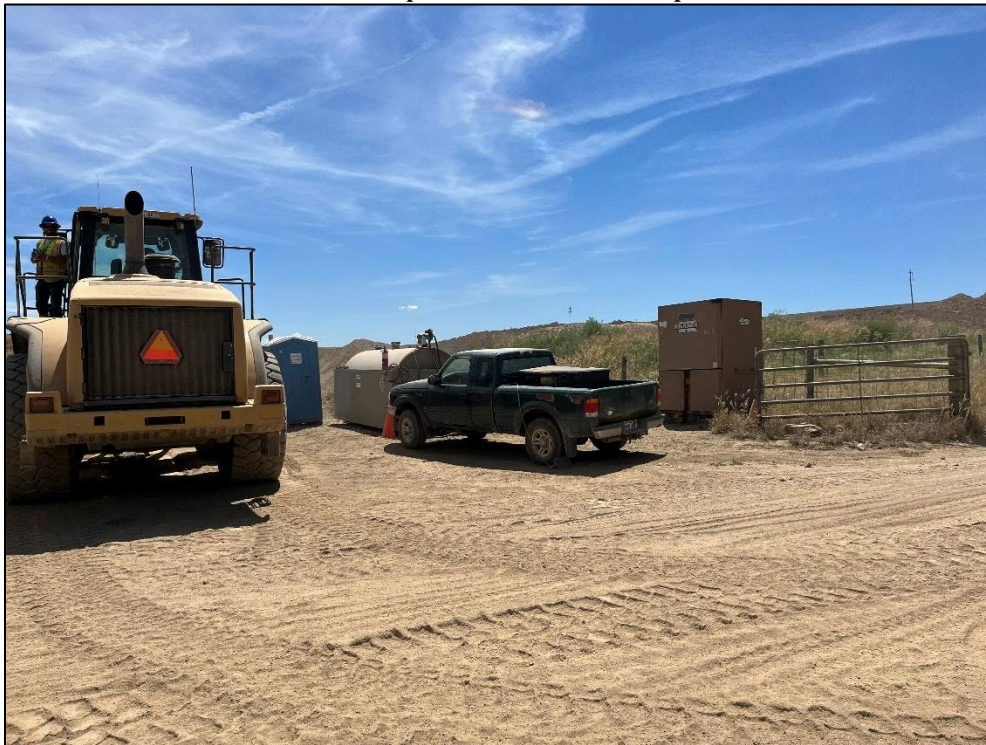
Photo 11: Fuel is stored in secondary containment. Site was active at the time of inspection.
