MINERALS PROGRAM INSPECTION REPORT
PHONE: (303) 866-3567

MINE NAME: North River Gravel Pit Extension	MINE/PROSPECTING ID#: M-1999-007	MINERAL: Gravel	COUNTY: Rio Blanco
INSPECTION TYPE: Surety Release Inspection	WEATHER: Clear	INSP. DATE: July 24, 2023	INSP. TIME: 12:30
OPERATOR: George T. Weldon Construction, LLC	OPERATOR REPRESENTATIVE: None	TYPE OF OPERATION: 110c - Construction Limited Impact	
REASON FOR INSPECTION: Surety Release Requested	BOND CALCULATION TYPE: None	BOND AMOUNT: \$11,750.00	
DATE OF COMPLAINT: NA	POST INSP. CONTACTS: None	JOINT INSP. AGENCY: None	
INSPECTOR(S): Amy Yeldell	INSPECTOR'S SIGNATURE:

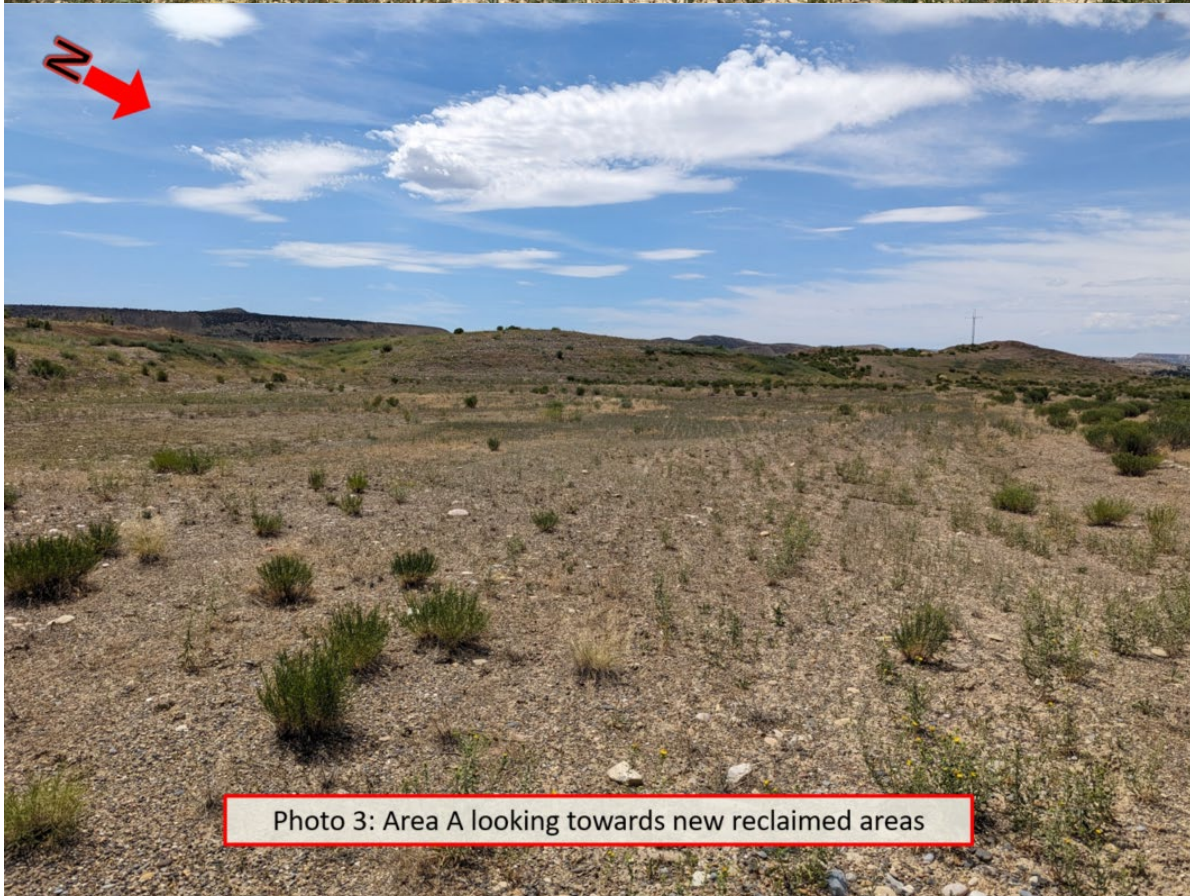
Photo 3: Area A looking towards new reclaimed areas

Area A did not require any sort of grading for final reclamation and has had volunteer shrubs (rabbit brush and saltbush) due to it being deserted. Only the southwestern portion of Areas A appear to have additional seeding. Cover is comprised of mostly desirable forbs (annual flowers) and shrubs. The recently reclaimed southwestern area has a lower density of desirable cover (See Photo Three). The rocky more open areas have significantly higher densities of cheatgrass and Russian Thistle.
