MINERALS PROGRAM INSPECTION REPORT
PHONE: (303) 866-3567

MINE NAME: Wedding Bell Project (Section 23 Area)	MINE/PROSPECTING ID#: P-2021-009	MINERAL: Uranium and vanadium	COUNTY: San Miguel
INSPECTION TYPE: Multi Person Inspection	WEATHER: Clear	INSP. DATE: July 11, 2023	INSP. TIME: 10:23
OPERATOR: Standard Minerals Inc.	OPERATOR REPRESENTATIVE: Tony Adkins	TYPE OF OPERATION: MP - Mineral Prospecting	
REASON FOR INSPECTION: Normal I&E Program	BOND CALCULATION TYPE: None	BOND AMOUNT: \$22,065.00	
DATE OF COMPLAINT: NA	POST INSP. CONTACTS: None	JOINT INSP. AGENCY: U.S.BLM	
INSPECTOR(S): Lucas West	INSPECTOR'S SIGNATURE:

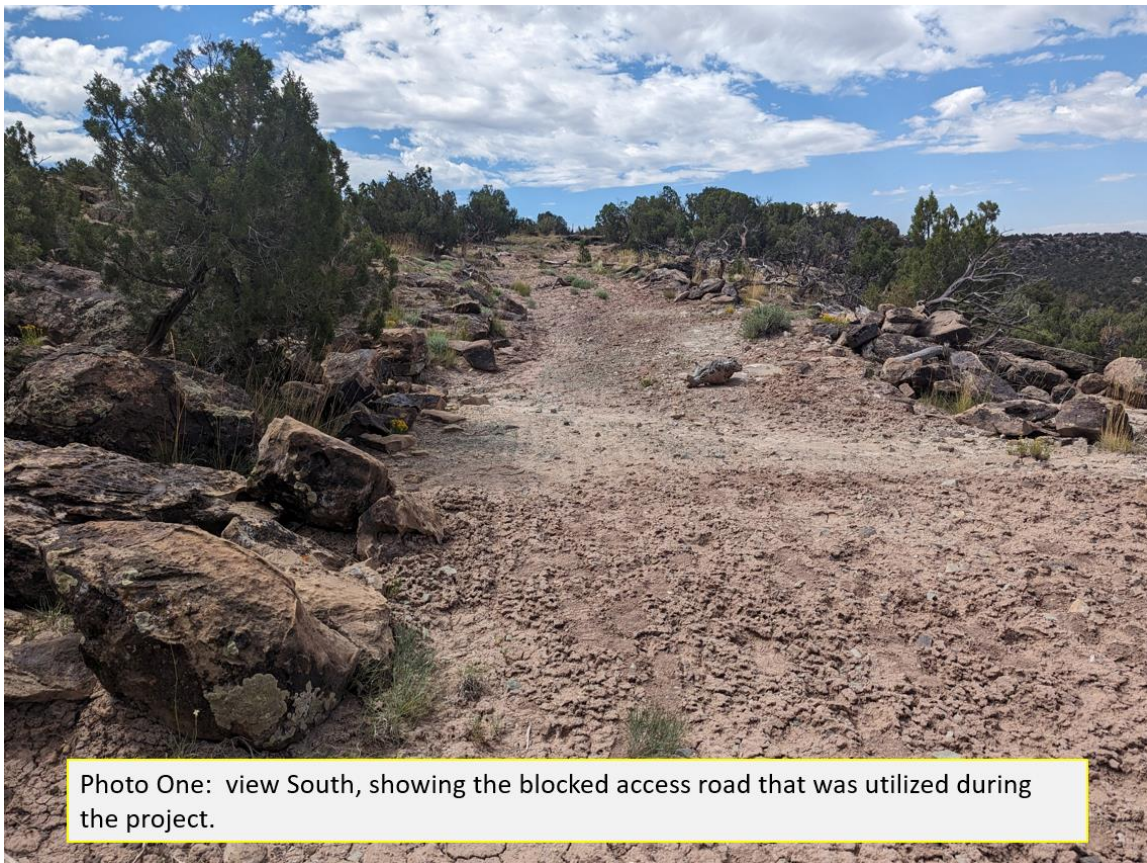
Photo One: view South, showing the blocked access road that was utilized during the project.

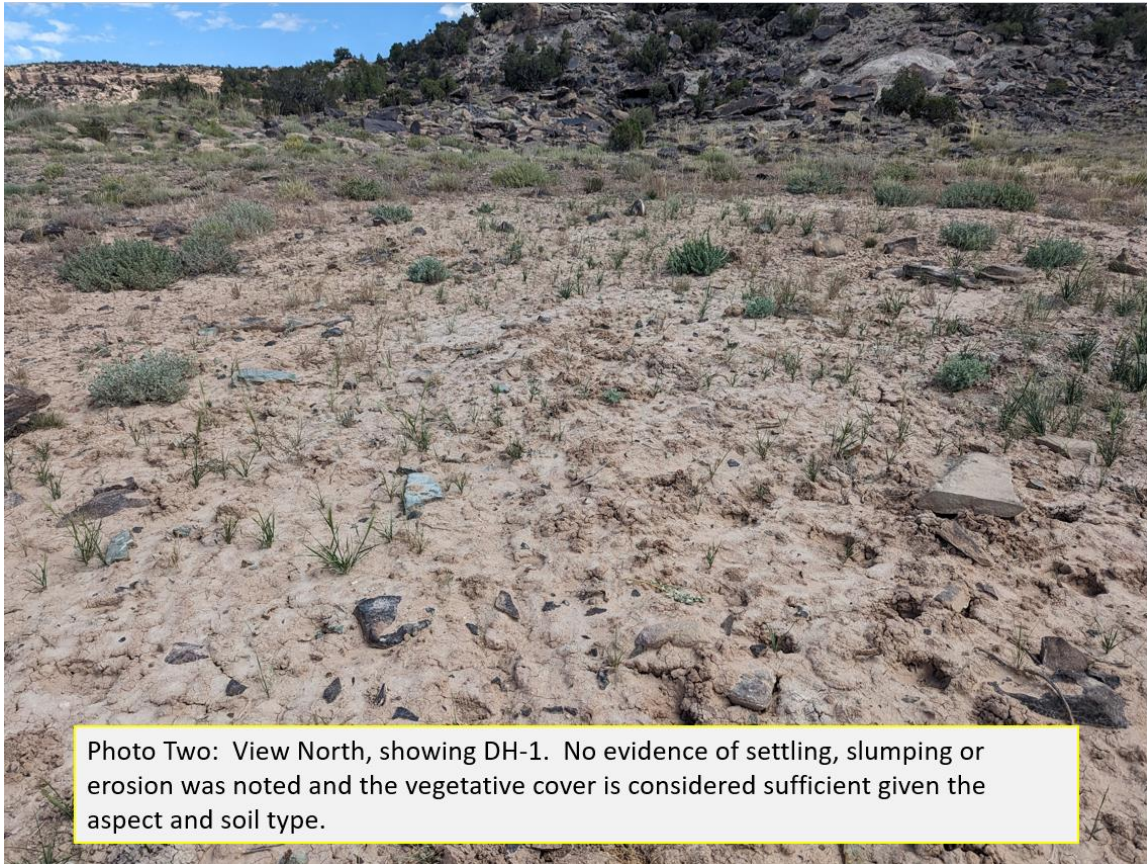
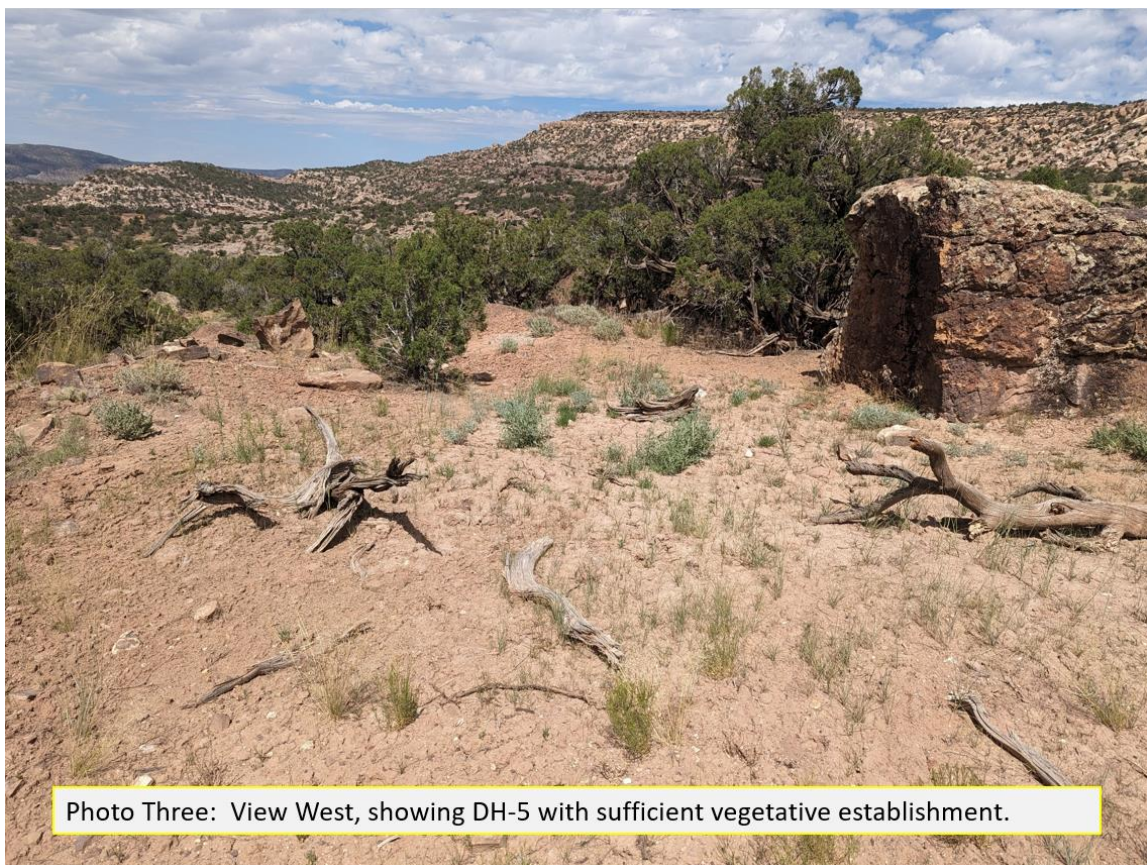
For pads DH- 1, 2, 3, 4, 5, 7 and 10, the vegetative cover has become well established. It ranges locally from dense and diverse, to somewhat sparse, however this mimics adjacent undisturbed conditions and is not considered insufficient. No state listed noxious weeds were observed on any of the reclaimed areas, and on site discussions with the Operator Representative indicate hand removal efforts have been employed. Examples of the pads with sufficient vegetative cover can be seen in Photos Two through Four.

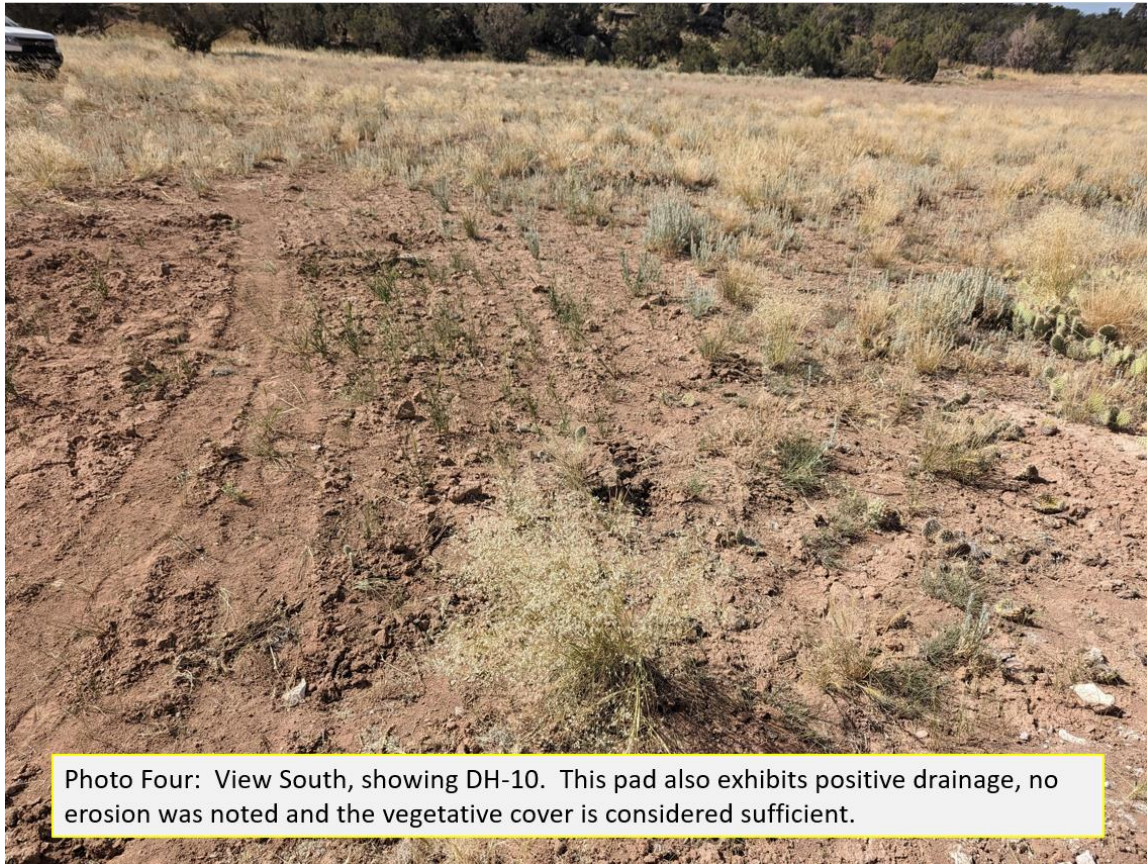
Photo Four: View South, showing DH-10. This pad also exhibits positive drainage, no erosion was noted and the vegetative cover is considered sufficient.

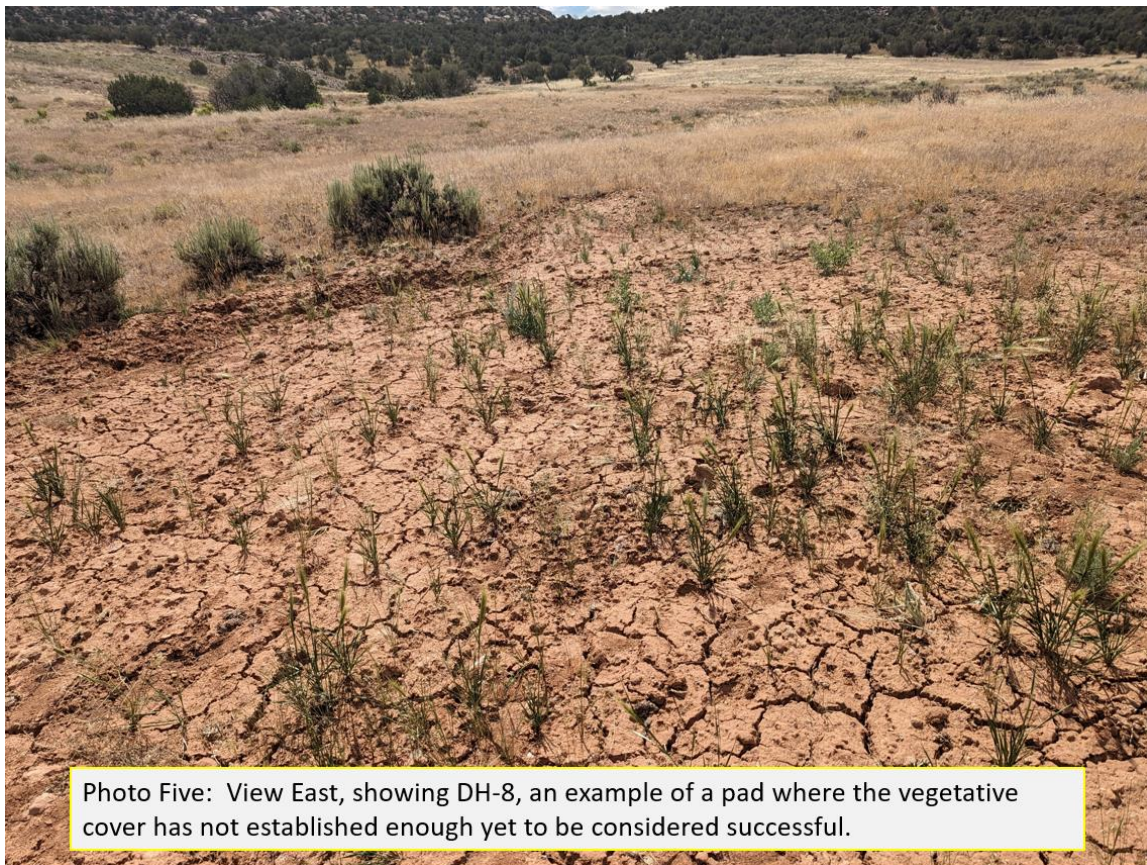
For pads DH- 6, 8, 9 and 11 the vegetative cover has not become well enough establish to be considered sufficient for reclamation. The vegetation is sparse, though some reclamation species were identified, they are significantly more bare than adjacent undisturbed lands. With at least one more growing season, it is anticipated the vegetation will become more established. Similar to the other drill pads, no state listed noxious weeds were noted. Examples of the pads with insufficient vegetative cover can be seen in Photos Five and Six.

Photo Five: View East, showing DH-8, an example of a pad where the vegetative cover has not established enough yet to be considered successful.

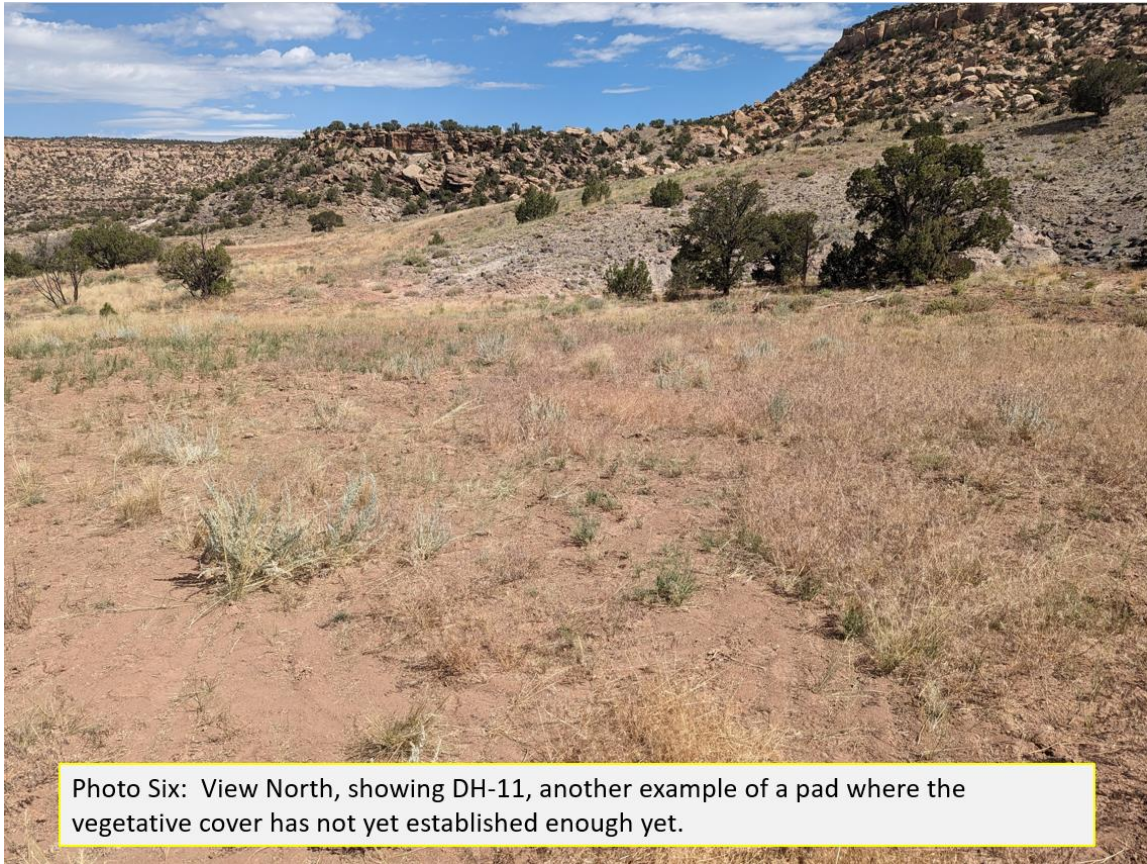
Photo Six: View North, showing DH-11, another example of a pad where the vegetative cover has not yet established enough yet.
