MINERALS PROGRAM INSPECTION REPORT
PHONE: (303) 866-3567

MINE NAME: Wedding Bell Project (Rim Rock Area)	MINE/PROSPECTING ID#: P-2021-010	MINERAL: Unknown commodity	COUNTY: Montrose
INSPECTION TYPE: Multi Person Inspection	WEATHER: Clear	INSP. DATE: July 11, 2023	INSP. TIME: 14:06
OPERATOR: Standard Minerals Inc.	OPERATOR REPRESENTATIVE: Tony Adkins	TYPE OF OPERATION: MP - Mineral Prospecting	
REASON FOR INSPECTION: Normal I&E Program	BOND CALCULATION TYPE:	BOND AMOUNT: \$6,942.00	
DATE OF COMPLAINT: NA	POST INSP. CONTACTS: None	JOINT INSP. AGENCY: U.S.BLM	
INSPECTOR(S): Lucas West	INSPECTOR'S SIGNATURE:

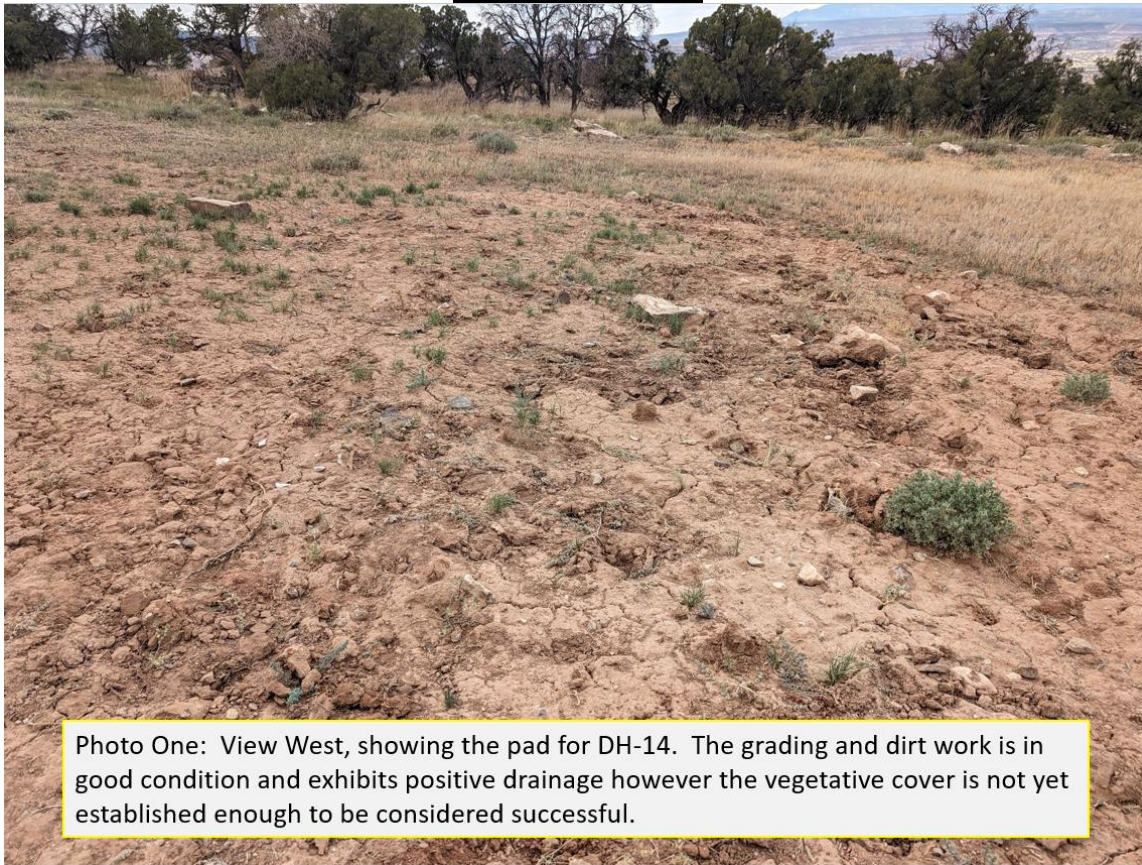
Photo One: View West, showing the pad for DH-14. The grading and dirt work is in good condition and exhibits positive drainage however the vegetative cover is not yet established enough to be considered successful.

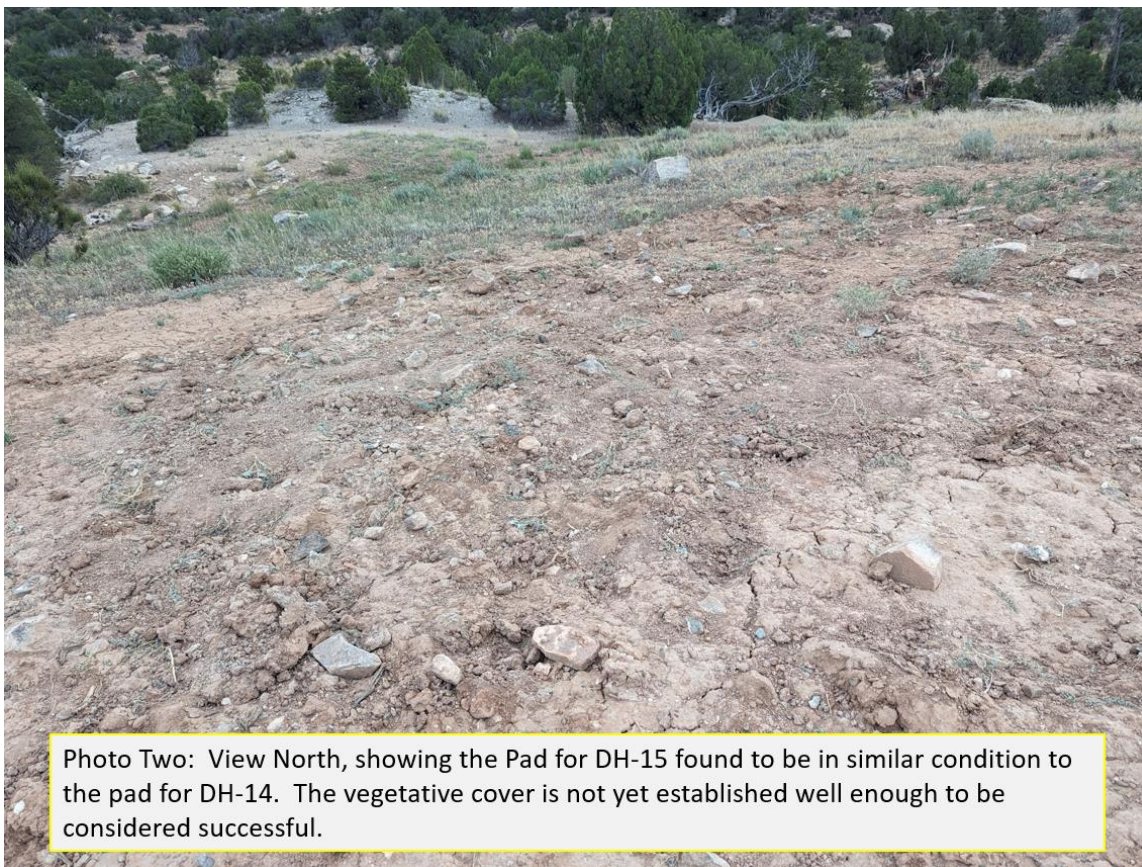
Photo Two: View North, showing the Pad for DH-15 found to be in similar condition to the pad for DH-14. The vegetative cover is not yet established well enough to be considered successful.
