MINERALS PROGRAM INSPECTION REPORT
PHONE: (303) 866-3567

| MINE NAME: Mahogany Research Project – Prospecting on SFOGI Land | MINE/PROSPECTING ID#: P-2003-022 | MINERAL: Oil shale | COUNTY: Rio Blanco |
| INSPECTION TYPE: Monitoring | WEATHER: Clear | INSP. DATE: July 26, 2023 | INSP. TIME: 07:45 |

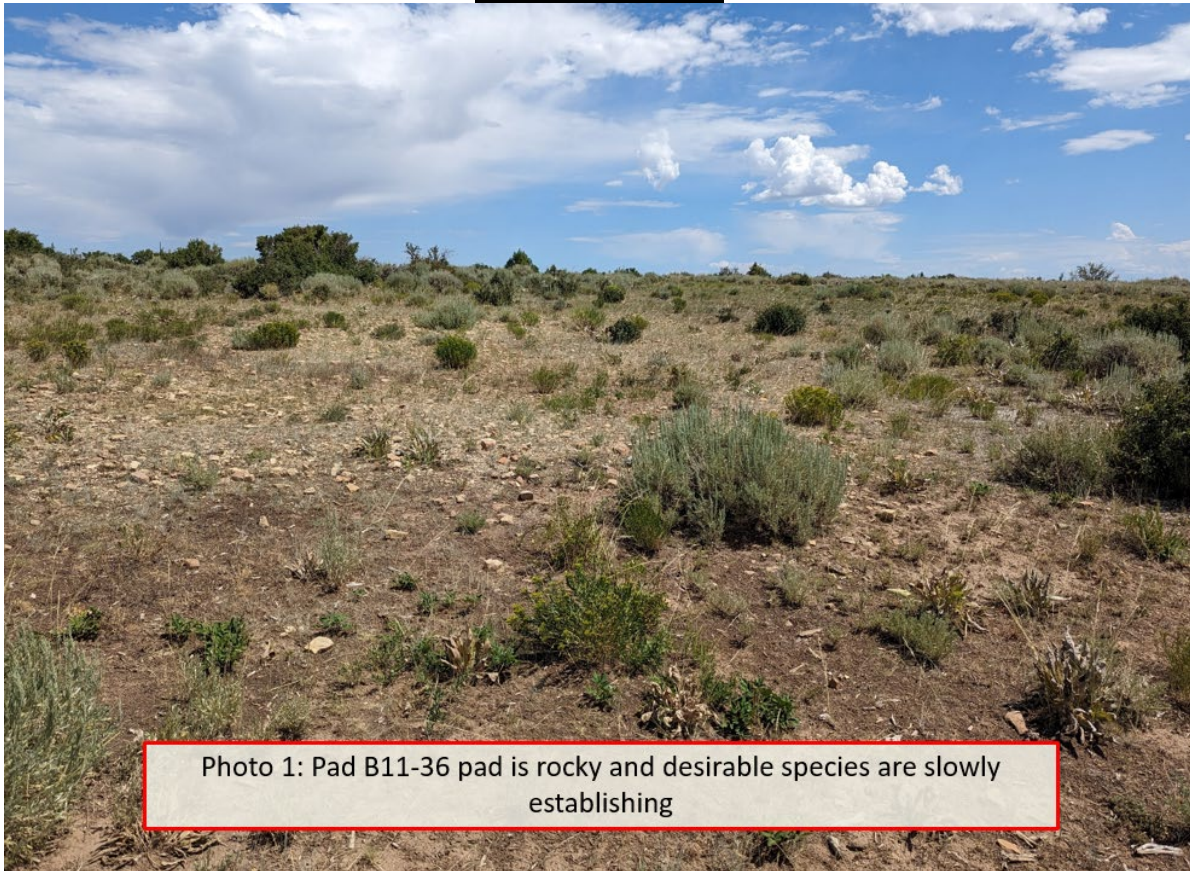
- B11-36: Short access road with gate. The weeds have improved significantly since the previous inspection, very few weeds remain. A wide variety of native shrubs/forbs are present with some perennial grasses coming. This pad has been grazed very hard but overall is doing well considering the pressure. Pad will likely be eligible for release next year if things continue to improve. See Photo One.

Photo 1: Pad B11-36 pad is rocky and desirable species are slowly establishing

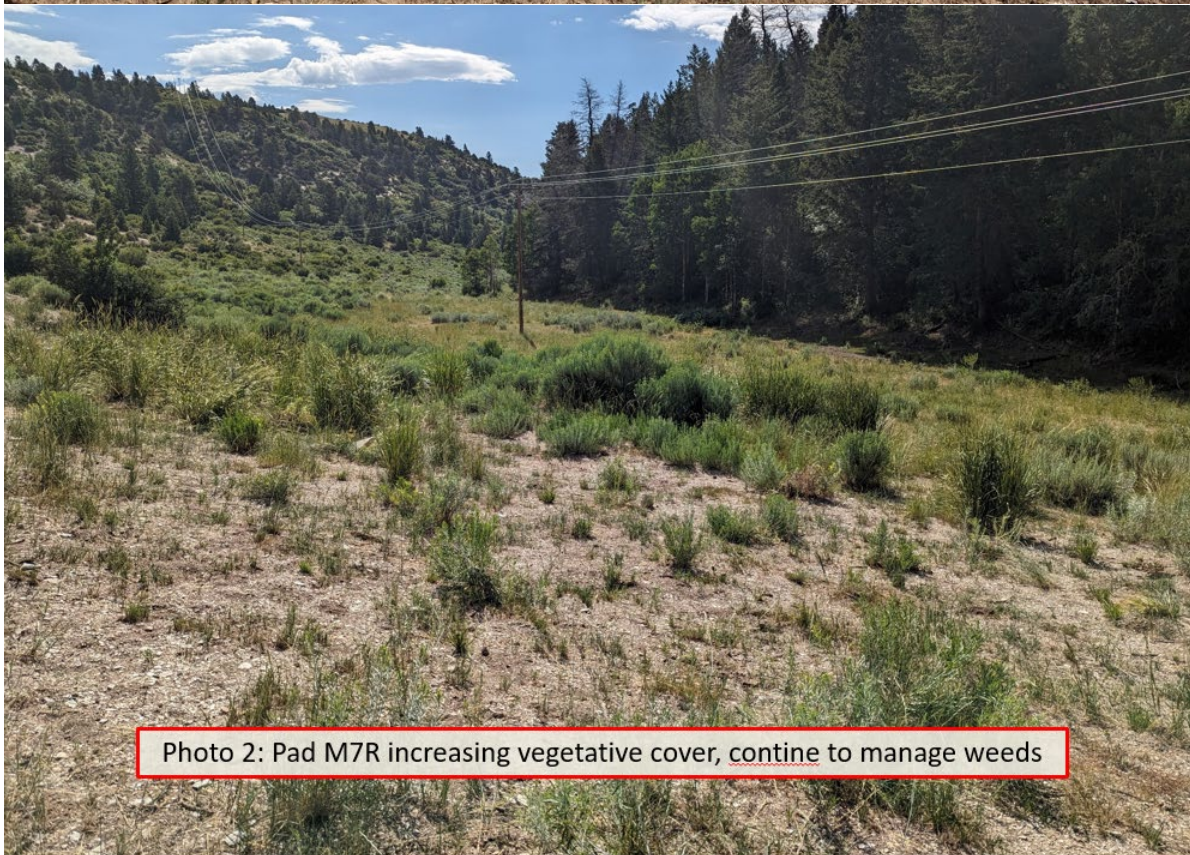
- M7R: Despite being on a steep slope the pad has very little erosion. Drill seed/ contours have nearly all flattened out now. A hand full of noxious weeds (Hounds tongue) still remain but the infestation is steadily decreasing year to year. Desirable vegetation is a blend of well-established shrubs and perennial grasses. Overall cover is 70% and comparable to surrounding areas. Continue to manage weeds over the summer and pad will likely be eligible next year. See Photo Two.

Photo 2: Pad M7R increasing vegetative cover, continue to manage weeds

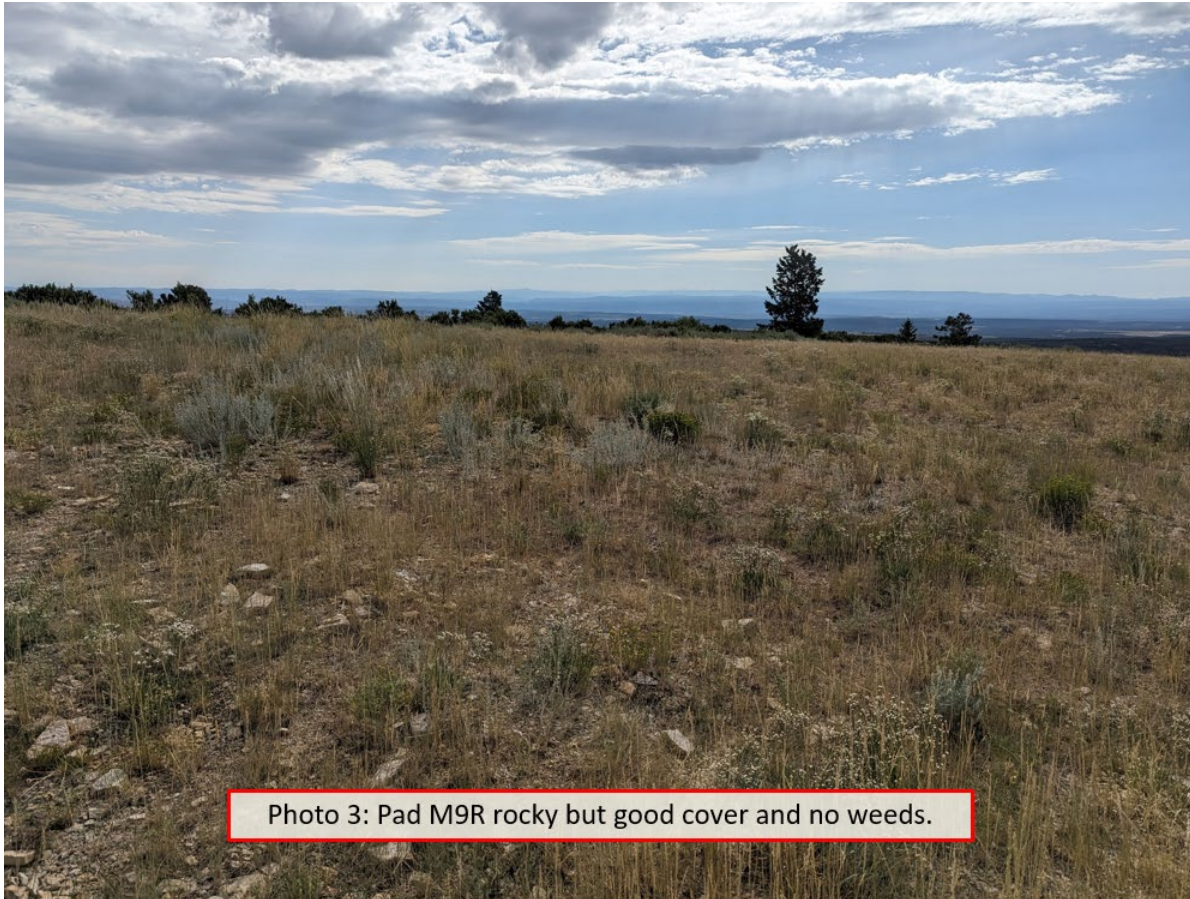
- *M9R: There is a short two track road with some evidence of use but overall is stable and mostly vegetated. Overall pad is rocky but good grass cover. The few shrubs and forbs appear to be well-established. Overall plant cover is diverse and approximately 80% with no noxious weeds observed. See Photo Three.

Photo 3: Pad M9R rocky but good cover and no weeds.

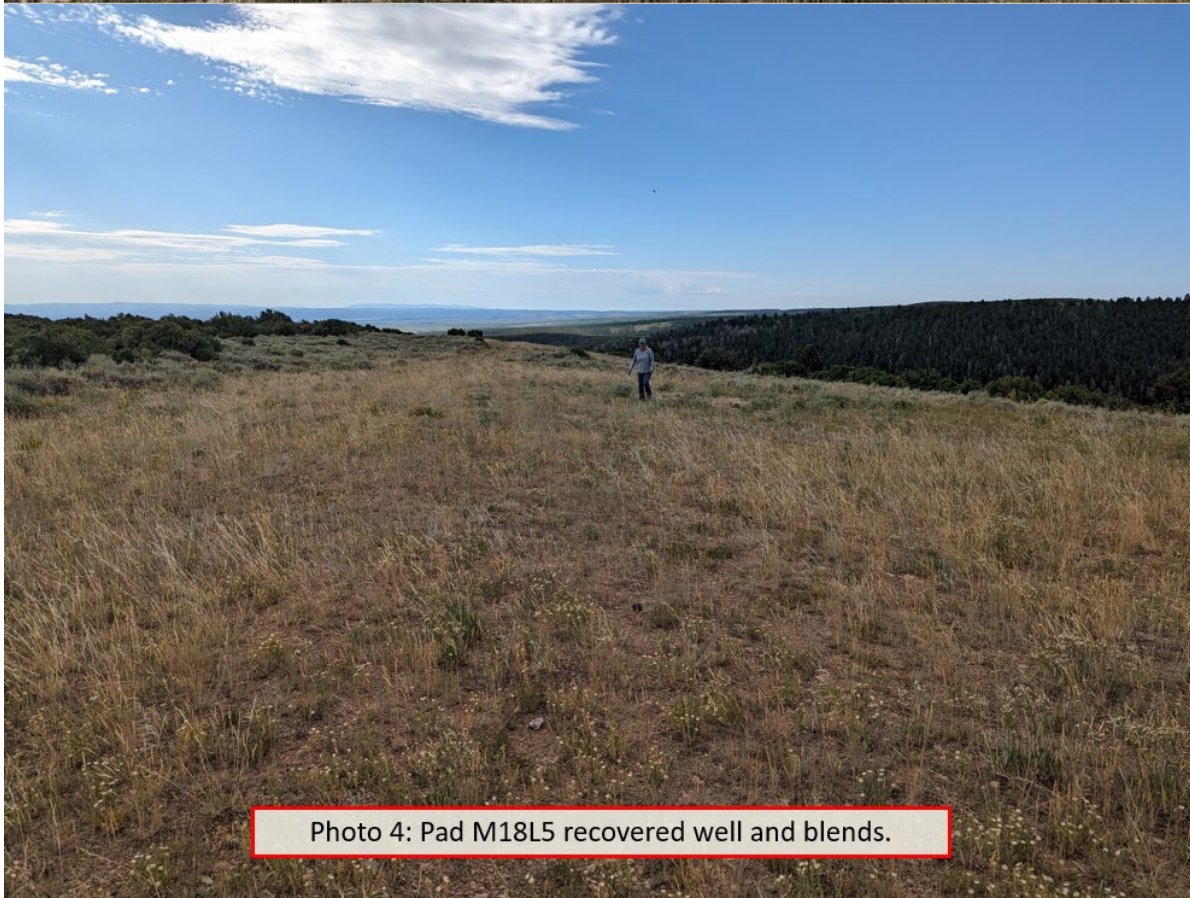
- *M18L5: This area is located off of Airplane Ridge road and has previously been utilized by another operator as a staging area. The area has since recovered well. Cheatgrass observed during the last inspection appears to be well controlled and desirable vegetation is outcompeting well. In general vegetation appears sustainable and comparable to the adjacent undisturbed areas. See Photo Four.

Photo 4: Pad M18L5 recovered well and blends.

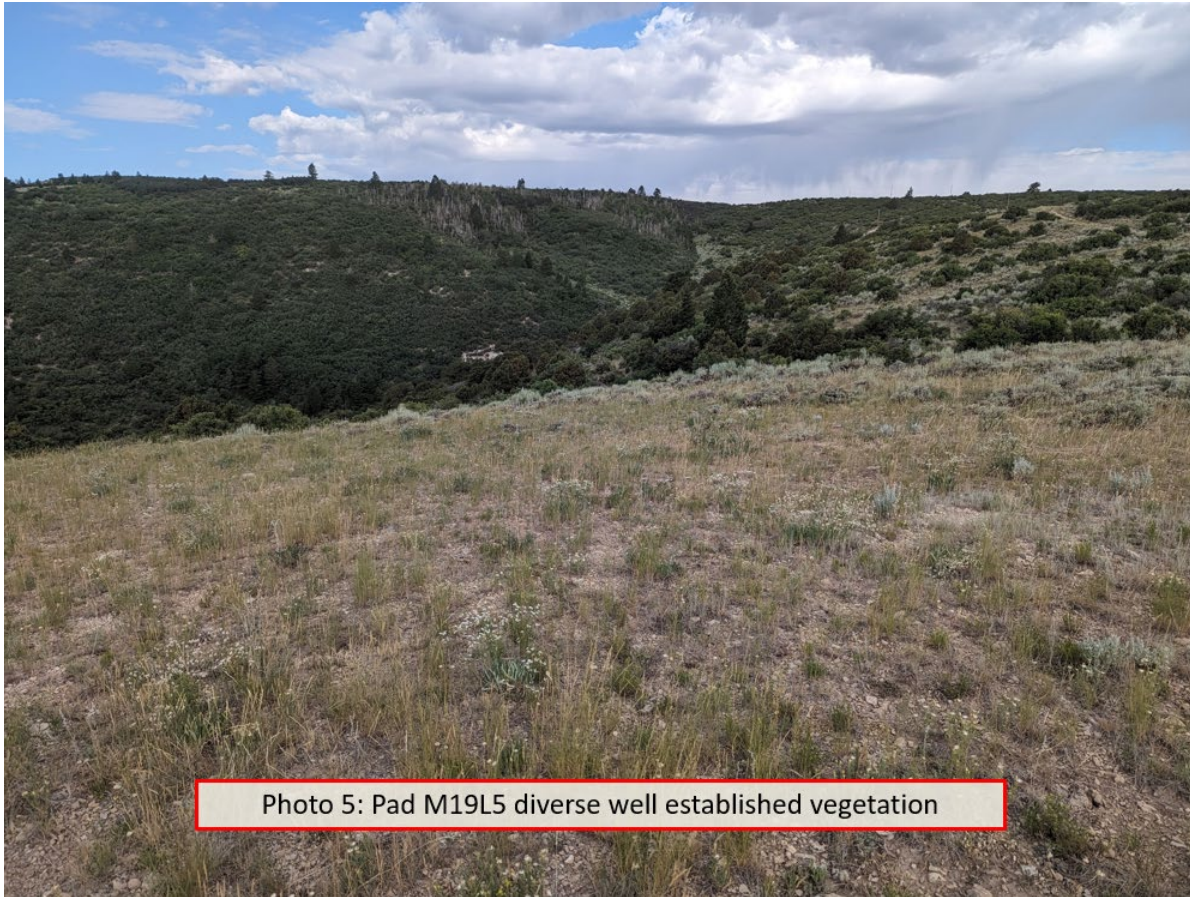
*M19L5: A long access road from pad M18L. This road is less frequently used but still has a faint two track. Vegetation is present throughout the road and erosion is well controlled even with use. The pad itself is slightly rocky but low shrubs appear to be doing well. Perennial grasses are also present with no weeds. See Photo Five.

Photo 5: Pad M19L5 diverse well established vegetation

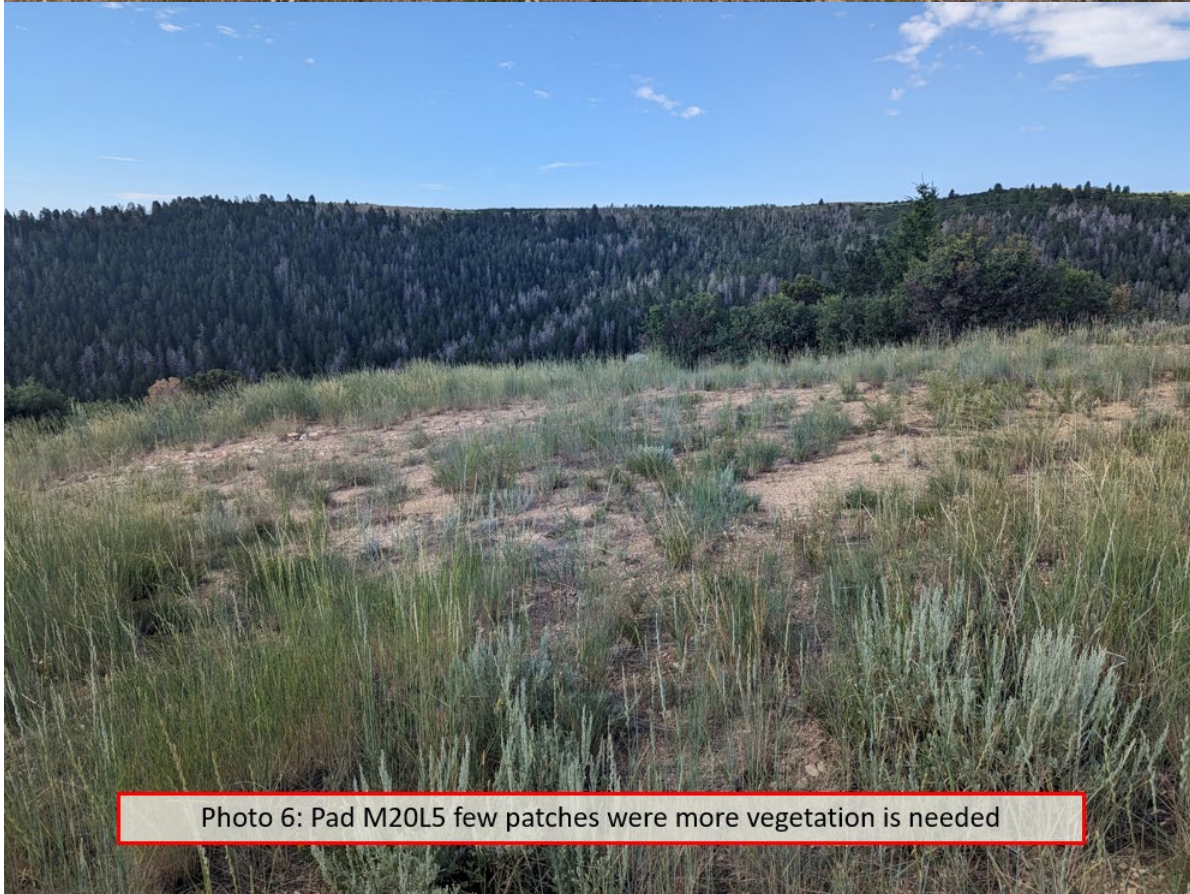
M20L5: Overall good plant diversity which includes perennial grasses, forbs, and flowers. There are patches where overall desirable plant density is low, likely due to previously having weeds that have since been treated. Weeds should continue to be maintained to allow for desirable species to continue to establish. See Photo Six.

Photo 6: Pad M20L5 few patches were more vegetation is needed

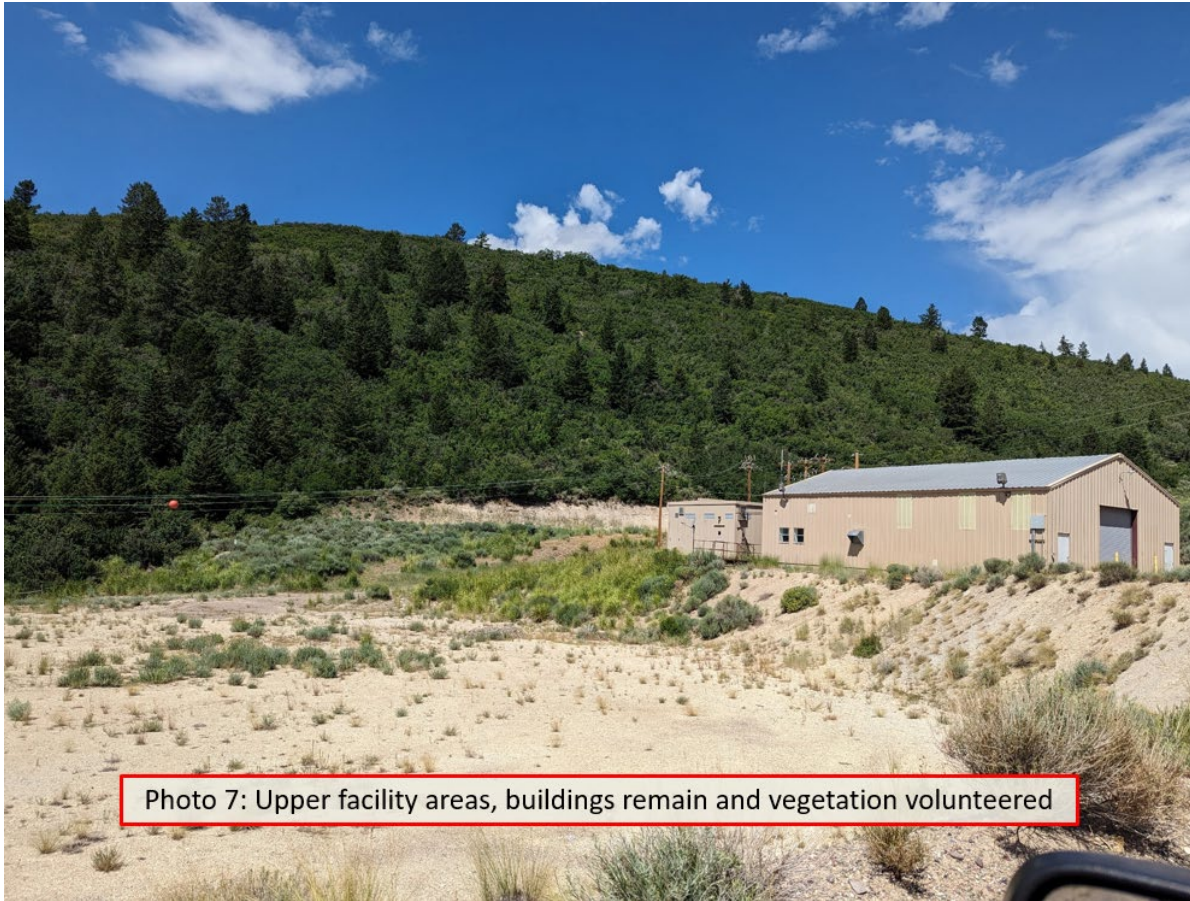
Upper Loop Road and Upper Facility Areas (MDP, DHT and MFE): Upper camp control room warehouse and electrical room remain in place per MD-5. The pad area has been graded and vegetation is continuing to volunteer. Establishment of vegetation is not required per MD-5 so long as erosion is well controlled. Slopes have been contoured and naturally blend with vegetation at approximately 50% cover. Weeds are being effectively managed and soils appear stable. The lower sediment/evaporation pond adjacent to the tank farm has resulted in a slight depression. Vegetation appears to be well established. See Photos Seven and Eight.

Photo 7: Upper facility areas, buildings remain and vegetation volunteered

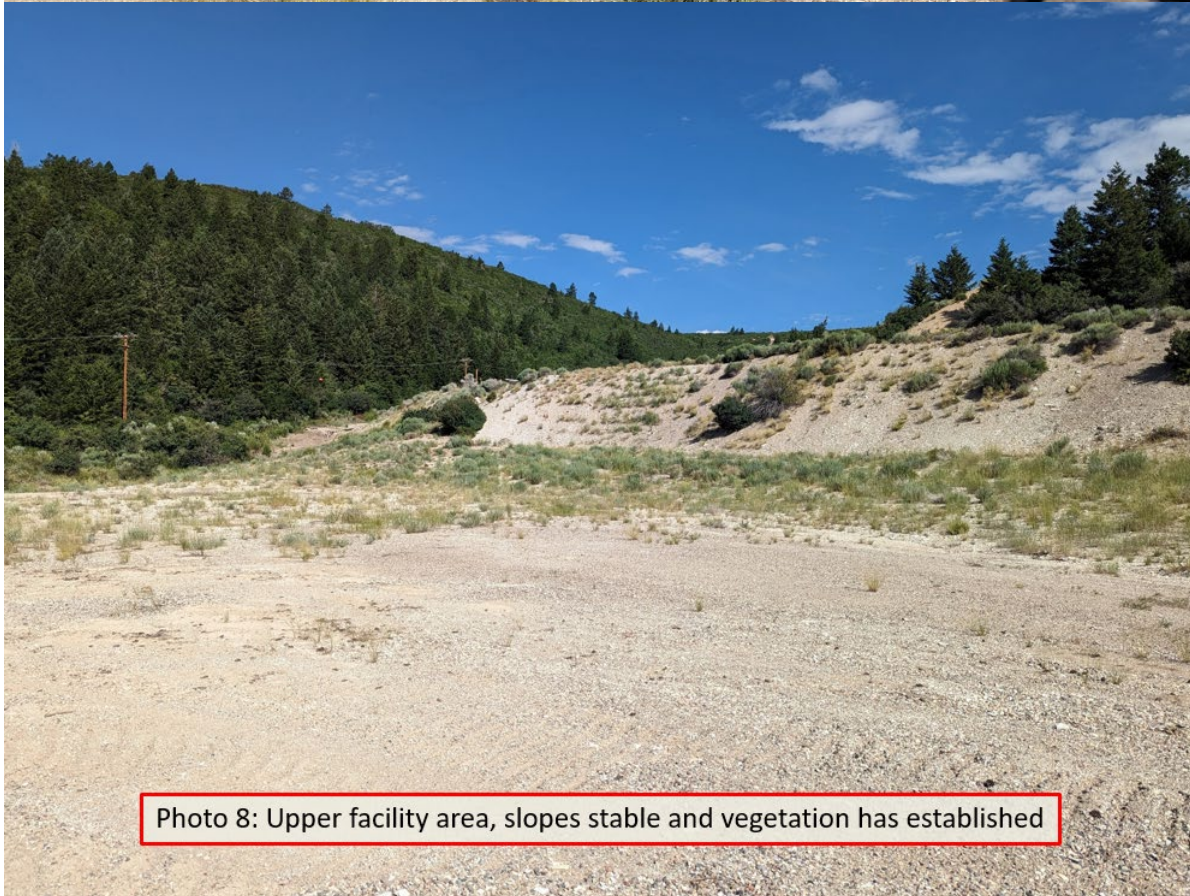
Photo 8: Upper facility area, slopes stable and vegetation has established

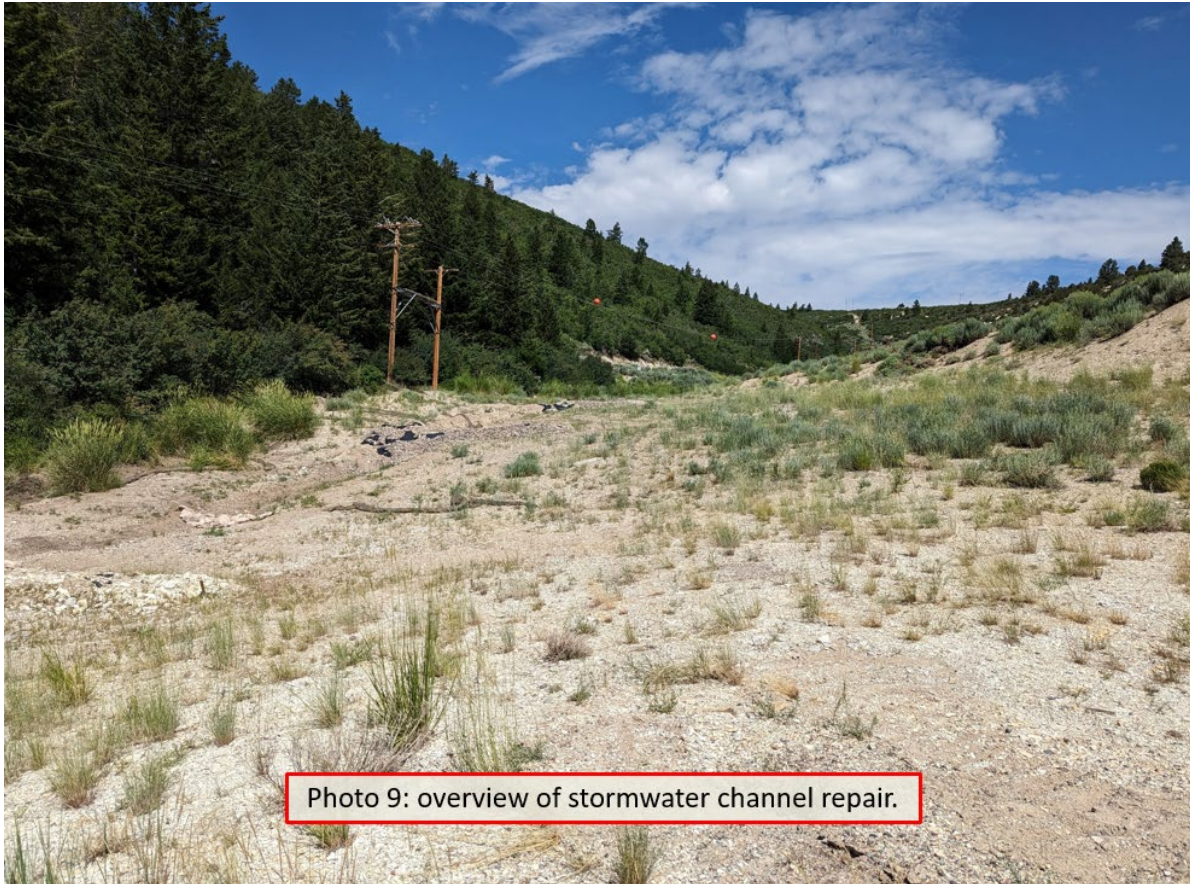
Repairs have begun on the stormwater channel. The previously installed straw waddles have proved inadequate over time. Earthen berms have been installed with a geomembrane that will be covered with imported rock. Additional rock is to be placed on and within the channel. It is recommended to add smaller rock check dams along the channel. Creating a more u-shaped channel rather than v-shaped will also help distribute the water and reduce downward cutting. Completion of this project is anticipated this fall. See Photo Nine.

Photo 9: overview of stormwater channel repair.

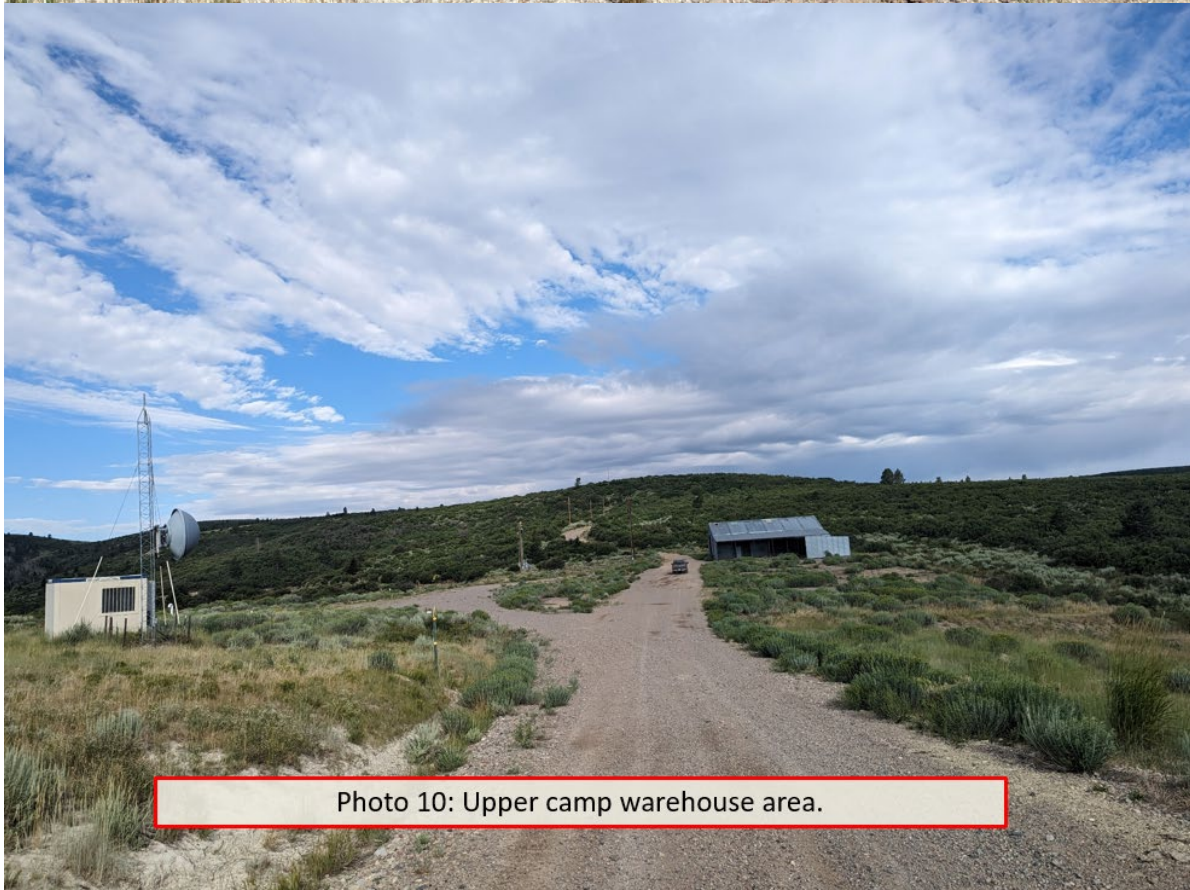
*Upper Camp: Warehouse building with cistern and septic system remains on site. Upper camp warehouse was permitted to remain in MD-5. All portable trailers have been removed. The communication/ radio building remains in place (identify if this is being taken over by another operator). Roads are stabilized with gravel. Surrounding areas are stabilized with vegetation. Weed management treatments appear to be appropriate. See Photo Ten.

Photo 10: Upper camp warehouse area.

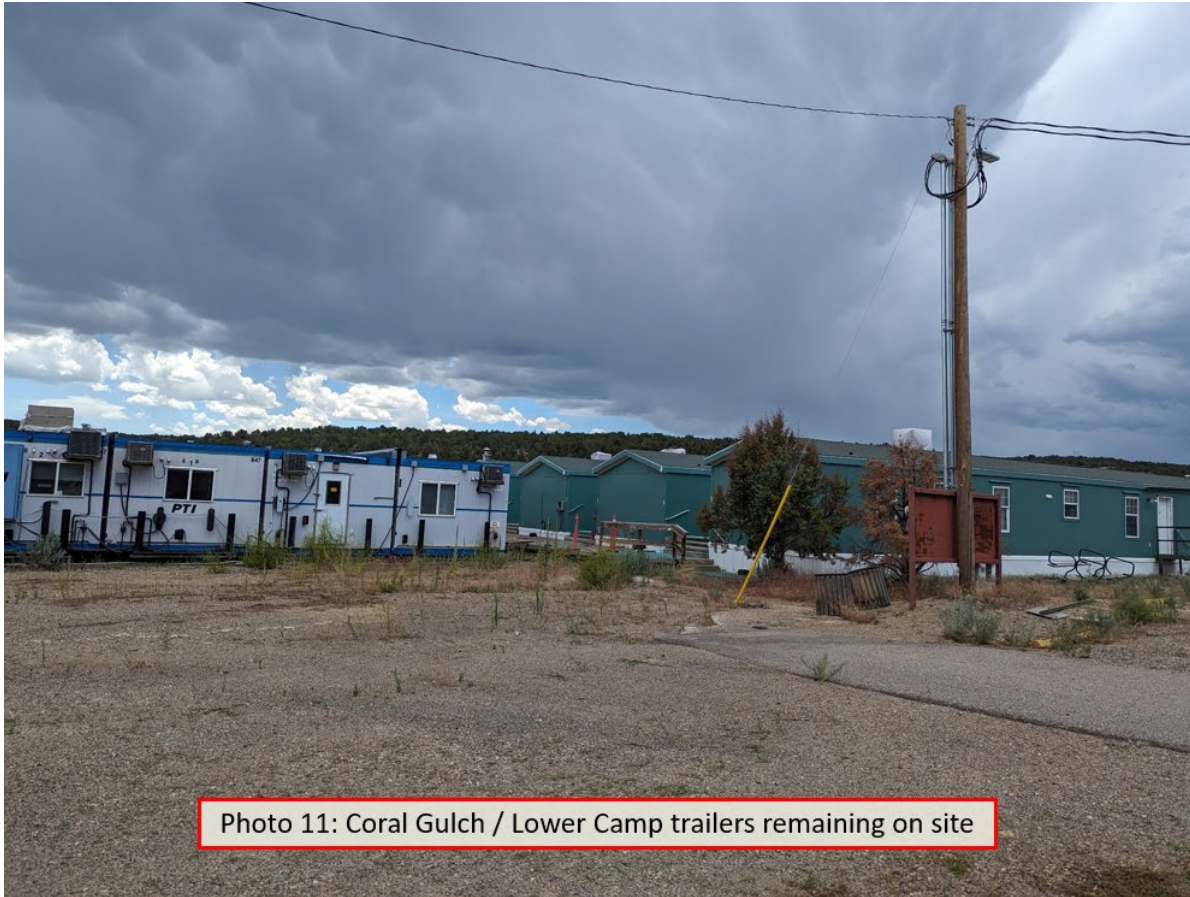
Lower Camp/Coral Gulch: Four office trailers, the galley and one living quarters trailer remains on site. Similarly the warehouse, gas station, buried propane, septic and gas sheds also remain on site. These features are being utilized by the landowner for purposes other than mining. The current reclamation plan calls for total removal of all features upon final reclamation. Given that the landowner bought these assets and wants to keep them the Operator needs to modify their reclamation plan to allow for them to remain post-mining. Documentation of the landowner assuming liability for the features will also be required. The domestic water well should be transferred, if it has not already been. Please provide documentation from Division of Water resources once complete. Once permit modifications are complete, release of eligible areas may be requested. Alternatively if they are 'double' permitted through DRMS, Shell could request release so long as there is no lapse in jurisdiction. See Photos Eleven and Twelve.

Photo 11: Coral Gulch / Lower Camp trailers remaining on site

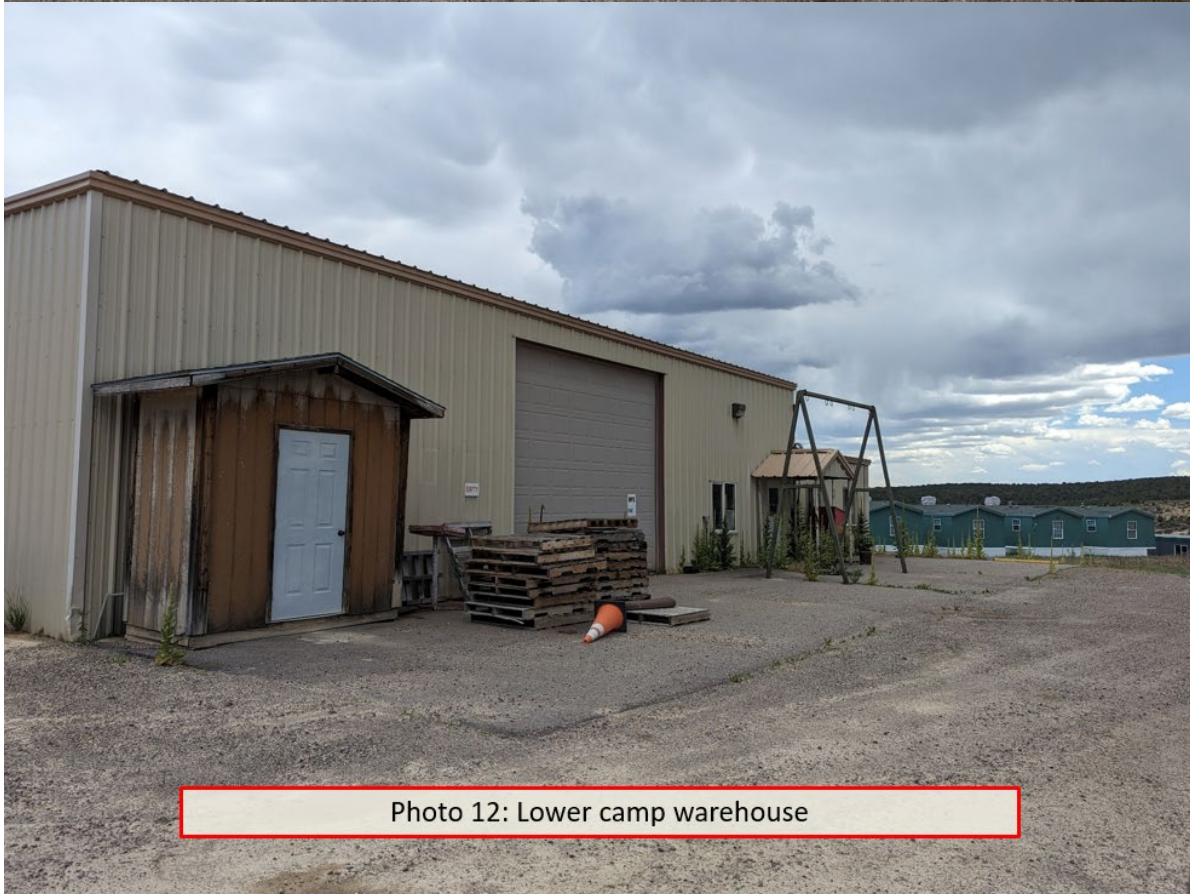
Photo 12: Lower camp warehouse
