**MINERALS PROGRAM INSPECTION REPORT**  
**PHONE: (303) 866-3567**

<b>MINE NAME:</b> 2005-06 Geo-hydrology Drilling and Coring - Public	<b>MINE/PROSPECTING ID#:</b> P-2005-001	<b>MINERAL:</b> Oil shale	<b>COUNTY:</b> Rio Blanco
<b>INSPECTION TYPE:</b> Monitoring	<b>WEATHER:</b> Clear	<b>INSP. DATE:</b> July 25, 2023	<b>INSP. TIME:</b> 07:30
<b>OPERATOR:</b> Shell Frontier Oil & Gas Inc.	<b>OPERATOR REPRESENTATIVE:</b> Samantha Baker	<b>TYPE OF OPERATION:</b> MP - Mineral Prospecting	
<b>REASON FOR INSPECTION:</b> Normal I&E Program	<b>BOND CALCULATION TYPE:</b> None	<b>BOND AMOUNT:</b> \$1,579,882.00	
<b>DATE OF COMPLAINT:</b> NA	<b>POST INSP. CONTACTS:</b> None	<b>JOINT INSP. AGENCY:</b> U.S.BLM	
<b>INSPECTOR(S):</b> Amy Yeldell	<b>INSPECTOR'S SIGNATURE:</b>

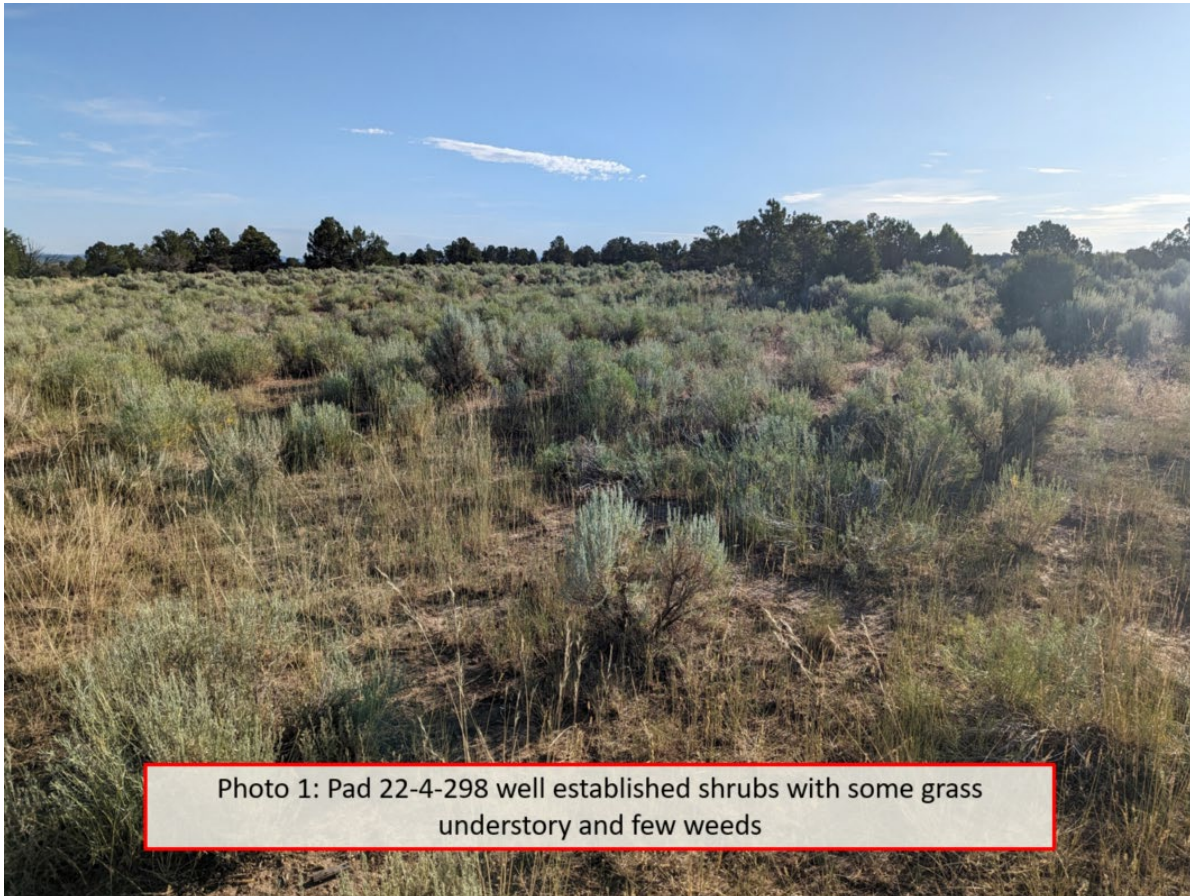
\*Pad 22-4-298: Overall pad has high coverage at nearly 80%. Vegetation is primarily sagebrush, rabbit brush and other shrubs/forbs. The grass understory is beginning to take hold. Cheatgrass and noxious weeds appear to be well managed and have significantly decreased since previous inspection. Overall about cover is about 80% which is comparable to surrounding areas. See Photo One.

Photo 1: Pad 22-4-298 well established shrubs with some grass  
understory and few weeds

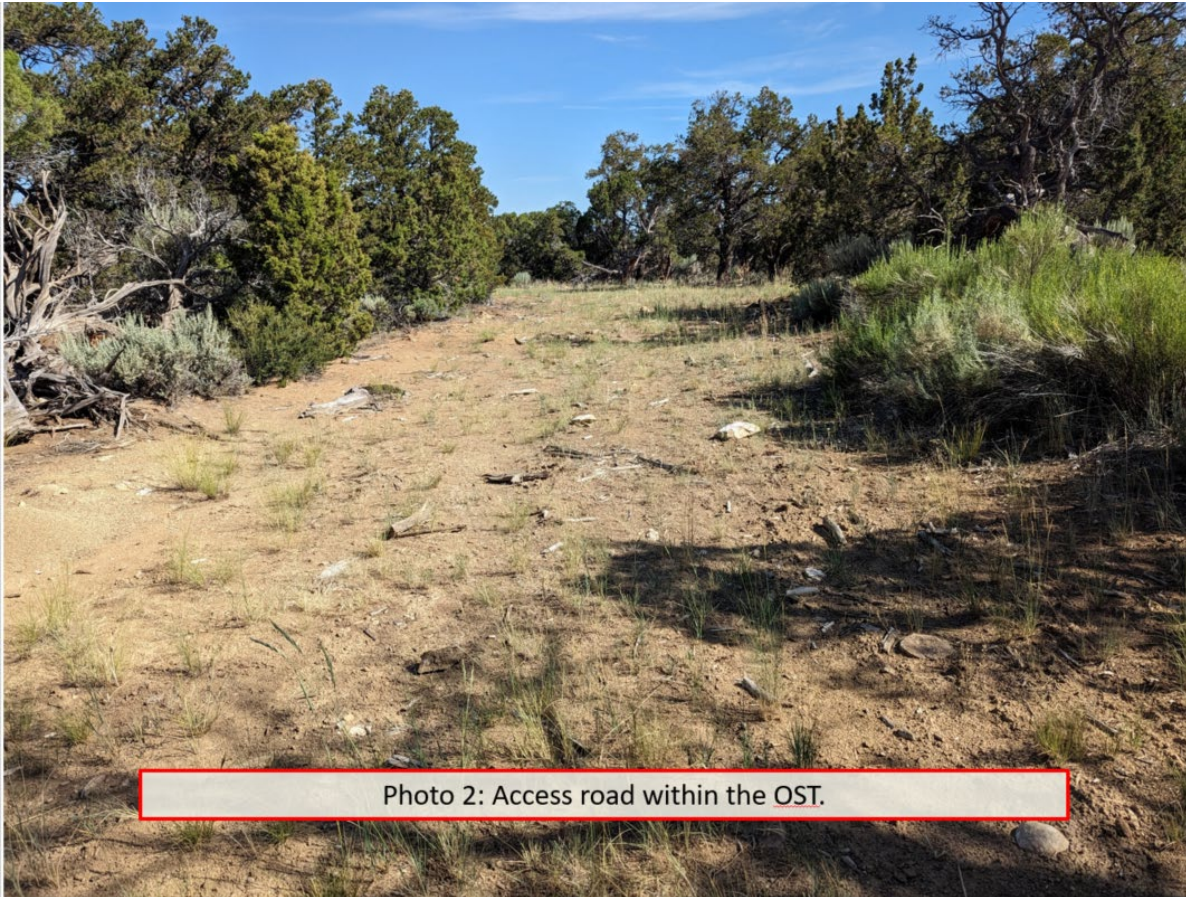
Note: Pads 39-46 are located within the OST general area. There is a gate located at the entrance to the complex that will be removed upon completion of final reclamation. Vegetation on access roads is establishing well. Vegetation is still primarily grasses at less than 30% cover but has been steadily increasing over the years. See Photo Two.

Photo 2: Access road within the OST.

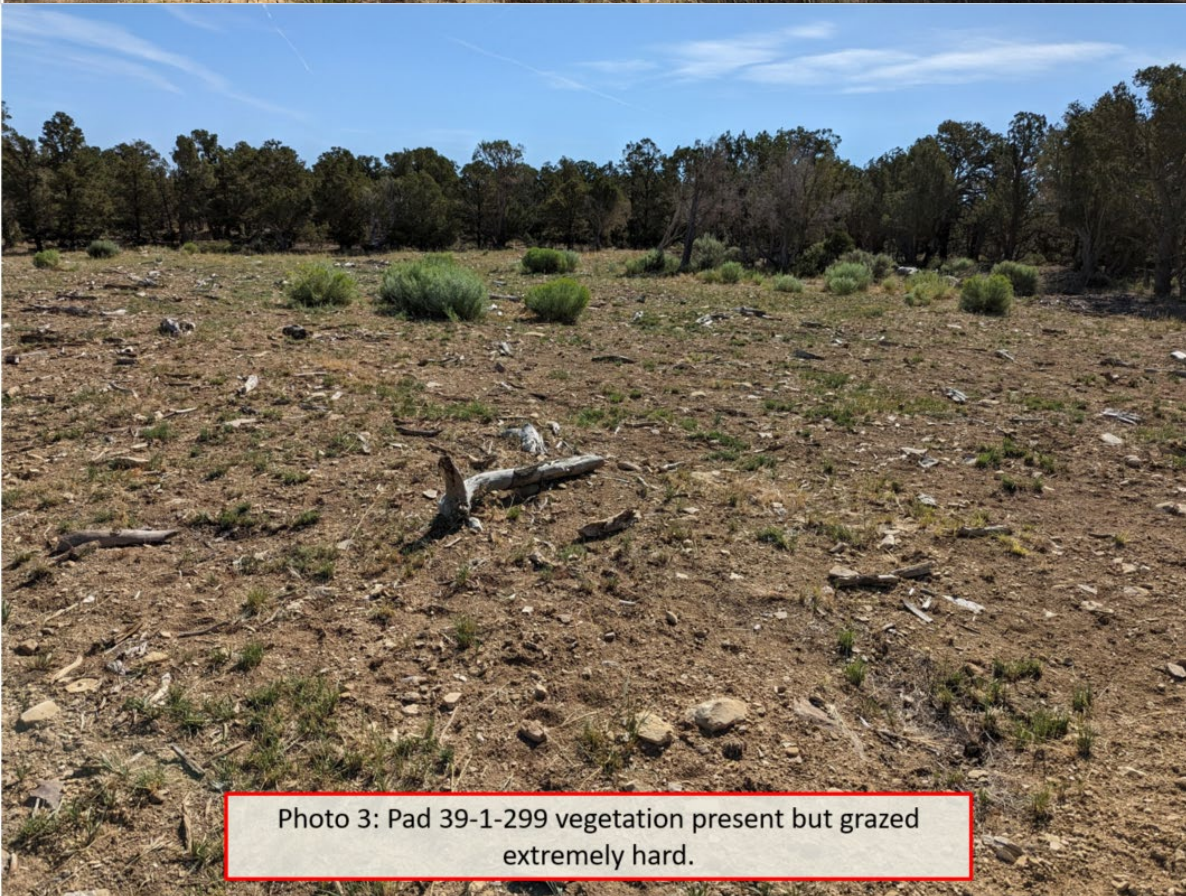
Pad 39-1-299: This pad has been grazed extremely hard. Overall site conditions have diminished since last year's inspection. Nearly all palatable vegetation has been eaten to the ground likely injuring or killing established vegetation. The few shrubs appear more resilient. Increasing woody debris might help detour grazing and provide shelter for newly established seedlings. See Photo Three.

Photo 3: Pad 39-1-299 vegetation present but grazed extremely hard.

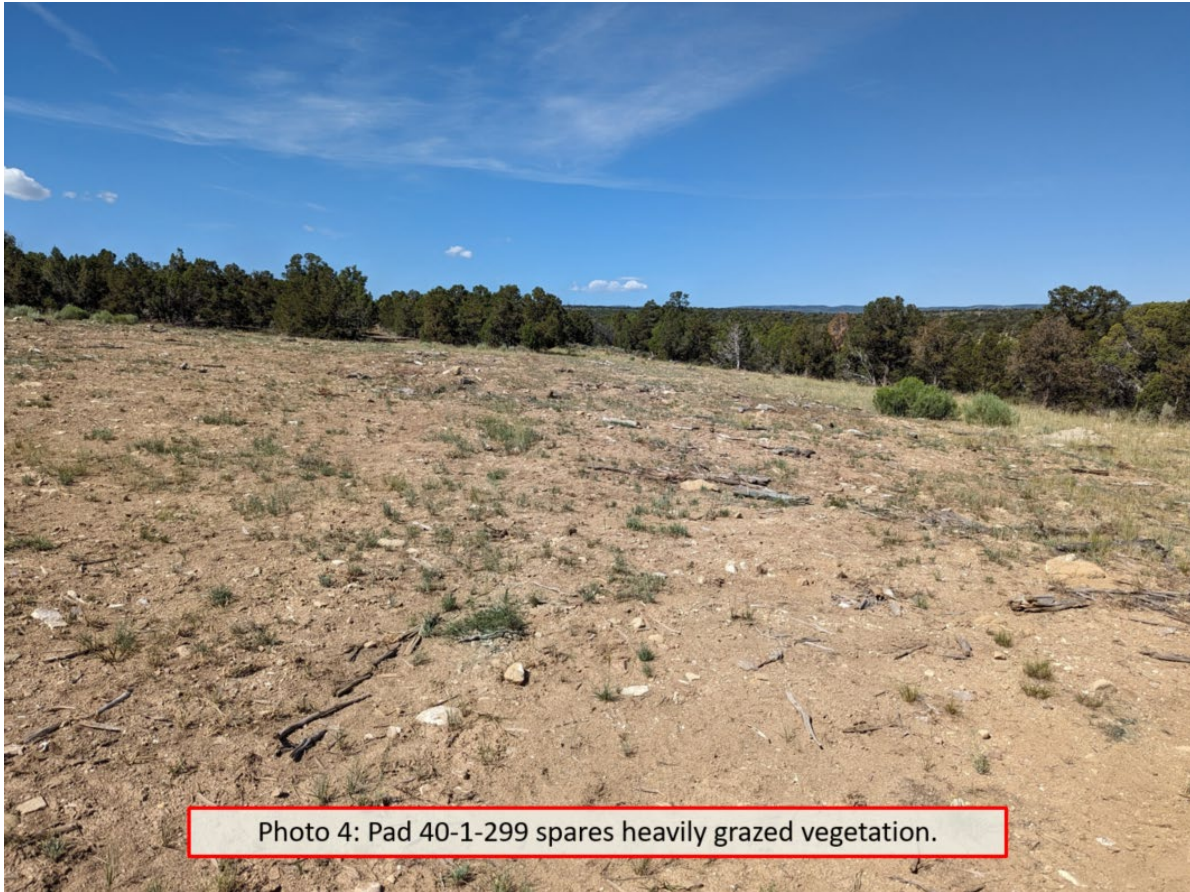
Pad 40-1-299: This pad has also been grazed extremely hard but seems to be fairing a little better. Overall there are less noxious weeds compared to year. Desirable cover is estimated at 30%. There was discussion of adding wood or other organic matter to help along reclamation. See Photo Four

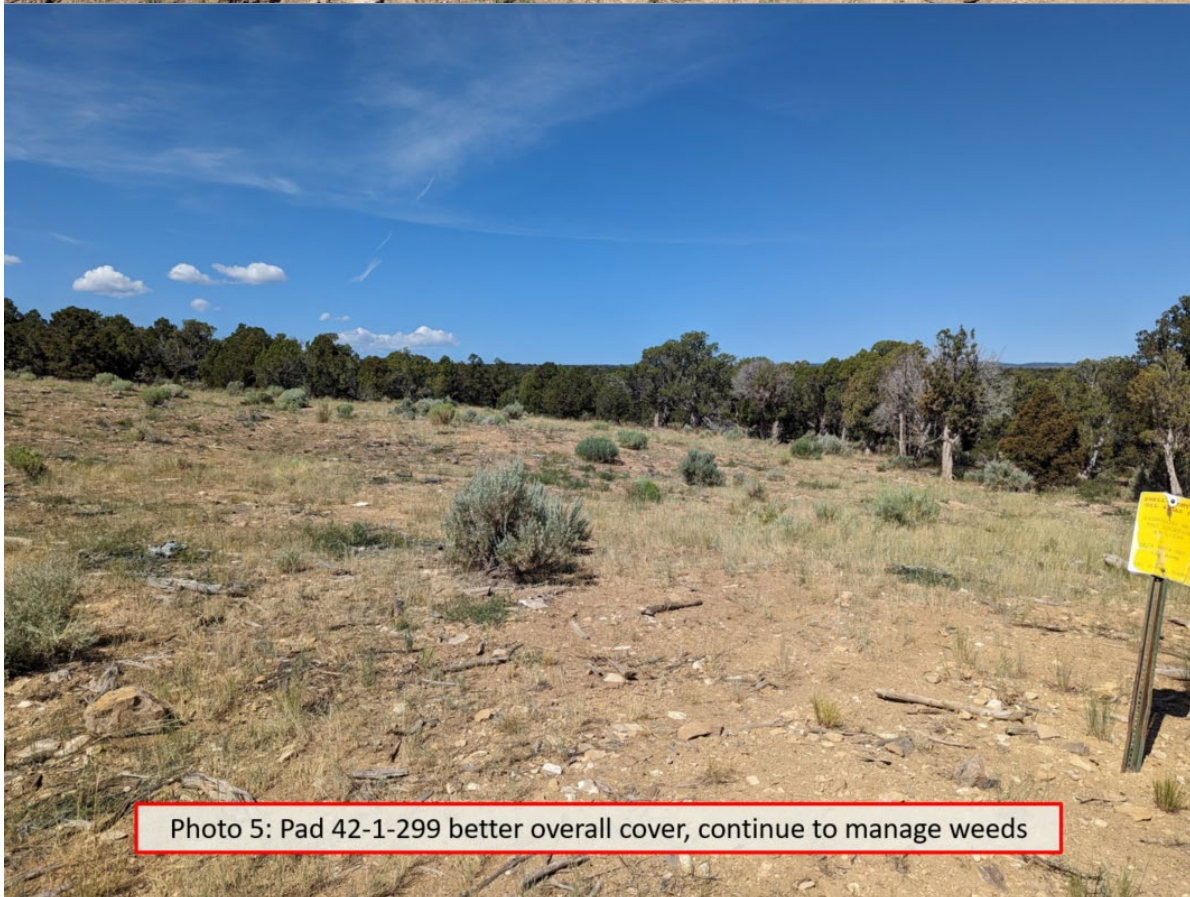
Pad 42-1-299: Grazing on this pad appears to be patchy. The bottom portion of the pad has more cover overall compared to the top. Both grasses and shrubs seem to be established better through the pad and resilient. Noxious (non-listed) weeds were observed but have been recently sprayed. See Photo Five.
