MINERALS PROGRAM INSPECTION REPORT
PHONE: (303) 866-3567

MINE NAME: 2005-06 Geo-hydrology Drilling and Coring - Private	MINE/PROSPECTING ID#: P-2005-002	MINERAL: Oil shale	COUNTY: Rio Blanco
INSPECTION TYPE: Monitoring	WEATHER: Clear	INSP. DATE: July 26, 2023	INSP. TIME: 07:45
OPERATOR: Shell Frontier Oil & Gas Inc.	OPERATOR REPRESENTATIVE: Samantha Baker	TYPE OF OPERATION: MP - Mineral Prospecting	
REASON FOR INSPECTION: Normal I&E Program	BOND CALCULATION TYPE: None	BOND AMOUNT: \$369,361.00	
DATE OF COMPLAINT: NA	POST INSP. CONTACTS: None	JOINT INSP. AGENCY: None	
INSPECTOR(S): Amy Yeldell	INSPECTOR'S SIGNATURE:

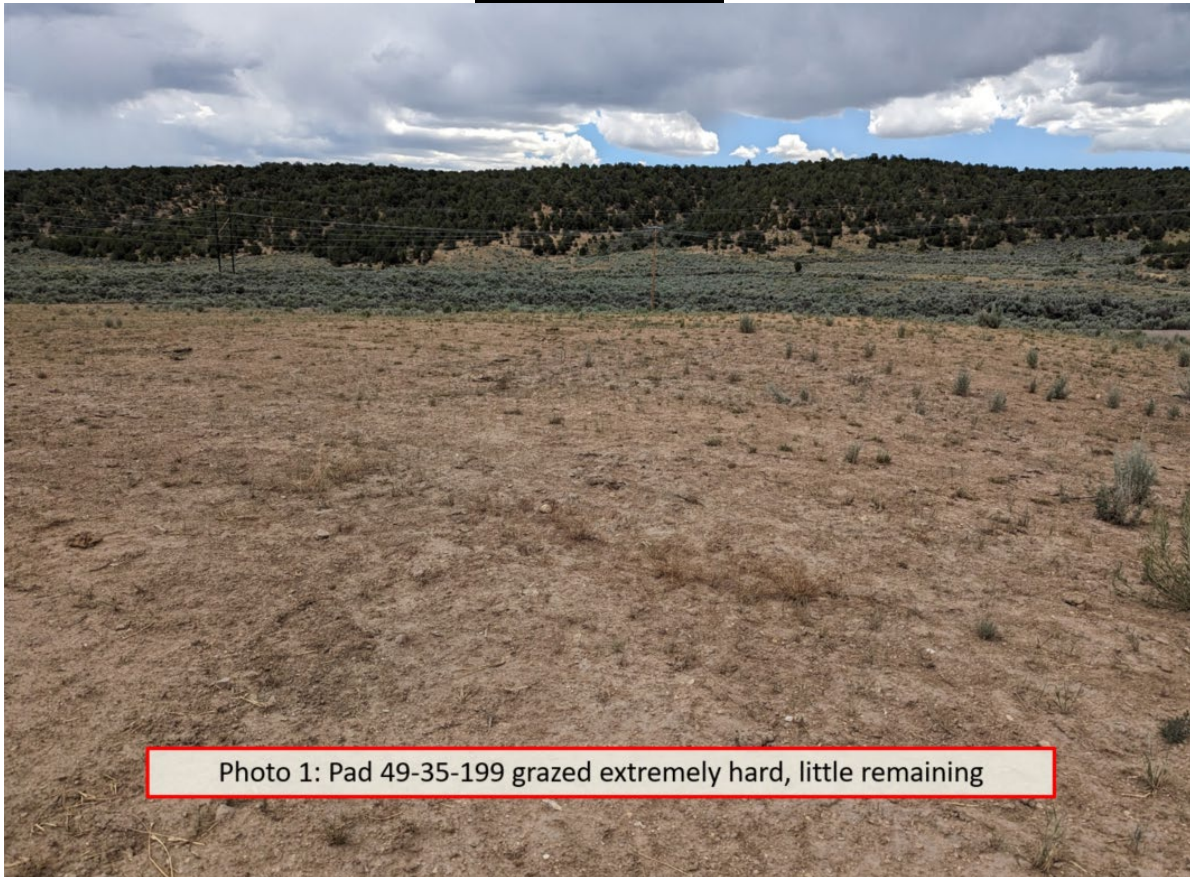
49-35-199: Some grasses have established but the pad has been grazed extremely hard. Given that the area is partially fenced finishing a grazing exclusion fence is recommended to help promote successful reclamation. See Photo One and Two.

Photo 1: Pad 49-35-199 grazed extremely hard, little remaining

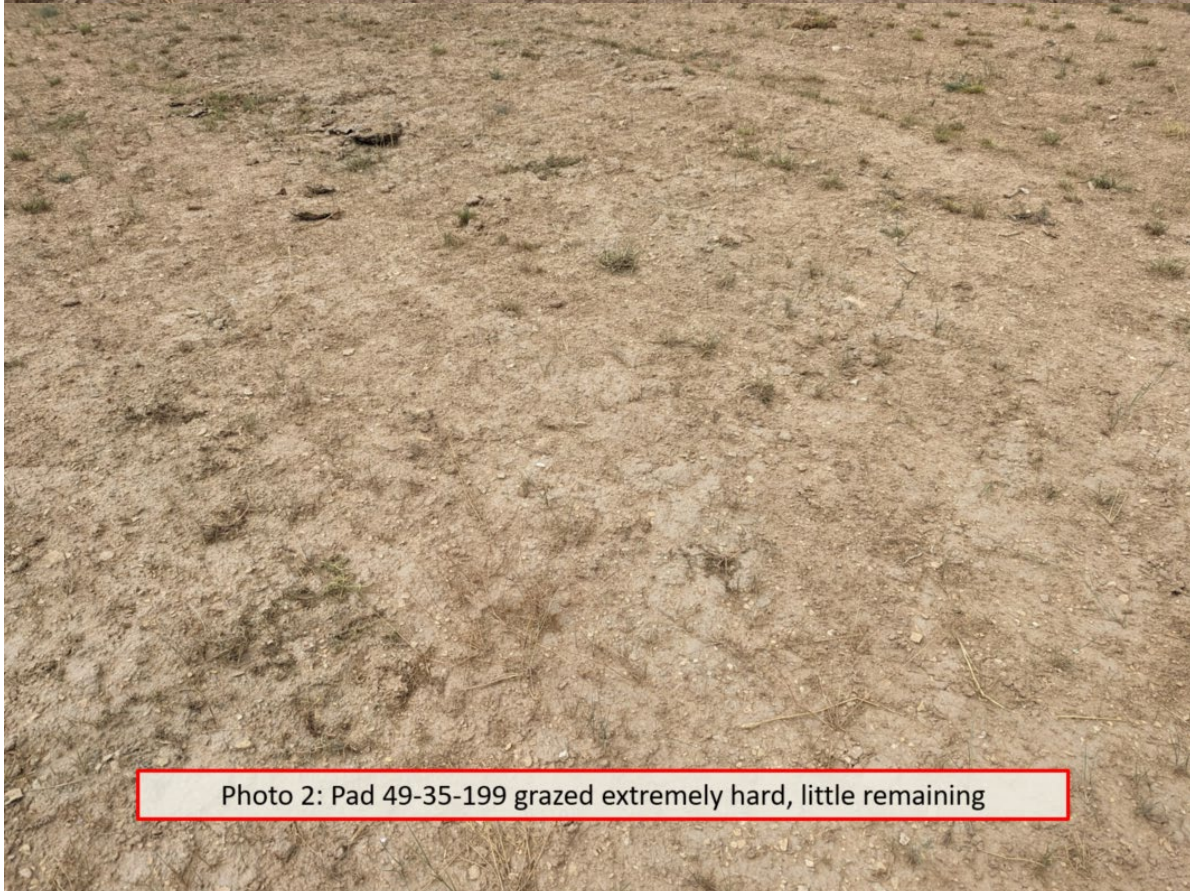
Photo 2: Pad 49-35-199 grazed extremely hard, little remaining

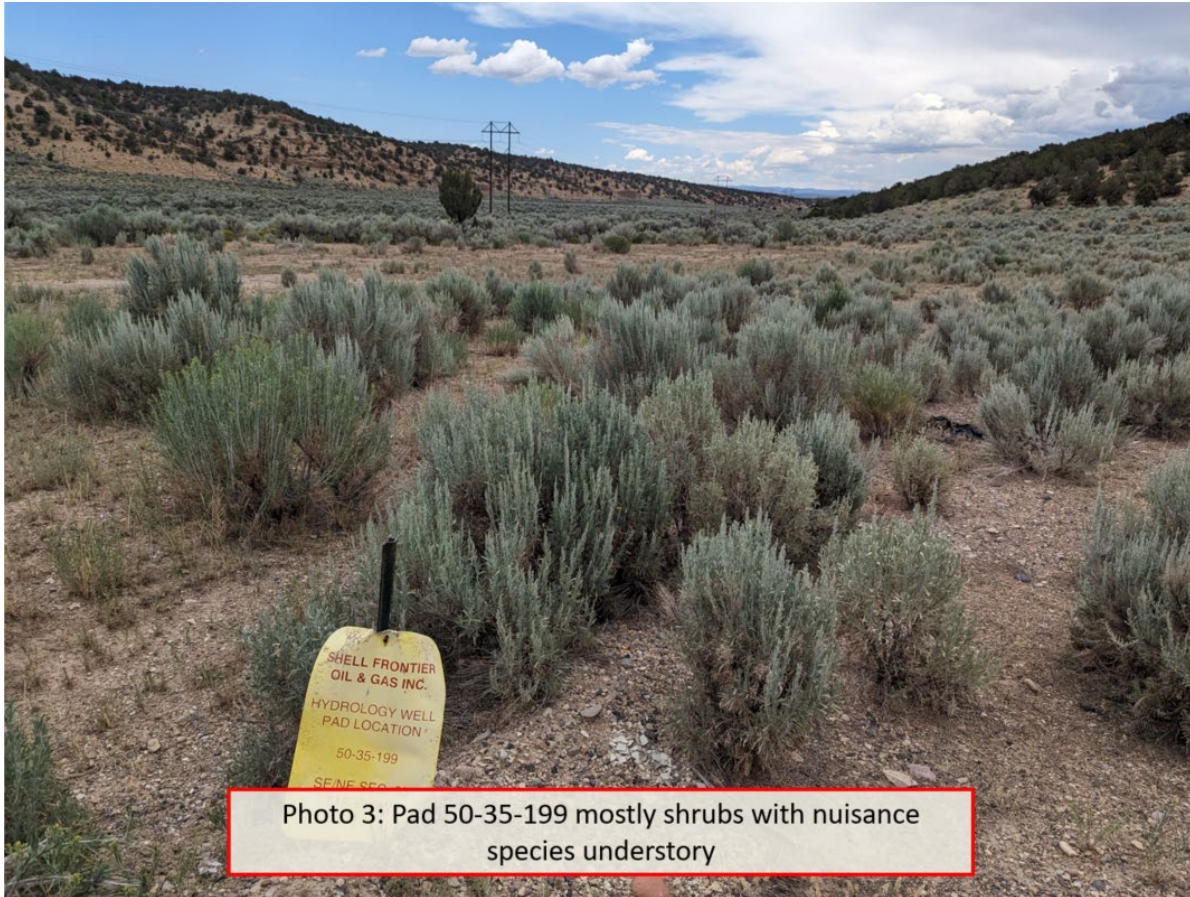
50-35-199: Located on the FWT plume pads (P-2005-017). Mostly shrubs with very few grasses. Nuisance species were observed and should be treated to avoid excess competition of desirable species. Grazing does not appear to be negatively affecting this area. See Photo Three.

Photo 3: Pad 50-35-199 mostly shrubs with nuisance species understory

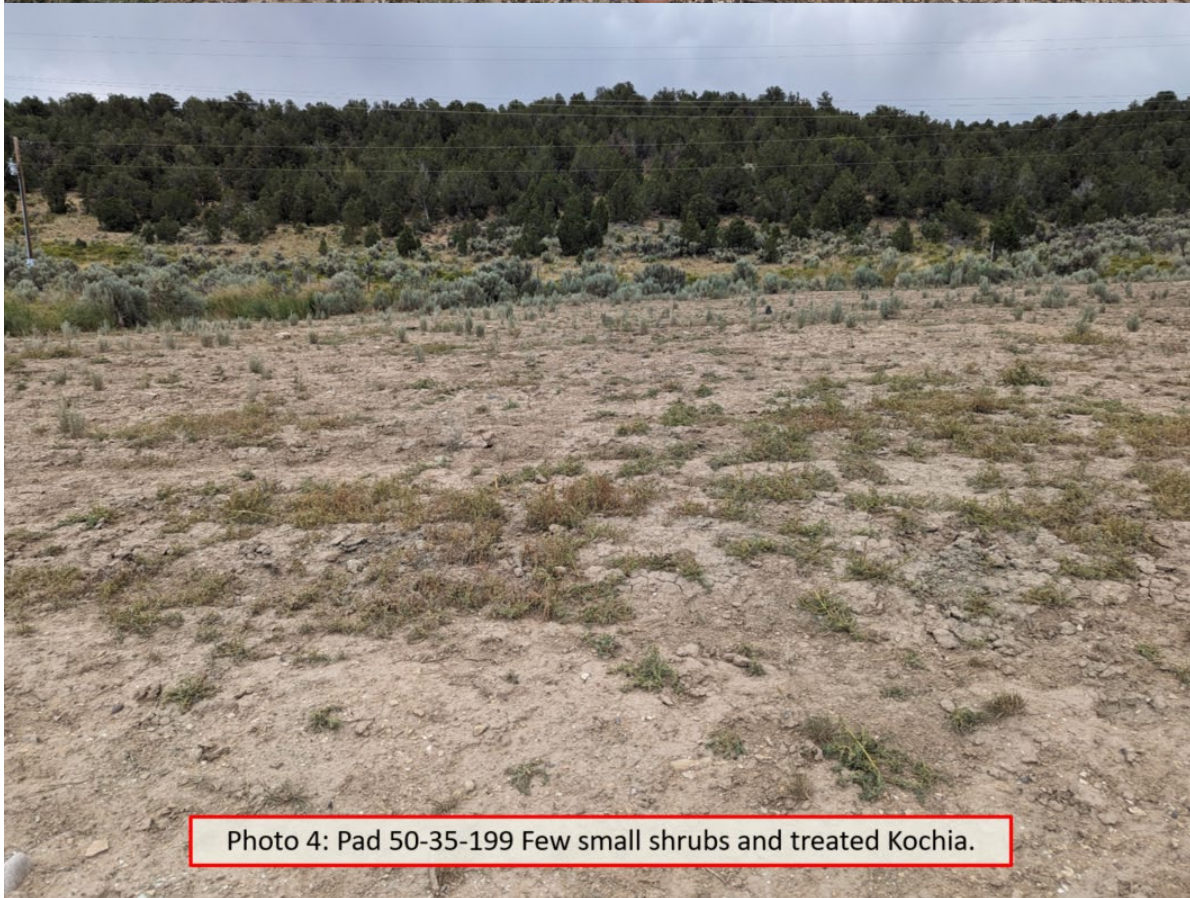
51-35-199: Behind the FWT. Vegetation is almost entirely comprised of nuisance plants lots of Kochia. Desirable vegetation is mostly shrubs with very little grasses. Treatment/ removal of nuisance species will leave the pad nearly bare and additional revegetation will likely be necessary to establish desirable species. Evidence of recent weed treatment was observed. Some evidence of grazing was observed. See Photo Four.

Photo 4: Pad 50-35-199 Few small shrubs and treated Kochia.
