MINERALS PROGRAM INSPECTION REPORT
PHONE: (303) 866-3567

MINE NAME: Henderson Mine	MINE/PROSPECTING ID#: M-1977-342	MINERAL: Molybdenum	COUNTY: Clear Creek, Grand
INSPECTION TYPE: Monitoring	WEATHER: Clear	INSP. DATE: July 26, 2023	INSP. TIME: 09:00
OPERATOR: Climax Molybdenum Company	OPERATOR REPRESENTATIVE: Geoff Niggeler	TYPE OF OPERATION: 112d-3 - Designated Mining Operation	
REASON FOR INSPECTION: Normal I&E Program	BOND CALCULATION TYPE: None	BOND AMOUNT: \$135,204,778.00	
DATE OF COMPLAINT: NA	POST INSP. CONTACTS: None	JOINT INSP. AGENCY: None	
INSPECTOR(S): Brock Bowles Timothy Cazier, P.E.	INSPECTOR'S SIGNATURE:

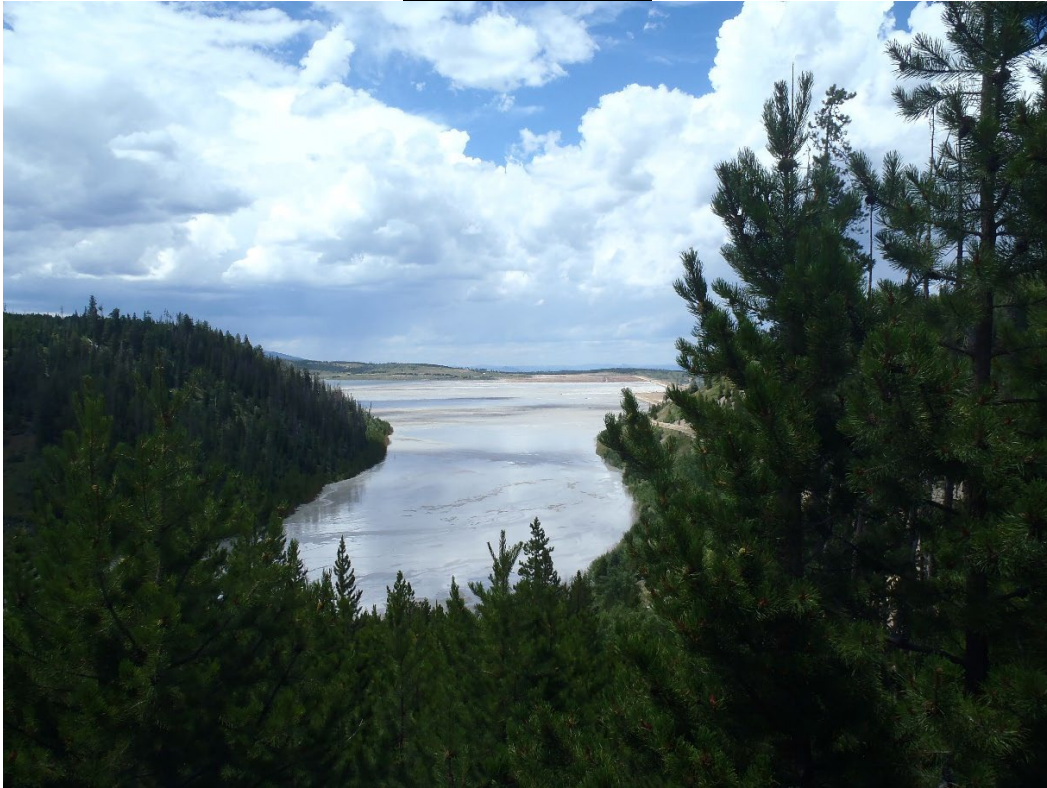
The southern end of the TSF is in the Ute Creek canyon (photo 1). The tailings in this area is contained by the canyon on 3 sides and the mass of 3 dam on the north. This area is used to store fine tailings which are separated out by a cyclone in the tailings pipeline.

Photo 1 – South end of TSF in Ute Creek Canyon

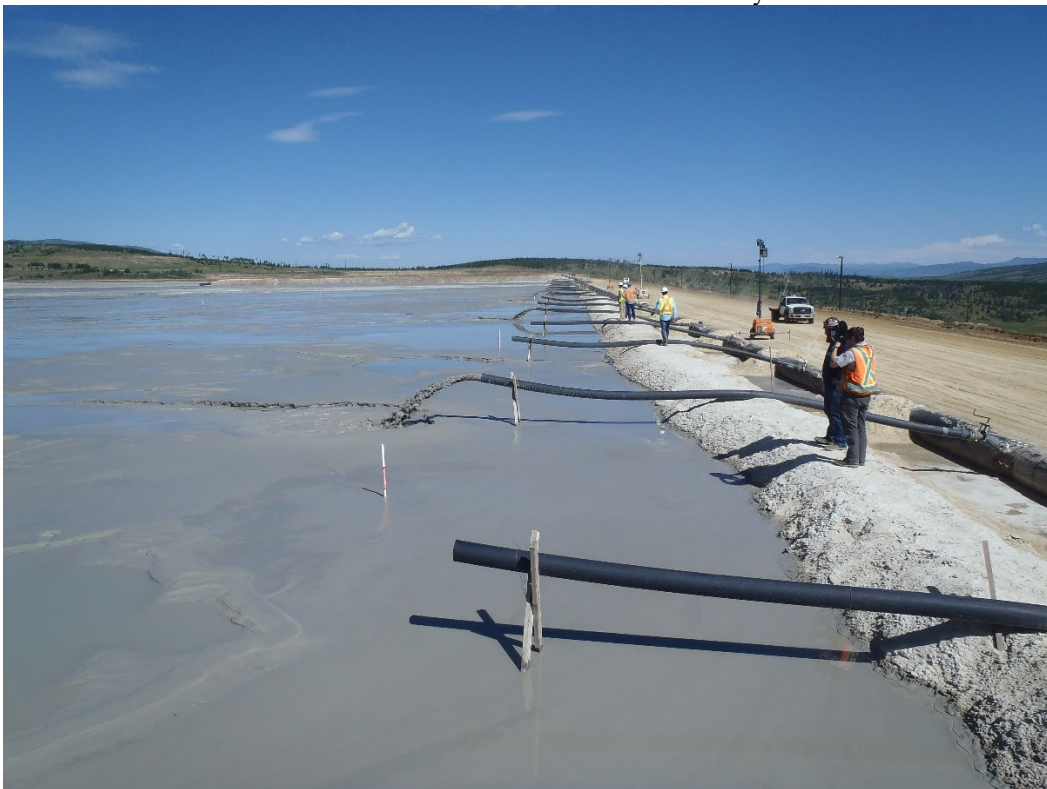
Tailings were being deposited on Dam 1. The tailings are deposited through a series of spigots located at the dam face (photo 2). The flow rate of each spigot is controlled by a mining engineer who monitors the deposition depths at each spigot to ensure an even distribution of material. A row of pvc pipes were placed vertically in the tailings at pre-determined heights next to the spigots and at 100 feet out from the spigots (photo 3). These pipes are a visual aid to monitor tailings deposition depth.

Photo 2 – Tailings line spigots depositing tailings on pile

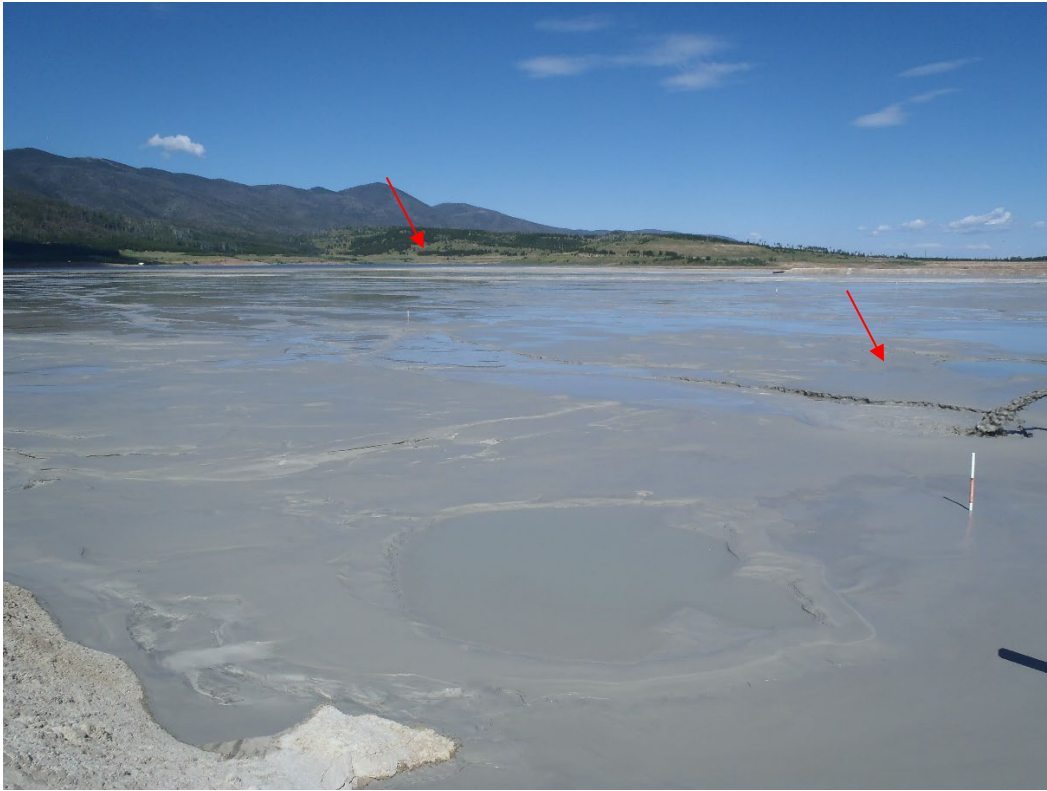
Photo 3 – PVC depth markers

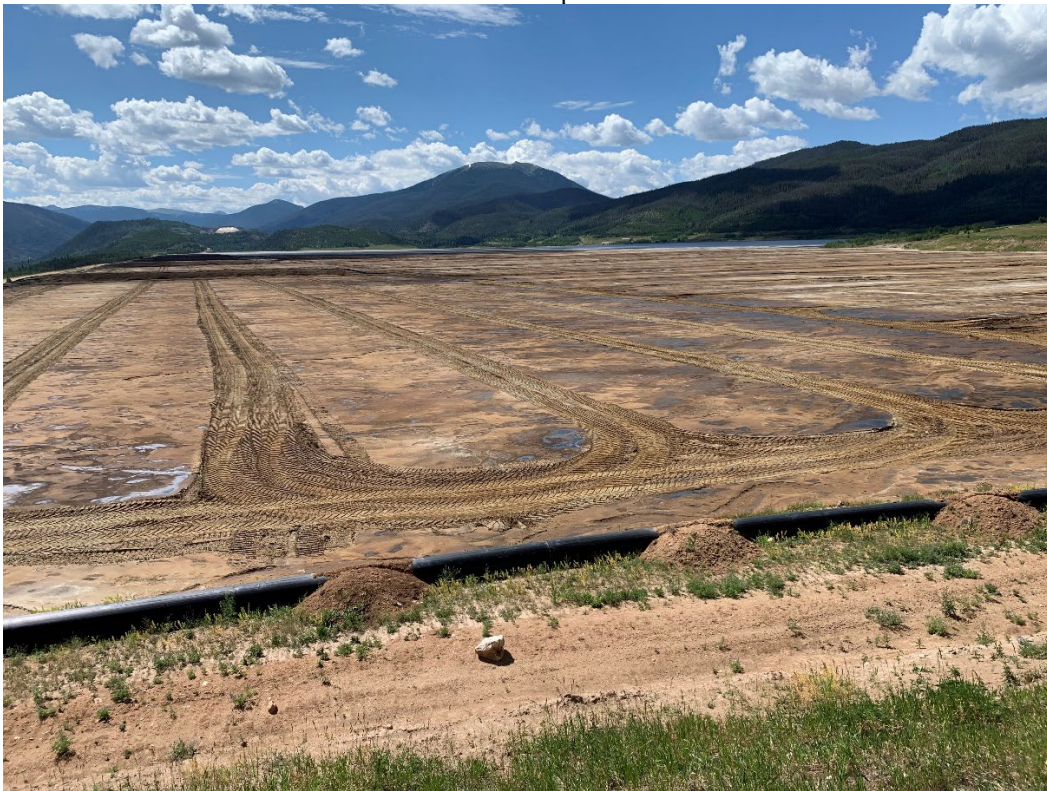
The areas on top of the TSF that were dry enough to support machinery had been treated with Coherex to control dust (photo 4). Coherex had also been applied to the dam faces.

Photo 4 – Coherex applied to top of TSF

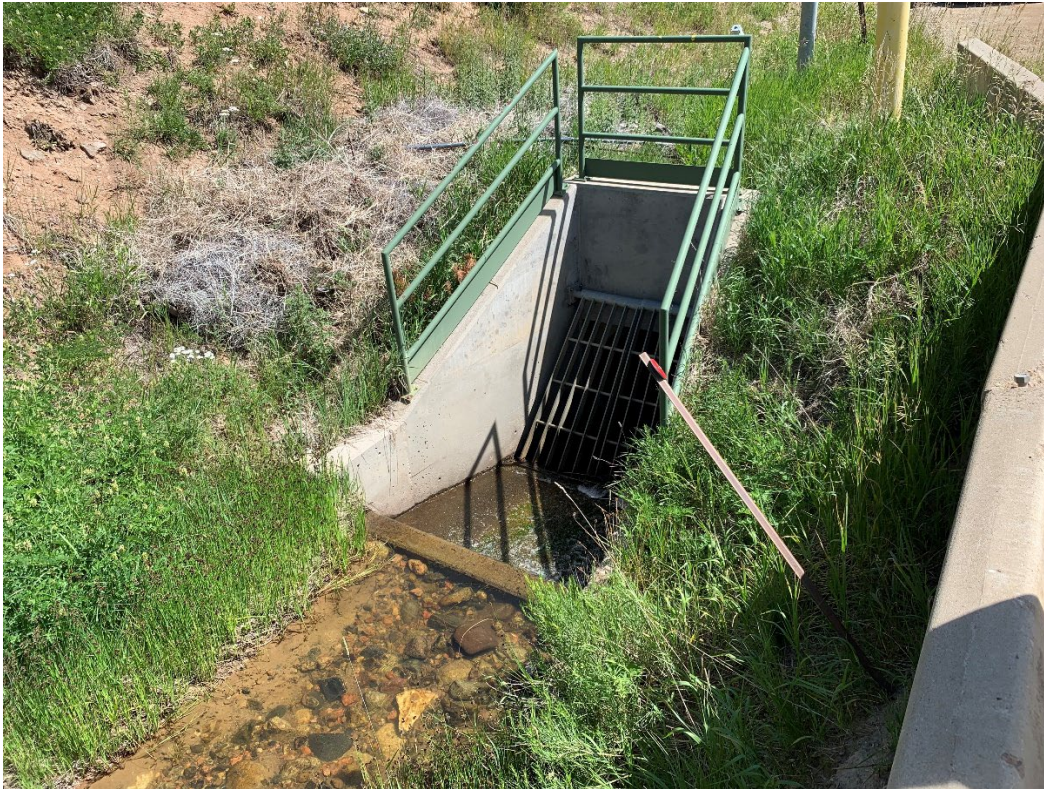
The clean water diversion around the west and north side of the TSF was in good condition. Water was flowing through the ditch and thrash rack on at the culvert entrance on the northeast side was free of obstructions (photo 5). A few small patches of cattails were seen in the ditch. The Henderson team explained they will be removed as part of the regularly scheduled maintenance this year.

Photo 5 – Clean water diversion ditch at culvert entrance

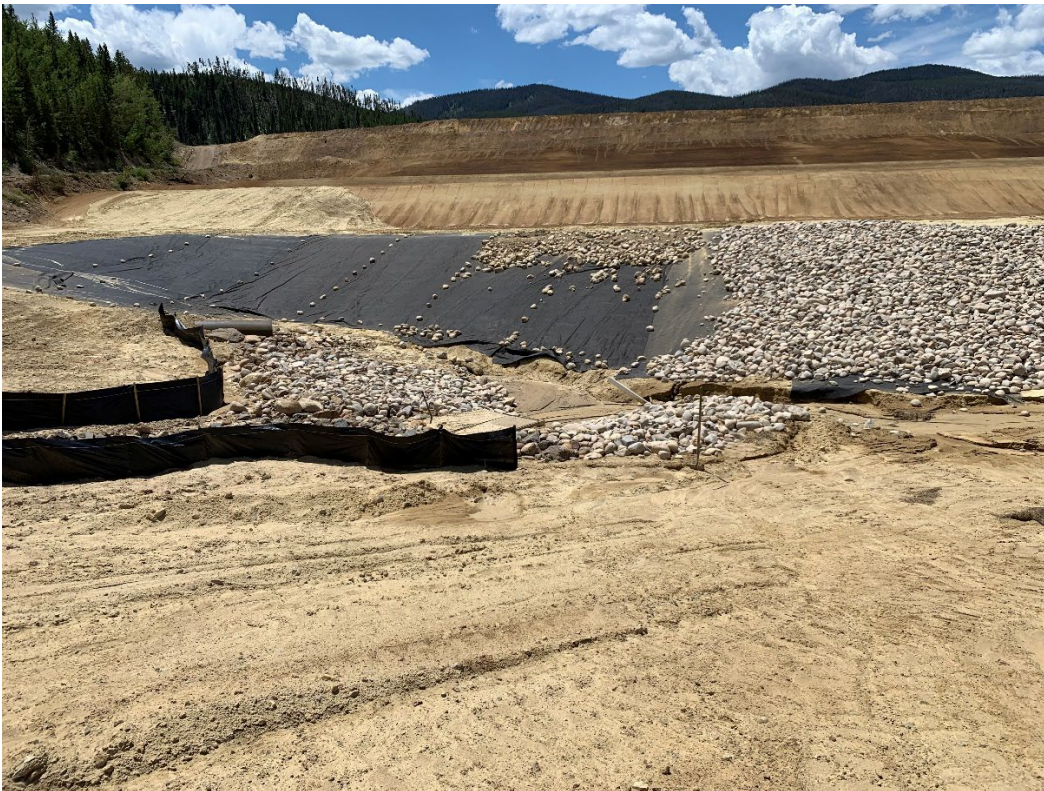
The horizontal drain wells at the toe of 1 and 3 Dams were looked at. The wells remove water that accumulates behind the dams. The water is directed into a series of ditches and culverts to the pump station. The dams and culverts were clear of obstructions. The surface drains at the 3 Dam were being ripped to control the sediment flow into the drains (photo 6).

Photo 6 – Drainages being riprapped on 3 Dam
