MINERALS PROGRAM INSPECTION REPORT
PHONE: (303) 866-3567

MINE NAME: Mahogany Research-Freeze Wall Test	MINE/PROSPECTING ID#: P-2005-017	MINERAL: Oil shale	COUNTY: Rio Blanco
INSPECTION TYPE: Monitoring	WEATHER: Clear	INSP. DATE: July 26, 2023	INSP. TIME: 07:45
OPERATOR: Shell Frontier Oil & Gas Inc.	OPERATOR REPRESENTATIVE: Samantha Baker	TYPE OF OPERATION: MP - Mineral Prospecting	
REASON FOR INSPECTION: Normal I&E Program	BOND CALCULATION TYPE: None	BOND AMOUNT: \$2,158,429.00	
DATE OF COMPLAINT: NA	POST INSP. CONTACTS: None	JOINT INSP. AGENCY: None	
INSPECTOR(S): Amy Yeldell	INSPECTOR'S SIGNATURE:

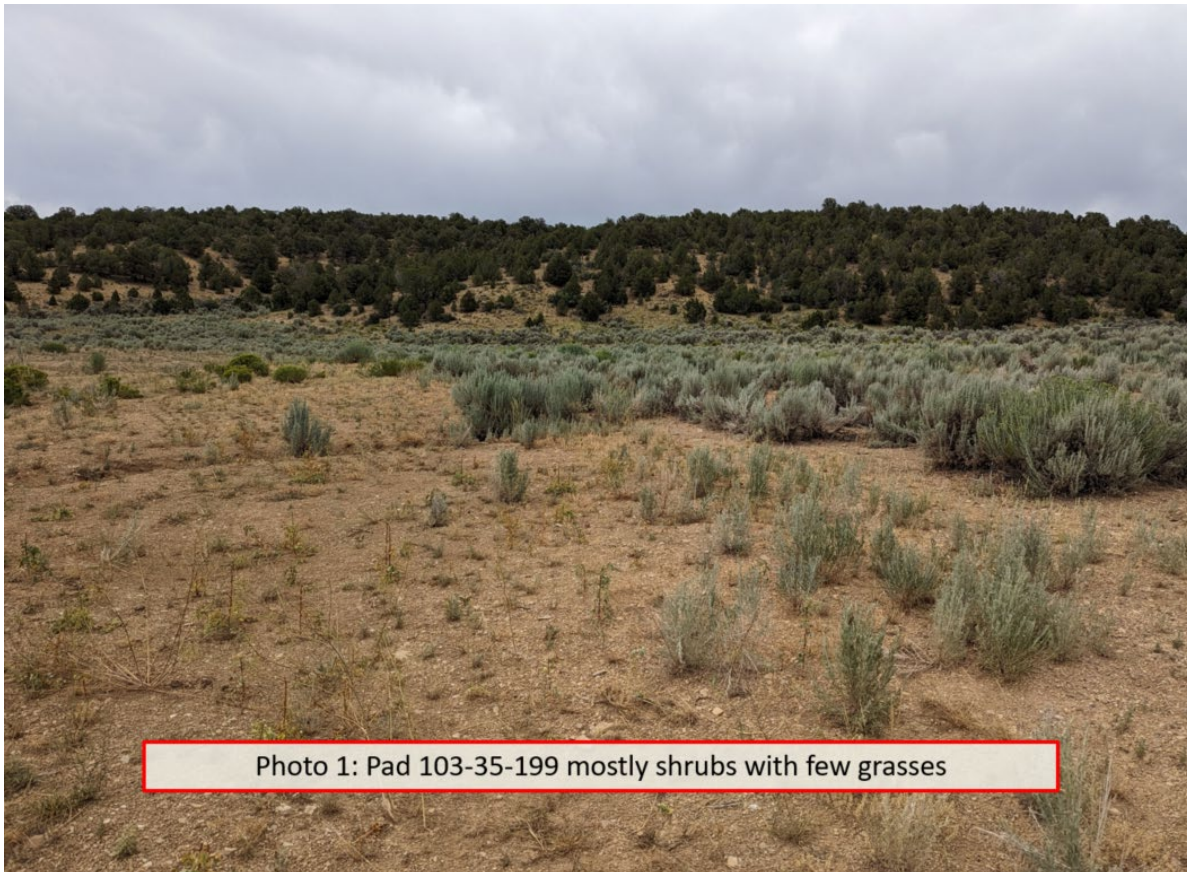
These pads were reseeded two years ago after being infested with Cheatgrass. Only the rabbit brush and sage remained. Now the vegetation is hit or miss. The pads are still primarily shrubs with patches of desirable grasses but most understory is weeds. Evidence of weed management was observed. Grazing does not appear to be negatively affecting this area

Photo 1: Pad 103-35-199 mostly shrubs with few grasses

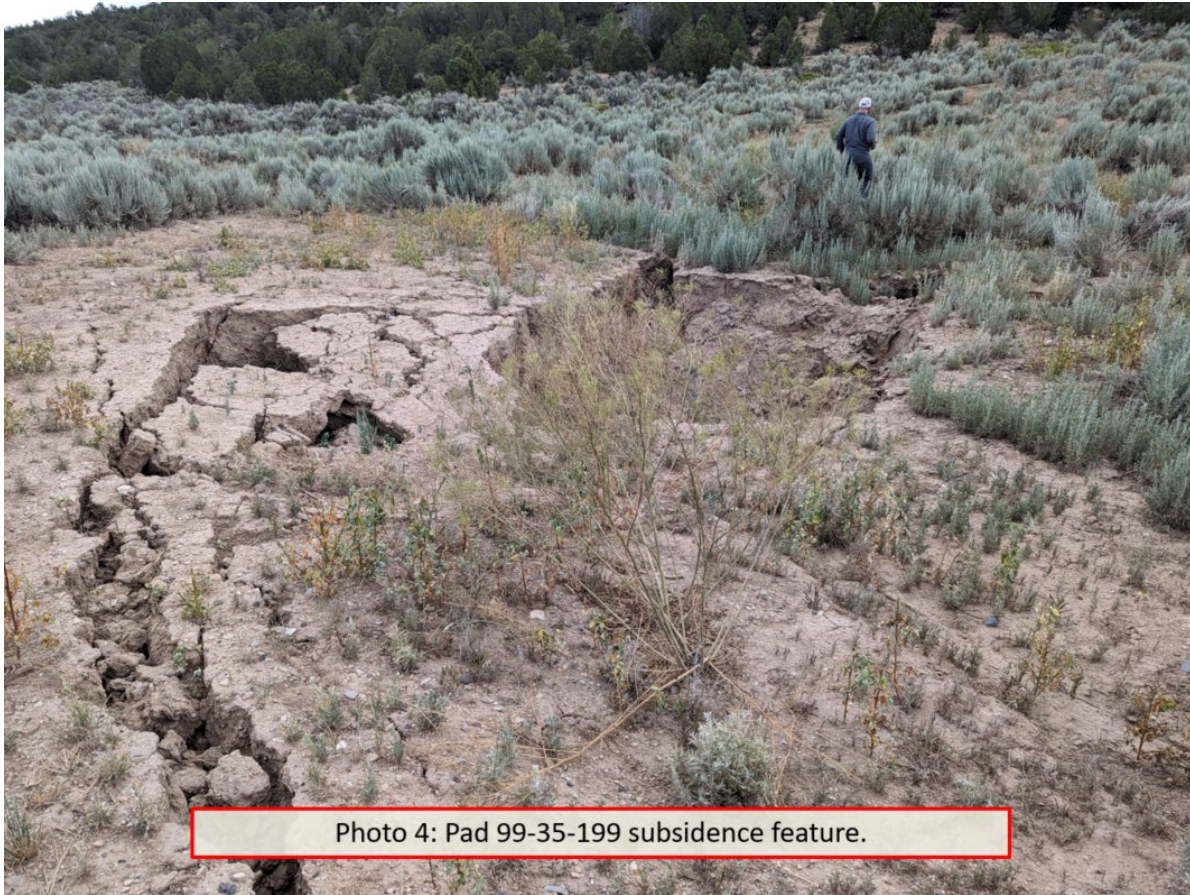
PROBLEM/POSSIBLE VIOLATION: Problem: The presence of a subsidence feature is cited as a problem pursuant to Rule 3.1.5(2) for failure to ensure adequate compaction for stability.

Pad 99-35-199 has a subsidence feature. Mr. Murray stated it is likely due to collapsible soils and the stormwater flowing differently now post reclamation. The subsidence feature is approximately 30' x 20'. At the time of the inspection soils were dry. It was indicated that an investigation is already taking place but that the final report has not yet been completed.

Photo 4: Pad 99-35-199 subsidence feature.

CORRECTIVE ACTIONS: In order to resolve this problem please provide the Division with 1) a summary of your investigation which should include an explanation as to what lead to the subsidence, documentation of the feature (size, depth, etc.) and supporting maps and pictures. 2) A remediation plan that explains how the Operator intends to repair the subsidence feature in a way that will avoid future problems. The findings and remediation plan shall be due within 60 days of this report. Completion of the repair work shall be completed within 30 days of the plan approval (with an expectation that reseeding will occur in fall of 2023).

summary of your investigation which should include an explanation as to what lead to the subsidence, documentation of the feature (size, depth, etc.) and supporting maps and pictures. 2) A remediation plan that explains how the Operator intends to repair the subsidence feature in a way that will avoid future problems. The findings and remediation plan shall be due within 60 days of this report (October 10, 2023). Completion of the repair work shall be completed within 30 days of the plan approval (with an expectation that reseedling will occur in fall of 2023). If additional land is needed for repair work beyond the permit boundary the Operator shall immediately notify the Division. No disturbances outside of the permit boundary are authorized.

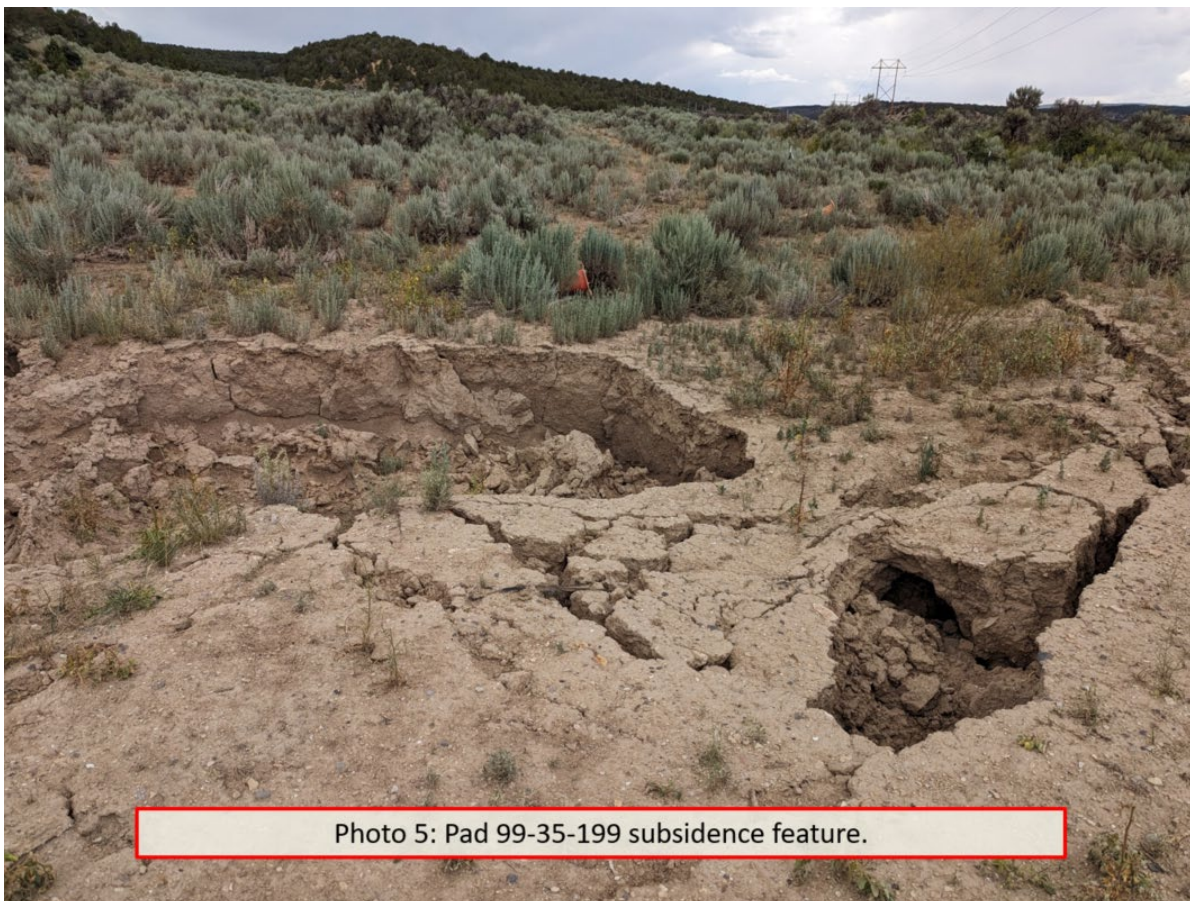
Photo 5: Pad 99-35-199 subsidence feature.

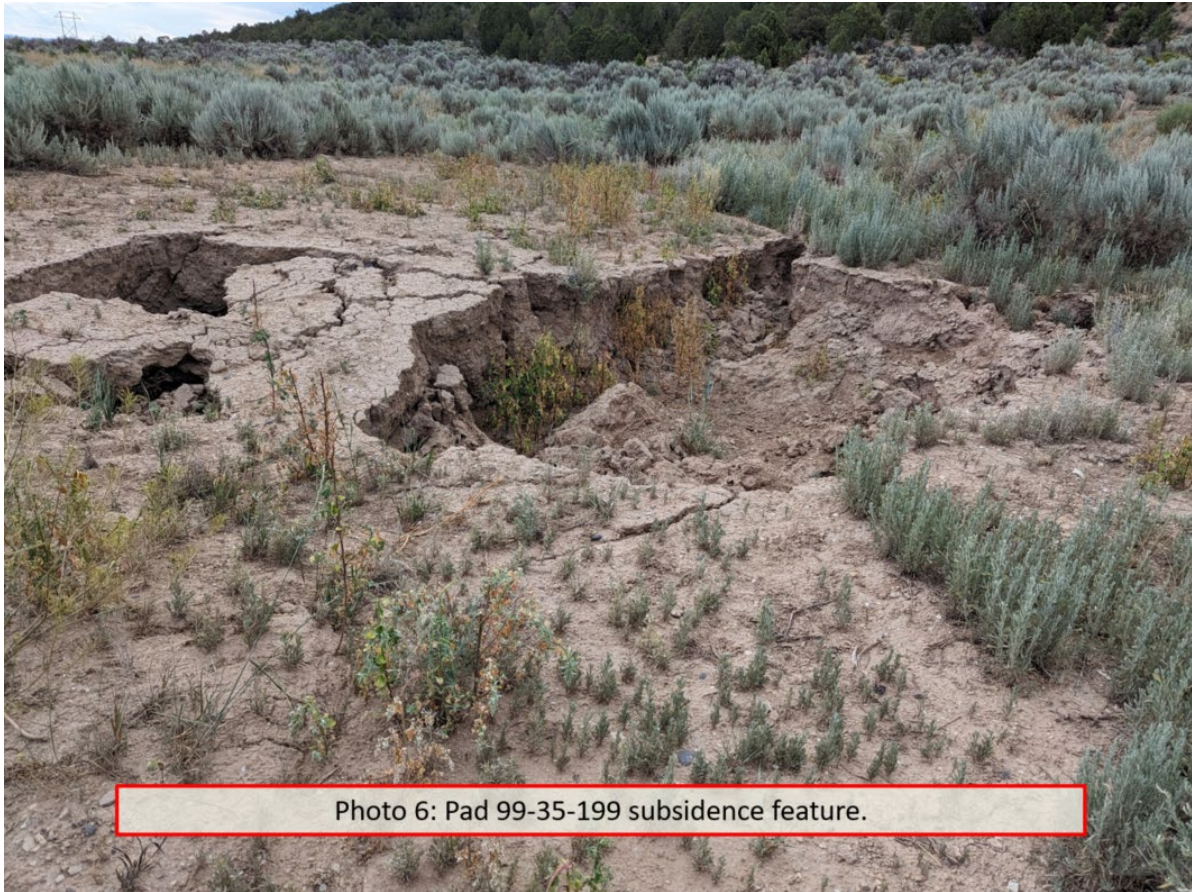
Photo 6: Pad 99-35-199 subsidence feature.

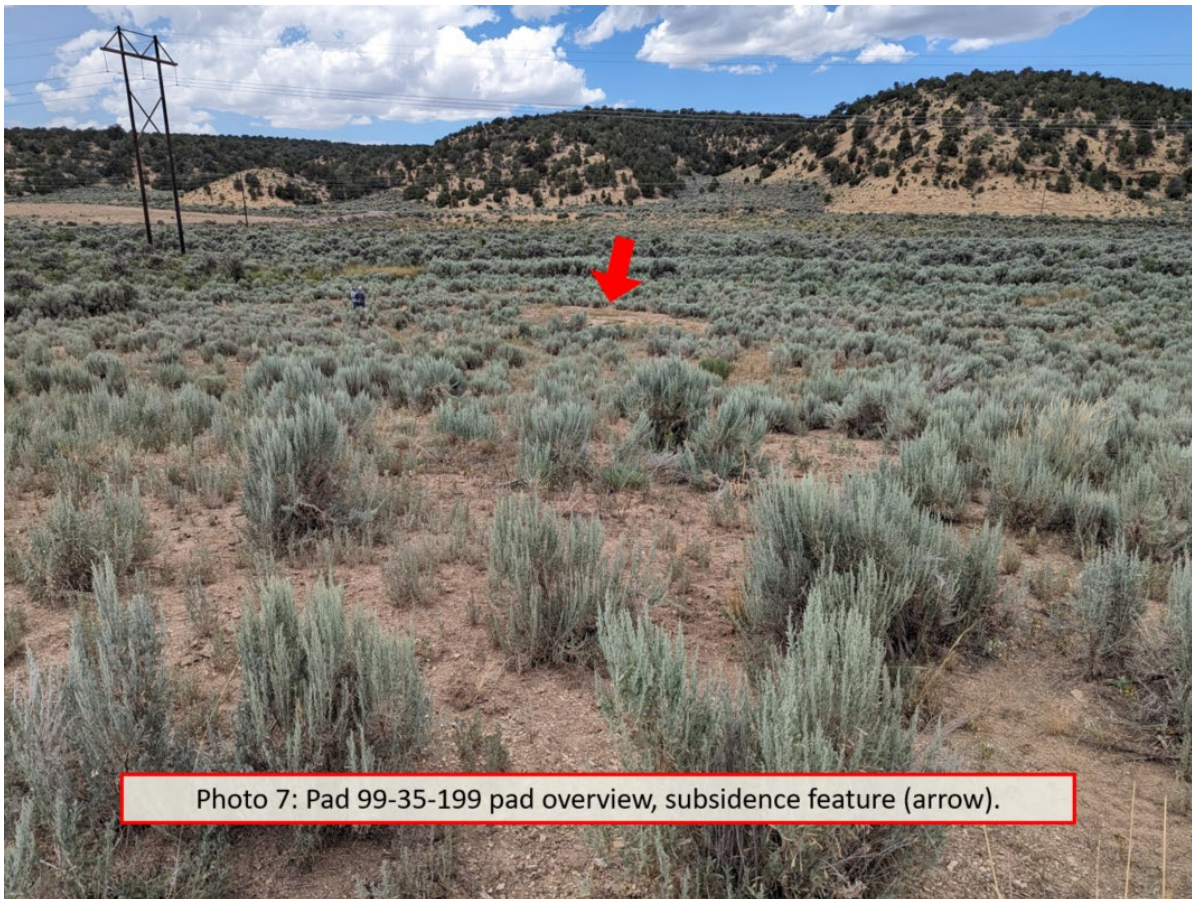
Photo 7: Pad 99-35-199 pad overview, subsidence feature (arrow).
