**MINERALS PROGRAM INSPECTION REPORT**  
**PHONE: (303) 866-3567**

<b>MINE NAME:</b> Pierce North Sand and Gravel Pit	<b>MINE/PROSPECTING ID#:</b> M-2009-062	<b>MINERAL:</b> Clay, sand, gravel	<b>COUNTY:</b> Weld
<b>INSPECTION TYPE:</b> Monitoring	<b>WEATHER:</b> Clear	<b>INSP. DATE:</b> August 10, 2023	<b>INSP. TIME:</b> 11:30
<b>OPERATOR:</b> Weld County Public Works	<b>OPERATOR REPRESENTATIVE:</b> Nate Gibson, Clay Kimmi	<b>TYPE OF OPERATION:</b> 112c - Construction Regular Operation	
<b>REASON FOR INSPECTION:</b> Normal I&E Program	<b>BOND CALCULATION TYPE:</b> Complete Bond	<b>BOND AMOUNT:</b> \$0.00	
<b>DATE OF COMPLAINT:</b> NA	<b>POST INSP. CONTACTS:</b> None	<b>JOINT INSP. AGENCY:</b> None	
<b>INSPECTOR(S):</b> Eric Scott	<b>INSPECTOR'S SIGNATURE:</b>

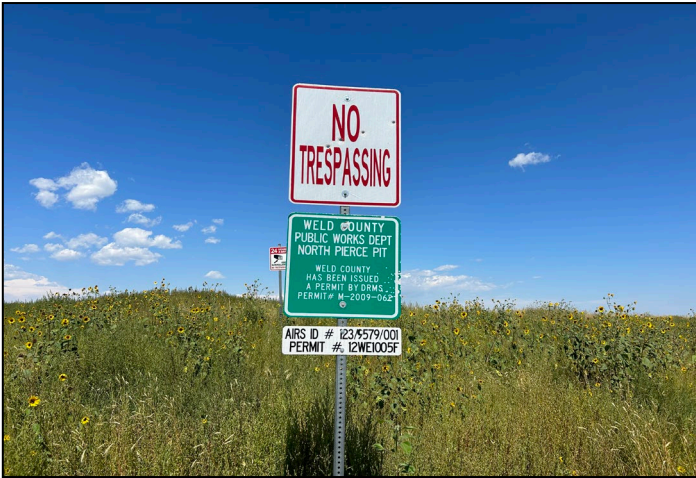
**Photo 1 – Site identification sign at SE corner of permit area.**

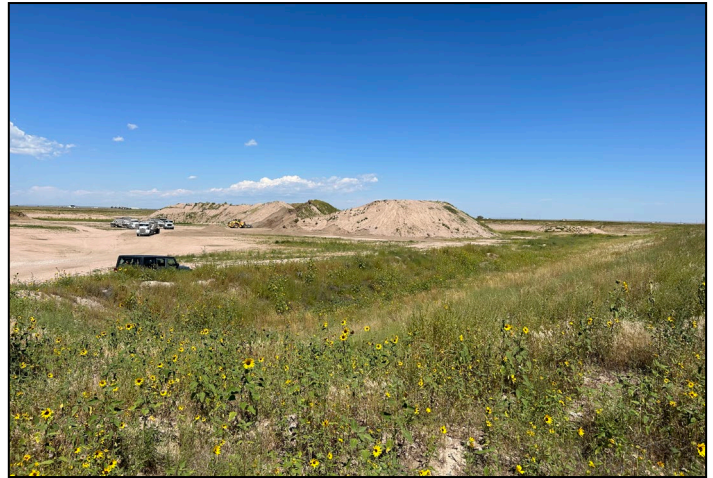
**Photo 2 – Site entrance looking NW at truck loading from material stockpile located in NE area of permit.**

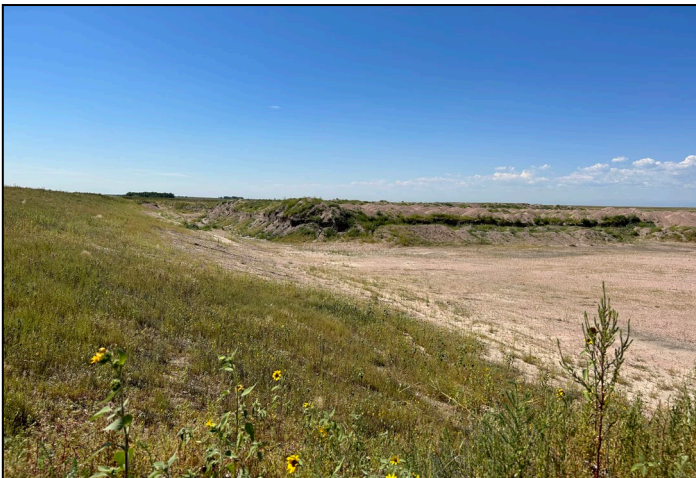
**Photo 3 – Site entrance looking S at excavated perimeter around unmined SE permit area.**

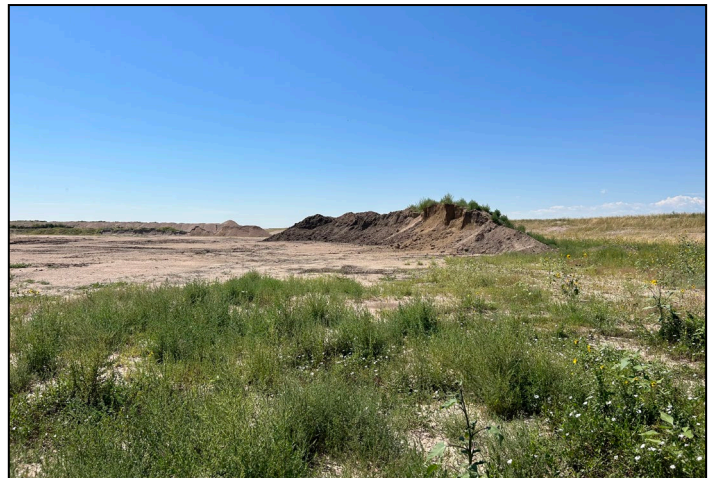
The only issue noted during this inspection that will require attention by the county is the concentration of weedy species becoming established in the currently affected areas of the site (Photos 4 and 5). Although it has not been cited in this report as a problem because most of the site will still require earthwork prior to final reclamation, species such as sunflower, bindweed, thistle, cheat grass and Russian thistle were observed in the currently affected areas of the permit. Weld County should try to minimize the concentrations of these undesirable species during operations, so they do not become a serious problem and delay the final reclamation.

**Photo 4 – Topsoil stockpile in NE permit area – Russian thistle and bindweed are primary vegetation in foreground of photo.**

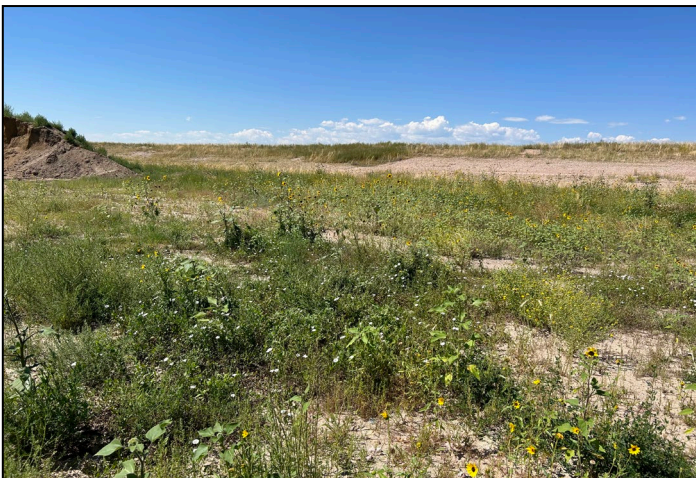
**Photo 5 – disturbed area in NE permit area – Russian thistle, sunflower, and bindweed are primary vegetation in foreground of photo.**
