MINERALS PROGRAM INSPECTION REPORT
PHONE: (303) 866-3567

| MINE NAME: Wagner Rock Pit | MINE/PROSPECTING ID#: M-1999-018 | MINERAL: Gravel | COUNTY: Moffat |
| INSPECTION TYPE: Monitoring | WEATHER: Clear | INSP. DATE: July 25, 2023 | INSP. TIME: 14:30 |

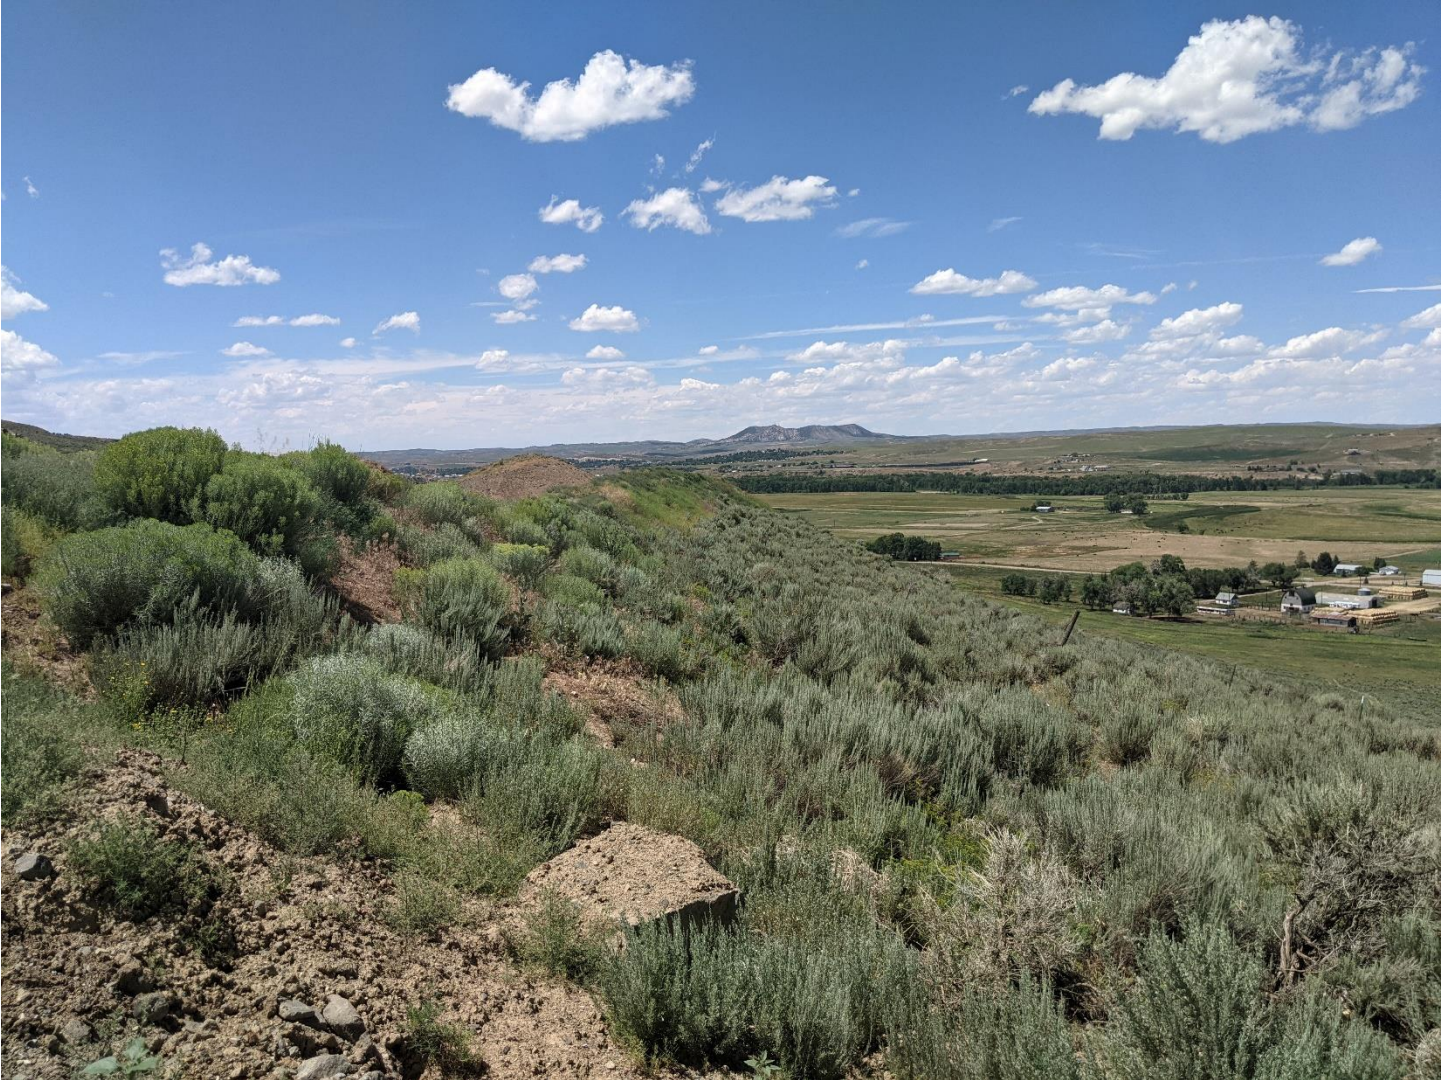
Picture 1.

the crest of the berm to the north is where the disturbance boundary meets the native slope which is relatively steep. This slope is mostly undisturbed and native (Pictures 1, 2 and 3). A ditch exists southwest of the mine along with two retention ponds. These surface water control features capture water from the remaining portion of the site in which the surface dips south and west as shown on the approved map, Exhibit C - Mining Plan Map, Water Control Features. The retention ponds were dry during the inspection and the ditch was stable and functional. To the west of the site, there is a natural drainage that begins just along the western pit disturbance. This drainage directs potential runoff in the direction of the Murphy Spring which is the spring of concern listed within the complaint. The Murphy Spring is located approximately 850' from the nearest mining disturbance and surface water would have to travel approximately 1200' per the approved Exhibit G of the mining permit. This drainage (Picture 5) was walked until the permit boundary was encountered. The drainage is undisturbed native ground that is well vegetated and there was no erosion encountered within the permit boundary. The nearest mining disturbance is graded to the east with a slope of approximately 3H:1V so that no disturbed surface runoff can flow in the direction of the drainage. Overall, no off-site impacts such as mining outside of the approved boundary, surface runoff, erosion, and/or gullyng that would be associated with the mine was observed.

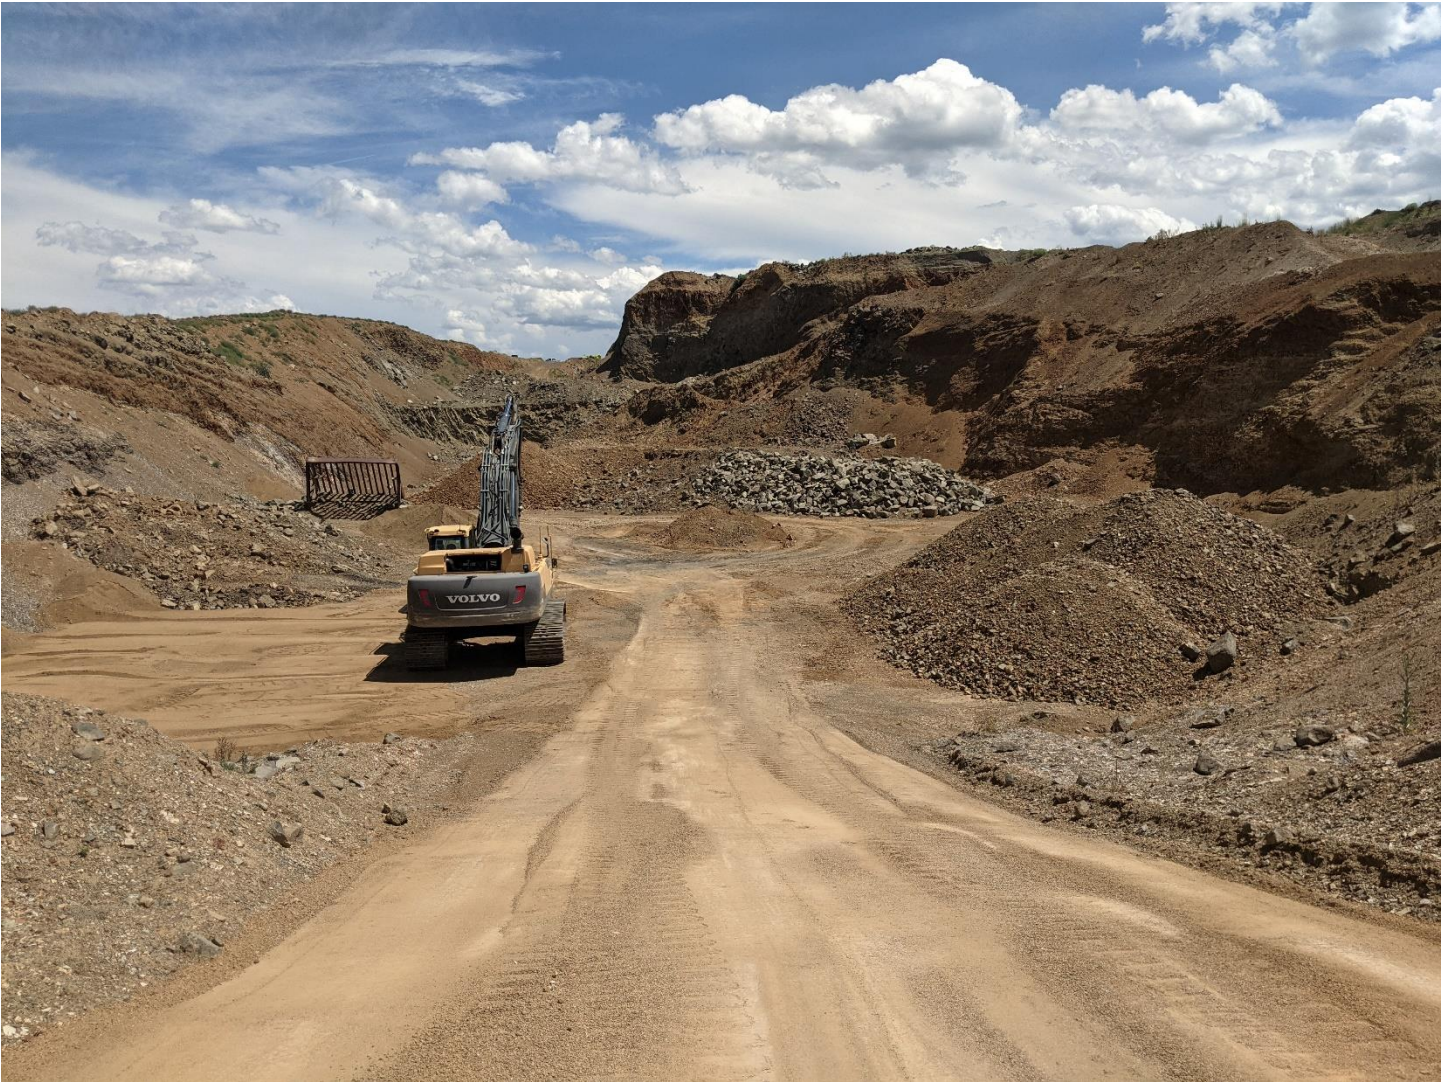
Picture 7.

As noted earlier, the excavated pit along with its associated highwalls were inspected (Pictures 7 and 8). The purpose for this was to look for any groundwater exposure, seeps or springs along the pit floor and highwalls that could indicate potential impacts to the Murphy Spring. The pit was inspected beginning from the west, nearest to the Murphy Spring, and walked in a counter-clockwise direction. During the inspection, there were no visible signs of any seeps or springs within any of the highwalls or groundwater coming from the pit floor. The pit floor and highwalls were completely dry, indicating the mining operation is occurring above the water table.
