**MINERALS PROGRAM INSPECTION REPORT**  
**PHONE: (303) 866-3567**

<b>MINE NAME:</b> Betz Borrow Pit	<b>MINE/PROSPECTING ID#:</b> M-2018-048	<b>MINERAL:</b> Borrow material for construction	<b>COUNTY:</b> Weld
<b>INSPECTION TYPE:</b> Monitoring	<b>WEATHER:</b> Clear	<b>INSP. DATE:</b> July 20, 2023	<b>INSP. TIME:</b> 10:50
<b>OPERATOR:</b> SEMA Construction, Inc.	<b>OPERATOR REPRESENTATIVE:</b> Tyson Geist	<b>TYPE OF OPERATION:</b> 111 - Construction by Government Agency	
<b>REASON FOR INSPECTION:</b> Normal I&E Program	<b>BOND CALCULATION TYPE:</b> None	<b>BOND AMOUNT:</b> \$74,925.00	
<b>DATE OF COMPLAINT:</b> NA	<b>POST INSP. CONTACTS:</b> None	<b>JOINT INSP. AGENCY:</b> None	
<b>INSPECTOR(S):</b> Robert Zuber, P.E.	<b>INSPECTOR'S SIGNATURE:</b>

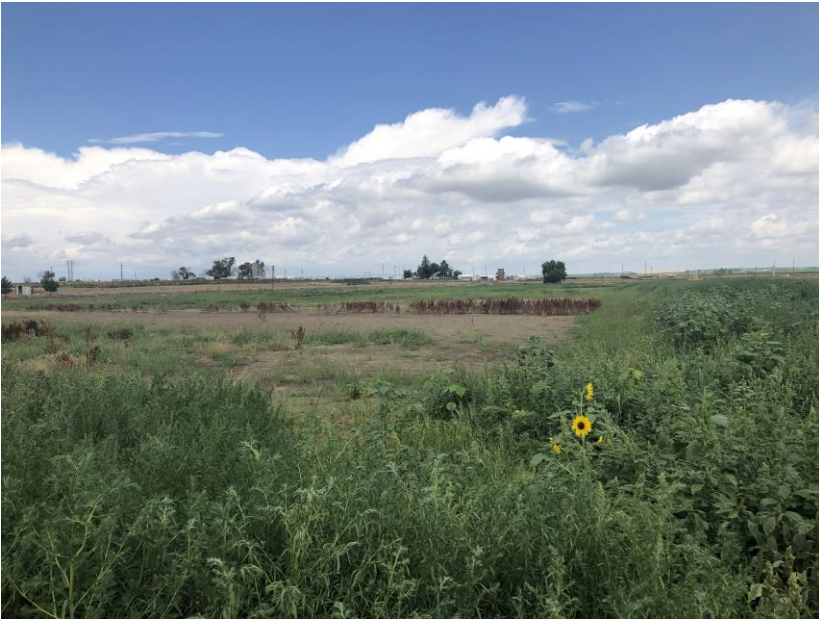
The approved post-mining land use for the site is rangeland. Much of the vegetation on the site consisted of desirable grasses, however, large bare spots were observed, and non-desirable species were also seen. These included thistle, kochia, curly dock, and cheatgrass. Only a small amount of thistle was observed. Tyson Geist indicated that weeds at the site are controlled with mowing and spraying (spraying done by the landowner).

**Large bare area near southwest corner**

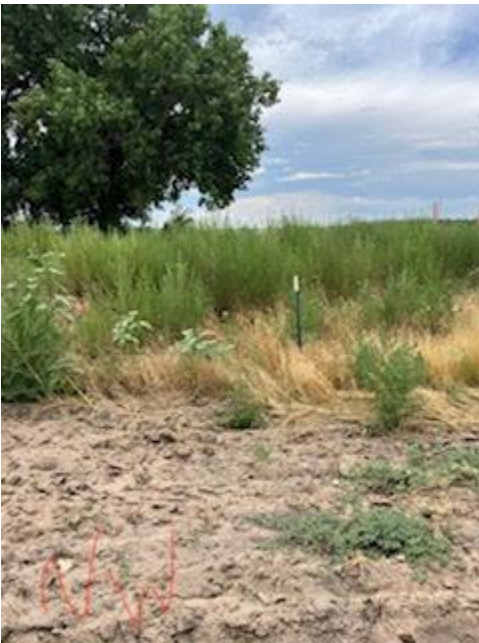
**Boundary marker at northwest corner**

The mine identification sign was in place and contained the required information. Boundary markers were not observed or appeared to be in the wrong locations. They apparently had been moved by the landowner or knocked down. Tyson Geist had his surveyor replace the markers after the inspection, and photos are included in this report.
