MINERALS PROGRAM INSPECTION REPORT
PHONE: (303) 866-3567

MINE NAME: 2006/07 Geo-Hydro Drill & Core Prgm-Public-PRL's	MINE/PROSPECTING ID#: P-2006-037	MINERAL: Oil shale	COUNTY: Rio Blanco
INSPECTION TYPE: Monitoring	WEATHER: Clear	INSP. DATE: July 25, 2023	INSP. TIME: 07:30
OPERATOR: Shell Frontier Oil & Gas Inc.	OPERATOR REPRESENTATIVE: Samantha Baker	TYPE OF OPERATION: MP - Mineral Prospecting	
REASON FOR INSPECTION: Normal I&E Program	BOND CALCULATION TYPE: None	BOND AMOUNT: \$168,818.66	
DATE OF COMPLAINT: NA	POST INSP. CONTACTS: None	JOINT INSP. AGENCY: U.S.BLM	
INSPECTOR(S): Amy Yeldell	INSPECTOR'S SIGNATURE:

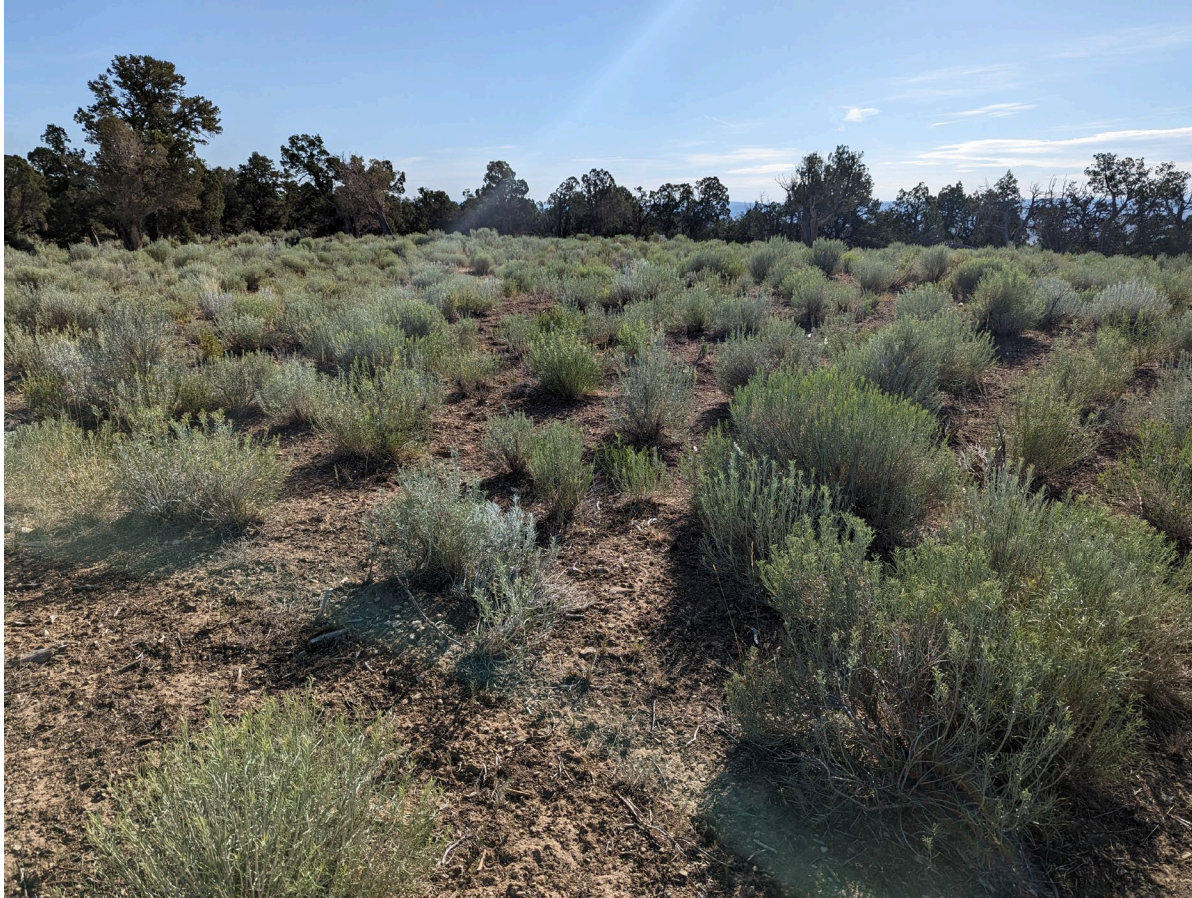
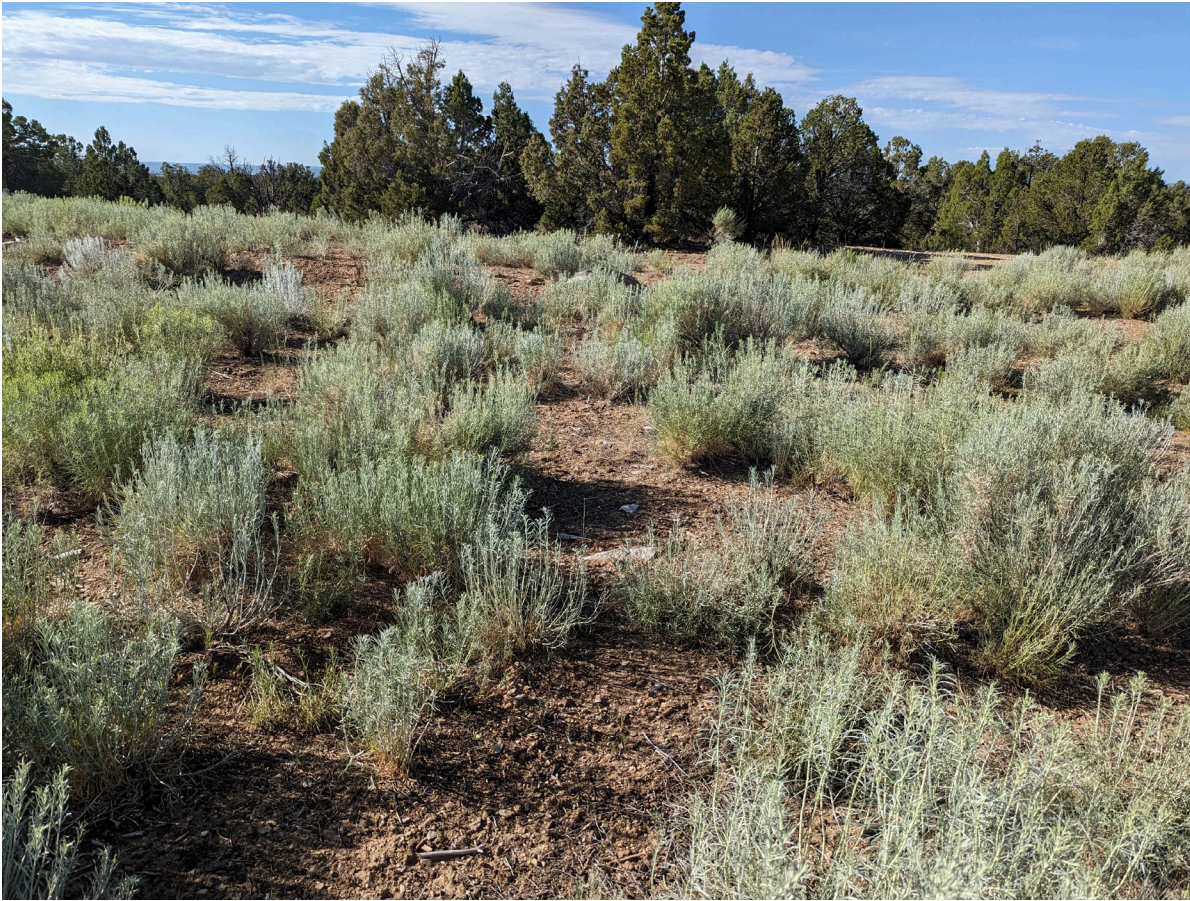
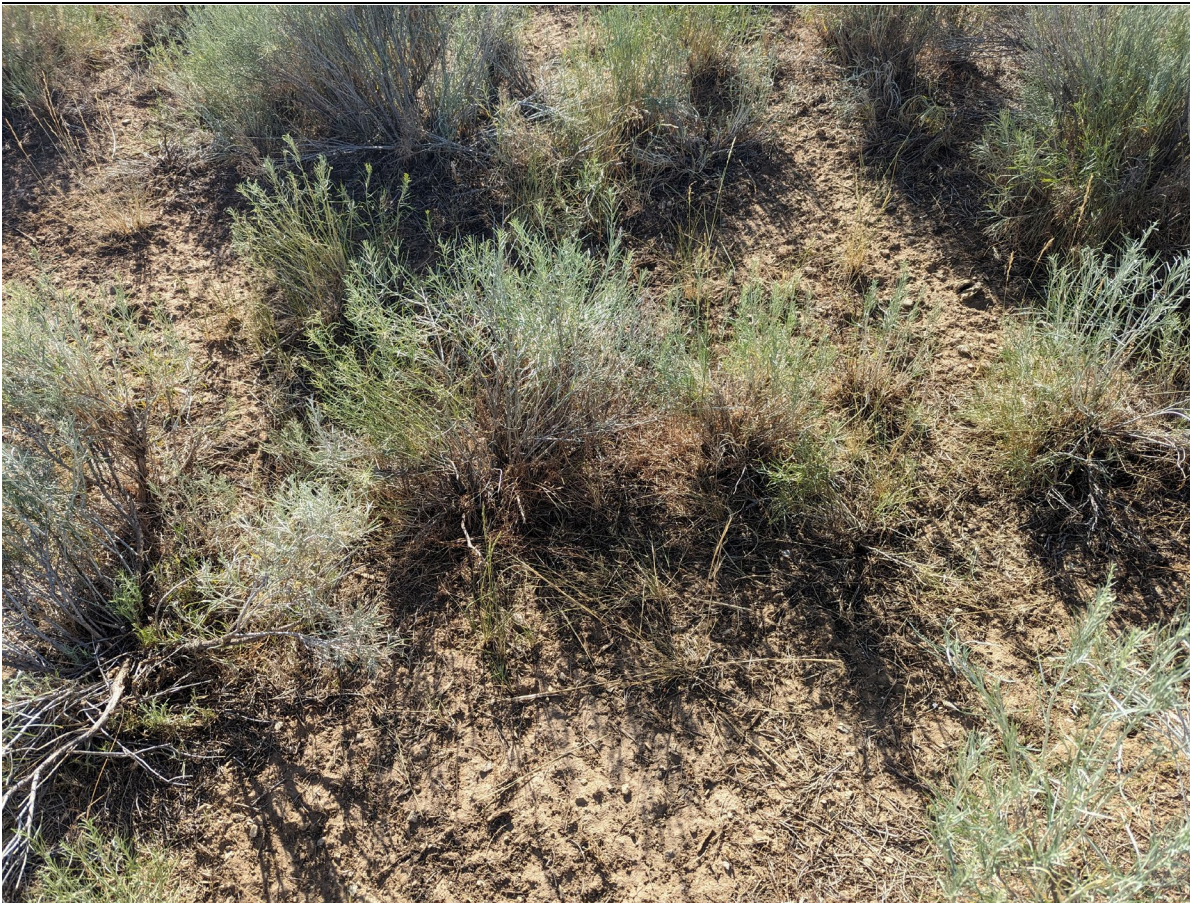
Pad 71-8-298: The predominant cover type remains to be Rabbit brush which seems to be only minimally affected by grazing. Some desirable understory (grasses) are present but have been grazed. Weeds are much better this year, continue to monitor and treat weeds. Likely eligible for release next year if conditions continue to improve.
