MINERALS PROGRAM INSPECTION REPORT
PHONE: (303) 866-3567

MINE NAME: 2007 Geo-hydrology Drilling and Coring Prgm-Ryan Gulch & Sta	MINE/PROSPECTING ID#: P-2007-010	MINERAL: Oil shale	COUNTY: Rio Blanco
INSPECTION TYPE: Monitoring	WEATHER: Clear	INSP. DATE: July 25, 2023	INSP. TIME: 07:30
OPERATOR: Shell Frontier Oil & Gas Inc.	OPERATOR REPRESENTATIVE: Samantha Baker	TYPE OF OPERATION: MP - Mineral Prospecting	
REASON FOR INSPECTION: Normal I&E Program	BOND CALCULATION TYPE: None	BOND AMOUNT: \$182,306.06	
DATE OF COMPLAINT: NA	POST INSP. CONTACTS: None	JOINT INSP. AGENCY: None	
INSPECTOR(S): Amy Yeldell	INSPECTOR'S SIGNATURE:

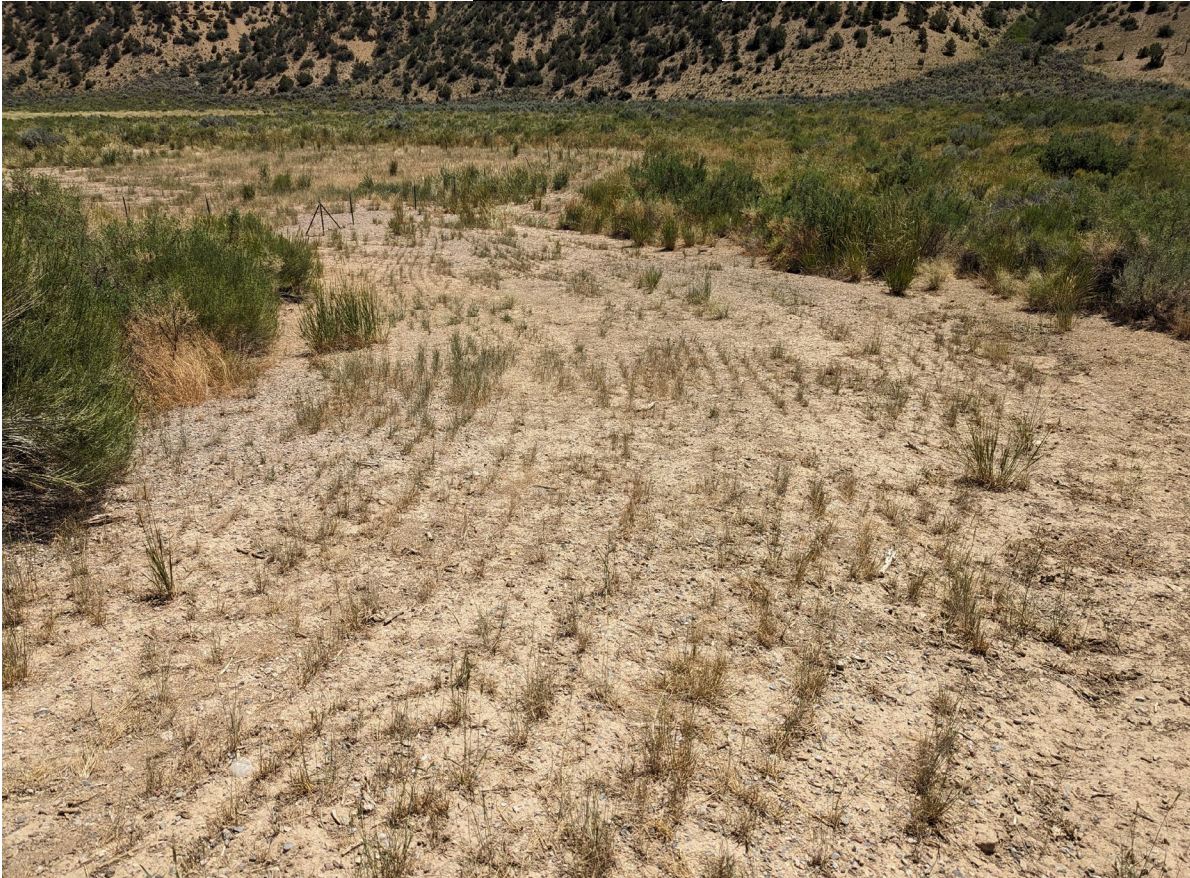
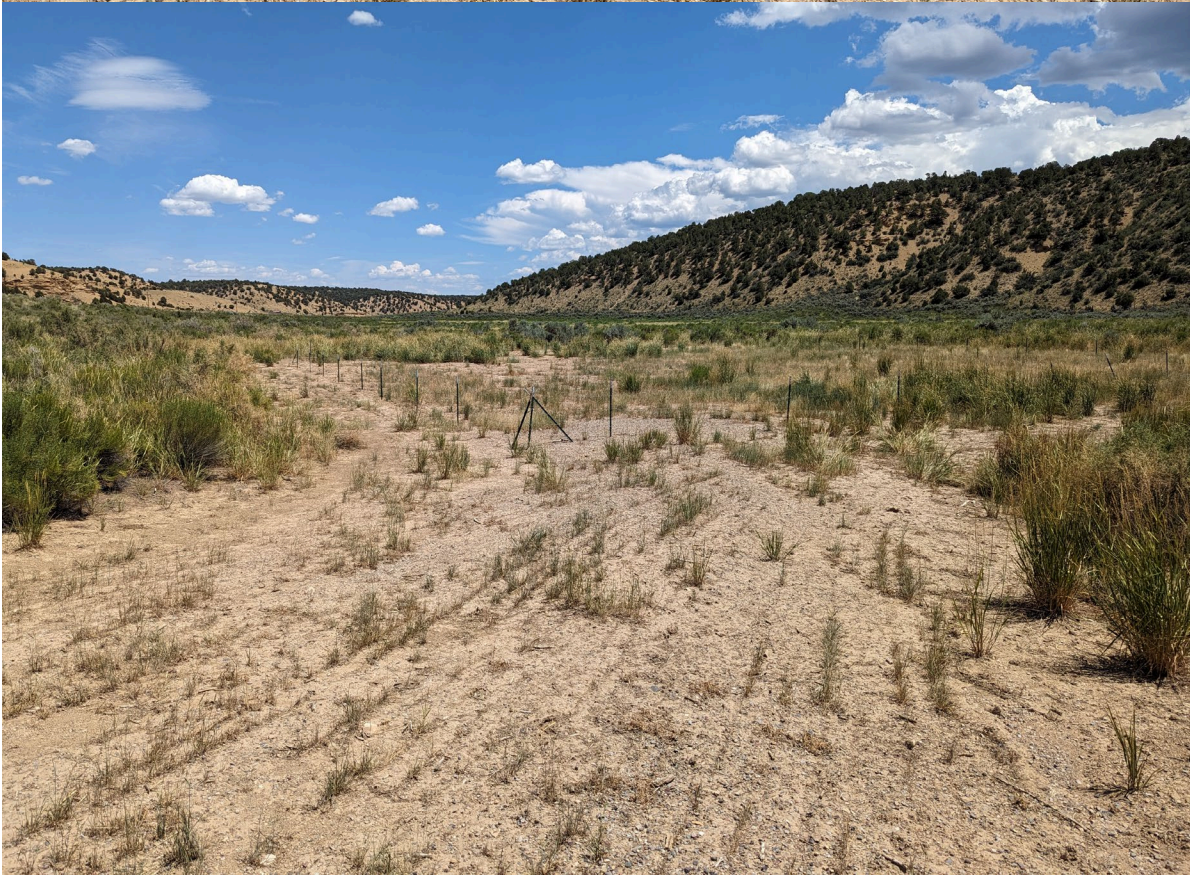
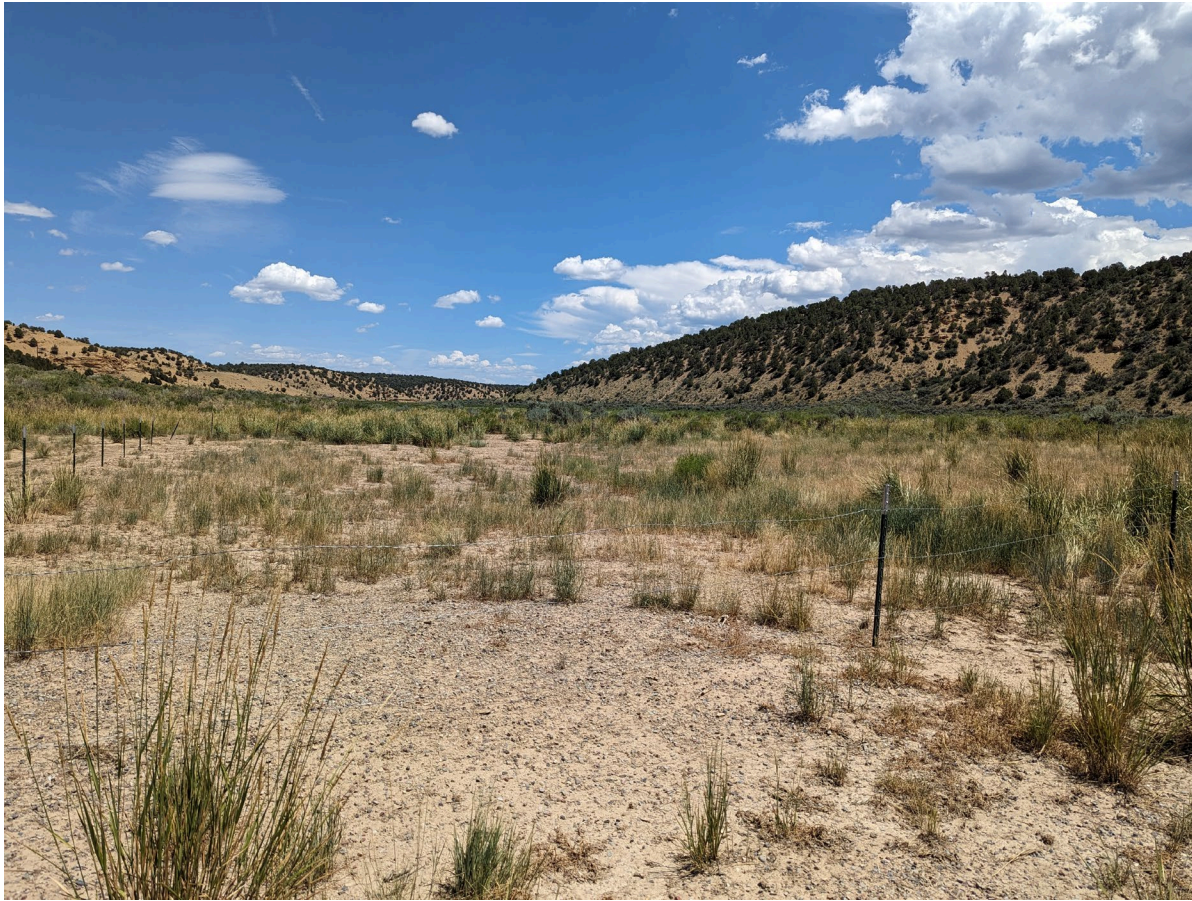
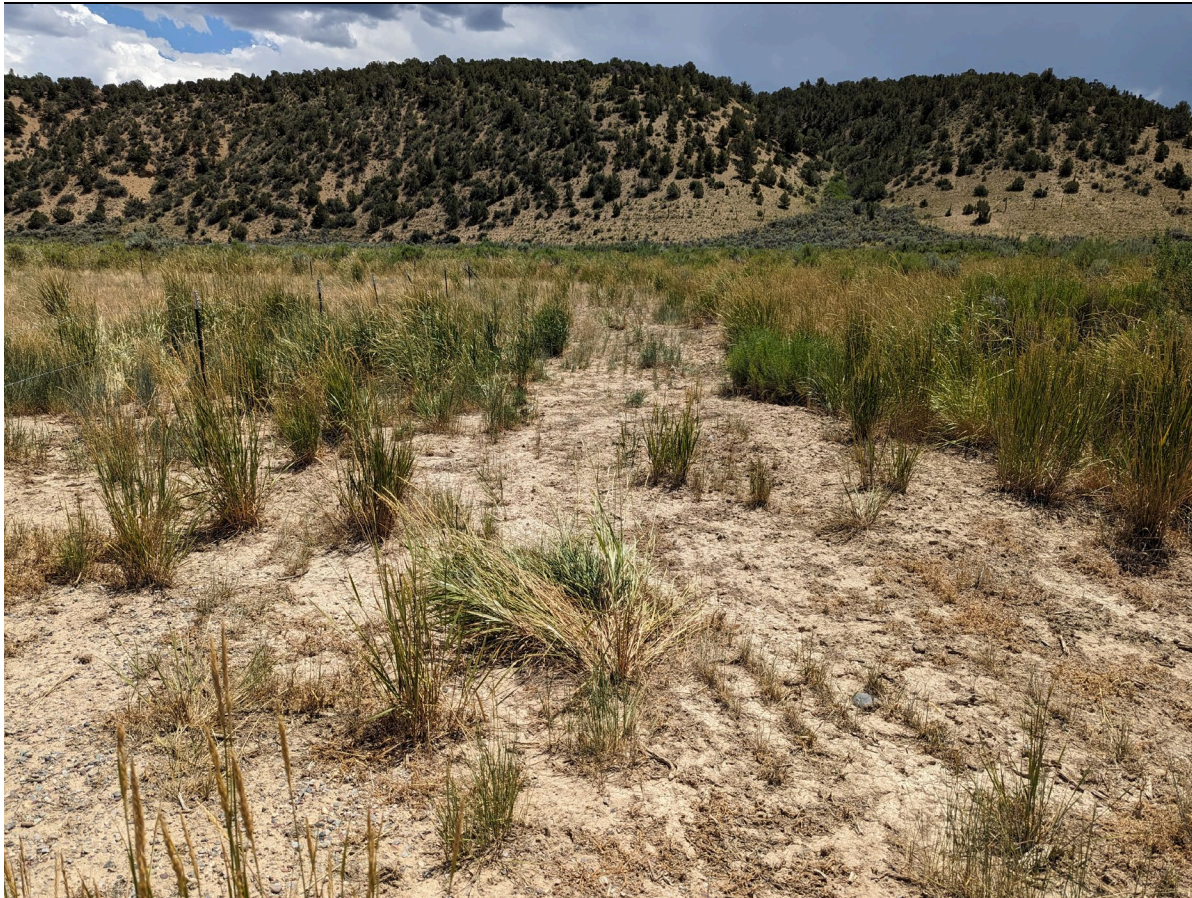
PHOTOGRAPHS

All hydrology wells have been abandoned and grading work was completed a number of years ago. The last reclamation efforts were completed in 2016 and now is awaiting adequate vegetation establishment. The pad is fenced off from grazing but the short access road is not. Over all the pad is stable with no signs of erosion. Vegetative growth on the pad is steadily increasing and appears mostly well established. There are a few patches with significantly less growth. The access road is very gravelly, which may be inhibiting reclamation success. Vegetation on the access road is significantly less than on the pad.
