**MINERALS PROGRAM INSPECTION REPORT**  
**PHONE: (303) 866-3567**

<b>MINE NAME:</b> Revenue Mine	<b>MINE/PROSPECTING ID#:</b> M-2012-032	<b>MINERAL:</b> Lead, silver and gold	<b>COUNTY:</b> Ouray
<b>INSPECTION TYPE:</b> Monitoring	<b>WEATHER:</b> Clear	<b>INSP. DATE:</b> July 20, 2023	<b>INSP. TIME:</b> 08:58
<b>OPERATOR:</b> Ouray Silver Mines Inc.	<b>OPERATOR REPRESENTATIVE:</b> CJ Dickerson	<b>TYPE OF OPERATION:</b> 112d-1 - Designated Mining Operation	
<b>REASON FOR INSPECTION:</b> Normal I&E Program	<b>BOND CALCULATION TYPE:</b>	<b>BOND AMOUNT:</b> \$517,219.00	
<b>DATE OF COMPLAINT:</b> NA	<b>POST INSP. CONTACTS:</b> None	<b>JOINT INSP. AGENCY:</b> None	
<b>INSPECTOR(S):</b> Lucas West	<b>INSPECTOR'S SIGNATURE:</b>

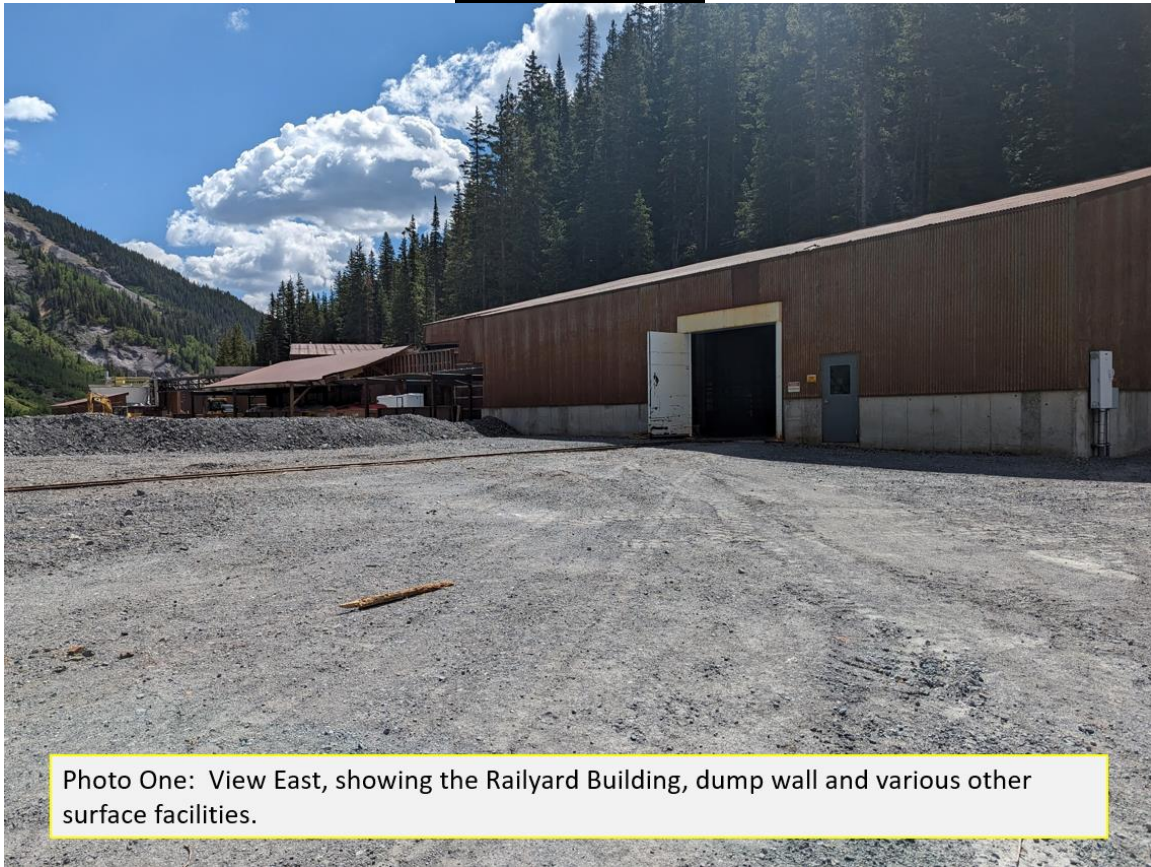
All Surface facilities including the materials storage warehouse, waste storage building, railyard building, compressor building and admin building are in good condition. Examples of the surface facilities including the railyard building can be seen in Photos One and Two. All hazardous materials stored in the waste storage building and materials storage warehouse is stored on appropriate spill pallets and was neat and orderly. The storage areas can be seen in Photos Three and Four. The onsite fuel storage tanks were observed and are in good condition with no evidence of leaks or spills. The dump wall and associated stockpiles of waste rock appeared to be stable at the time of the inspection and no evidence of significant erosion was noted. Throughout the entire site, despite the recent Precipitation, no evidence of erosion was observed. All observed storm water control structures appeared to be functioning as designed.

Photo One: View East, showing the Railyard Building, dump wall and various other surface facilities.

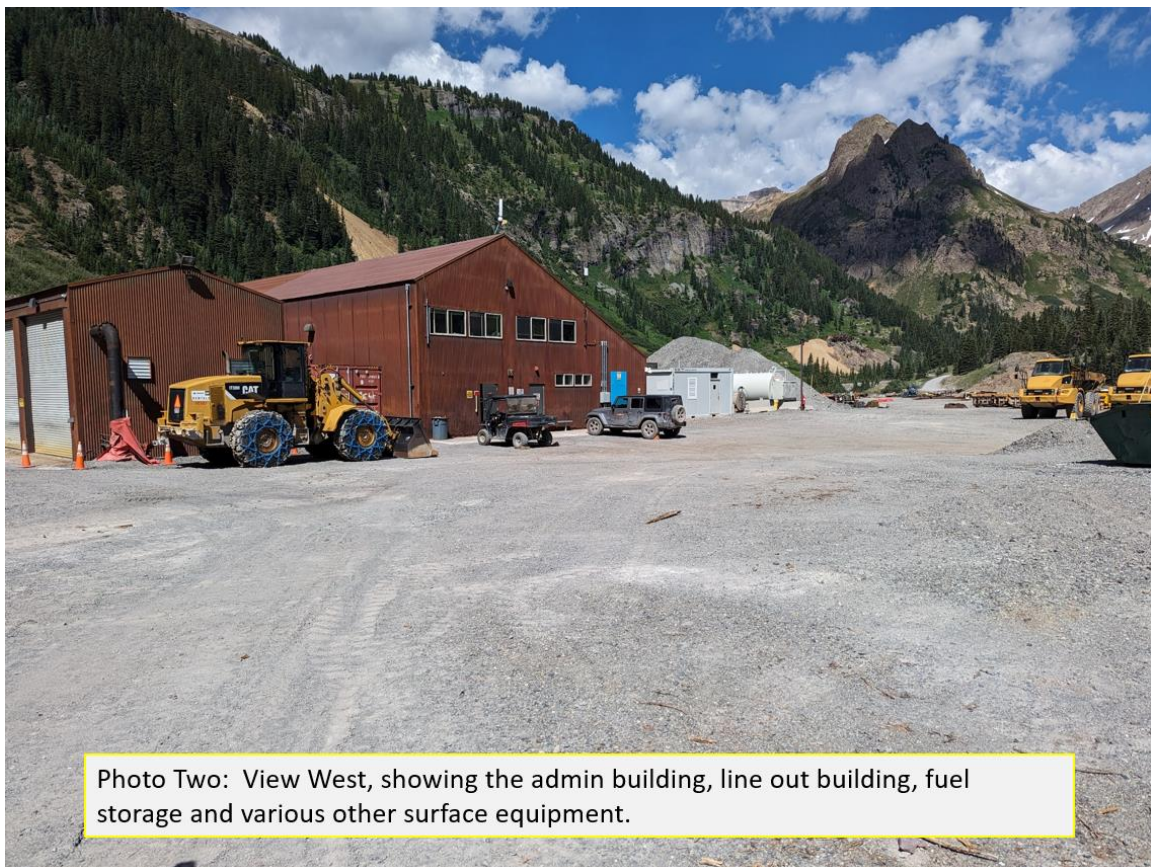
Photo Two: View West, showing the admin building, line out building, fuel storage and various other surface equipment.

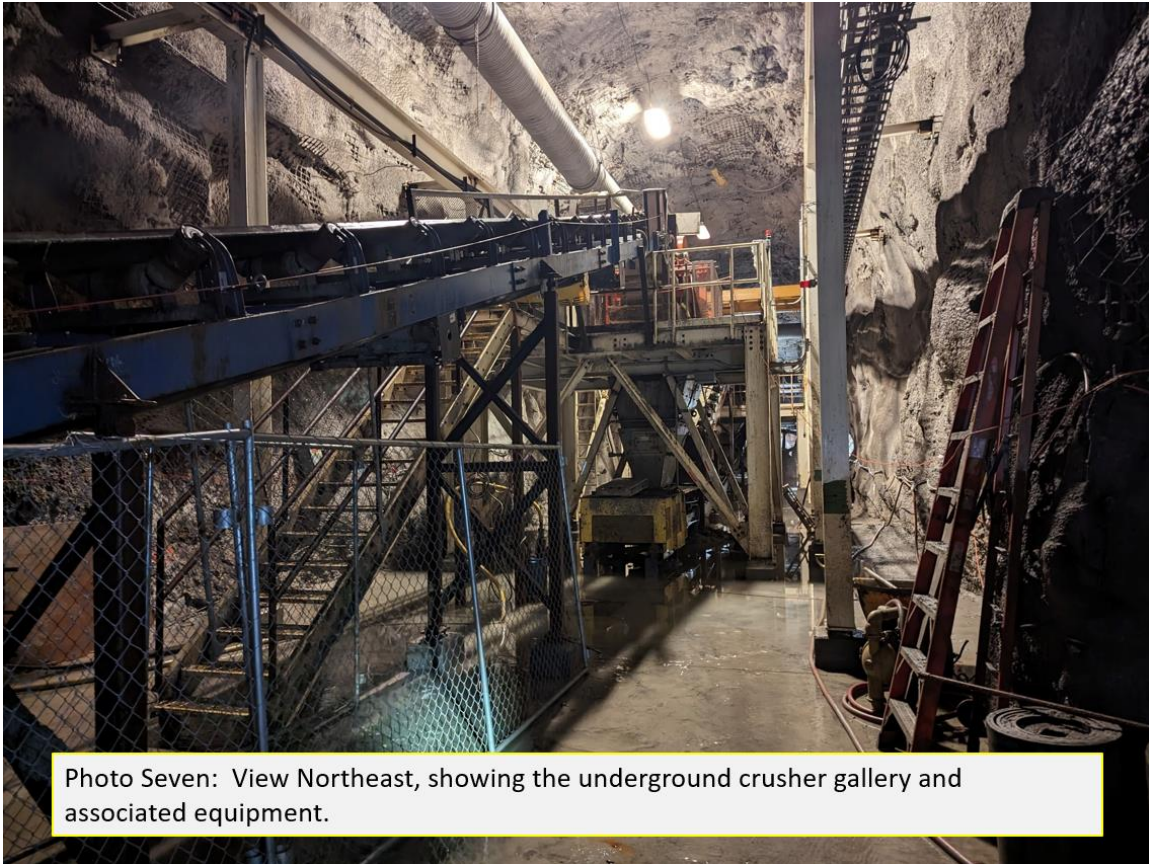
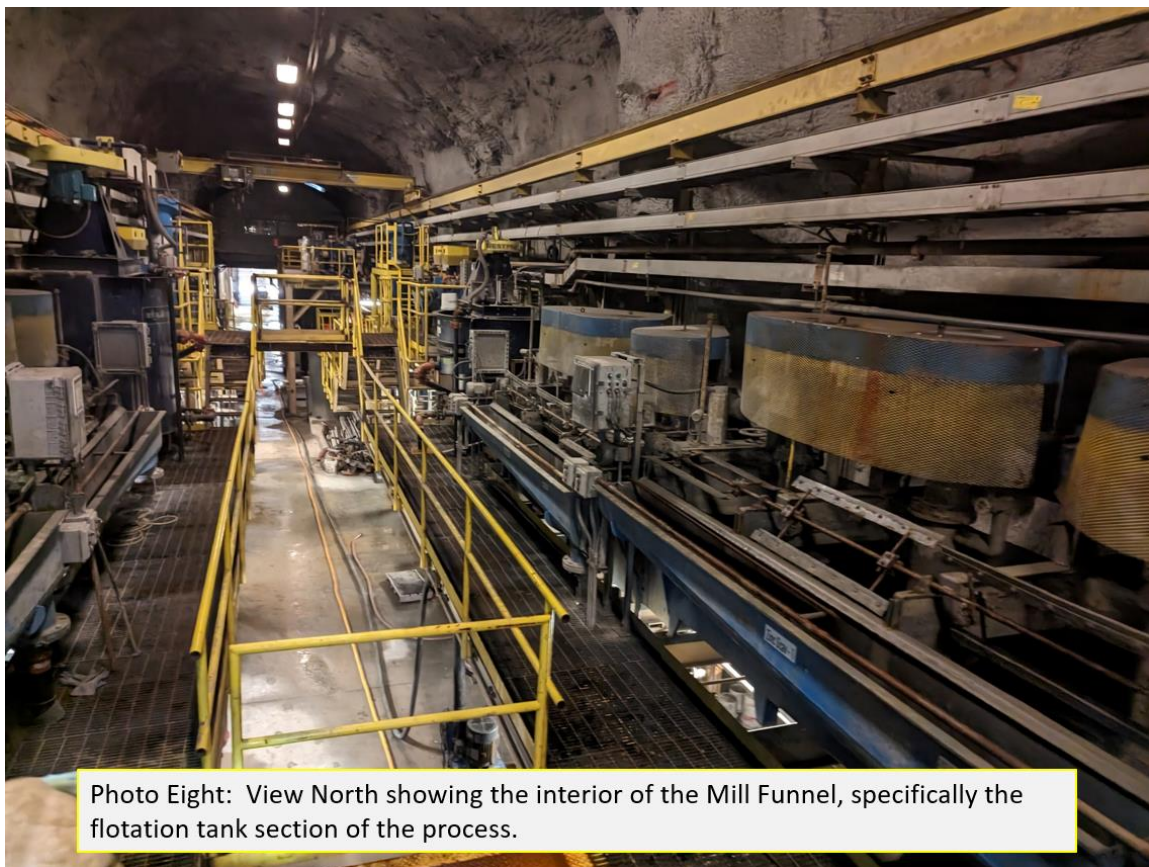
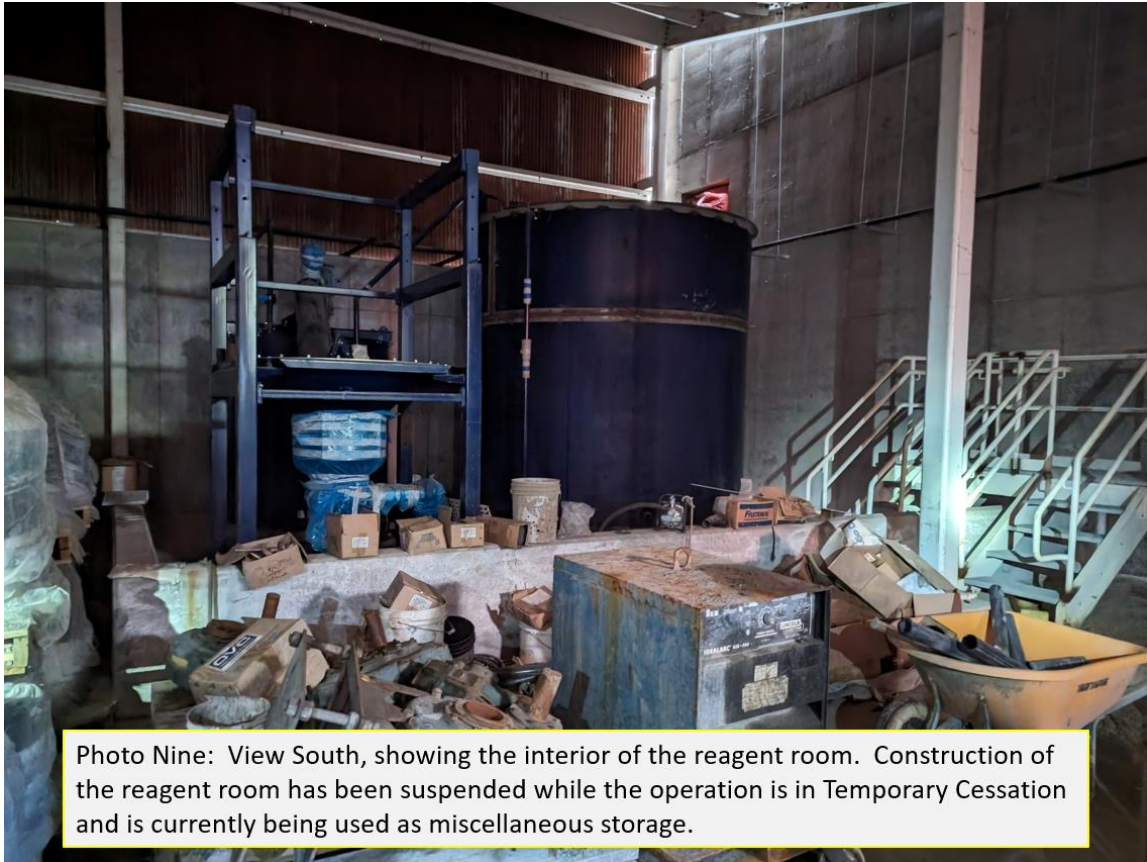
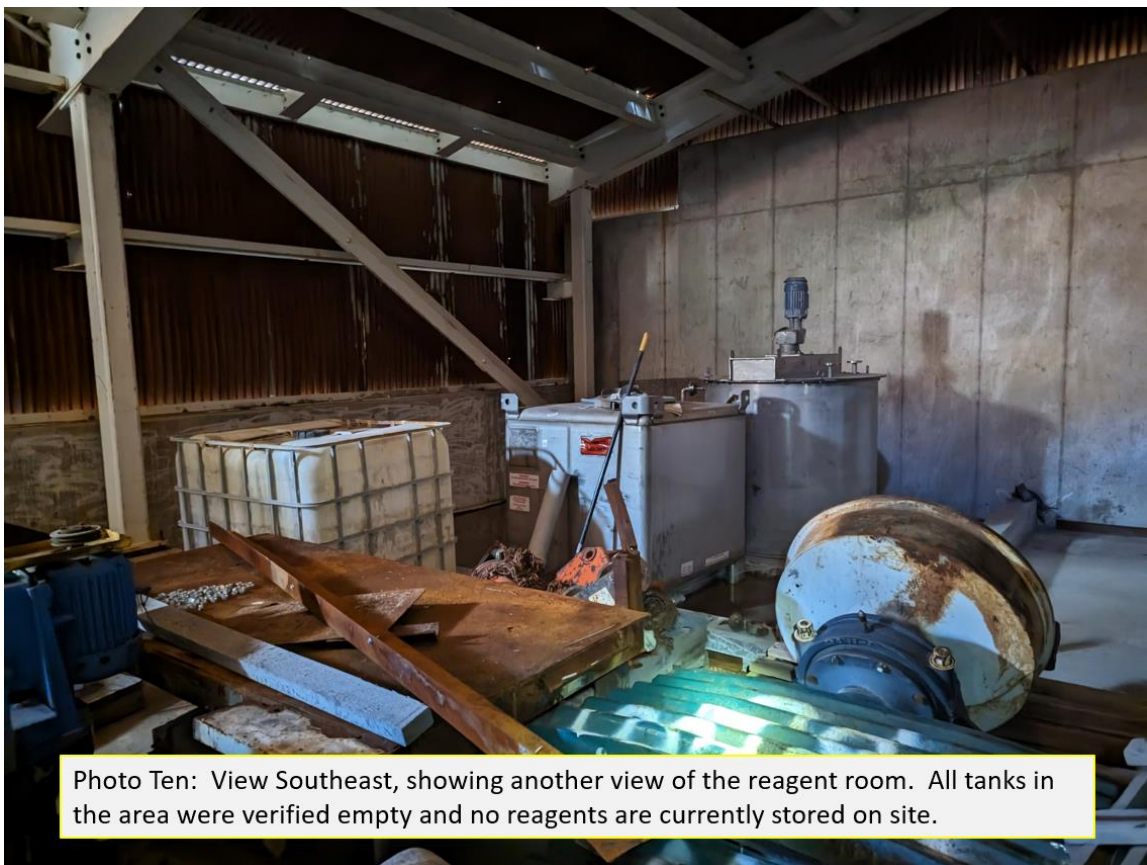
The underground elements of the crusher and floatation circuits of the Mill were observed during the inspection. The crusher gallery was not in operation during the inspection, however all elements and equipment associated with it was observed to be in good condition. None of the sumps were pumping during the inspection and minimal water was noted in the containment area of the crusher gallery. The crusher gallery and equipment can be seen in Photo Seven. Similar to the crusher equipment the equipment associated with the floatation circuit was not active during the inspection. The floatation circuit, all equipment and the mill tunnel can be seen in Photo Eight. All equipment appeared to be in good working order, and evidence of various maintenance activities were observed. All reagents involved in the milling process have been removed from the site, and the day tanks in the floatation gallery were confirmed to be empty. The concentrate packing area, filter press bay, and tailings dump bay were observed to be in good condition.

Adjacent to the mill building, the compressor room and reagent room, which is mid construction, were observed. The compressor room was neat and organized. The reagent room contained a small amount of standing water from snowmelt from the unsecured exterior of the structure. The interior of the room appeared to be in good condition and can be seen in Photos Nine and Ten. All tanks that have been set and containment devices appeared to be in good condition, and the progress of the construction remains largely unchanged. The Operator has submitted a notice of suspension of construction of the facility due to the site entering into Temporary Cessation. This notice has been acknowledged by the Division. The exterior of the reagent room, mill building and area around the tailings thickener tank is neat and well kept.

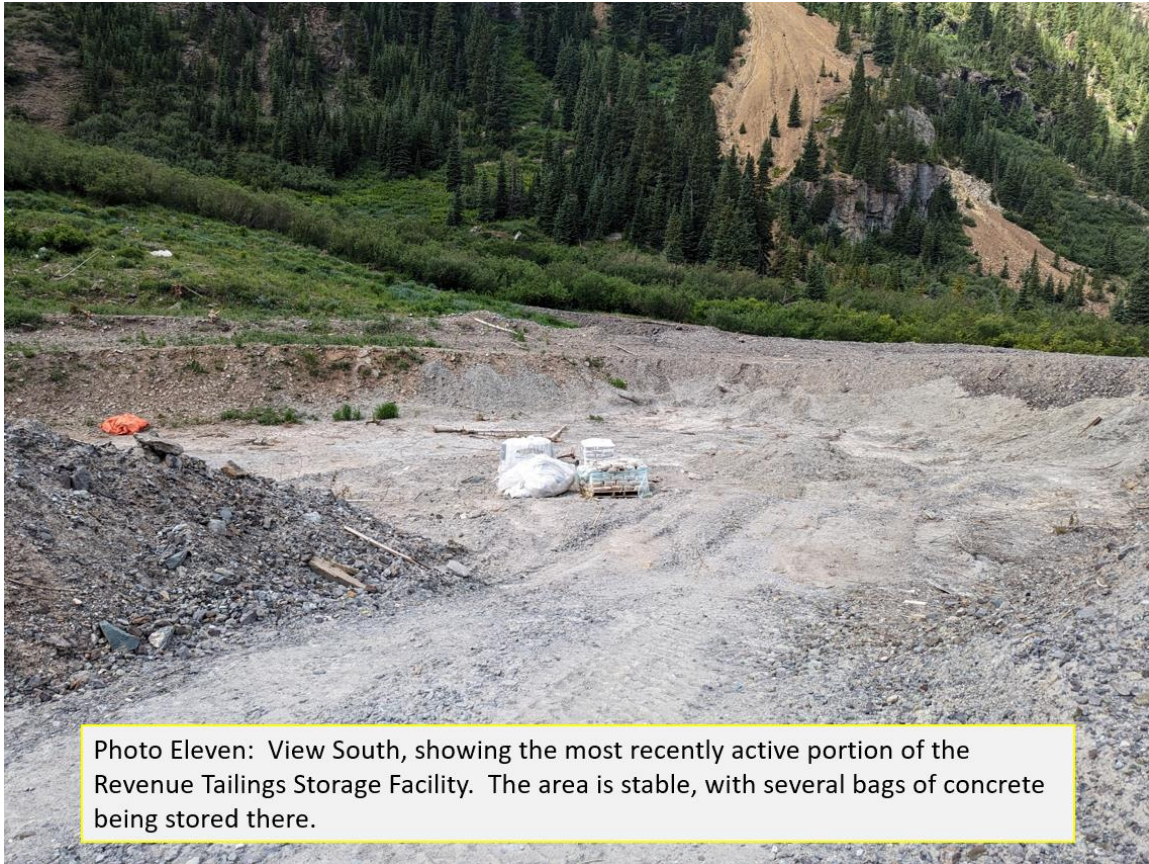
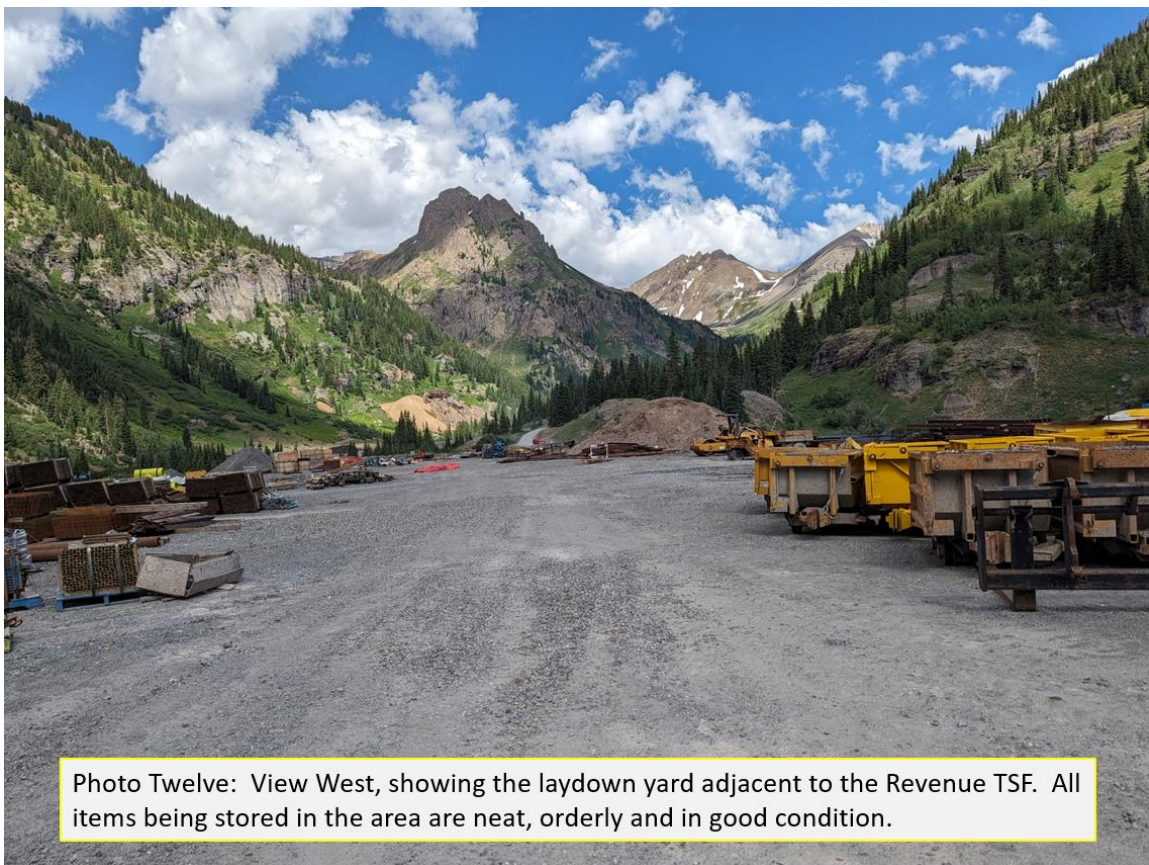
Adjacent to the admin building the Revenue Tailings Storage Facility and lay down yard was observed. The tailings storage area is free from trash and debris and no additional tailings have been placed since the Divisions previous inspection. The most recently active portion of the TSF can be seen in Photo Eleven. The laydown yard near the Revenue TSF has undergone extensive cleanup and organization. All items stored in this area are neat, orderly and in excellent condition as seen in Photo Twelve.

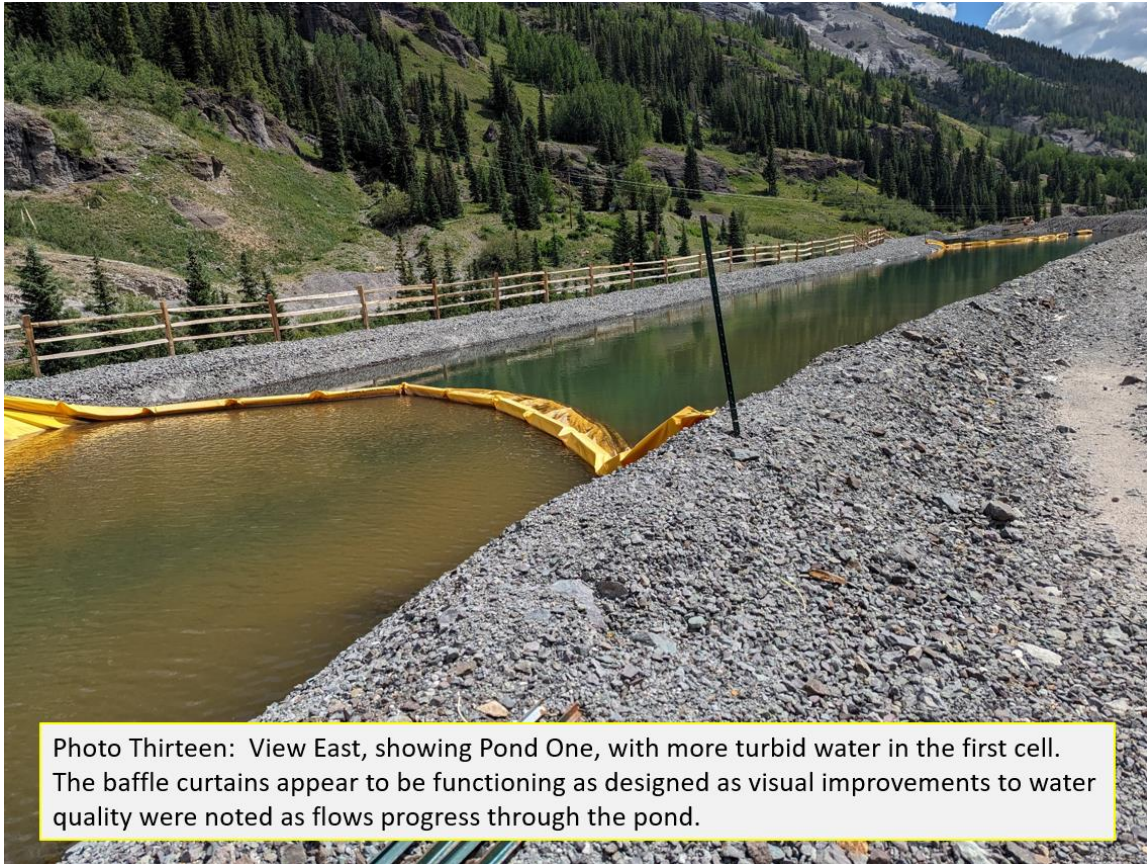
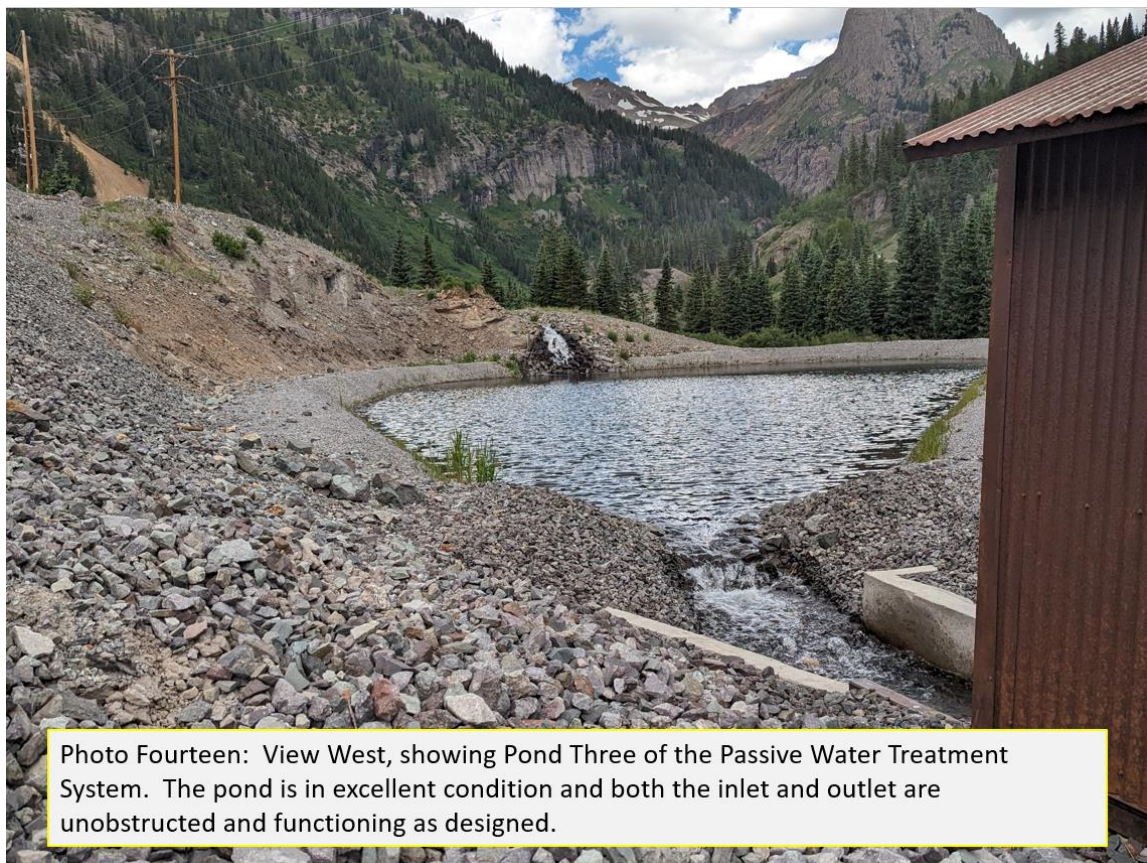
The Passive Mine Water Treatment system was flowing and functioning as designed at the time of the inspection. Pond One was slightly more turbid in the first cell, upstream of the first baffle curtain due to some underground pump replacement, however the curtains are functioning as designed and the water settles to its original color and turbidity prior to discharge into Pond Two. Ponds Two and Three are in excellent condition and appeared to be functioning as designed. Examples of the various ponds can be seen in Photos Thirteen and Fourteen.

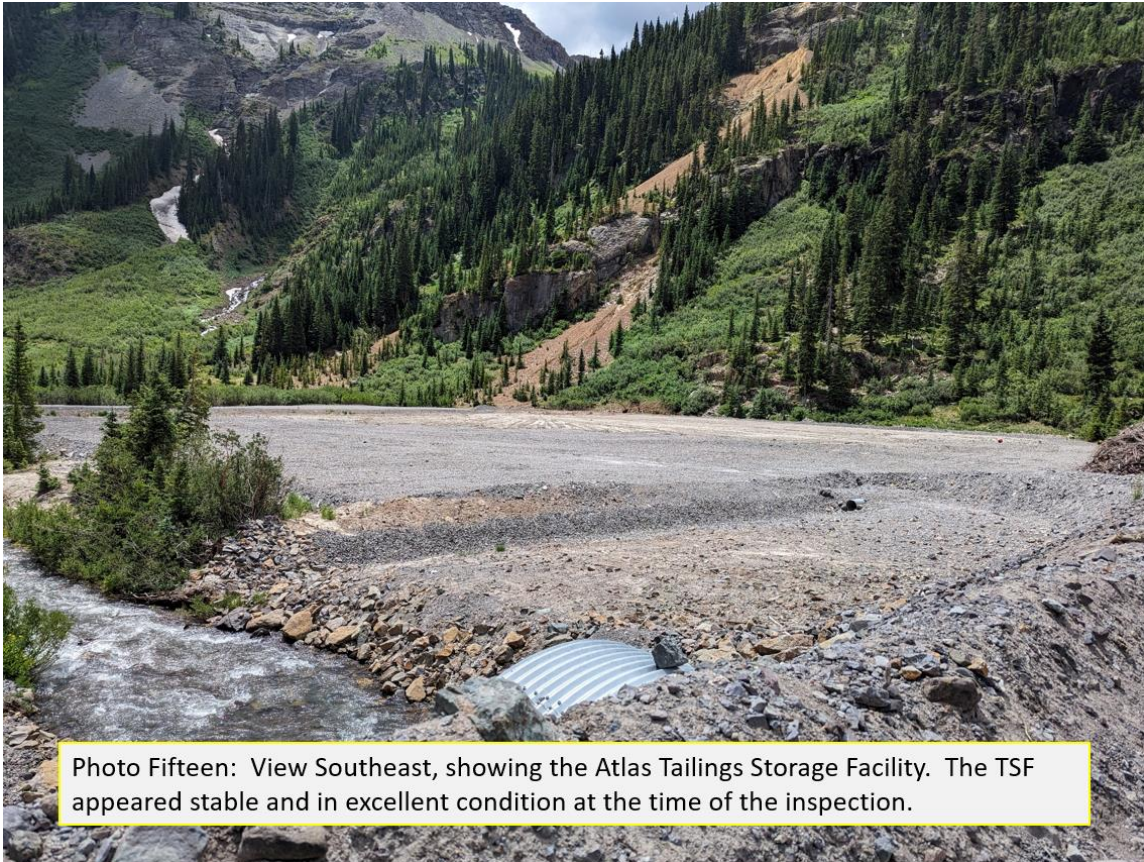
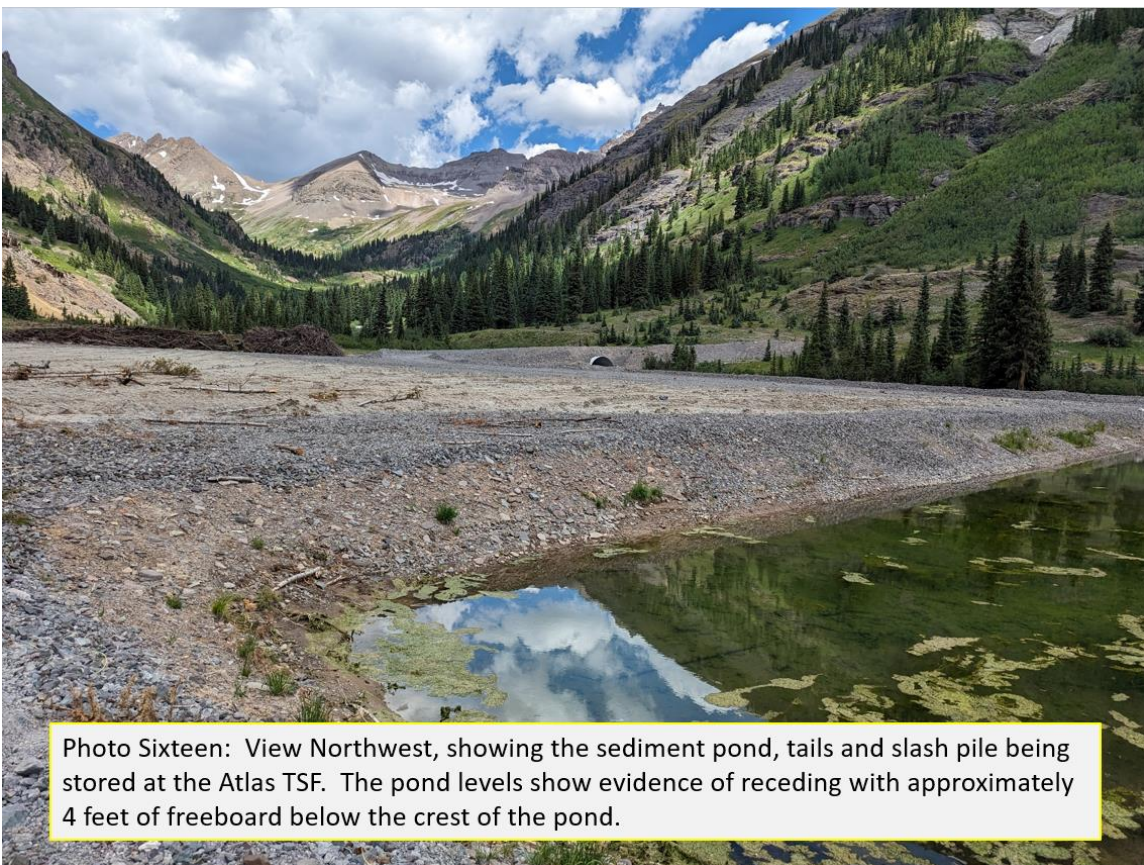
Located just west of the main revenue, separated by Atlas Creek, is the Atlas Tailings Storage Facility. Access to the TSF is gained by a separate locked gate just off County Road 26. The main pad of the facility is graded to the east to promote positive drainage. The surface is constructed of waste rock material that was compacted and stable at the time of the inspection. All drainage generated from the facility is directed to the sediment pond located on the east end of the TSF. The pond was observed with minimal standing water from surface runoff of recent precipitation. Around the perimeter of the facility, an upland diversion and storm water channel was constructed in order to prevent run on from surrounding areas from impacting the TSF. The full extent of the channel was inspected and found to be unobstructed and able to function as designed. All tailings that are stored on the pad have been spread and compacted to the extent possible. No evidence of material transport or erosion of the tailings material was noted. The Atlas TSF, the pond and tails can be seen in Photos Fifteen and Sixteen.
