MINERALS PROGRAM INSPECTION REPORT
PHONE: (303) 866-3567

MINE NAME: M & G Pit	MINE/PROSPECTING ID#: M-1986-079	MINERAL: Sand and gravel	COUNTY: Adams
INSPECTION TYPE: Surety-Related Inspection	WEATHER: Clear	INSP. DATE: August 1, 2023	INSP. TIME: 10:00
OPERATOR: Mann Lake Holdings, LLC	OPERATOR REPRESENTATIVE: Andy Blackford	TYPE OF OPERATION: 112c - Construction Regular Operation	
REASON FOR INSPECTION: Surety Release Requested	BOND CALCULATION TYPE: None	BOND AMOUNT: \$31,403.00	
DATE OF COMPLAINT: NA	POST INSP. CONTACTS: None	JOINT INSP. AGENCY: None	
INSPECTOR(S): Nikie Gagnon	INSPECTOR'S SIGNATURE:

OBSERVATIONS

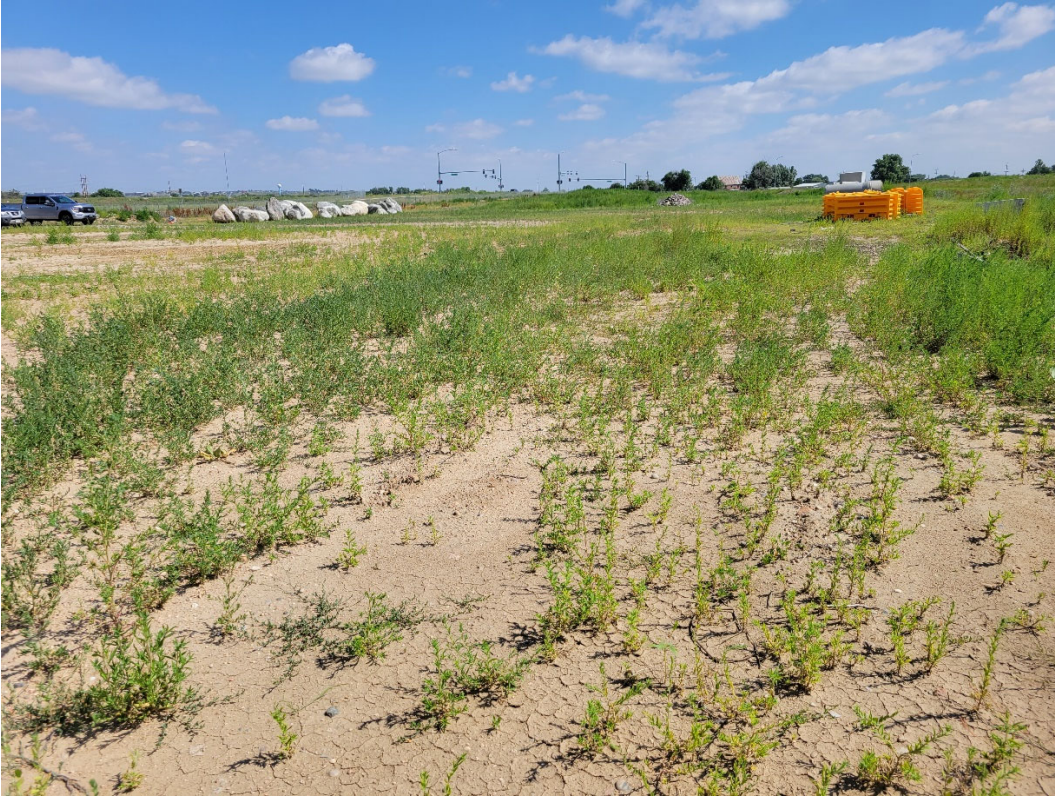
Reclamation is not complete in the northern parcel on the western side of the swale, near the front entrance. A mobile office, concrete pipes and landscaping boulders stored in this area need to be removed in accordance with the approved reclamation plan. Additionally, the topsoil should be ripped to reduce compaction and seeded with the approved seed mix. Generally, after two growing seasons, the operator may request a release if the revegetation effort in this area is successful.

Photo 1: Looking northwest at the storage area near the front entrance area.

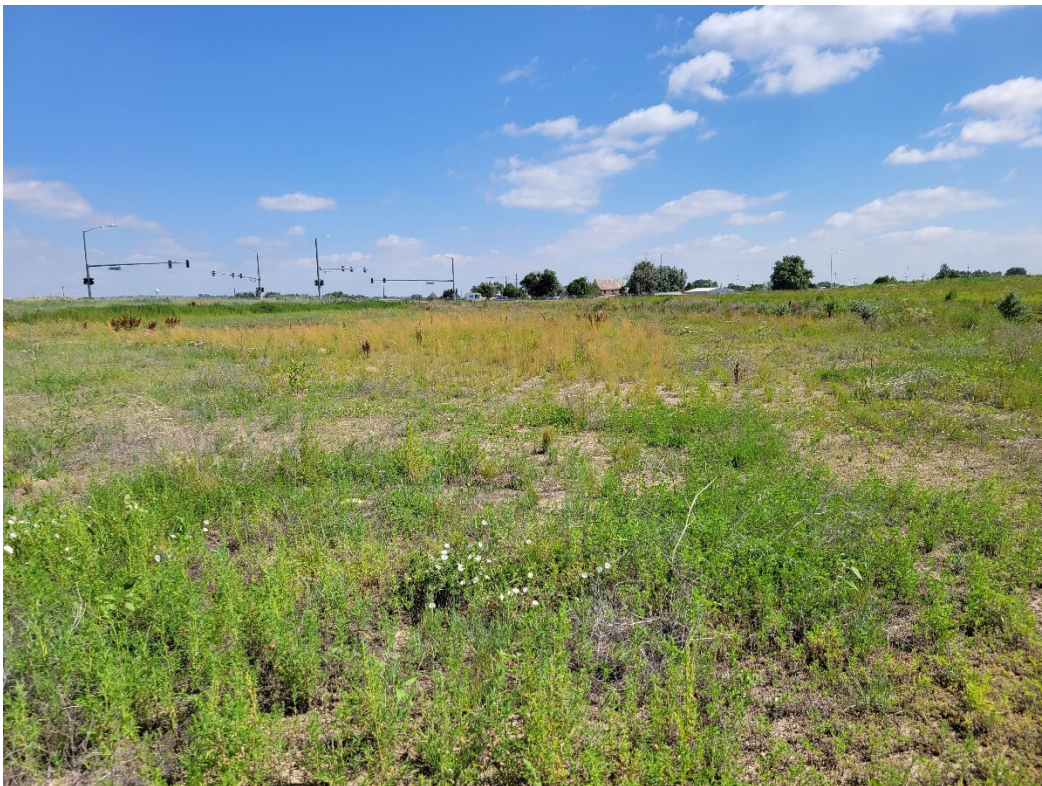
Photo 2: Looking north from entrance. Weeds and bare ground observed in this area.

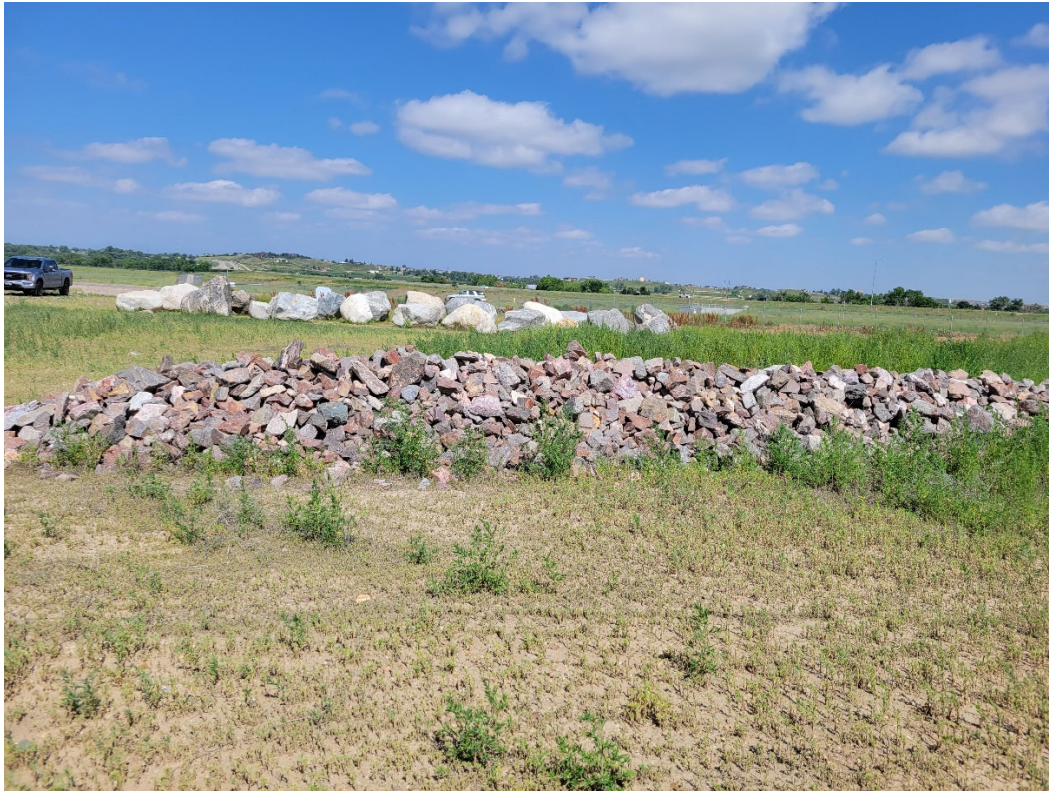
Photo 3: Stockpiled material stored near entrance to mine site.

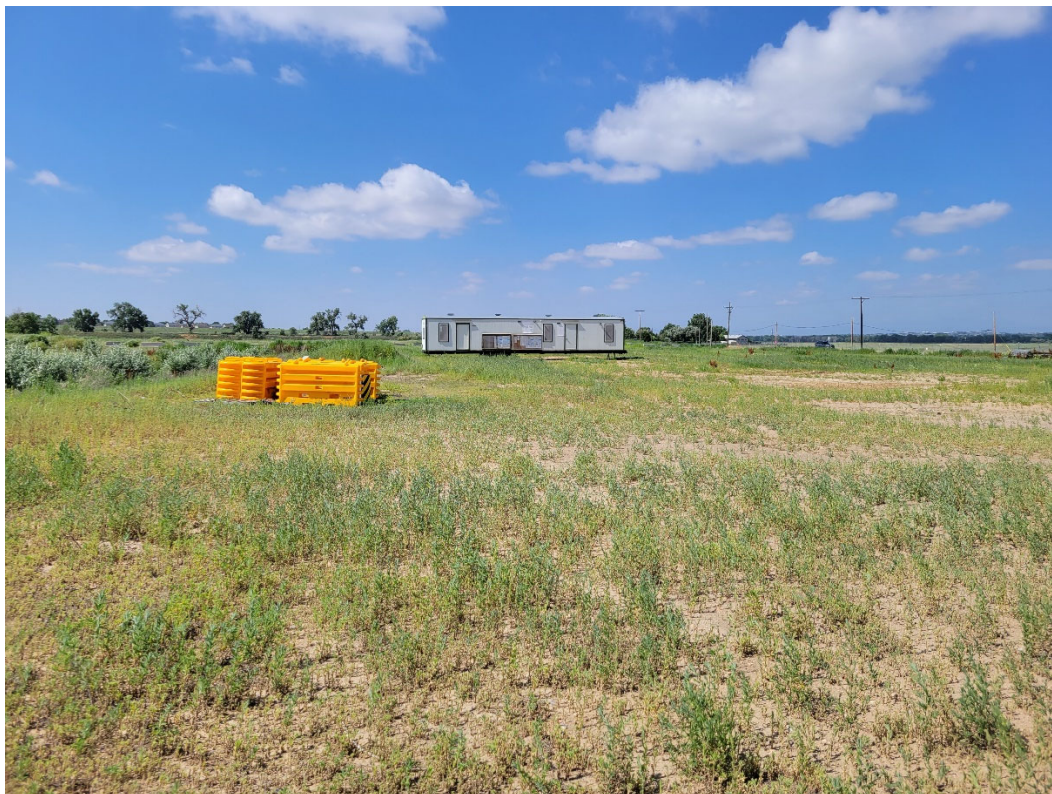
Photo 4: Looking south at mobile office and equipment stored along the western permit boundary.

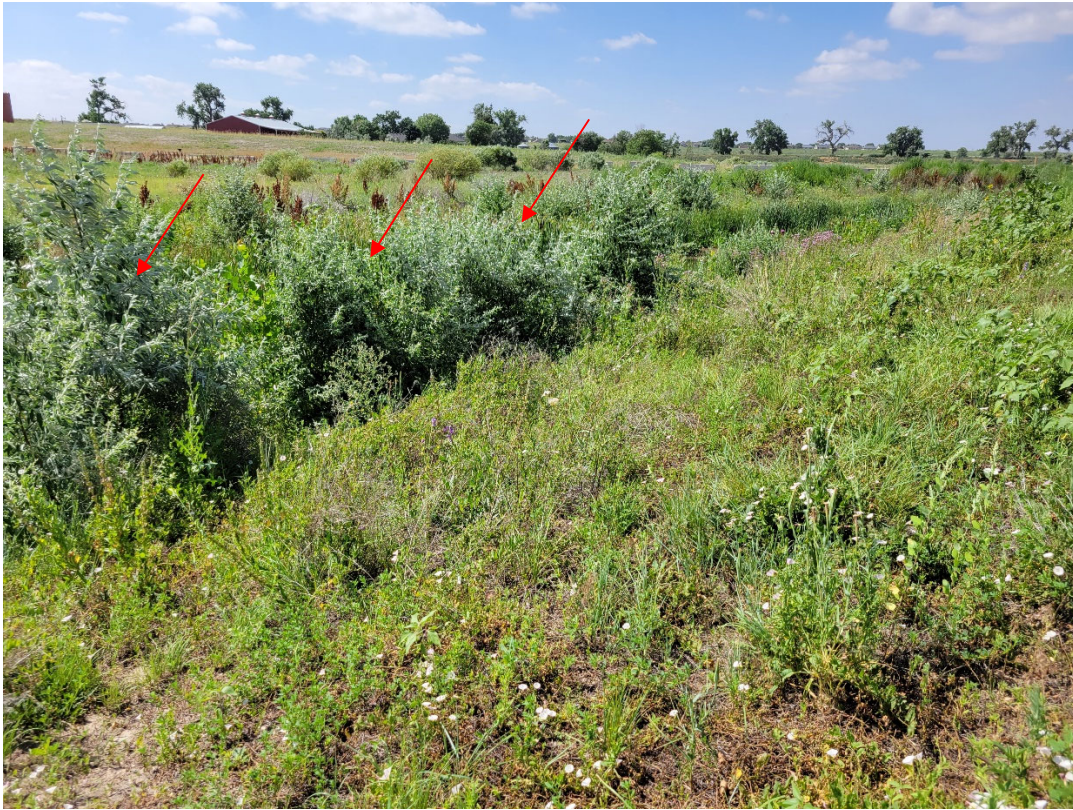
Russian olive trees were observed along the banks of the swale in both parcels. Russian olive is a designated List B noxious weed species. The Division informed the Operator of the requirement to remove the trees to prevent spreading. Additionally, the Division observed invasive weeds across most of the permit area, including bindweed, kochia, and thistle. The operator must conduct weed control in accordance with Rule 3.1.10(6) and submit evidence of weed control to the Division prior to seeking a release of any portion of the permit area.

Photo 5: Looking south at the swale in the northern parcel. Arrows point to Russian olive trees. Bindweed and other invasive weeds observed along the banks.

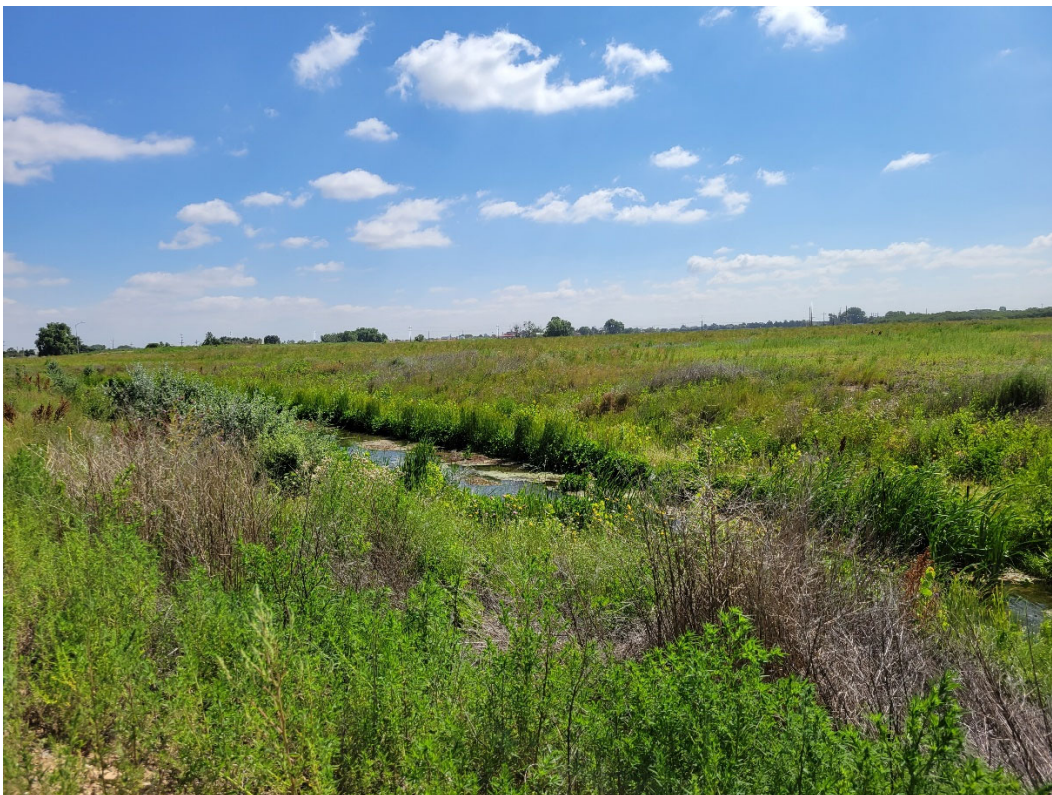
Photo 6: Looking north along the swale in the northern parcel. Vegetation is well established here. Recommend weed control and removal of Russian olive.

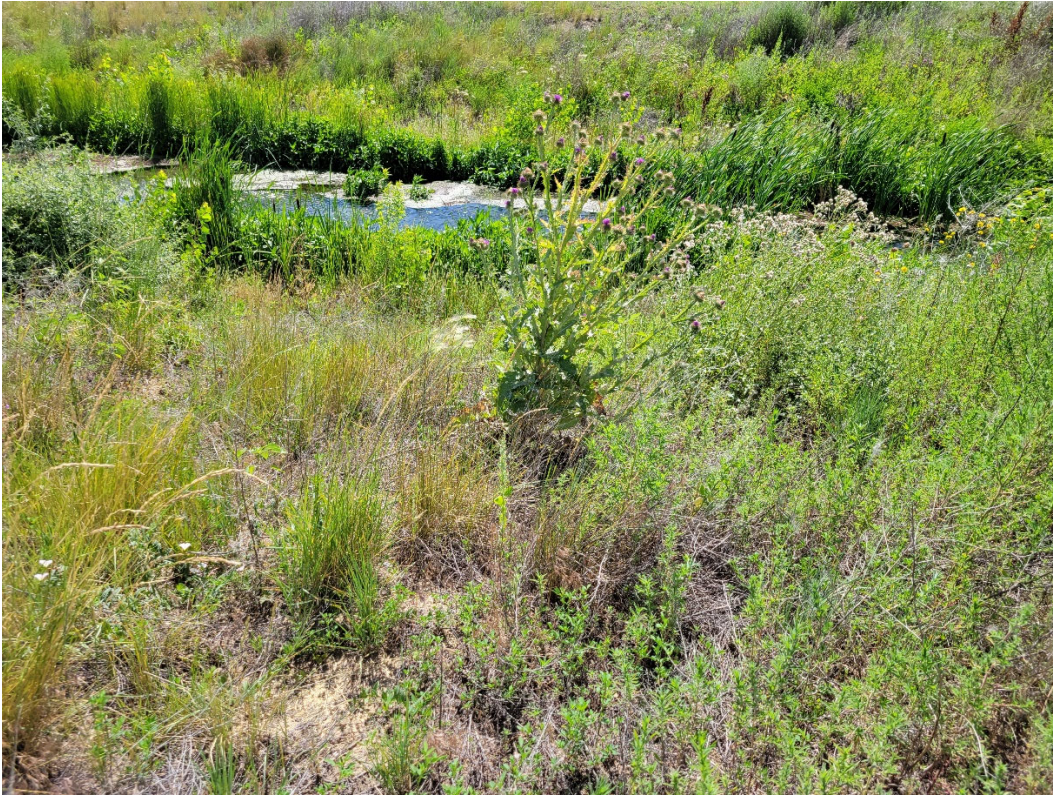
The southern parcel is utilized for llama pasture. Adequate vegetation cover was observed on the berms and in the field, however, areas of kochia, bindweed and other invasive weeds were observed. A thick patch of thistles were observed encroaching on the swale on the southern end. The thistles were inside the fenced pasture above the banks of the swale. The Division recommends weed control in this area to control the spread of thistle across the entire permit site.

Photo 7: Thistles observed on the bank of the swale.

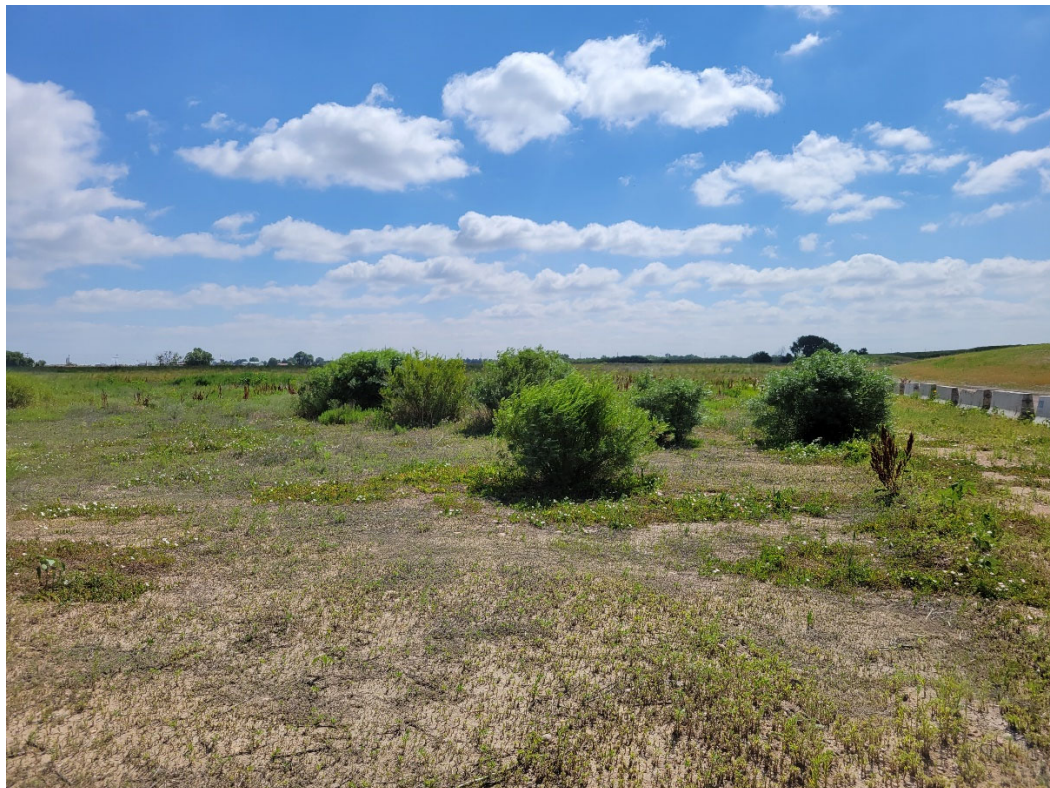
During this inspection, the Division observed that revegetation is not consistently successful across the entire site. Portions of the northern permit area east of the swale have adequate coverage with native grasses and forbs. However, there are compacted bare spots, primarily along the new road, that need to be scarified and overseeded.

Photo 8: Northern parcel adjacent to new road that bisects the site. Weedy area with inadequate revegetation.

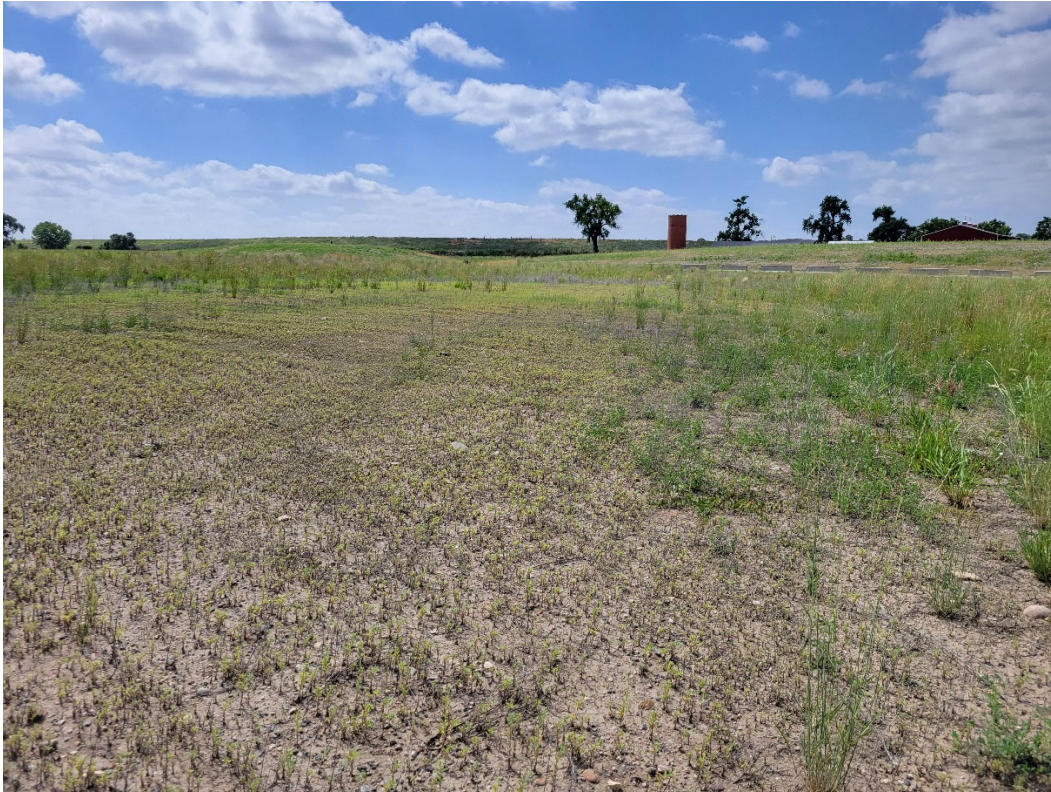
Photo 9: Northern parcel looking southeast at compacted ground with patchy vegetation.

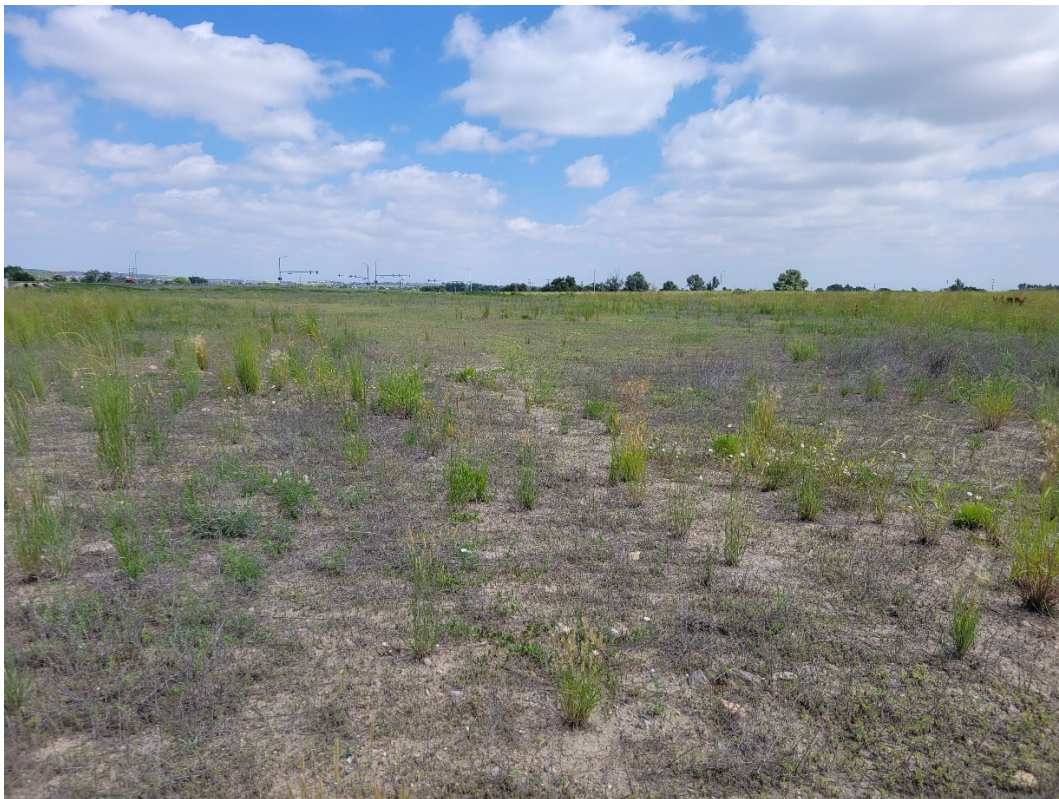
Photo 10: Northern parcel looking north from east side of the swale. Sparse vegetation and bare ground in this area.

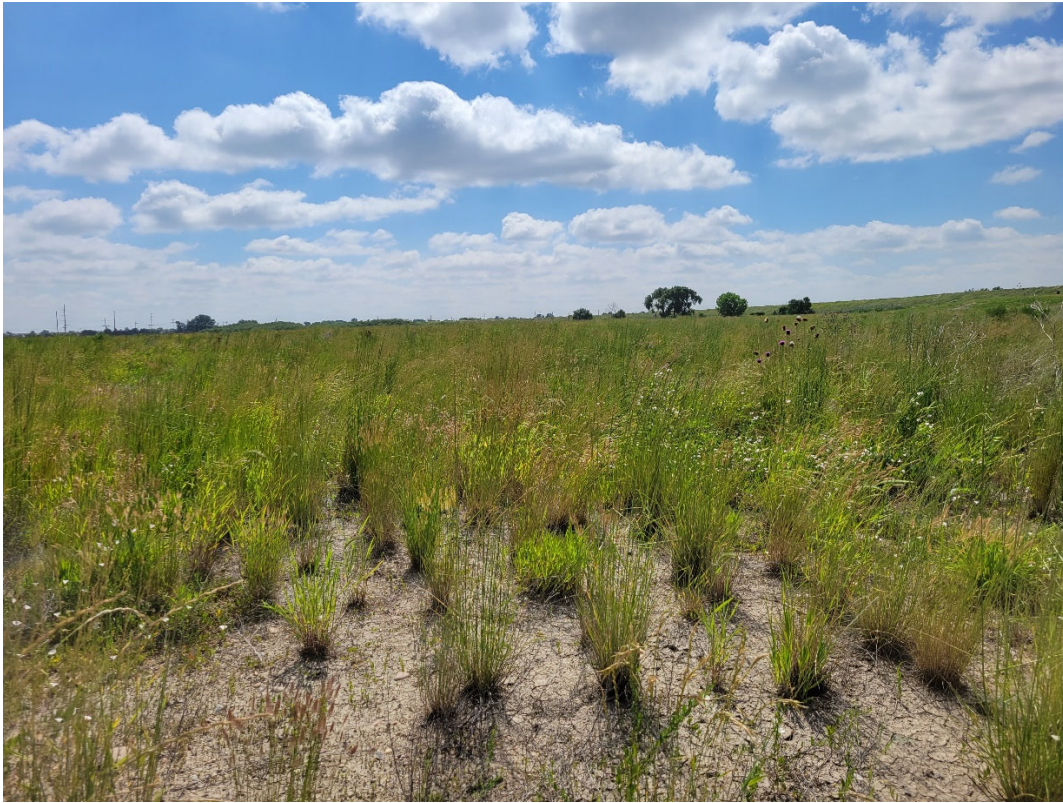
Photo 11: Northern parcel looking east at area with adequate revegetation.

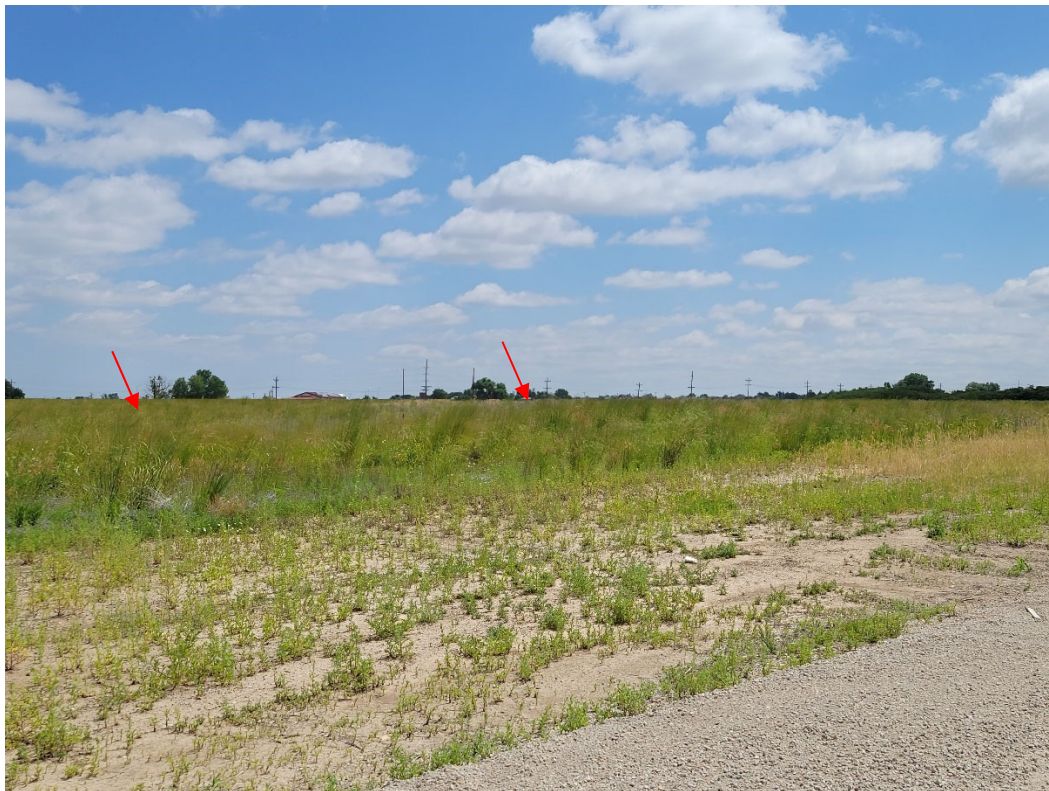
Photo 12: Northern parcel looking east from the eastern end of the new road. Arrows point to area of adequate revegetation.

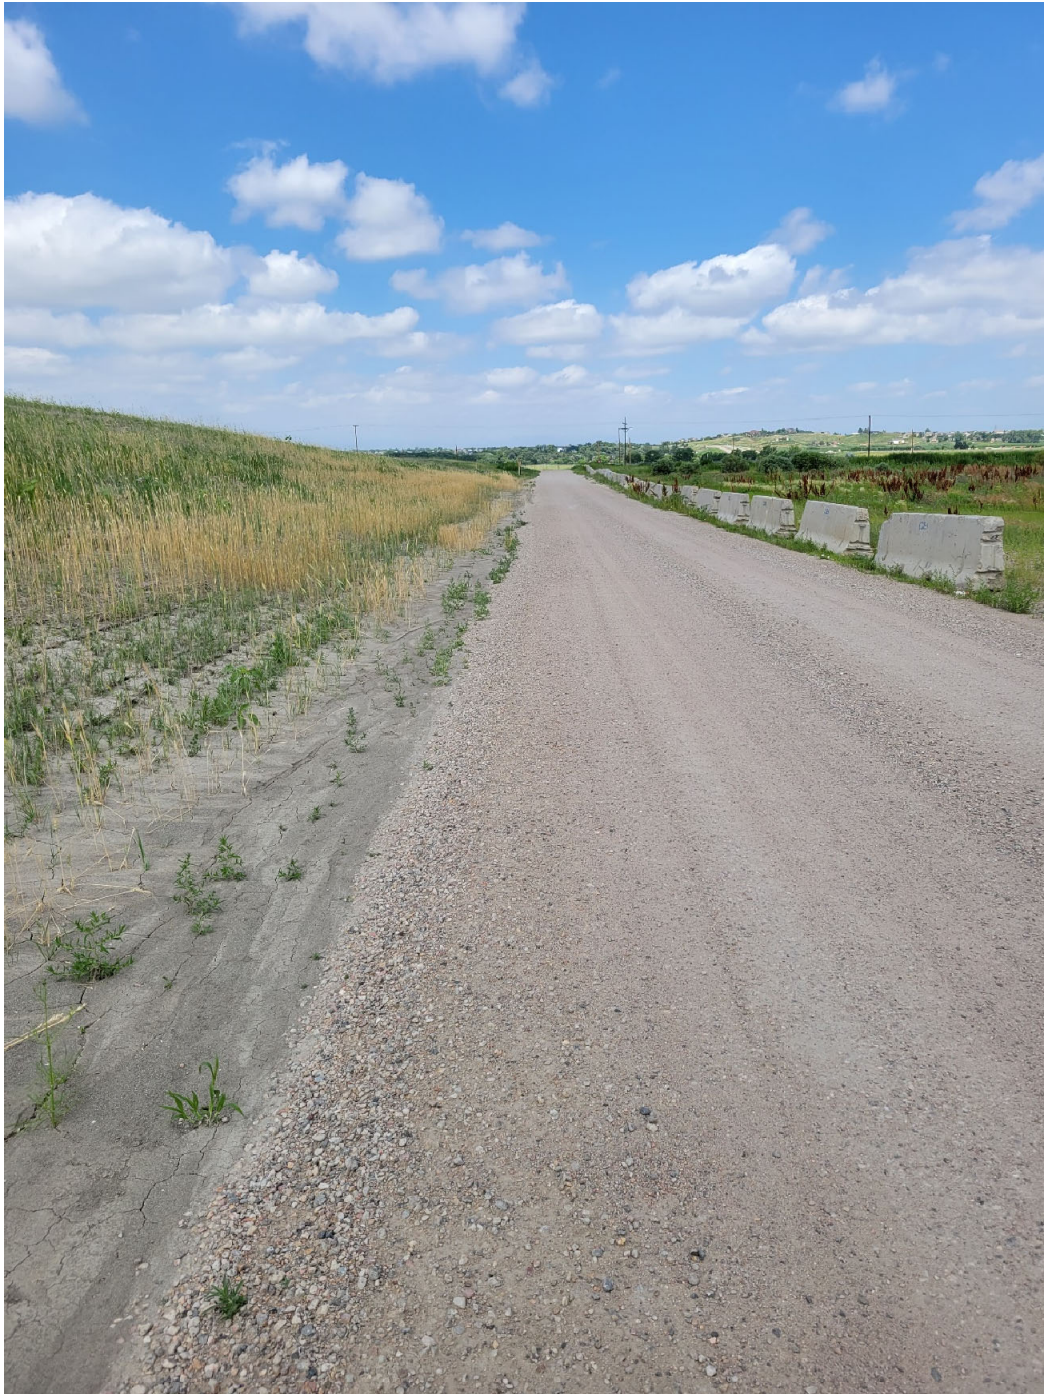
The mining permit covers two parcels. The Division observed a newly installed access road in the center of the permit area, running east/west along the boundary between the two parcels. The access road is not part of the approved reclamation plan. On August 14, 2023, the Operator submitted a Technical Revision (TR10) to add the access road to the final reclamation plan. The Division will review the application and make a decision on the application by September 13, 2023. The Division observed a vegetated berm on the south side of the road. Grasses are starting to fill in the bare spots on the berm. Recommend weed control and repair of erosion gullies as necessary.

Photo 13: Newly constructed gravel road observed splitting the permit area. Operator submitted TR10 on August 14, 2023 to add the road to reclamation plan.

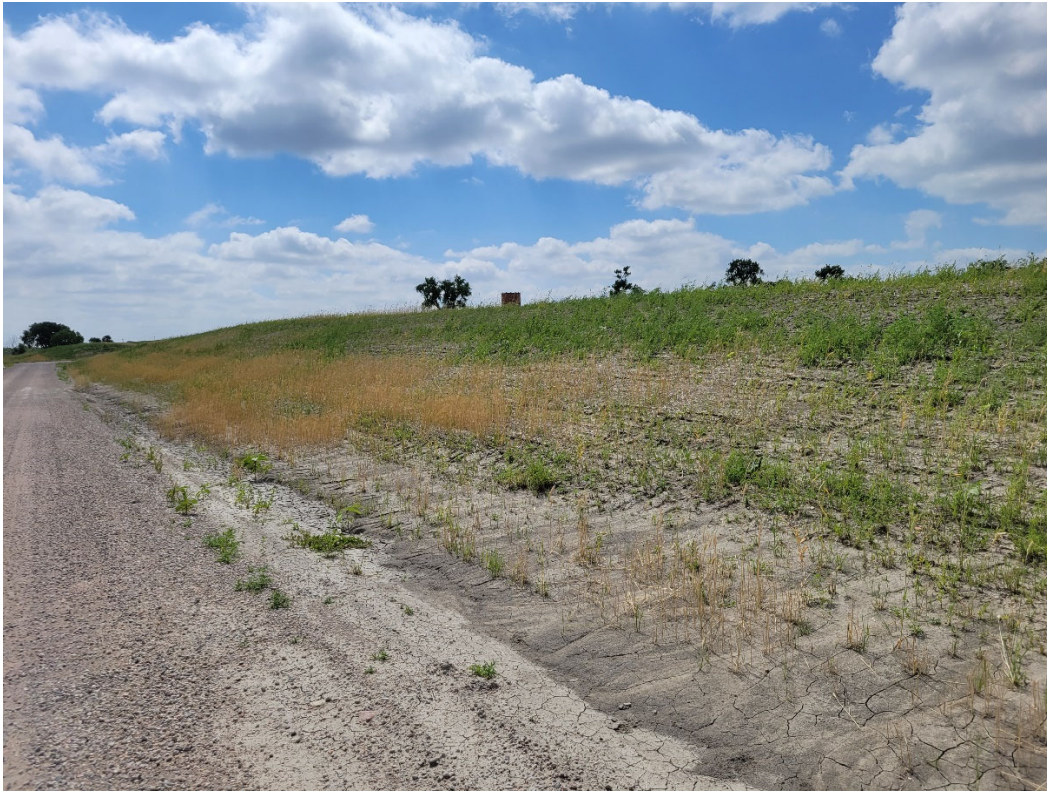
Photo 14: Revegetated berm on south side of road.

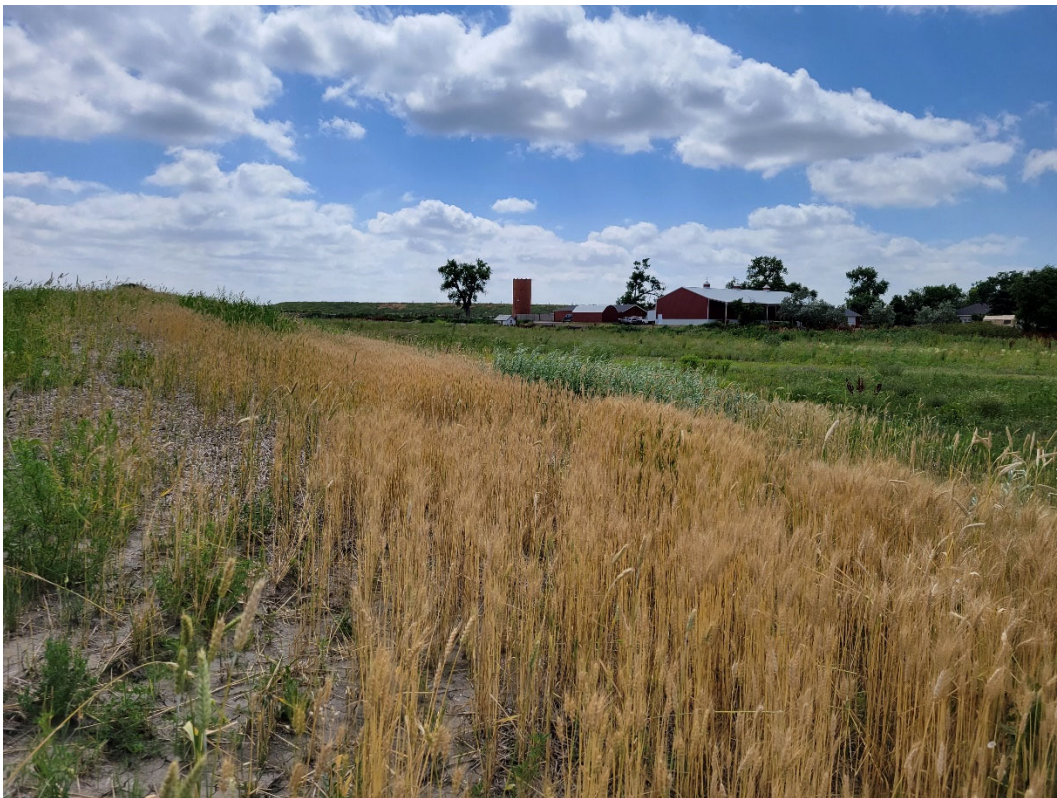
Photo 15: South side of berm along the access road.

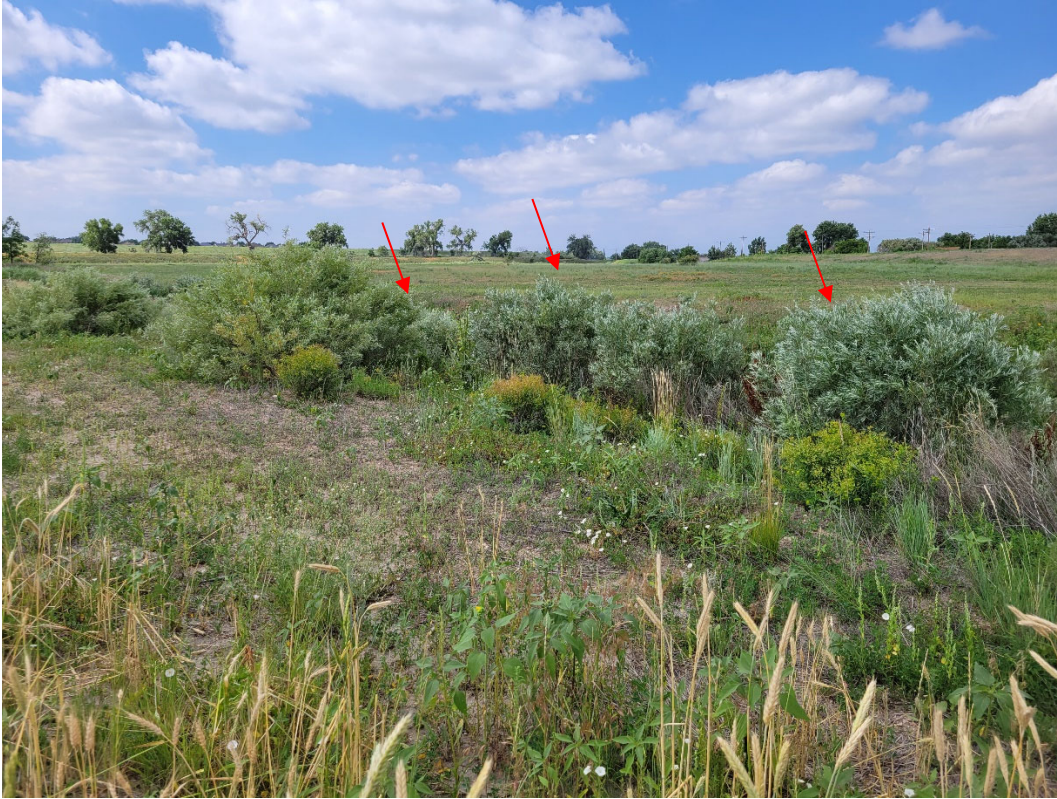
Photo 16: Looking southwest across southern permit area. Russian olive trees in swale.

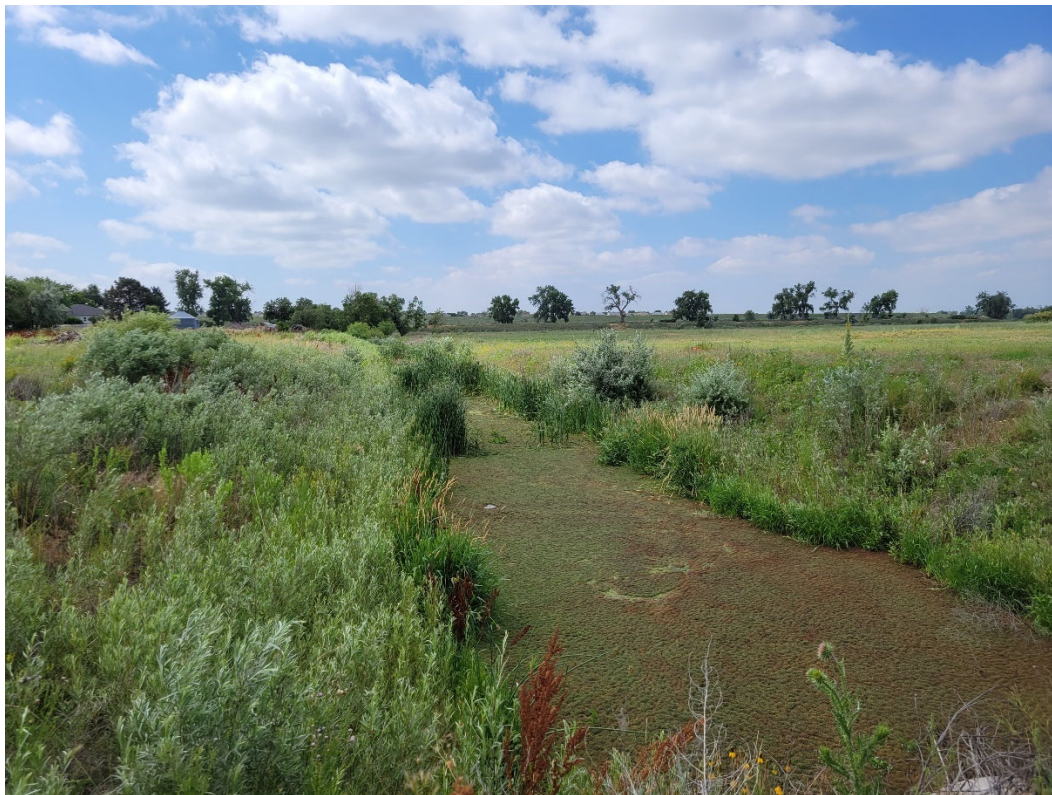
Photo 17: Looking south at swale in southern permit area.

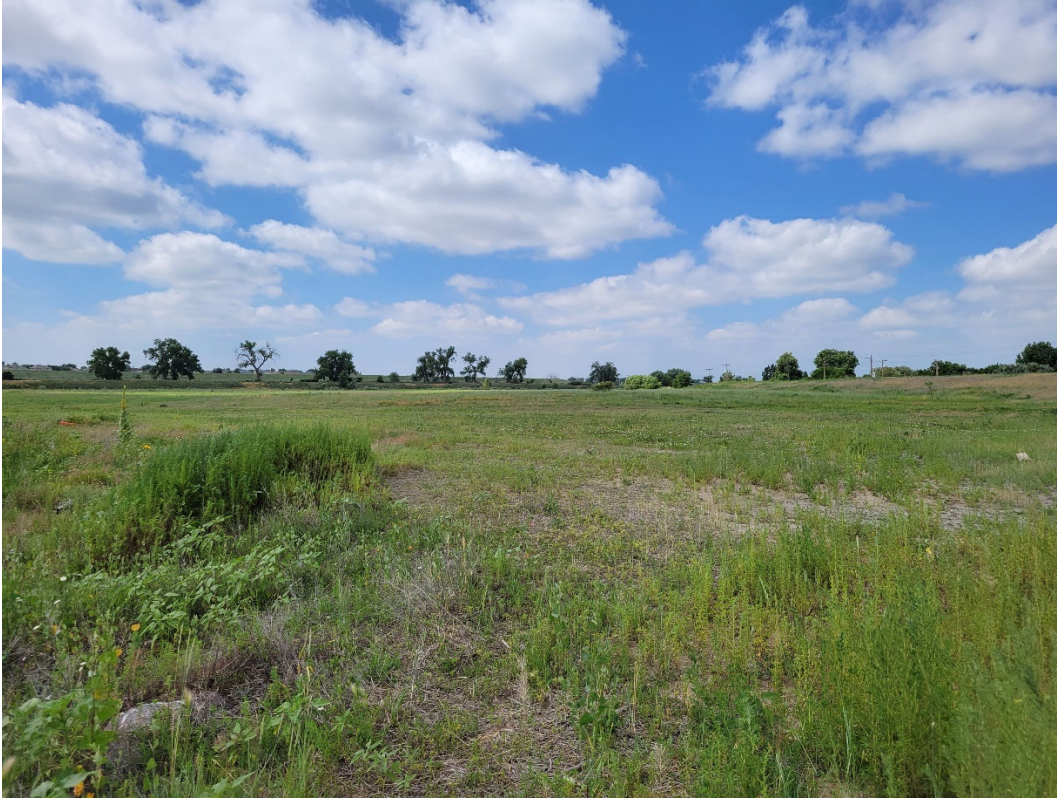
Photo 18: Looking southwest across pasture in southern permit area.

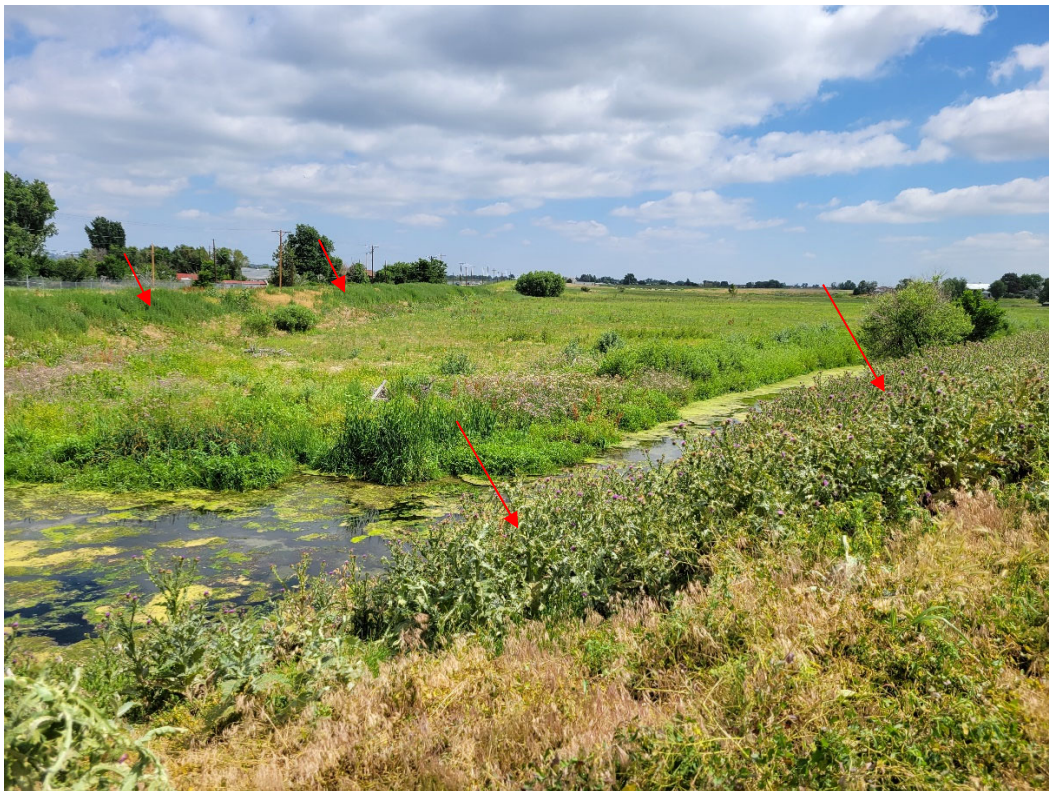
Photo 19: Looking north from the southwestern corner of the permit area. Vegetated berm runs along the Brighton Rd. Recommend weed control on berm and dense thistle patch growing along the swale in this area.

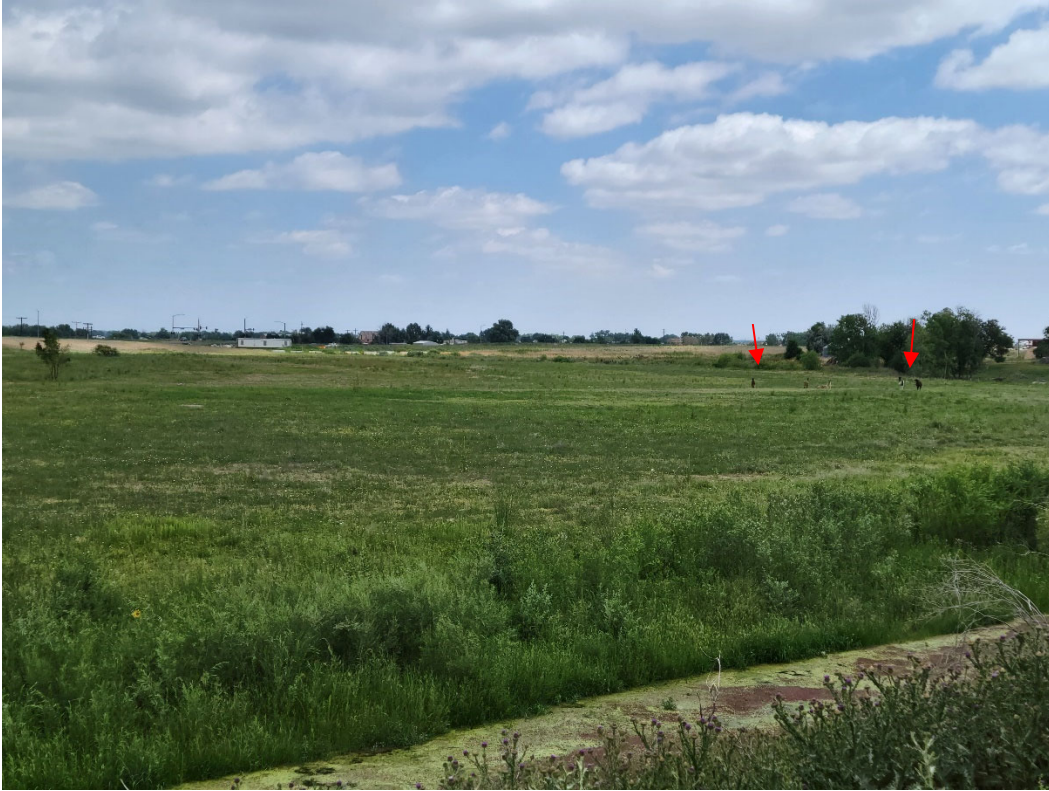
Photo 20: Looking north across the pasture. Arrows point to llamas grazing in the field.
