MINERALS PROGRAM INSPECTION REPORT
PHONE: (303) 866-3567

MINE NAME: AMSO RD&D Project-Phase 1	MINE/PROSPECTING ID#: P-2008-046	MINERAL: Oil shale	COUNTY: Rio Blanco
INSPECTION TYPE: Monitoring	WEATHER: Clear	INSP. DATE: August 7, 2023	INSP. TIME: 12:00
OPERATOR: American Shale Oil, LLC	OPERATOR REPRESENTATIVE: Bruce Smith	TYPE OF OPERATION: MP - Mineral Prospecting	
REASON FOR INSPECTION: Normal I&E Program	BOND CALCULATION TYPE: None	BOND AMOUNT: \$46,789.00	
DATE OF COMPLAINT: NA	POST INSP. CONTACTS: None	JOINT INSP. AGENCY: None	
INSPECTOR(S): Amy Yeldell	INSPECTOR'S SIGNATURE:

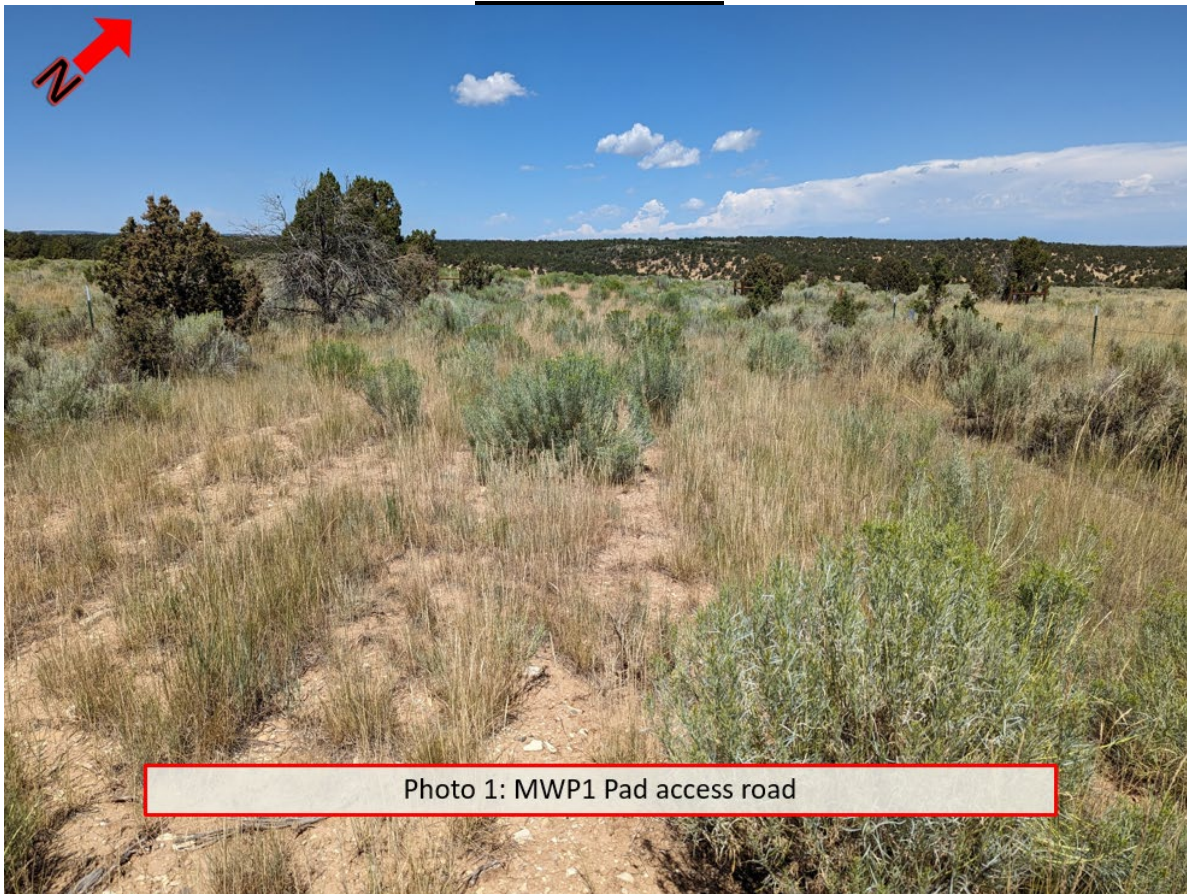
The MWP1 has a short access road leading to the pad (Photo One). Overall the pad has good shrub cover which has increased since the previous inspection. Some grasses have established but they do not seem to be increasing or spreading as expected. There is a fair amount of Russian Thistle which has been treated. Treatment of noxious weed species has resulted in areas with sparse vegetation and desirable grasses have not volunteered to fill in the gaps (Photo Two). Desirable cover is estimated to be approximately 50%.

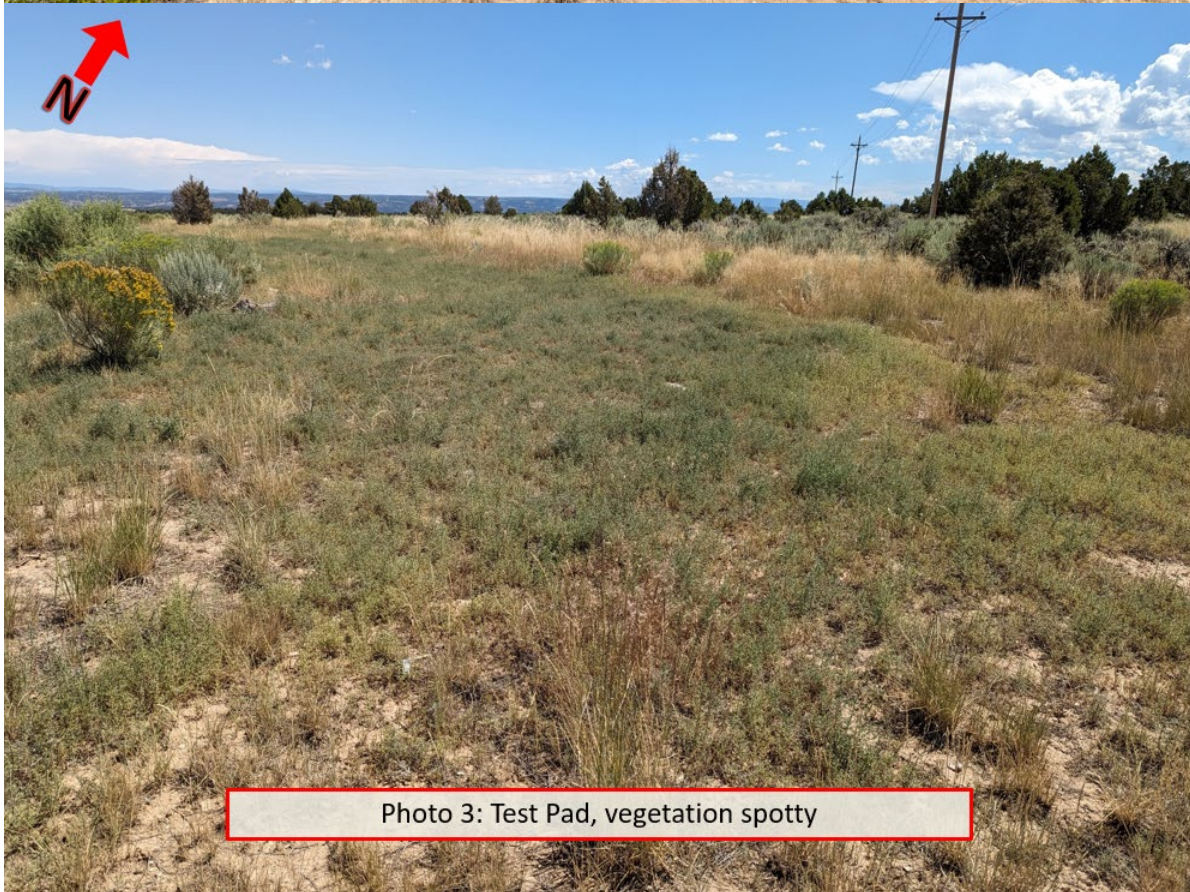
Photo 3: Test Pad, vegetation spotty

The Test Pad has two access roads. The back road to the radio tower remains in place as reclaimed two-track for access to the tower. The front one is fenced and reclaimed. Reclamation on the pad is extremely patchy especially along the southwest corner. Vegetation tends to be entirely noxious weeds or dense patches of desirable plants (Photo Three). Russian Thistle is primarily the species of concern in this area but Kochia and Cheatgrass were also identified. Overall the shrubs seem to be progressing well but the understory grass is struggling to outcompete the weeds (Photo Four).

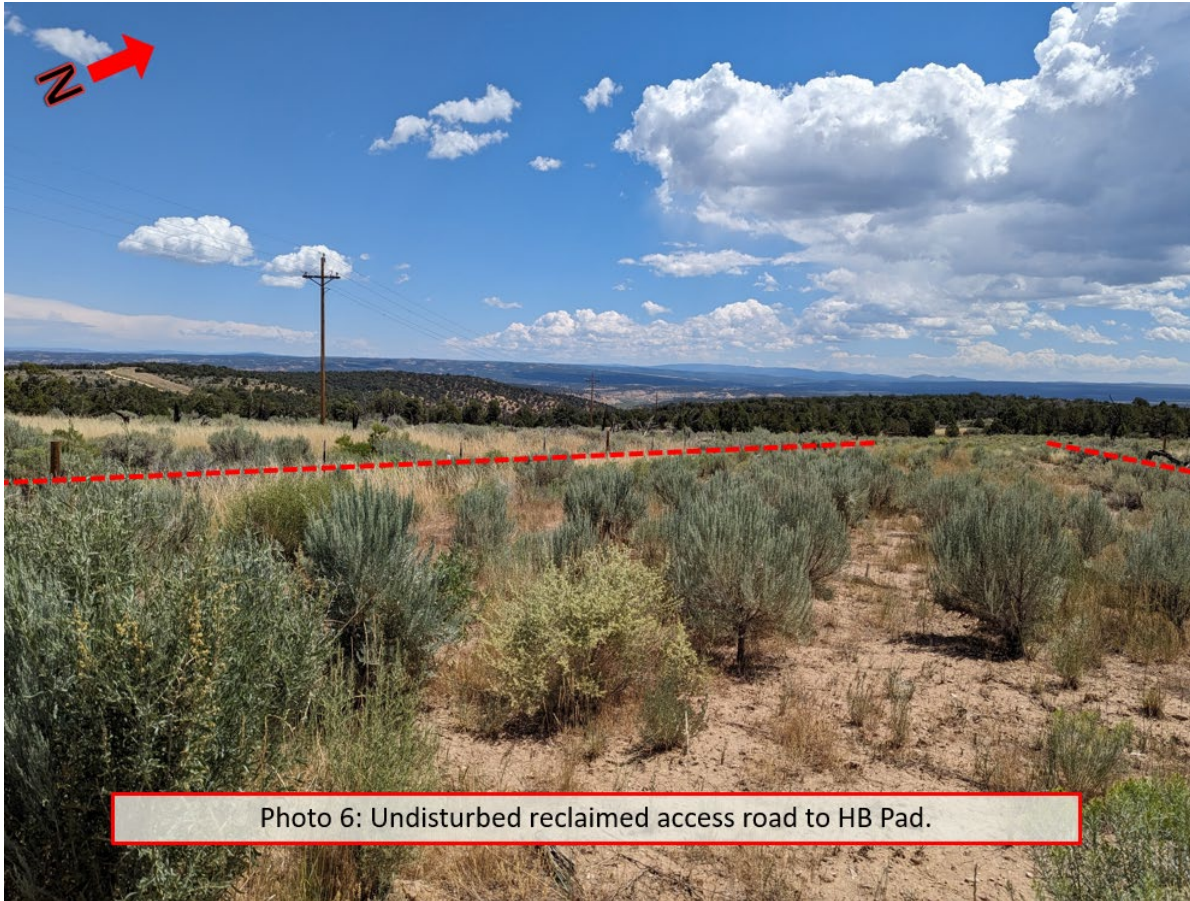
*The HB Pad has a fairly long access road with a break to allow for cattle to cross. Adjacent to the county road is a pipeline which crosses the access road. This pipeline has recently been reworked (Photo Five). The Operator is not liable for reclamation of this area as areas were previously reclaimed prior to disturbance by the gas company (Photo Six). Vegetation naturally blends with surroundings. Reclaimed areas have dense well established shrubs. Native grasses have also established in the understory and overall cover is at least 80% (Photos Seven and Eight). Little to no weeds were observed aside from a few stray Russian Thistle and Cheatgrass. Undesirable species were less than 3% of overall cover and comparable to surrounding areas.

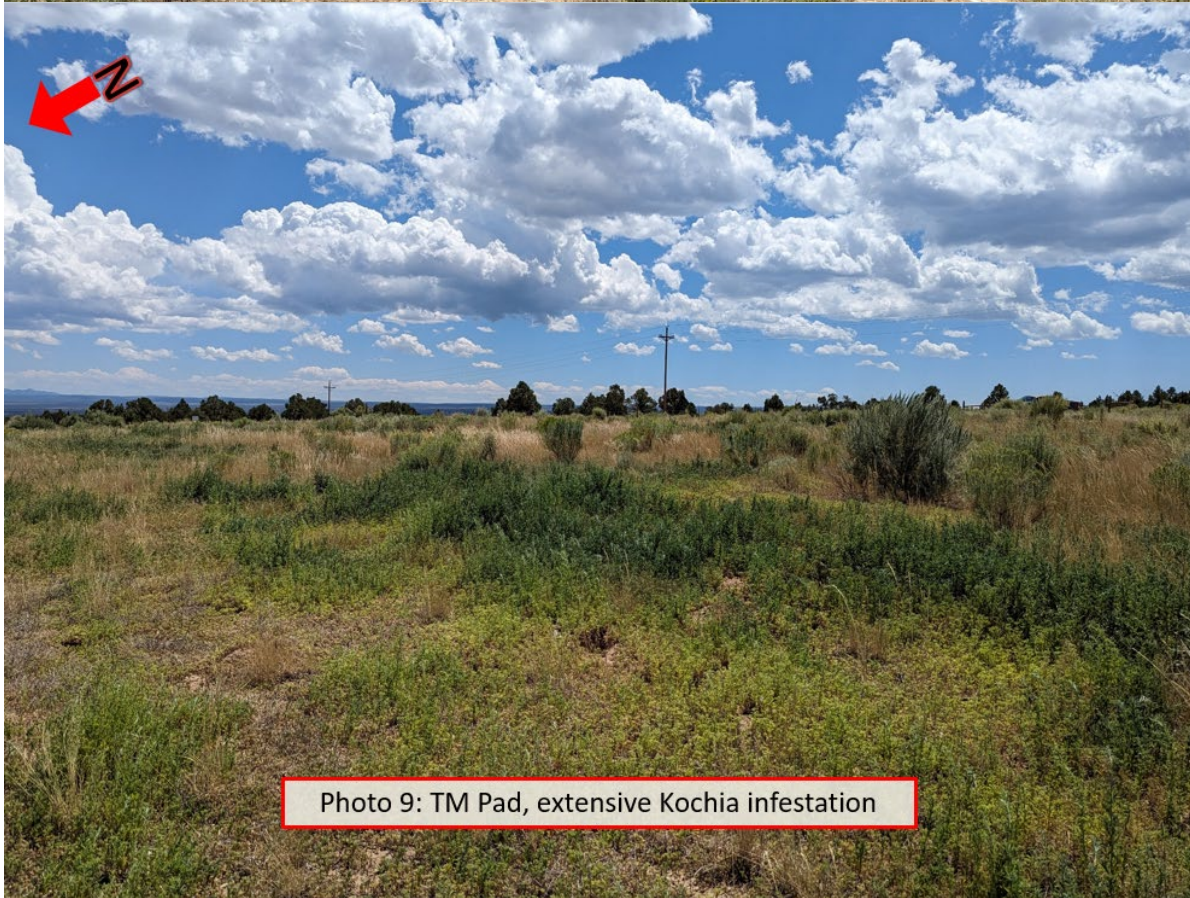
The TM Pad is similar to the Test Pad in that vegetation is either entirely weeds or desirable, with little in between. However the Kochia seems to be much worse here compared to the other pads. The Division estimates that 50% of all vegetation is noxious weeds (Photos Nine and Ten). Very few shrubs and grasses have established. Additional reclamation measures will likely be necessary for final reclamation to be achieved given that routine weed treatments have proven unsuccessful.

general the site would benefit from a more aggressive weed management plan. Multiple surveys and treatments throughout the growing season are critical for effective management. The Operator may wish to explore alternative method for noxious weed management as well. Both burning and controlled grazing were discussed as potential options. The Operator should first discuss these options with the BLM and gain approval prior to implementation. Given that overall initial reclamation efforts with the current weed management have proven inadequate the Operator will likely need to re-reclaim areas of failure. The two growing season minimum for evaluation of reclamation success will begin anew for any areas where reclamation efforts have started over.

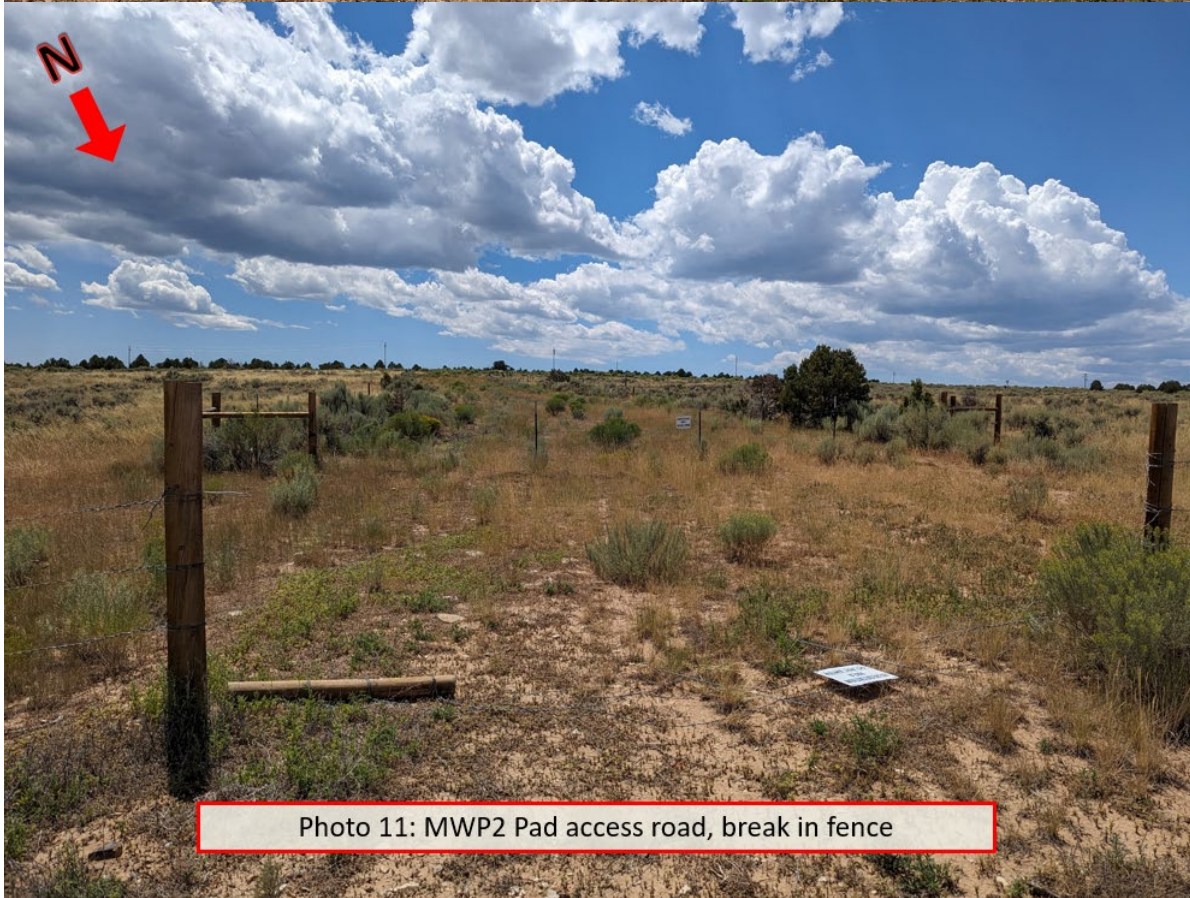
Photo 11: MWP2 Pad access road, break in fence

The MWP-2 Pad have a very long access road off of the east side of TM pad. It also has a break in the exclusion fencing to allow for animals to cross. Overall reclamation of the road is spotty. Areas within the fence break appear to be doing no worse than areas within the protection of the fencing. The northern section of road is better established compared to the south (Photo Eleven). The pad itself has sufficient shrub cover but the understory is mostly Russian Thistle (undesirable). Very few areas were observed without some presence of Russian Thistle (Photo Twelve). Desirable grasses were observed but they are not abundant enough to outcompete weeds or to be considered sustainable or successfully reclaimed.
