MINERALS PROGRAM INSPECTION REPORT
PHONE: (303) 866-3567

MINE NAME: Del Norte Pit	MINE/PROSPECTING ID#: M-1984-026	MINERAL: Sand and gravel	COUNTY: Rio Grande
INSPECTION TYPE: Monitoring	WEATHER: Cloudy	INSP. DATE: July 19, 2023	INSP. TIME: 13:00
OPERATOR: Southway Construction Company, Inc.	OPERATOR REPRESENTATIVE: Paul Bottini	TYPE OF OPERATION: 112c - Construction Regular Operation	
REASON FOR INSPECTION: Normal I&E Program	BOND CALCULATION TYPE: Complete Bond	BOND AMOUNT: \$238,311.00	
DATE OF COMPLAINT: NA	POST INSP. CONTACTS: None	JOINT INSP. AGENCY: None	
INSPECTOR(S): Todd Jesse	INSPECTOR'S SIGNATURE:

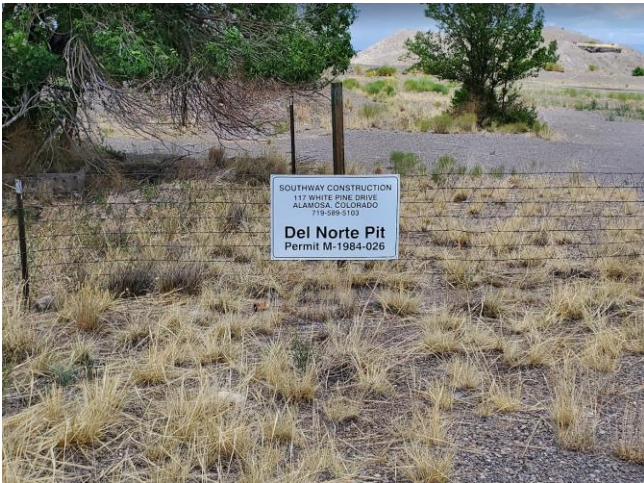
The proper mine identification signage was posted at the entrance to the site. Permit boundaries are clearly marked with berms. The site was not active at the time of the inspection, but there was a single loader on site. The only on-site support facility is a scale used to weigh outgoing loads. There are no hydrocarbons stored in the permit area. The site acts as an intermittent source of material for Southway Construction.

View to the north showing proper Mine ID signage posted at the entrance to the site.

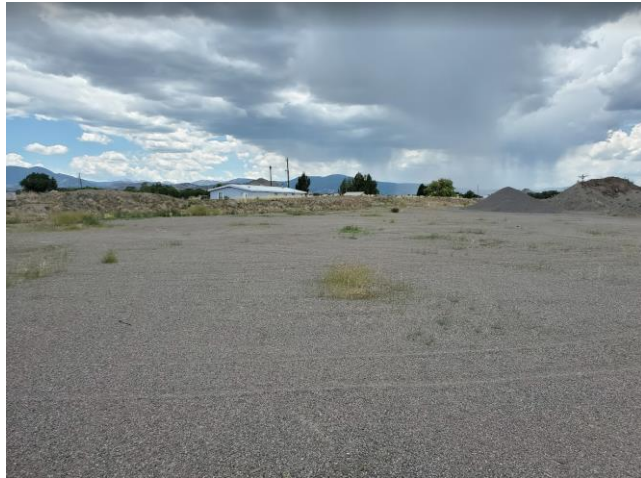
View to the southwest of berm that marks boundary.

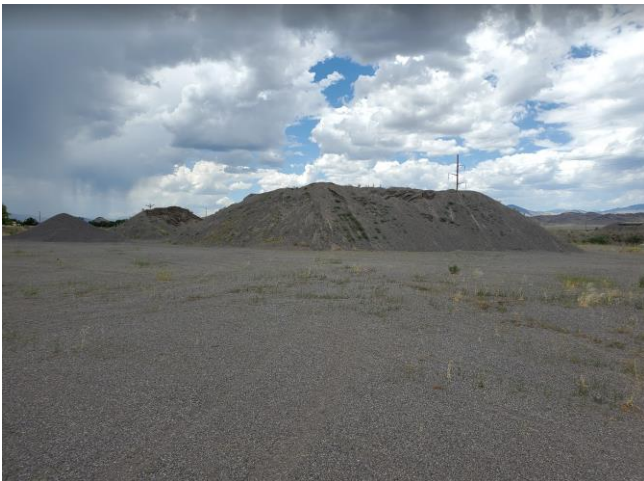
View to the northwest showing product stockpiles on site.

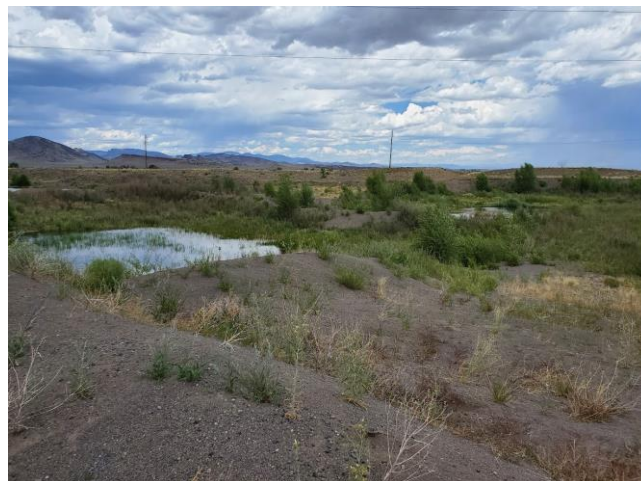
View to the northwest showing water in pit floor.

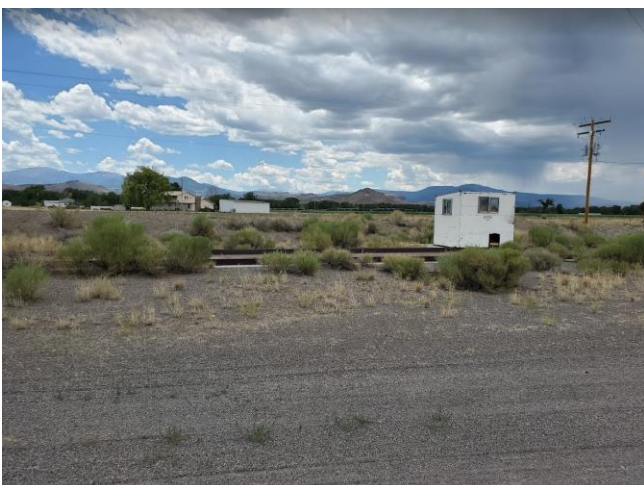
View to the south of scale one site.

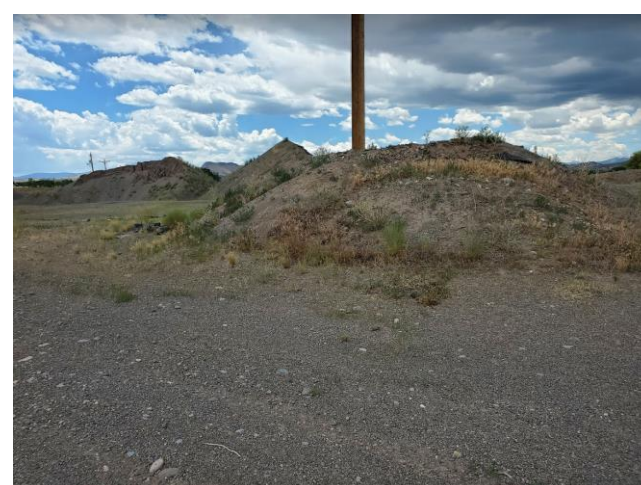
Mining has been conducted according to the submitted plan within the permit boundary. The walls of the pit are at an approximate reclamation grade resulting in no highwall on site. The side slopes of the pit are stable and well vegetated in most areas with volunteer species - showing no signs of erosion or slumping. The pit floor has multiple stockpiles of various sized materials both processed and unprocessed. In addition to product stockpiles there is also a topsoil stockpile used as a berm around the boundary. There appears to be an adequate amount of topsoil stockpiled for the permitted reclamation plan. Topsoil stockpiles are protected by vegetation and appear stable. No state listed invasive species were identified on site during the inspection. There was water present in the floor of the pit. This is in accordance with the approved mine plan. The pit is a recharge pond for return irrigation water. Powerlines cross the permit. Pillars are left around the poles according to the mine plan.

View of power pole with support pillar.
