**MINERALS PROGRAM INSPECTION REPORT**  
**PHONE: (303) 866-3567**

<b>MINE NAME:</b> Del Norte NKS Pit	<b>MINE/PROSPECTING ID#:</b> M-2012-007	<b>MINERAL:</b> Borrow material for	<b>COUNTY:</b> Rio Grande
<b>INSPECTION TYPE:</b> Monitoring	<b>WEATHER:</b> Clear	<b>INSP. DATE:</b> July 19, 2023	<b>INSP. TIME:</b> 15:00
<b>OPERATOR:</b> RMS Utilities, Inc.	<b>OPERATOR REPRESENTATIVE:</b> Kaitlyn Gallardo	<b>TYPE OF OPERATION:</b> 110c - Construction Limited Impact	
<b>REASON FOR INSPECTION:</b> Normal I&E Program	<b>BOND CALCULATION TYPE:</b> Complete Bond	<b>BOND AMOUNT:</b> \$15,620.00	
<b>DATE OF COMPLAINT:</b> NA	<b>POST INSP. CONTACTS:</b> None	<b>JOINT INSP. AGENCY:</b> None	
<b>INSPECTOR(S):</b> Todd Jesse	<b>INSPECTOR'S SIGNATURE:</b>

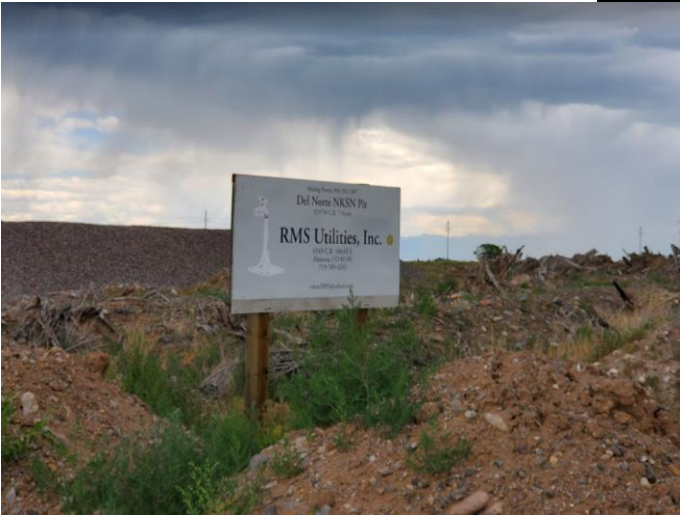
View to the north showing proper Mine ID signage posted at the entrance to the site.

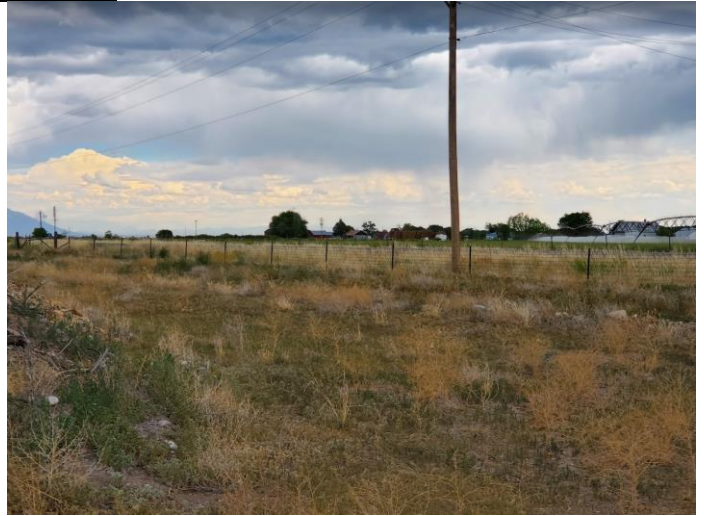
View to the southeast showing fence line that marks permit boundary.

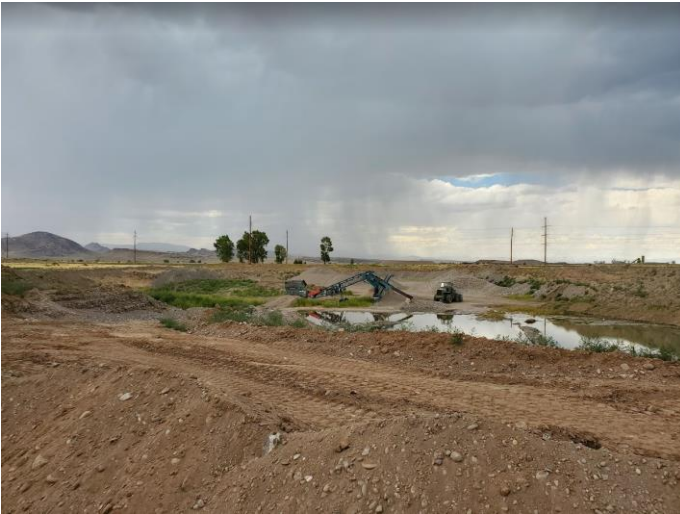
Mining has been conducted according to the submitted plan within the permit boundary. The walls of the pit are at an approximate 2:1 grade resulting in no highwall on site. The side slopes of the pit are stable and well vegetated in most areas with volunteer species - showing no signs of erosion or slumping. The pit floor has multiple stockpiles of various sized materials both processed and unprocessed. In addition to product stockpiles there is also a topsoil stockpile along the northern and eastern edges of the pit. There appears to be an adequate amount of topsoil stockpiled for the permitted reclamation plan. All stockpiles are protected by volunteer plant species and appear stable. No state listed invasive species were identified on site during the inspection. There was water present in the southwest corner of the pit. The water appears to be a few inches in depth and from a meteoric source. There is no permanent vegetation such as willows to suggest that this is ground water and there are lines on the pit wall that indicate that the water is receding. Neighboring pits that are slightly deeper have encountered the water table. Please be aware that in order to expose ground water a Gravel Well Pond Permit is required from the Colorado Division of Water Resources.

Overview of the pit with screening equipment looking to the north. Water is present in the south end of the pit.

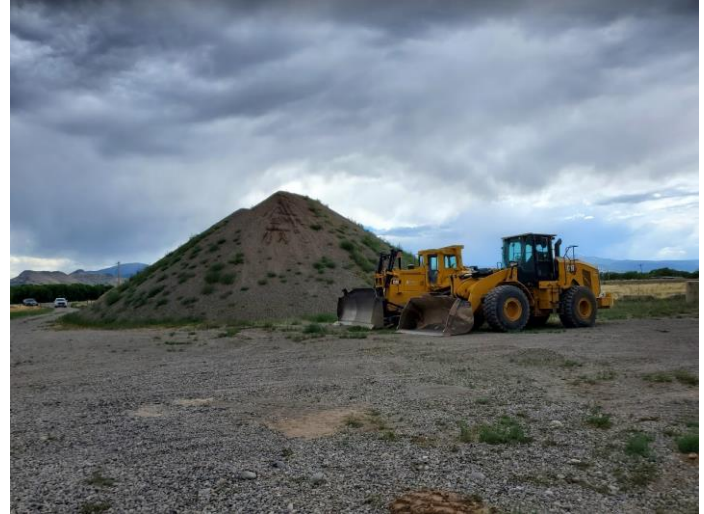
View to the south showing product stockpile, loader, and dozer.

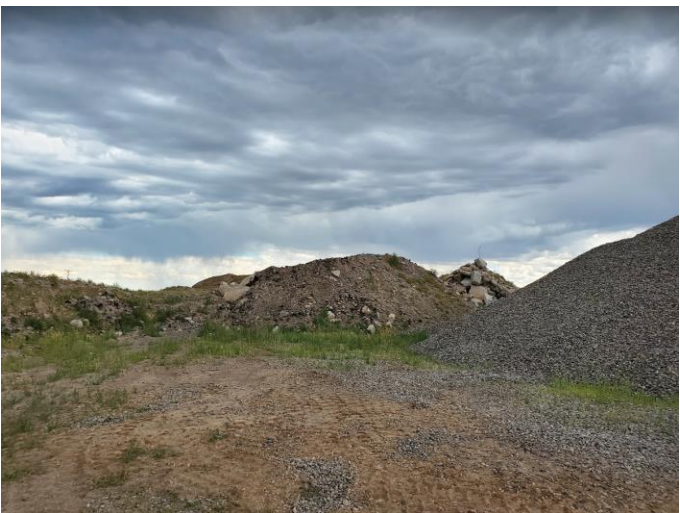
View to the southeast showing imported material to be processed.

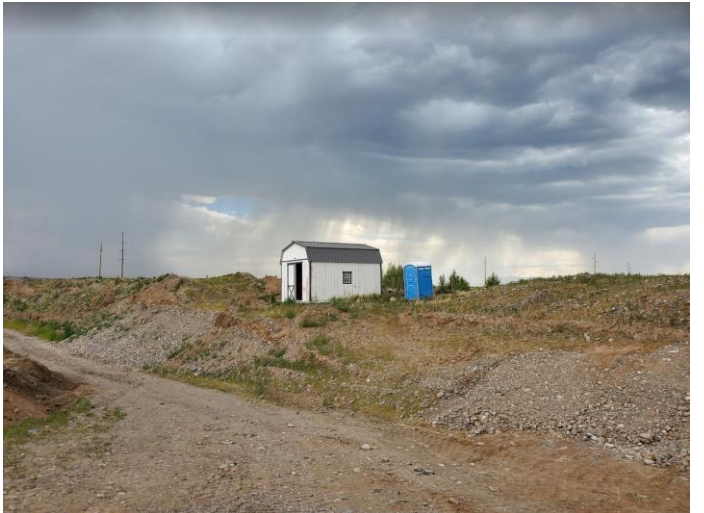
The proper mine identification signage was posted at the entrance to the site. Permit boundaries are clearly marked with fence line. The site was not active at the time of the inspection, but screening and loading equipment was on site. The only on-site support facility is a small shed used for storage and first aid. There are no hydrocarbons stored in the permit area. The site acts as an intermittent source of material for RMC Utilities.

View to the northeast showing on-site support facilities.
