MINERALS PROGRAM INSPECTION REPORT
PHONE: (303) 866-3567

MINE NAME: 374 Pit	MINE/PROSPECTING ID#: M-1987-020	MINERAL: Sand and gravel	COUNTY: Rio Grande
INSPECTION TYPE: Monitoring	WEATHER: Clear	INSP. DATE: July 19, 2023	INSP. TIME: 10:15
OPERATOR: Rio Grande County	OPERATOR REPRESENTATIVE: Patrick Sullivan	TYPE OF OPERATION: 112c - Construction Regular Operation	
REASON FOR INSPECTION: Normal I&E Program	BOND CALCULATION TYPE: None	BOND AMOUNT: \$0.00	
DATE OF COMPLAINT: NA	POST INSP. CONTACTS: None	JOINT INSP. AGENCY: None	
INSPECTOR(S): Todd Jesse	INSPECTOR'S SIGNATURE:

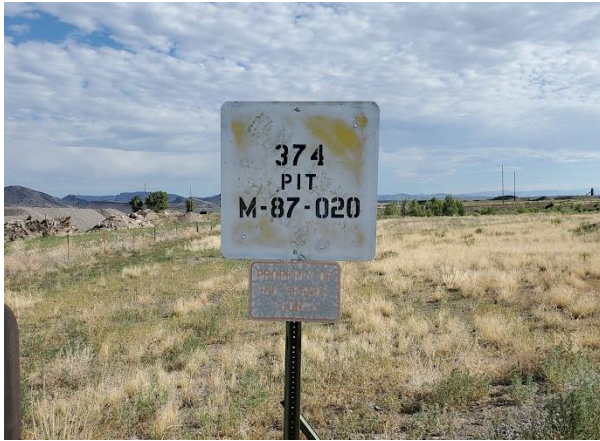
View to the north showing proper Mine ID signage posted at the entrance to the site.

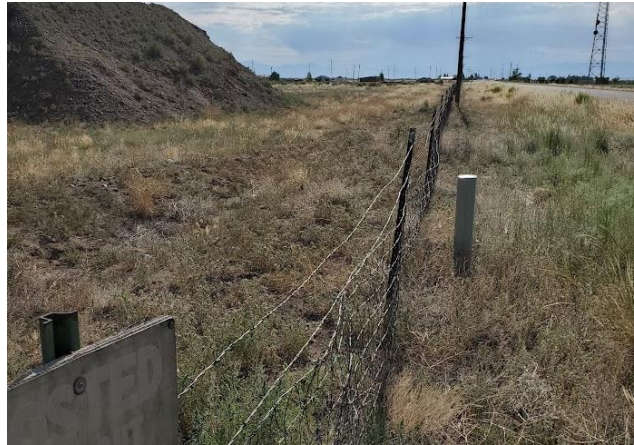
View to the east showing fence that marks the permit boundary.

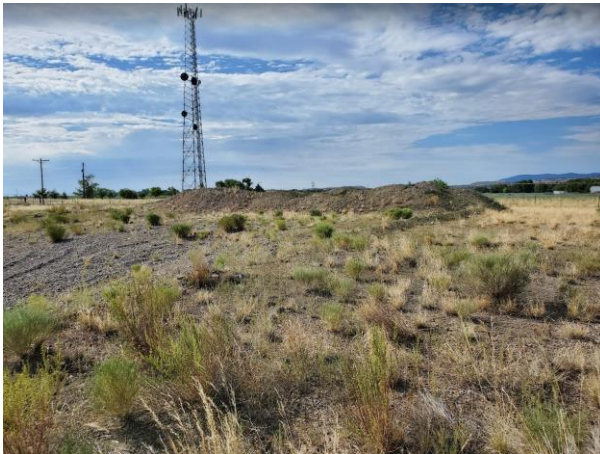
View to the southeast showing topsoil stockpile with vegetation cover.

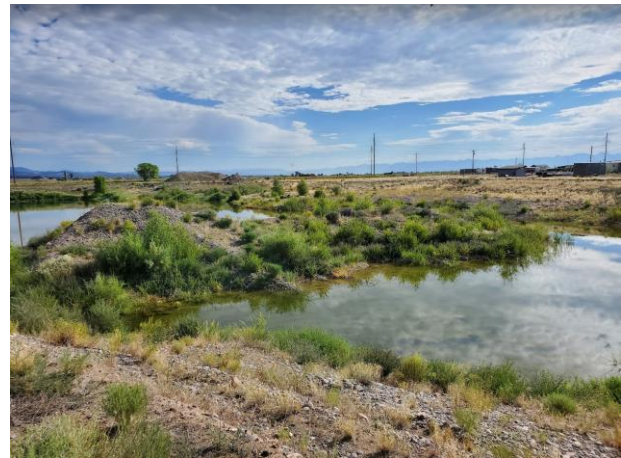
View to the northeast showing product stockpile on pit floor. Pit floor has water when nearby ditch flows.

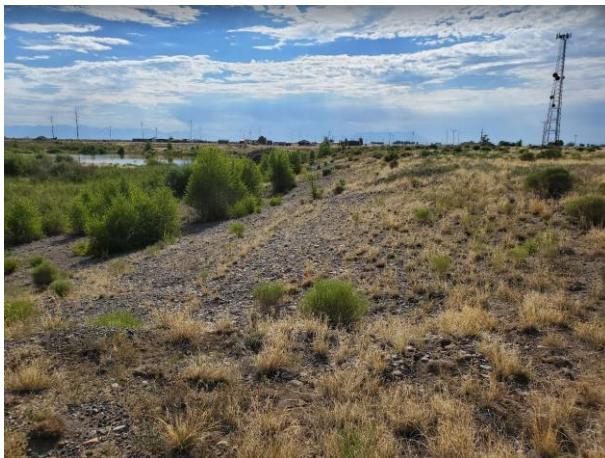
View to the east showing embankment of the pit. It has been mined near reclamation grade.

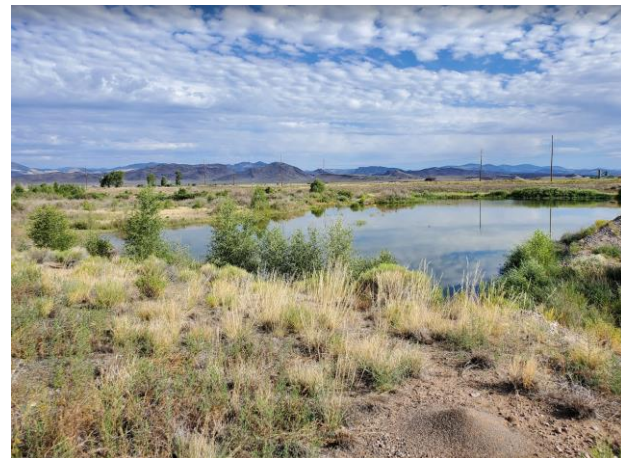
View to the northwest showing water in low areas of the pit floor. Deer were seen in the area.
