MINERALS PROGRAM INSPECTION REPORT

MINE NAME: South Fork Pit		MINE/PROSPECTING ID#: M-1987-019		MINERAL: Sand and gravel	COUNTY: Rio Grande
INSPECTION TYPE: Monitoring		WEATHER: Clear		INSP. DATE: July 19, 2023	INSP. TIME: 09:30
OPERATOR: Rio Grande County		OPERATOR REPRESENTATIVE: Patrick Sullivan		TYPE OF OPERATION: 110c - Construction Limited Impact	
REASON FOR INSPECTION: Normal I&E Program		BOND CALCULATION TYPE: None		BOND AMOUNT: \$0.00	
DATE OF COMPLAINT: NA		POST INSP. CONTACTS: None		JOINT INSP. AGENCY: None	
INSPECTOR(S): Todd Jesse		INSPECTOR'S SIGNATURE:

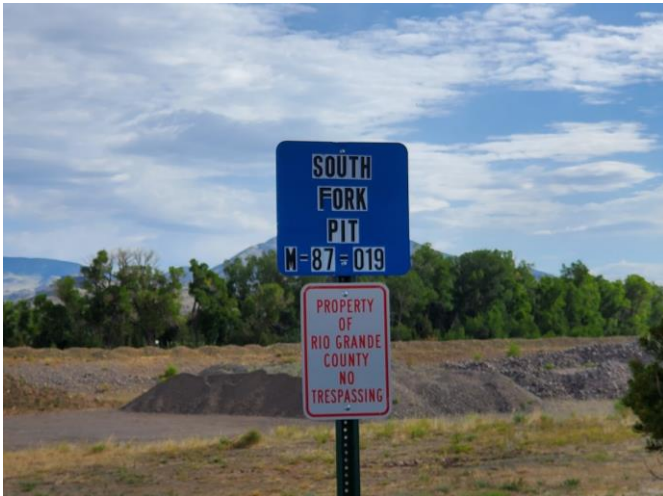
View to the north showing proper Mine ID signage posted at the entrance to the site.

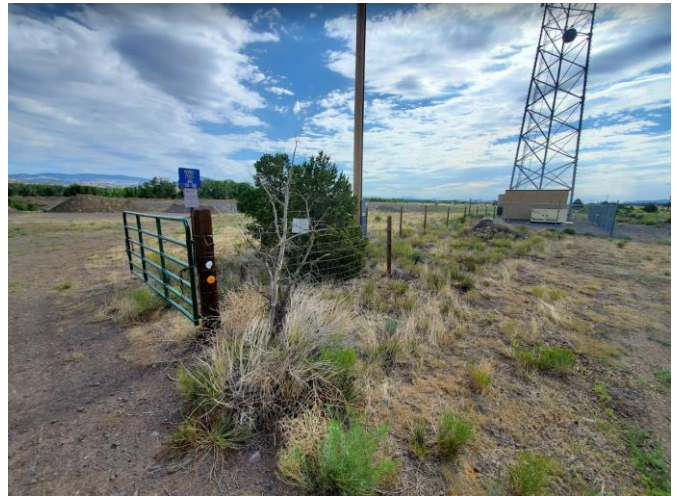
View to the east fence that marks permit boundary

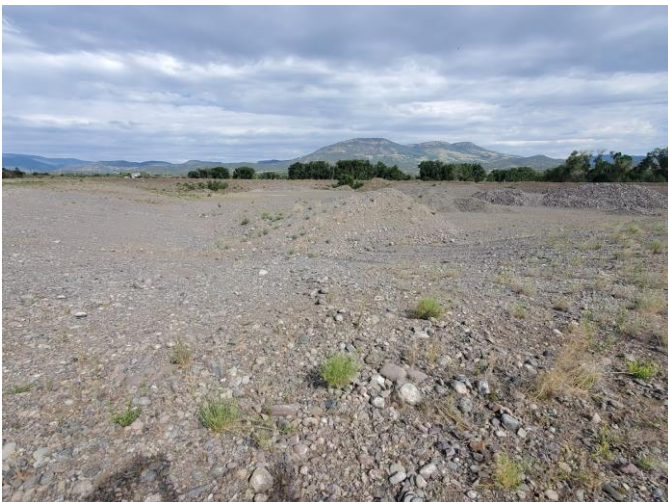
Overview of the pit looking to the northwest with stockpile of pit run material in foreground and screen material in background.

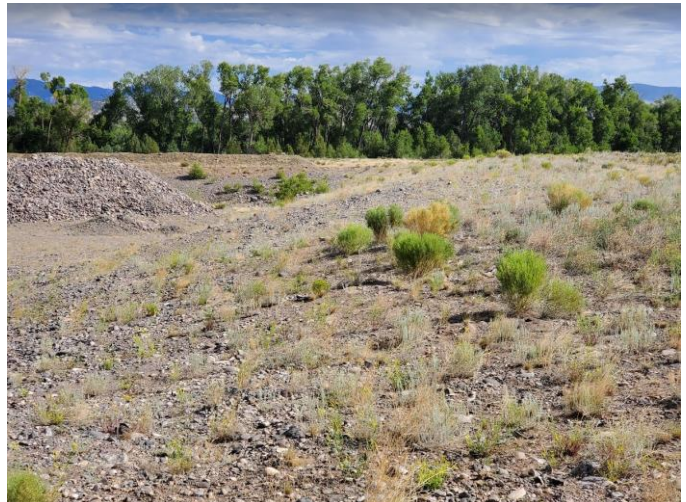
View to the north along the eastern edge of the pit showing slope of pit walls and volunteer vegetation.

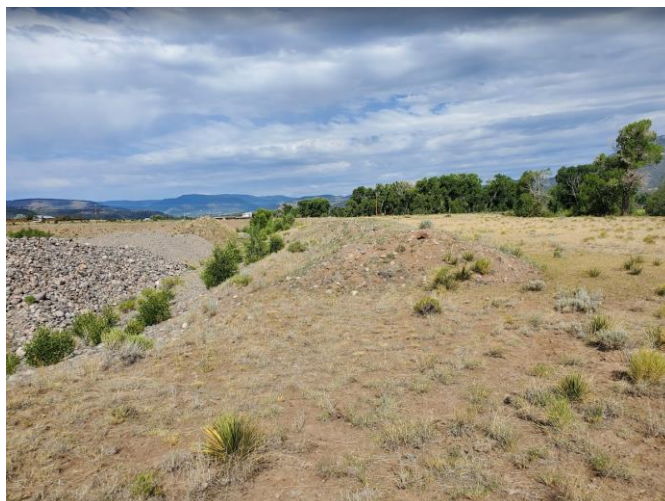
View to the west along northern edge of the pit showing topsoil stockpile.
