## MINERALS PROGRAM INSPECTION REPORT

<b>MINE NAME:</b> Seven Mile Plaza		<b>MINE/PROSPECTING ID#:</b> M-1978-065	<b>MINERAL:</b> Sand and gravel	<b>COUNTY:</b> Rio Grande
<b>INSPECTION TYPE:</b> Monitoring		<b>WEATHER:</b> Clear	<b>INSP. DATE:</b> July 19, 2023	<b>INSP. TIME:</b> 09:15
<b>OPERATOR:</b> Rio Grande County		<b>OPERATOR REPRESENTATIVE:</b> Patrick Sullivan	<b>TYPE OF OPERATION:</b> 110c - Construction Limited Impact	
<b>REASON FOR INSPECTION:</b> Normal I&E Program		<b>BOND CALCULATION TYPE:</b> None	<b>BOND AMOUNT:</b> \$0.00	
<b>DATE OF COMPLAINT:</b> NA		<b>POST INSP. CONTACTS:</b> None	<b>JOINT INSP. AGENCY:</b> None	
<b>INSPECTOR(S):</b> Todd Jesse	<b>INSPECTOR'S SIGNATURE:</b>

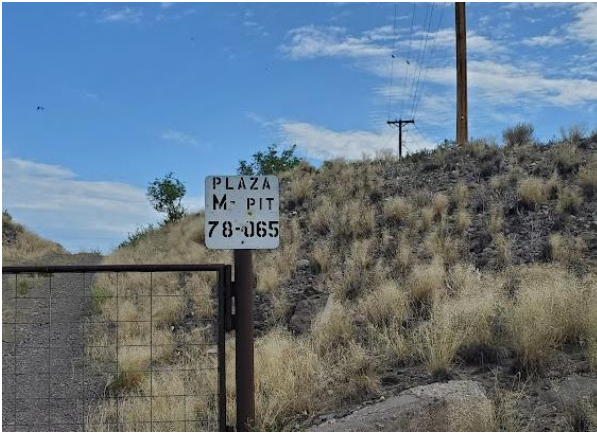
The proper mine identification signage was posted at the entrance to the site. Permit boundaries are clearly marked with earthen berms and t-posts. The site was not active at the time of the inspection and no mining/processing equipment was present. There are no on-site support facilities or hydrocarbon storage of any kind. The site acts as an intermittent source of material for Rio Grande Road and Bridge. Equipment is brought to site when there is a need to mine and process more material.

View to the north showing proper Mine ID signage posted at the entrance to the site.

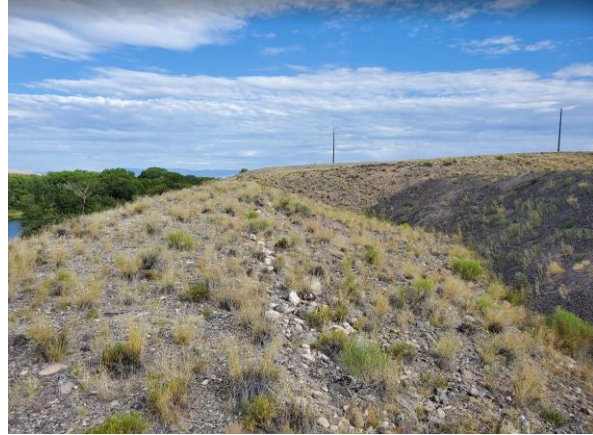
View to the northeast showing berm that marks permit boundary with t-posts in background.

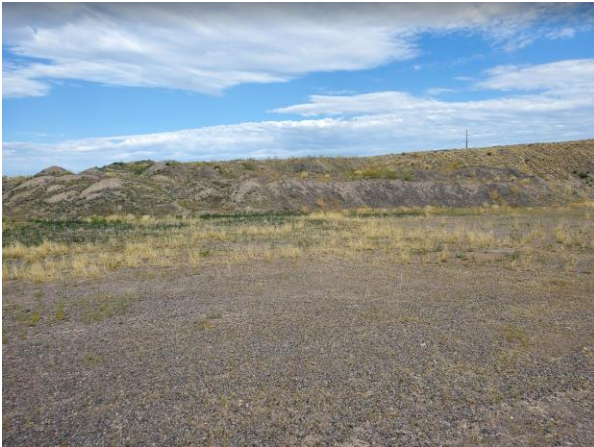
View to the northwest showing product stockpile protected by volunteer vegetation.

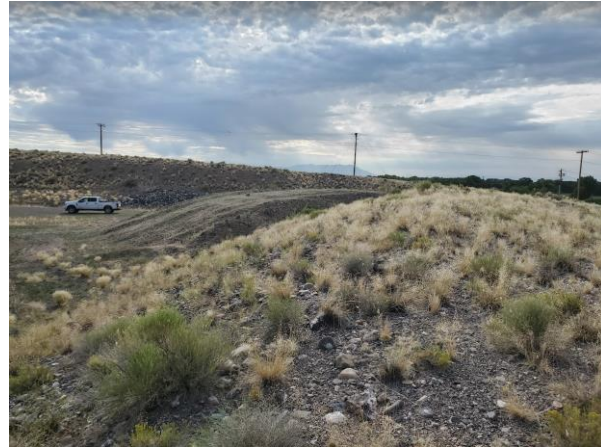
View to the east showing topsoil stockpile at end of berm. Stockpile is protected by vegetation.

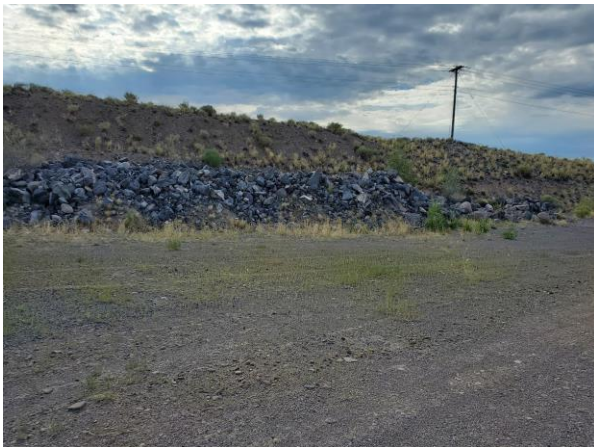
View to the east showing riprap stockpile.

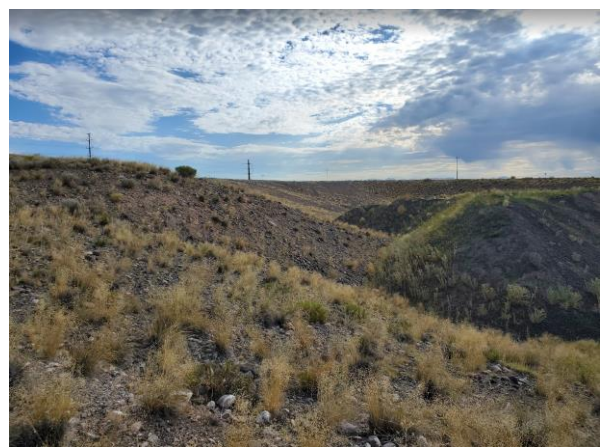
Mining has been conducted according to the submitted plan. Material was extracted at approximately reclamation grade resulting in no highwall on site. The side slopes of the pit are stable and well vegetated with volunteer species - showing no signs of erosion or slumping. The pit floor has multiple stockpiles various sized materials both processed and unprocessed. In addition to product stockpiles there is also a topsoil pile on site. There appears to be an adequate amount of topsoil stockpiled for the permitted reclamation plan. All stockpiles are protected by volunteer plant species and appear stable. No state listed invasive species were identified on site during the inspection. No groundwater has been exposed in the pit. The affected area exhibits positive drainage and no impounded meteoric water was present during the inspection.

View to the east showing northern embankment of the pit with multiple product stockpiles.
