C-1981-035 King Mine July 2023 Partial Inspection Report

PERMIT INFORMATION

Permit Number: C-1981-035 Mine Name: King Coal Mine Operator: GCC Energy, LLC Operator Address: Mr Jordan McCourt 6473 County Road 120 Hesperus, CO 81326	County: La Plata Operation Type: Underground Permit Status: Active Ownership: Private
	Operator Representative Present: Wade Wymore
Operator Representative Signature: (Field Issuance Only)

INSPECTION INFORMATION

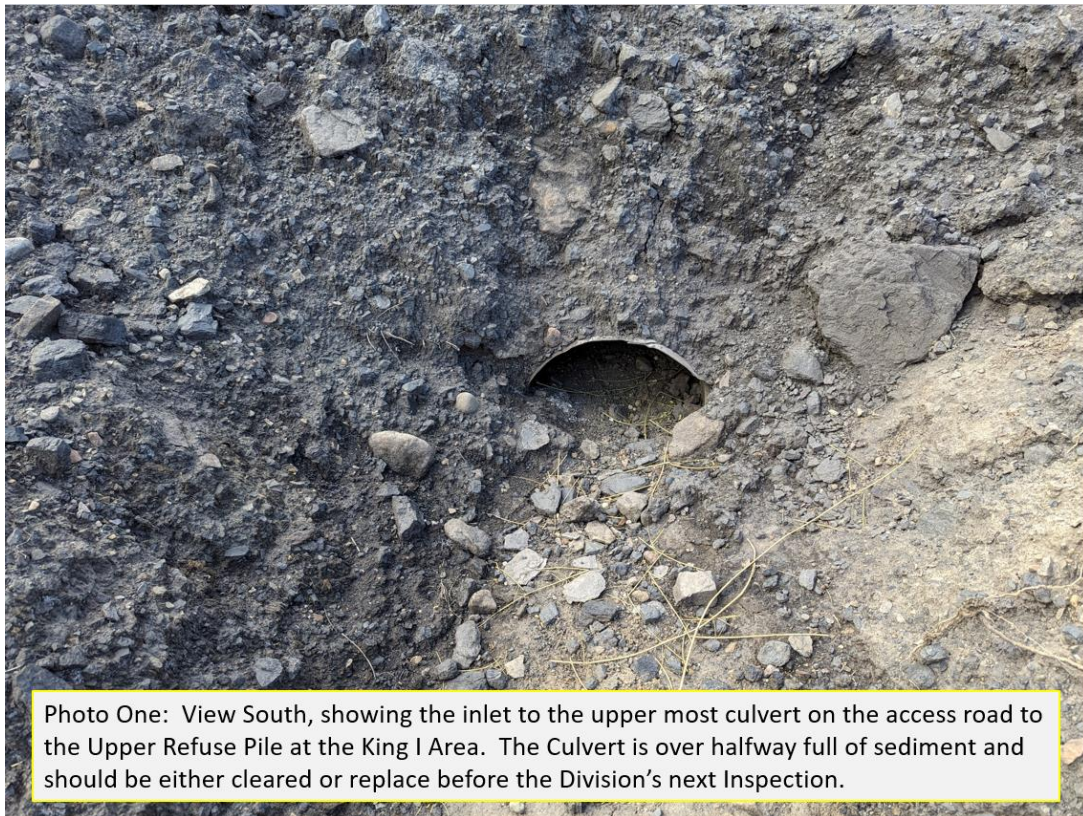
The internal drainage structures that had been identified as previous maintenance items were observed, specifically the culverts along the access road leading from the Lower Refuse Pile to the Upper Refuse Piles. Along that access road, the lower most culvert has been cleared and appeared to be able to function as designed. The middle culvert has not yet been cleared, however the Operator investigated the issue and determined that replacing the culvert was the best course of action. The new culvert is staged for installation however has not been installed yet. The Operator should replace the culvert as soon as conditions allow. The upper most culvert has not been cleared nor replaced. As seen in Photos One and Two the culvert is over half full of sediment and should either be cleared or replaced. The Operator took immediate action and the culvert was being cleaned that day. The Division will follow up to ensure completion during the next regular inspection.

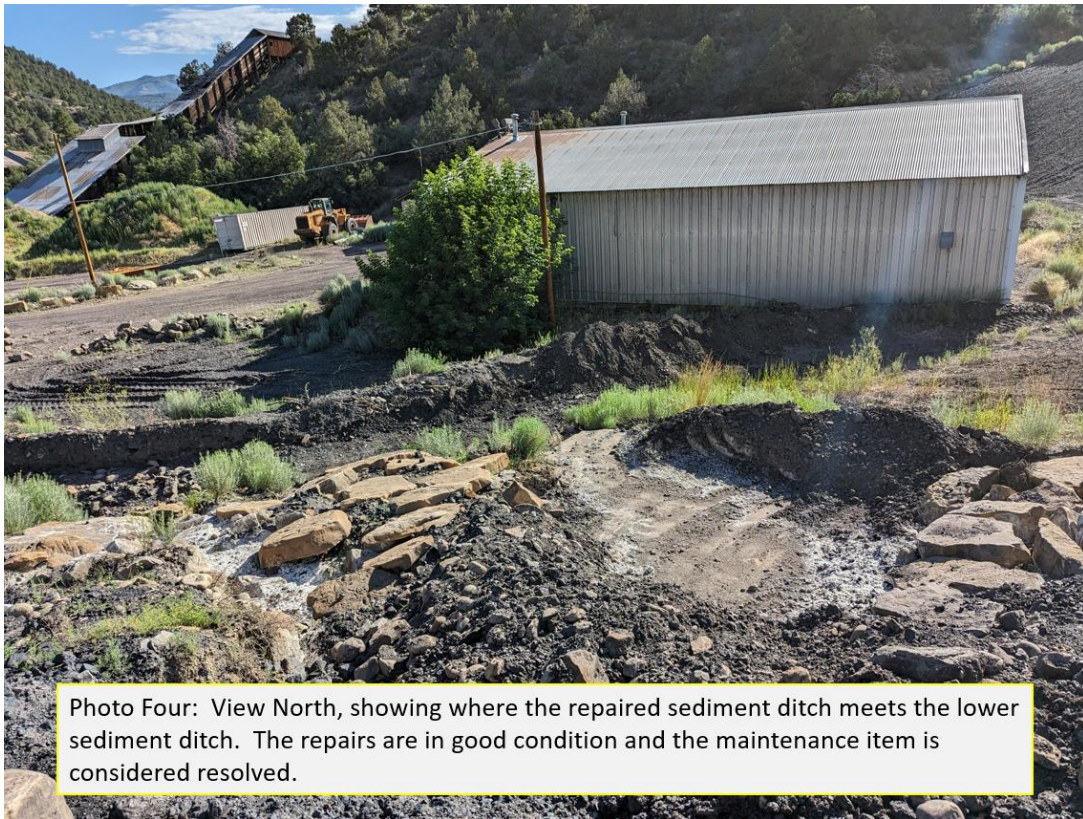
During the Division's previous inspections it was identified that the sediment ditch leading from the lower refuse pile, adjacent the access road, to the West Sediment Pond was in need of repair. The Operator has completed the task and installed rock check dams along the ditch to dissipate energy and prevent erosion. This maintenance item is considered resolved and the repaired sediment ditch can be seen in Photos Three and Four. The East and West Sediment Ponds at the King I area is in good condition and appear to be well below the design capacity. The

Photo Four: View North, showing where the repaired sediment ditch meets the lower sediment ditch. The repairs are in good condition and the maintenance item is considered resolved.

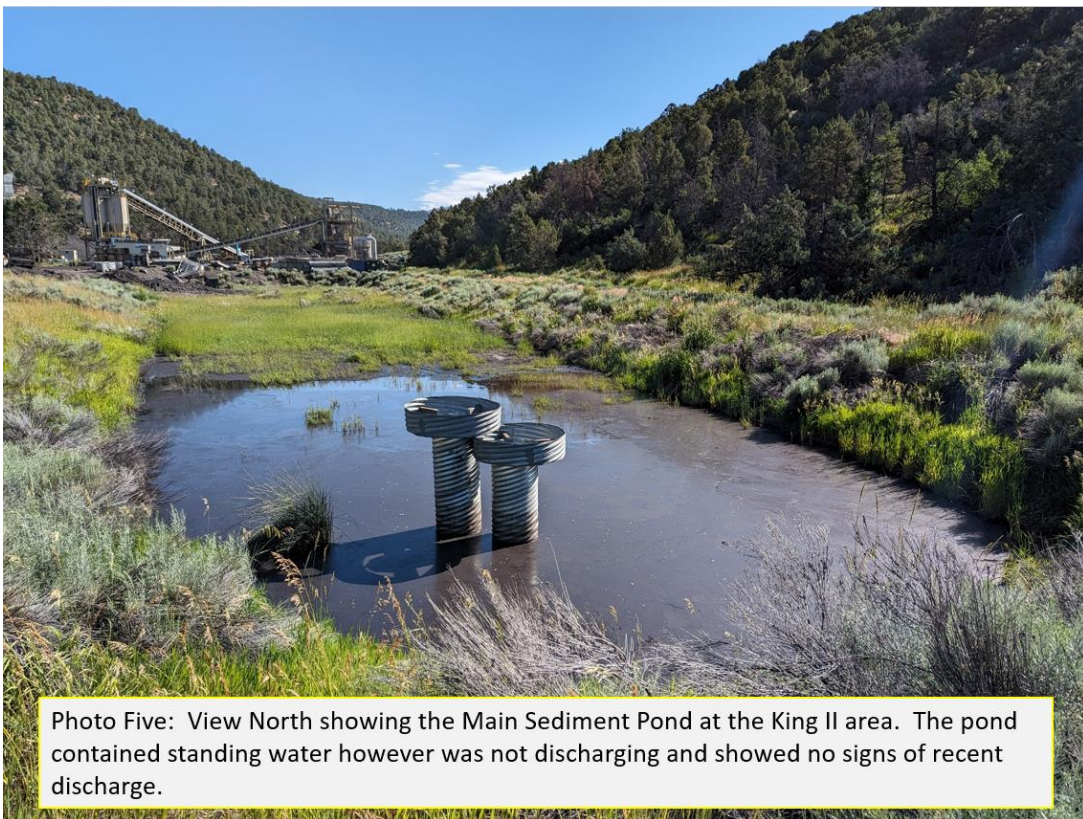
Photo Five: View North showing the Main Sediment Pond at the King II area. The pond contained standing water however was not discharging and showed no signs of recent discharge.

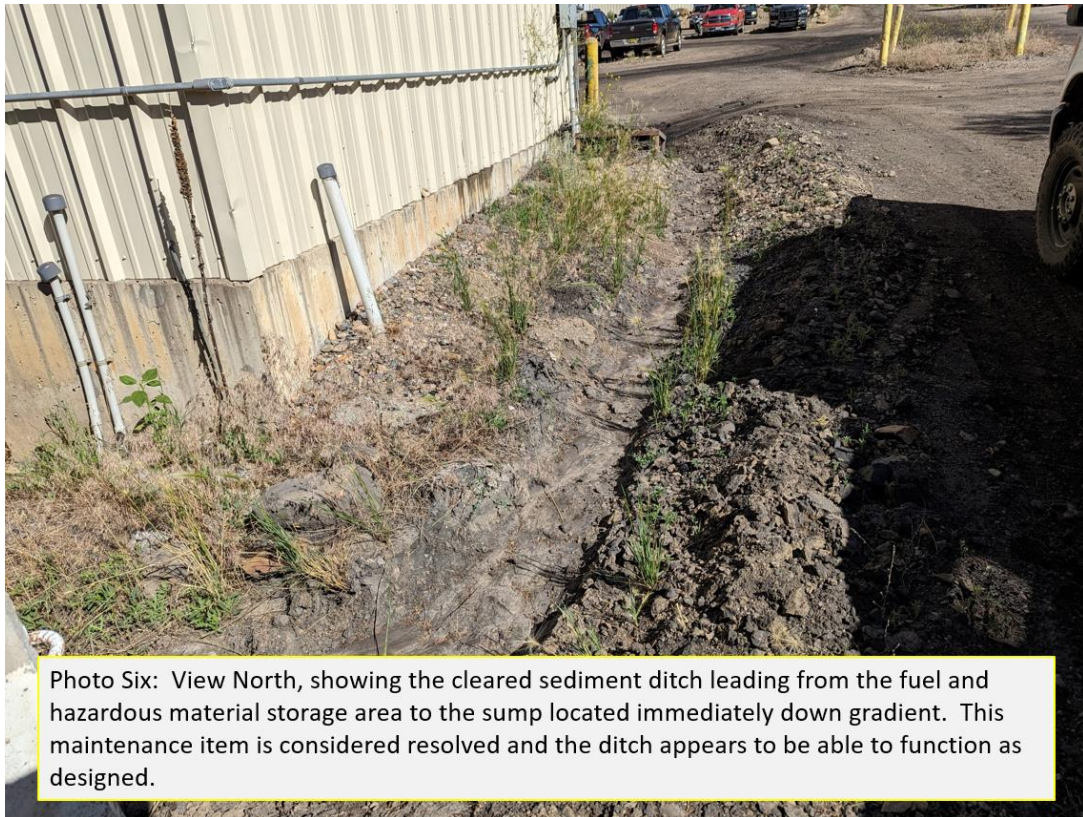
All other internal drainage structures at the King II area were observed to be in good condition and functioning as designed. One small ditch, leading from the fuel and hazardous materials storage area to a sump was identified as needing cleaned out during the Division's previous inspection. Photo Six shows the ditch has been cleared and appears to be able to function as designed. This maintenance item is considered resolved and no further action, other than monitoring is necessary.

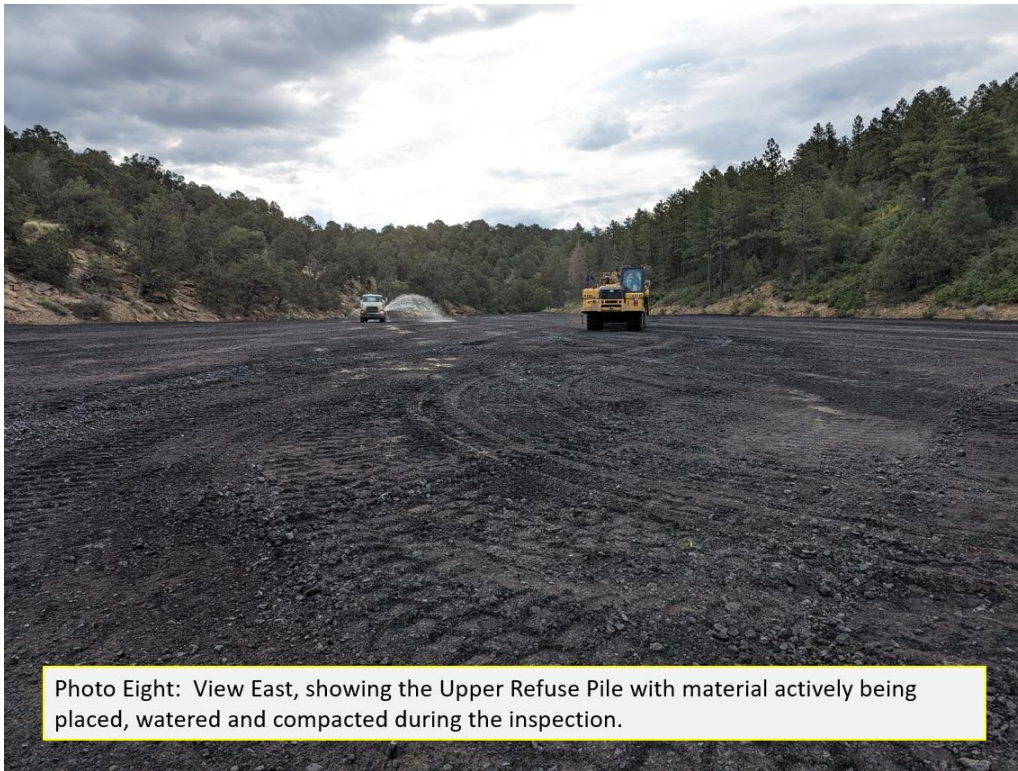
The Upper Refuse Pile was also observed to be in excellent condition as seen in Photos Eight and Nine. All material on the pile has been spread in lifts, watered and compacted in accordance with the design specifications. The pile exhibits positive drainage and no evidence of settling slumping or erosion, with the exception of a small area on the out slope of the face, near the southeast corner was noted. This area was eroded by melting snow and precipitation however is slated for repair soon. On site discussions with the Operator indicate the repair efforts will include pulling back the entire slope of the face to tie it in with the compacted surface, resulting in a gentler slope to prevent erosion. The discussed repair and sloping is slated to happen within the next few weeks, and the Division will follow up with the Operator during the next regularly scheduled inspection.

Photo Eight: View East, showing the Upper Refuse Pile with material actively being placed, watered and compacted during the inspection.

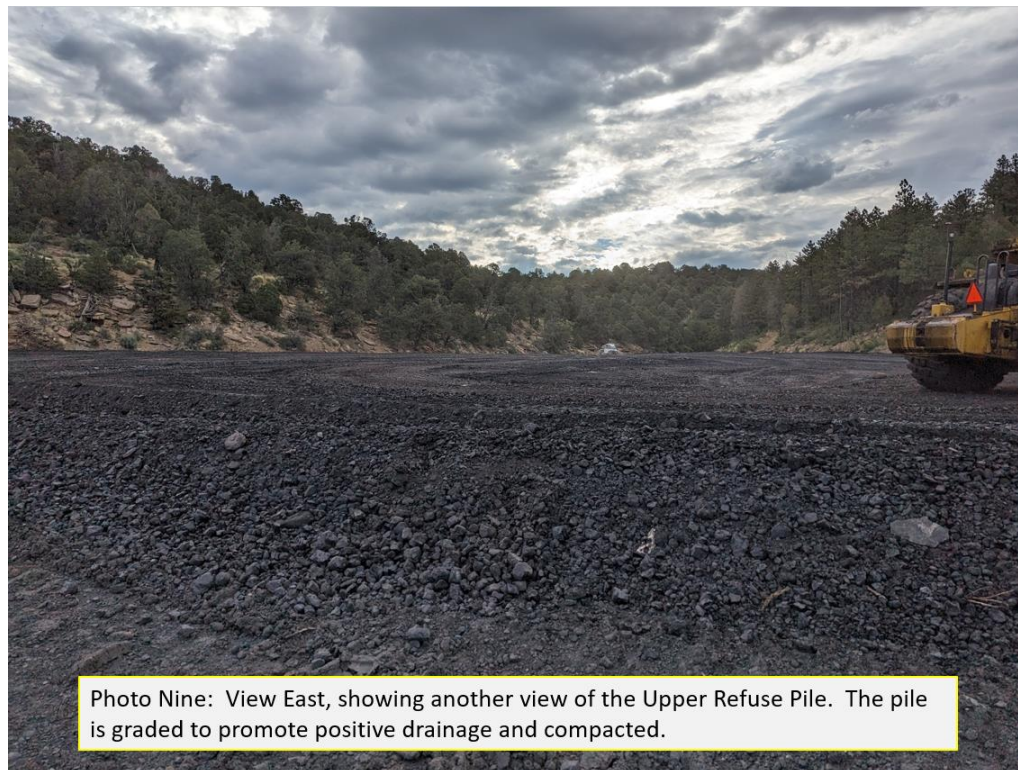
Photo Nine: View East, showing another view of the Upper Refuse Pile. The pile is graded to promote positive drainage and compacted.
